# **NATIONAL TRANSPORTATION SAFETY BOARD**

## **AIRCRAFT ACCIDENT REPORT**

**AIR PENNSYLVANIA 501  
PIPER PA-31-350, N5MS  
PHILADELPHIA, PENNSYLVANIA  
JULY 25, 1980**

**NTSB-AAR-87-1**

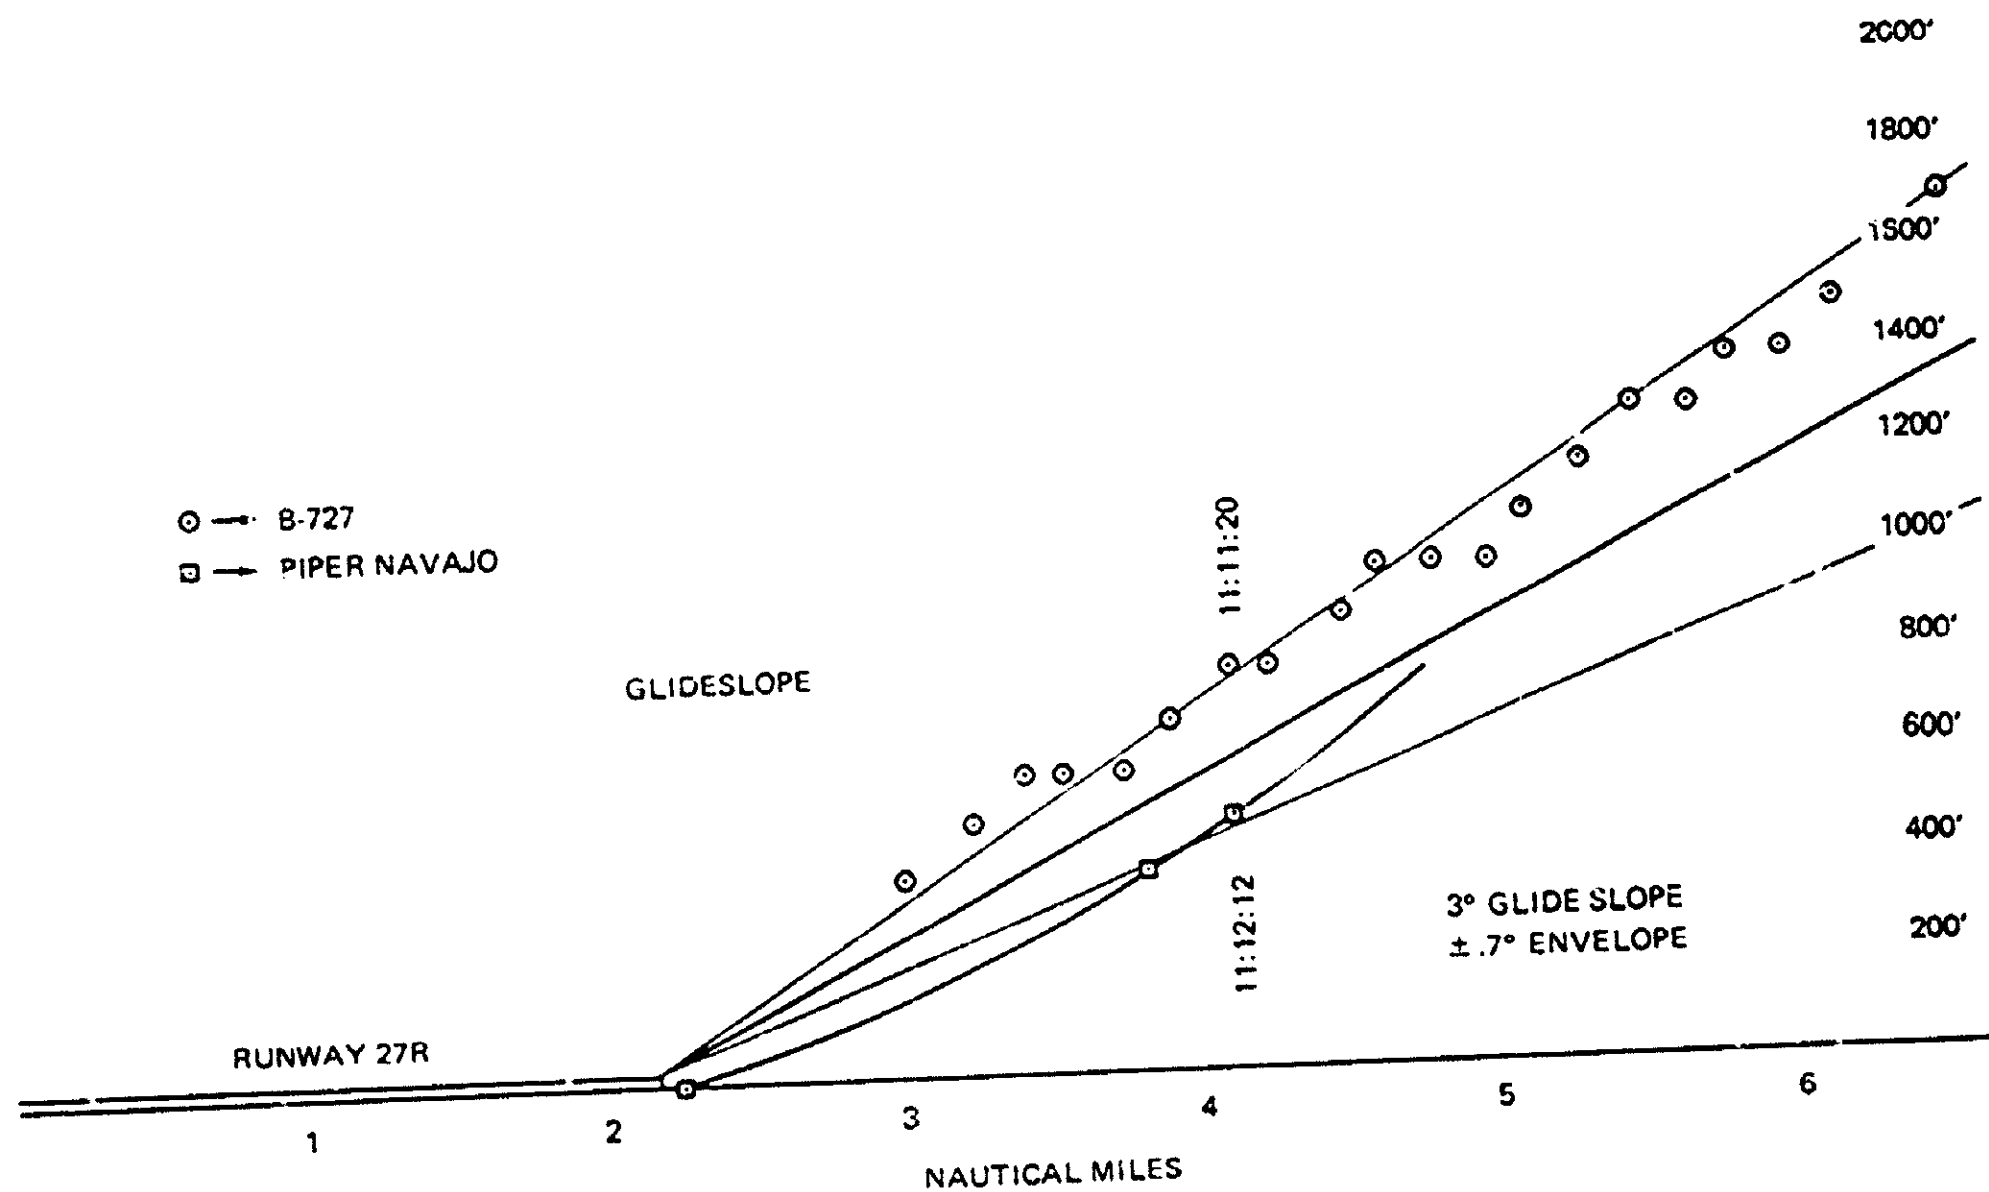
Figure 2. ARTS III ground track and glideslope (glideslope).

Automated Radar Terminal System III (ARTS III) ground track data for Air Pennsylvania 501 and United 555 were provided by Philadelphia Approach Control personnel under Safety Board direction. The data were plotted in three dimensions by the Safety Board's performance engineers. (See figures 1 and 2). <sup>3/</sup>

United Flight 555's ground track indicated that the aircraft was about 1,800 feet right (north) of the runway 27R centerline when it was 4 miles from the runway. The track gradually merged left, joining the centerline about 3/4 mile from the end of the runway. United 555's glidepath indicated a constant rate of descent on a 3.6° glideslope. At 0711:20, the aircraft was 2 miles from the runway end at 800 feet.

Air Pennsylvania 501's ground track indicated that the aircraft turned onto the final approach course 2 miles out, overshooting the runway slightly to the left (south). Air Pennsylvania 501's glidepath indicated descent on an approximate 2.3° glideslope. At 0712:12, the aircraft was 2 miles from the runway end at 500 feet.

When Flight 501 arrived at Philadelphia, the winds were reported as calm. Studies have shown that in calm wind conditions, wingtip vortices are strongest and most constant behind and below the generating aircraft. Therefore, pilots of small aircraft should fly above the larger aircraft's flightpath, altering course as necessary to avoid the area behind and below the generating aircraft. The pilot of Flight 501 flew a flightpath that was lower and flatter than the flightpath of United 555.

Flight in the vortex cores of a large aircraft can cause hazardous, induced rolling moments which can exceed the roll control capabilities of the encountering aircraft. The rolling effect is caused by the right wingtip vortex core rotating counterclockwise and the left wingtip vortex core rotating clockwise. Since Flight 501 rolled inverted to the left and collided with the ground left (south) of runway centerline, it is most likely that the aircraft encountered the right wingtip vortex generated by United 555.
