Aircraft Accident Investigation

Report 802-1017

Advance Airlines of Australia
Beech Super King Air 200 VH-AAV
Sydney (Kingsford Smith) Airport,
New South Wales
21 February 1980.

September 1981

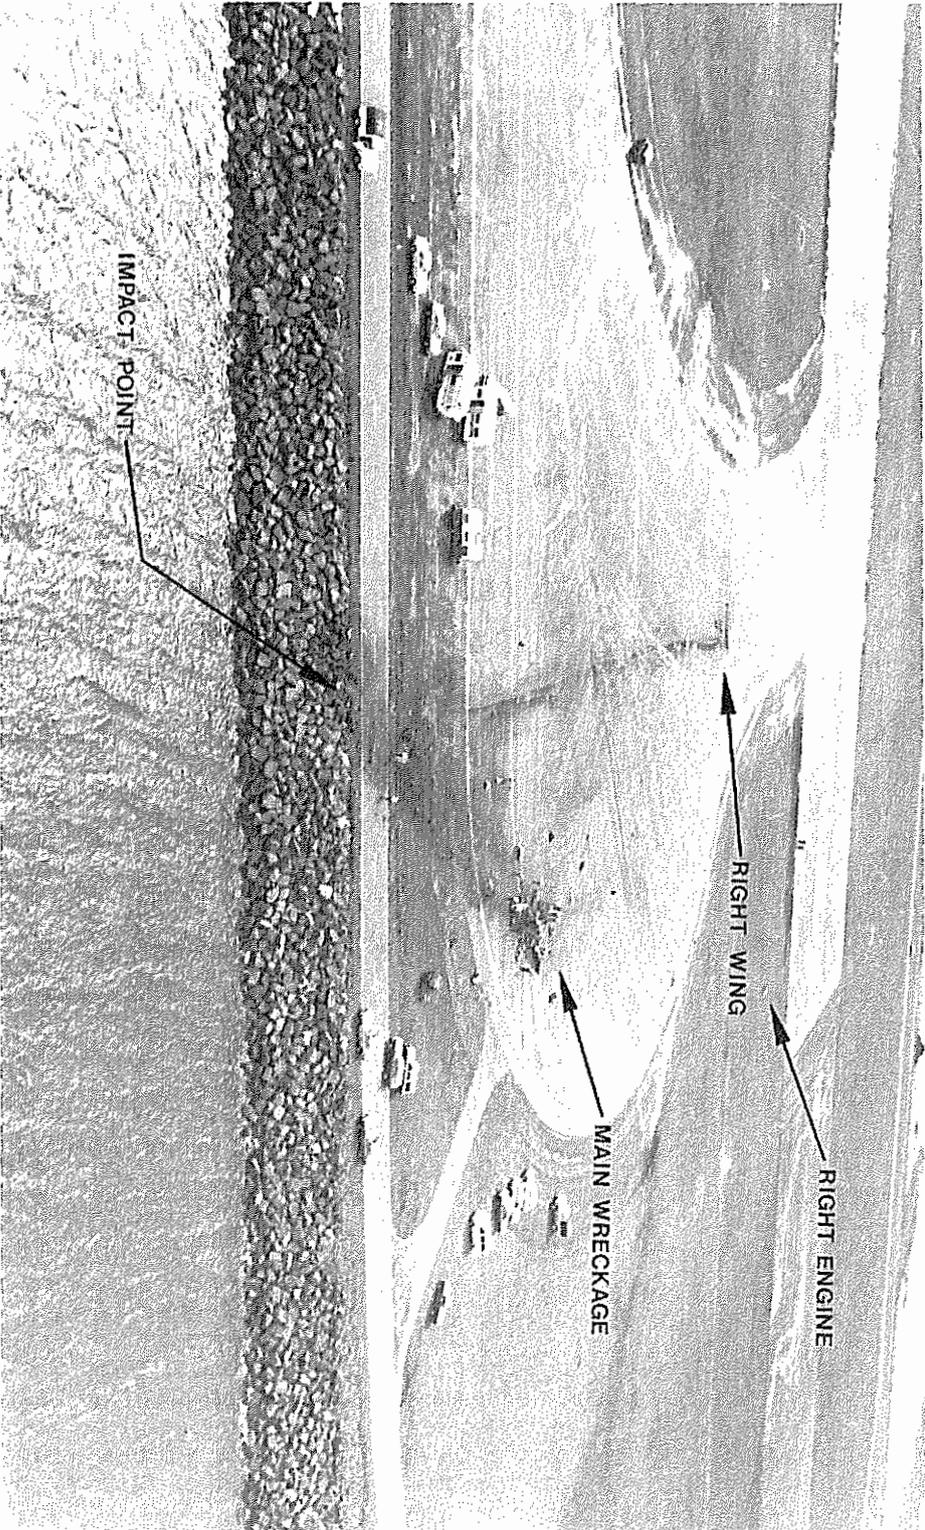
The aircraft struck the sea wall in a nose-high attitude, banked approximately 5 degrees to the left and skidding 19 degrees to the right.

Fig. 2. The accident site

On impact with the sea wall the aircraft's left wing disintegrated and the fuel contained therein ignited in a 'fire ball' explosion that engulfed the fuselage. The detached right wing spilled burning fuel as it was thrown across the ground. The fire zone was therefore some 125 metres long, with main centres at the fuselage and right wing.

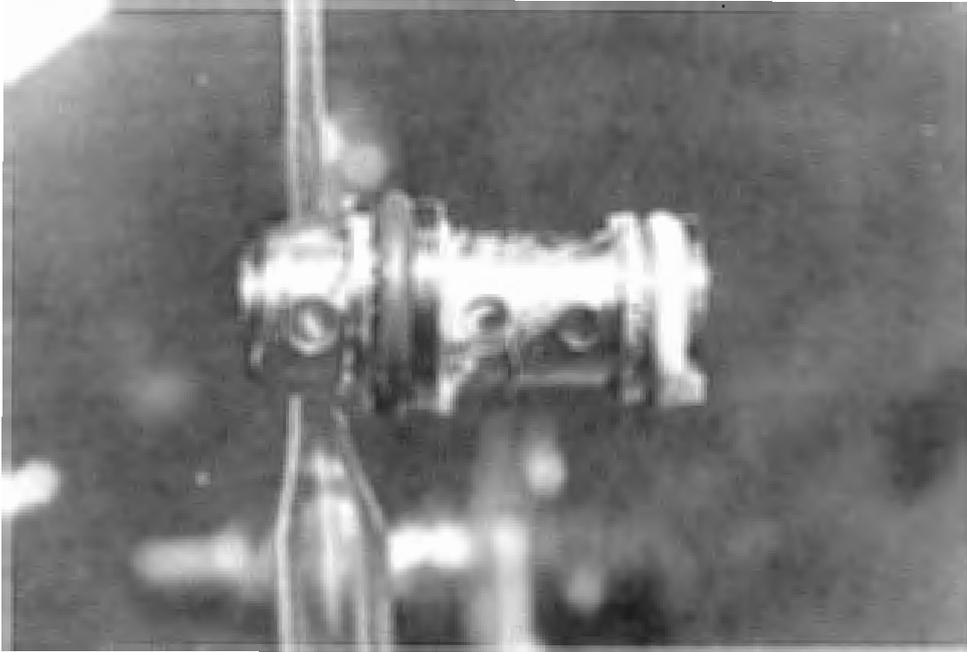
Fig. 3. Gelatinous deposit on left engine FCU bypass valve sleeve assembly.

Water was found throughout the various chambers of the FCU and its associated fuel pump. In addition, many of the components, such as valves, were found to be coated with a translucent material, resembling petroleum jelly. On drying, these became white powdery deposits. The deposits varied from thin films to quite thick coatings, and were sometimes associated with rust-like deposits. (Refer Figs. 3 and 4)

As noted in Section 1.16.1, many of the components of the left FCU were coated in a translucent material that, on drying, became a white powder. Electron probe micro analysis of a sample was carried out. The results indicated that the sample contained the elements aluminium, oxygen, chlorine and potassium. The former two were present in considerable quantity whilst chlorine was estimated at 5 to 10 per cent and potassium as a strong trace. No other elements, above the atomic number of carbon, were evident. It was noted that the sample displayed slight volatility and charring under the conditions of the electron beam and vacuum, a situation typically associated with the presence of an organic material.

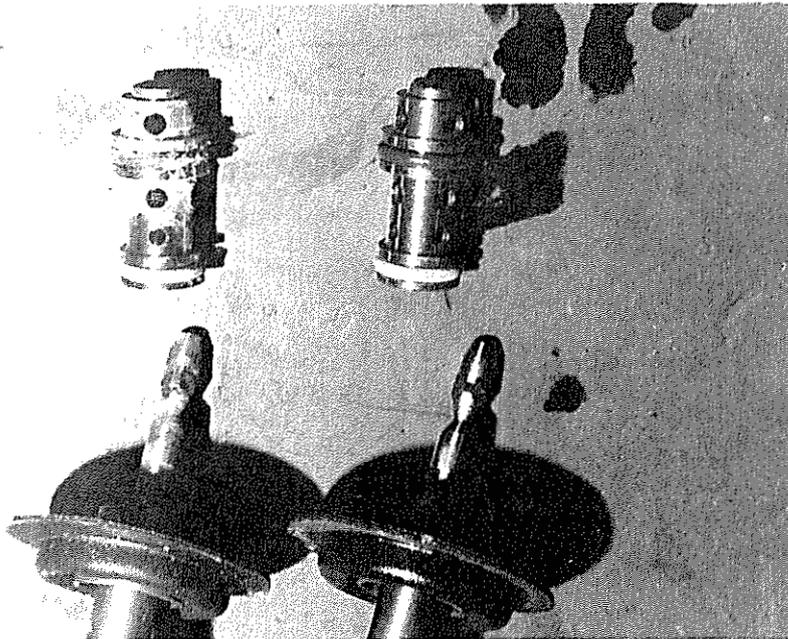
Fig. 4. Bypass valve and sleeve assemblies of left and right engine FCUs. The left engine components show considerable rusting and deposits. The gelatinous deposit on the left engine sleeve assembly has dried to a white powdery material.
