Aircraft Accident Investigation

Report 802-1017

Advance Airlines of Australia
Beech Super King Air 200 VH-AAV
Sydney (Kingsford Smith) Airport,
New South Wales
21 February 1980.

September 1981

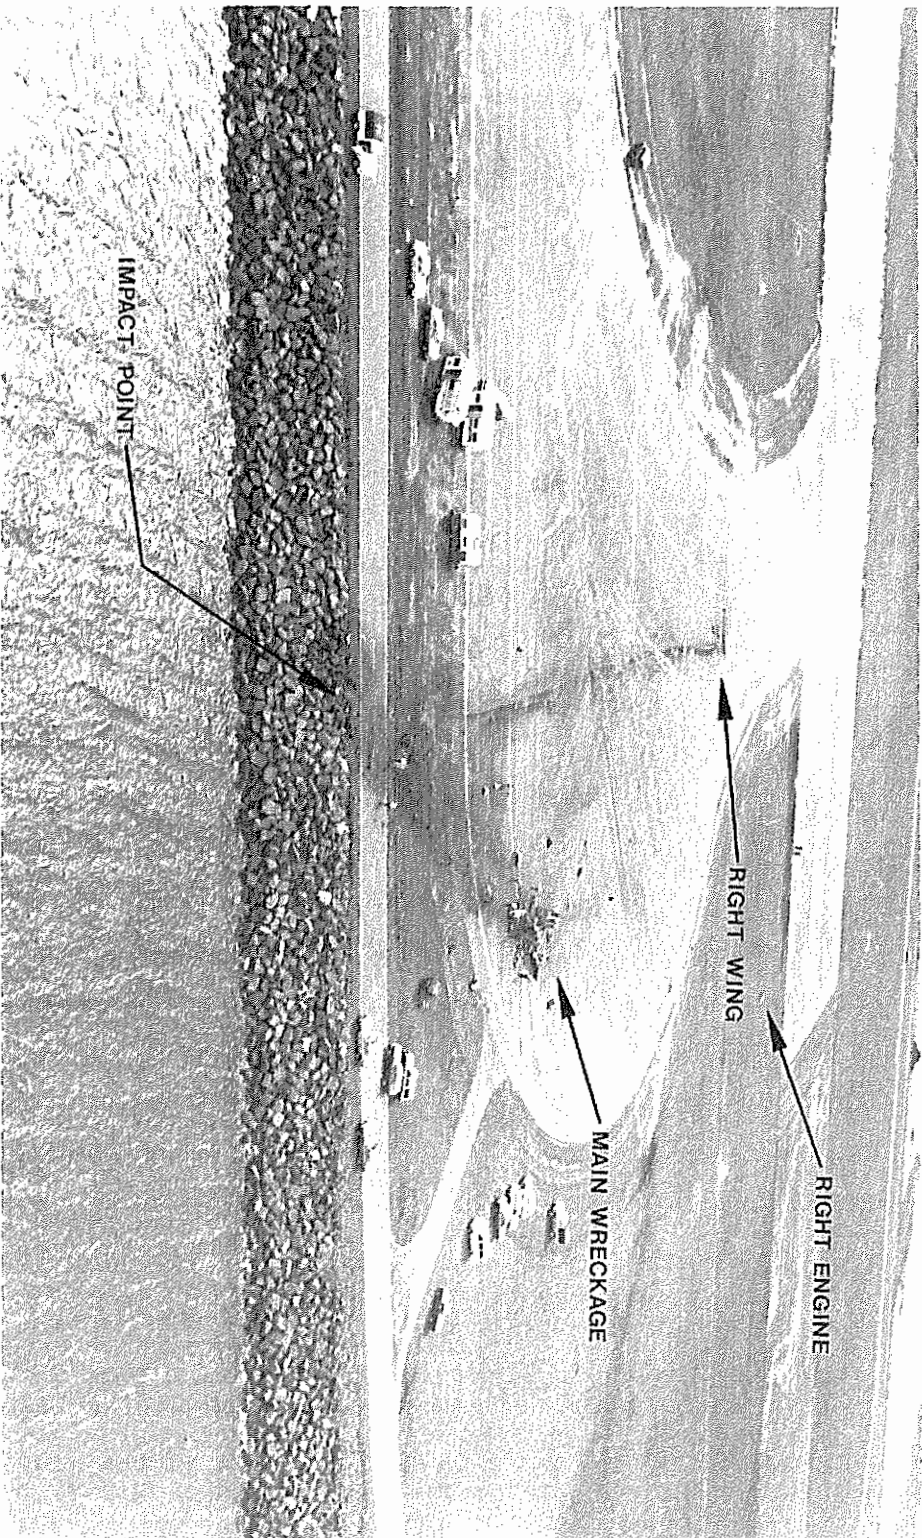
Fig. 2. The accident site

The aircraft struck the sea wall in a nose-high attitude, banked approximately 5 degrees to the left and skidding 19 degrees to the right.

As the lower fuselage was destroyed by fire, it was not possible to establish an accurate pitch attitude at impact. However, the nose section, as far aft as Station 77, had cleared the wall and there was ample evidence that the fuselage had been subjected to high vertical deceleration at impact. Because of the large angle of yaw and nose-high attitude, it is considered likely that the collision with the sea wall was not the first impact. It is probable that the aircraft struck the water first and then ricocheted into the sea wall. Damage to the right propeller supports this hypothesis. There was forward bending of all blades, consistent with contacting a medium such as water.

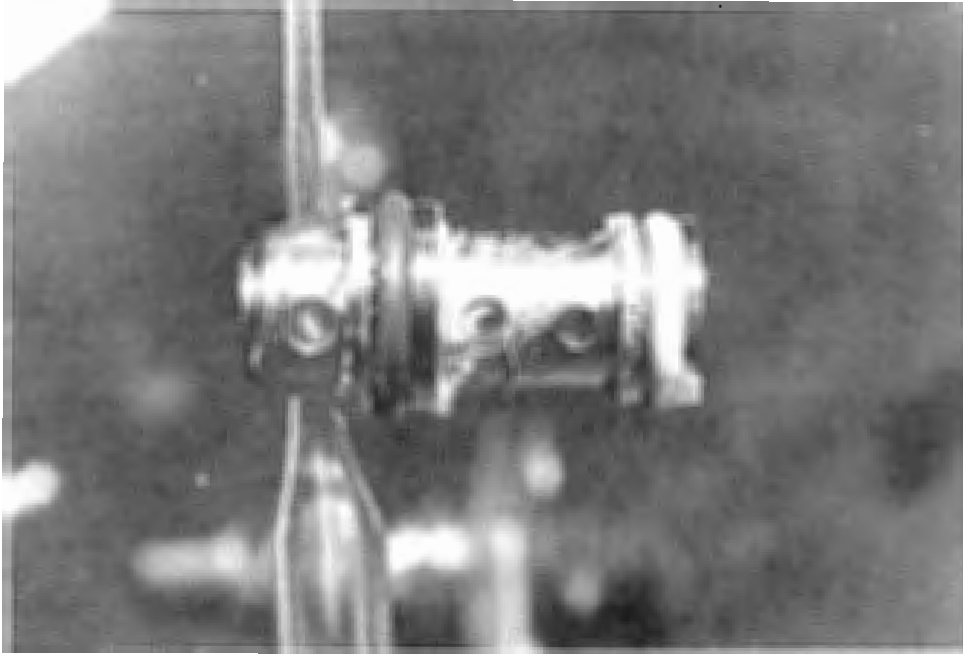
Fig. 3. Gelatinous deposit on left engine FCU bypass valve sleeve assembly.

Water was found throughout the various chambers of the FCU and its associated fuel pump. In addition, many of the components, such as valves, were found to be coated with a translucent material, resembling petroleum jelly. On drying, these became white powdery deposits. The deposits varied from thin films to quite thick coatings, and were sometimes associated with rust-like deposits. (Refer Figs. 3 and 4)

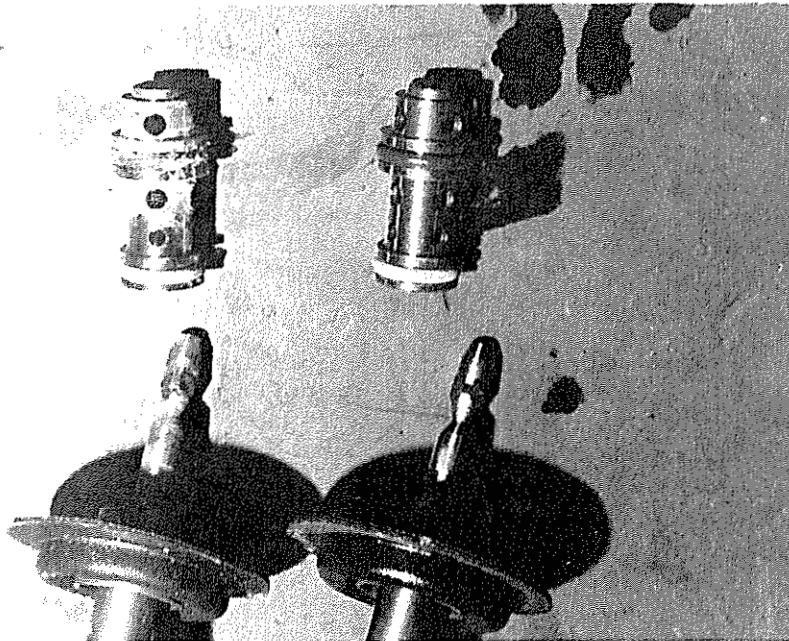
Fig. 4. Bypass valve and sleeve assemblies of left and right engine FCUs. The left engine components show considerable rusting and deposits. The gelatinous deposit on the left engine sleeve assembly has dried to a white powdery material.

As noted in Section 1.16.1, many of the components of the left FCU were coated in a translucent material that, on drying, became a white powder. Electron probe micro analysis of a sample was carried out. The results indicated that the sample contained the elements aluminium, oxygen, chlorine and potassium. The former two were present in considerable quantity whilst chlorine was estimated at 5 to 10 per cent and potassium as a strong trace. No other elements, above the atomic number of carbon, were evident. It was noted that the sample displayed slight volatility and charring under the conditions of the electron beam and vacuum, a situation typically associated with the presence of an organic material.
