Accident No. 45-59-504

WAR DEPARTMENT
U. S. ARMY AIR FORCES
REPORT OF AIRCRAFT ACCIDENT

(1) Place A-38 (2) Date 9 May 1945 (3) Time 0804
 AIRCRAFT: (4) Type and model C-47B-2 (5) A. F. No. 43-46830 (6) Station A-38
 Organization: (7) IX TCC (8) 441st TCG (9) 302nd TCG
 (Command and Air Force) (Group) (Squadron)

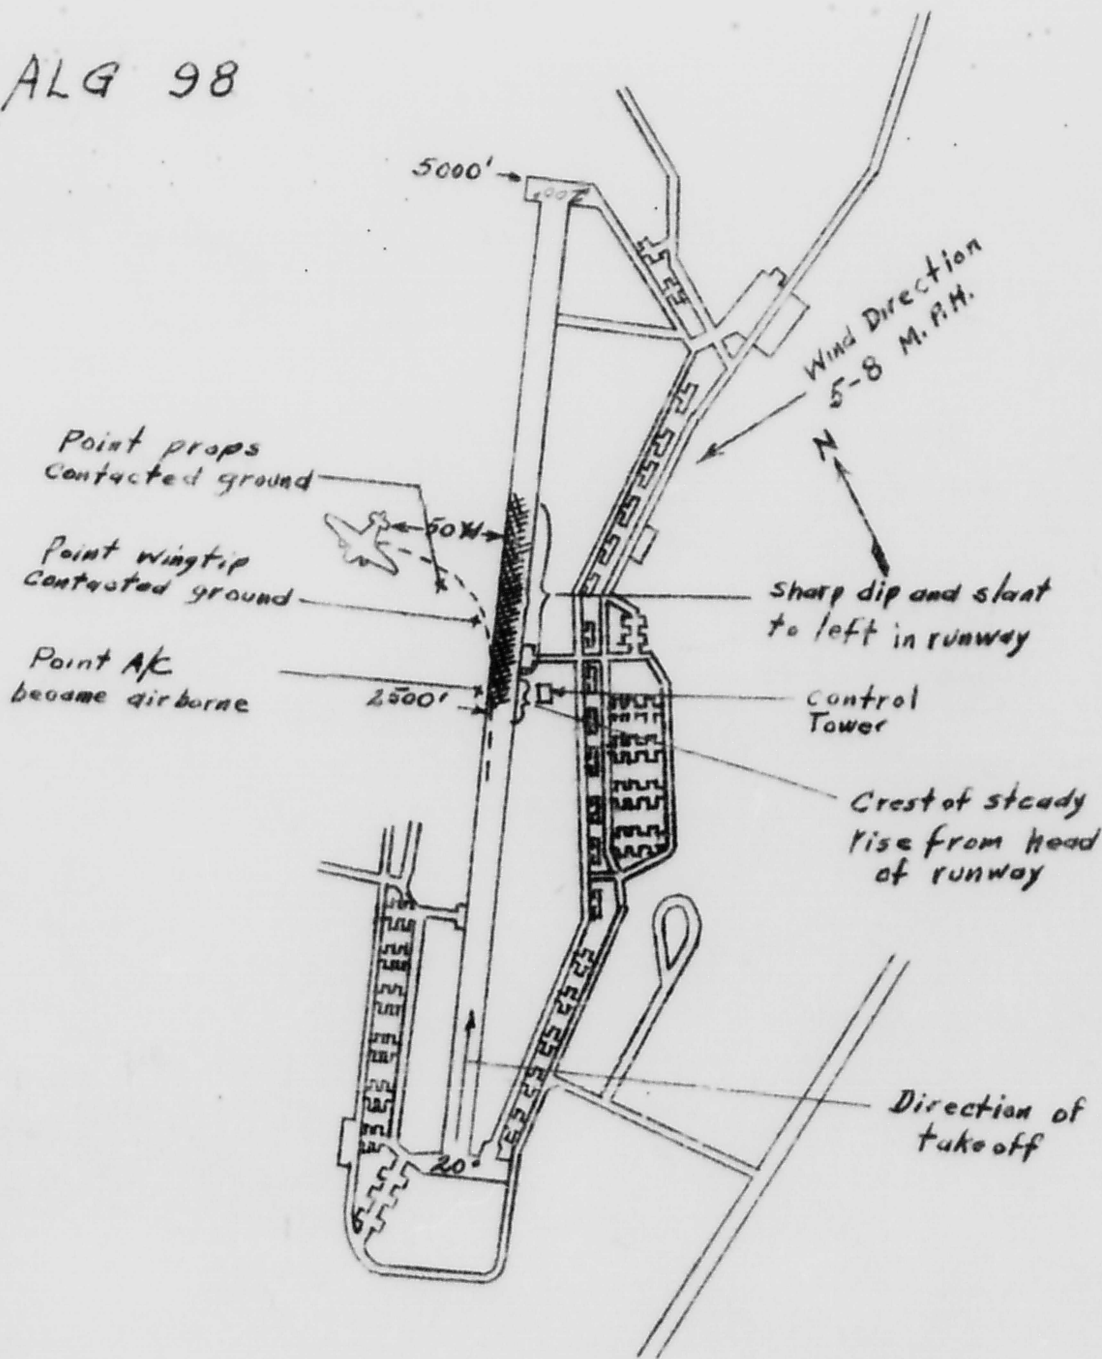
Diagram of accident involving aircraft # 43-48880
at A-98, 0804 hours, 9 May 1945

STATEMENT OF RESPONSIBILITY: It is the opinion of the investigating committee that pilot error was the major cause of the accident. The plane did not follow a true course down the runway and did not have enough flying speed to remain airborne in propwash. The gear was in the process of being retracted. However, the runway has a definite hump at approximately the point that loaded C-47 type aircraft normally become airborne, the runway definitely slopes to the left and the pilot had a slight crosswind from the right. It is felt that these factors did contribute to the accident in a minor degree but all other planes of this squadron took off under the same conditions without mishap.

The runway (PSP construction-5000ft. long) is uneven with a steady rise for 2500 ft. then it drops quickly for approximately 1000 ft. and rises to the end. Over the crest of the rise and for about 1000 ft. beyond, the runway slants to the left.

Number thirteen aircraft of the formation (loaded with 700 gals. of gas-6160 Lbs. became airborne at the crest of the rise. It was on the left side of the strip and immediately after leaving the ground knocked the top off a runway marker (3 ft. high - 4 ft. from the edge of the PSP).

The pilot held the ship in the air and appeared to have flying speed. As the gear was being retracted the aircraft encountered propwash which threw the left wing down and apparently reduced the airspeed. It banked to the left in an uncontrollable fashion, leaving the runway about 3000 ft down. It lost altitude until the left wingtip dragged the ground, turning the ship and causing it to crash land facing 135° from the runway heading and about 50 yds from the runway. The ship immediately started to burn but all five crew members were able to get out with only minor injuries. The ship continued to burn despite efforts of the fire fighter crew and was a total loss.

RECOMMENDATIONS: Recommend that whenever possible aircraft of this type and size be prohibited from operating loaded out of fields with uneven runways. If this is impossible recommend that lighter loads be carried.
