Accidents Investigation Branch

Department of Transport

**Report on the accident to
Cessna Citation 500 G-U ESS
10 nm south-east of Stornoway aerodrome,
Isle of Lewis
on 8 December 1983**

Aircraft Accident Report No. 5/84
(EW/C857)

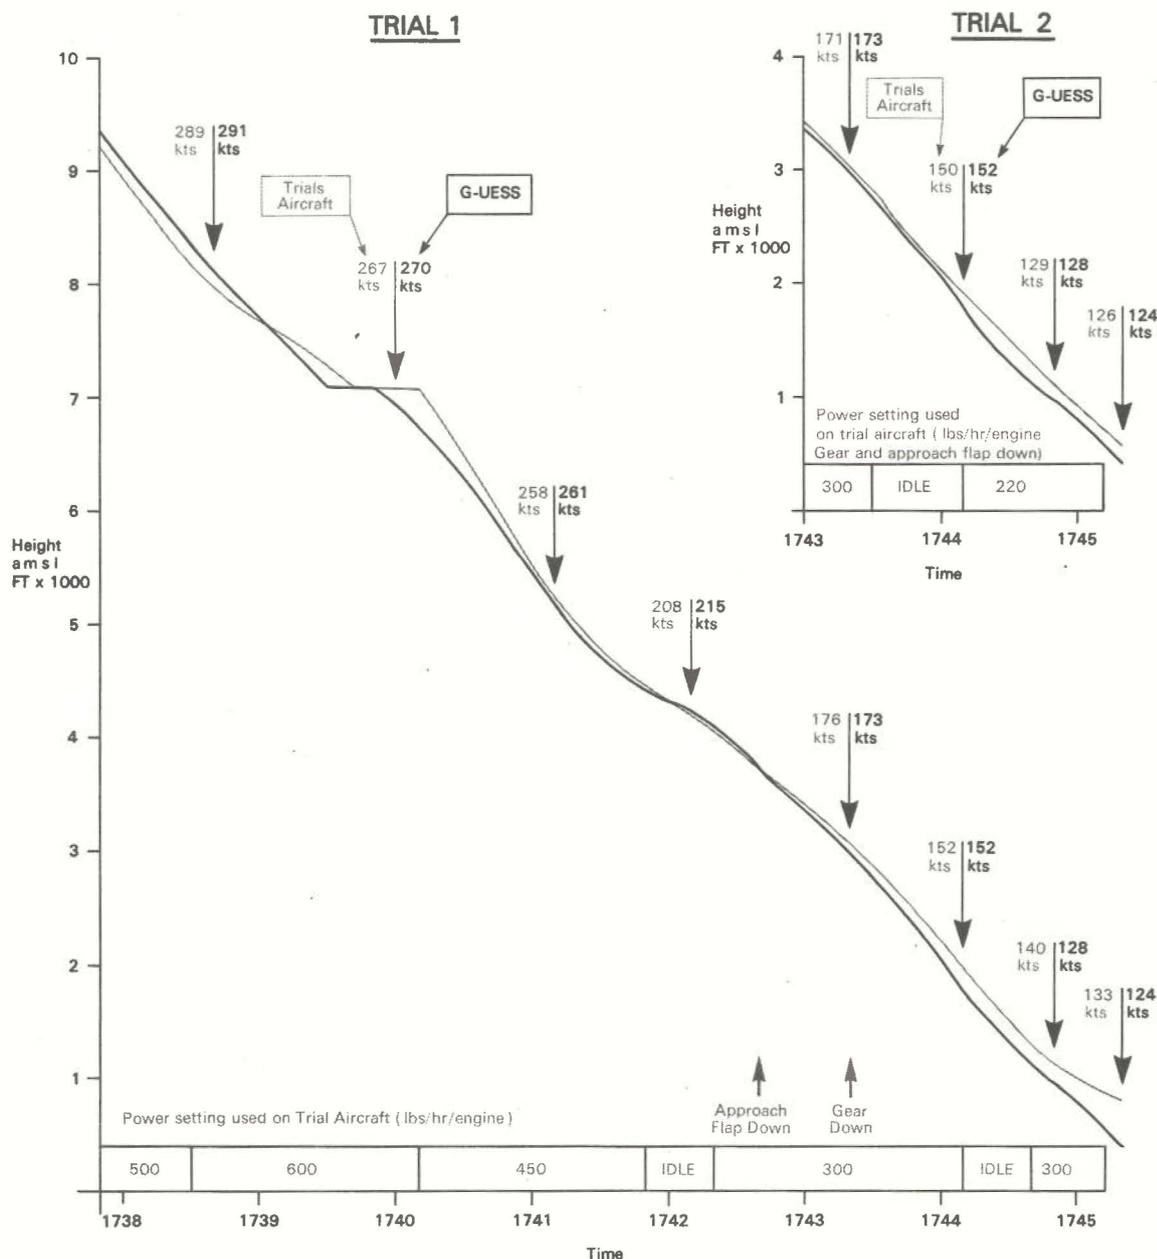
Flight trials simulation of descent (paragraph 1.16.3)

This hypothetical profile was then flown and recorded on radar, again at the estimated accident weight of G-UCESS. In the descent from 10,000 to 4,500 feet, power settings between 450 and 600 lb/hr/engine were found to parallel closely the flight path of G-UCESS. At 4,500 feet it was found necessary to reduce to idle power in order to decelerate to the maximum speed for lowering approach flap. Idle power was maintained for 30 seconds, then approach flap was lowered at 4,100 feet and 202 kt IAS, and power was increased to 300 lb/hr/engine. Landing gear was lowered at 3,100 feet and 176 kt IAS, and the descent was continued at 300 lb/hr/engine. At 2,000 feet it was apparent that the rate of descent was less than that achieved by G-UCESS, and idle power was again selected for 30 seconds before 300 lb/hr/engine was restored. The flight path achieved during this first trial descent had been similar to that of G-UCESS until 3,600 feet but below that height, despite the low power settings used; the rate of descent of the trial aircraft was not as great as that of G-UCESS.

At the end of the second trial run, full power was applied on one engine only, with the other engine at idle power. At the accident weight, the aircraft was found to be capable of transition from a descent at 1,200 fpm at 124 kt, with approach flap and landing gear down, to climb in clean configuration on one engine with a height loss of no more than 50 feet.
