# NATIONAL TRANSPORTATION SAFETY BOARD

## AIRCRAFT ACCIDENT REPORT

MIDWEST EXPRESS AIRLINES, INC.,  
DC-9-14, N100ME  
GENERAL BILLY MITCHELL FIELD  
MILWAUKEE, WISCONSIN  
SEPTEMBER 6, 1985

NTSB/AAR-87/01

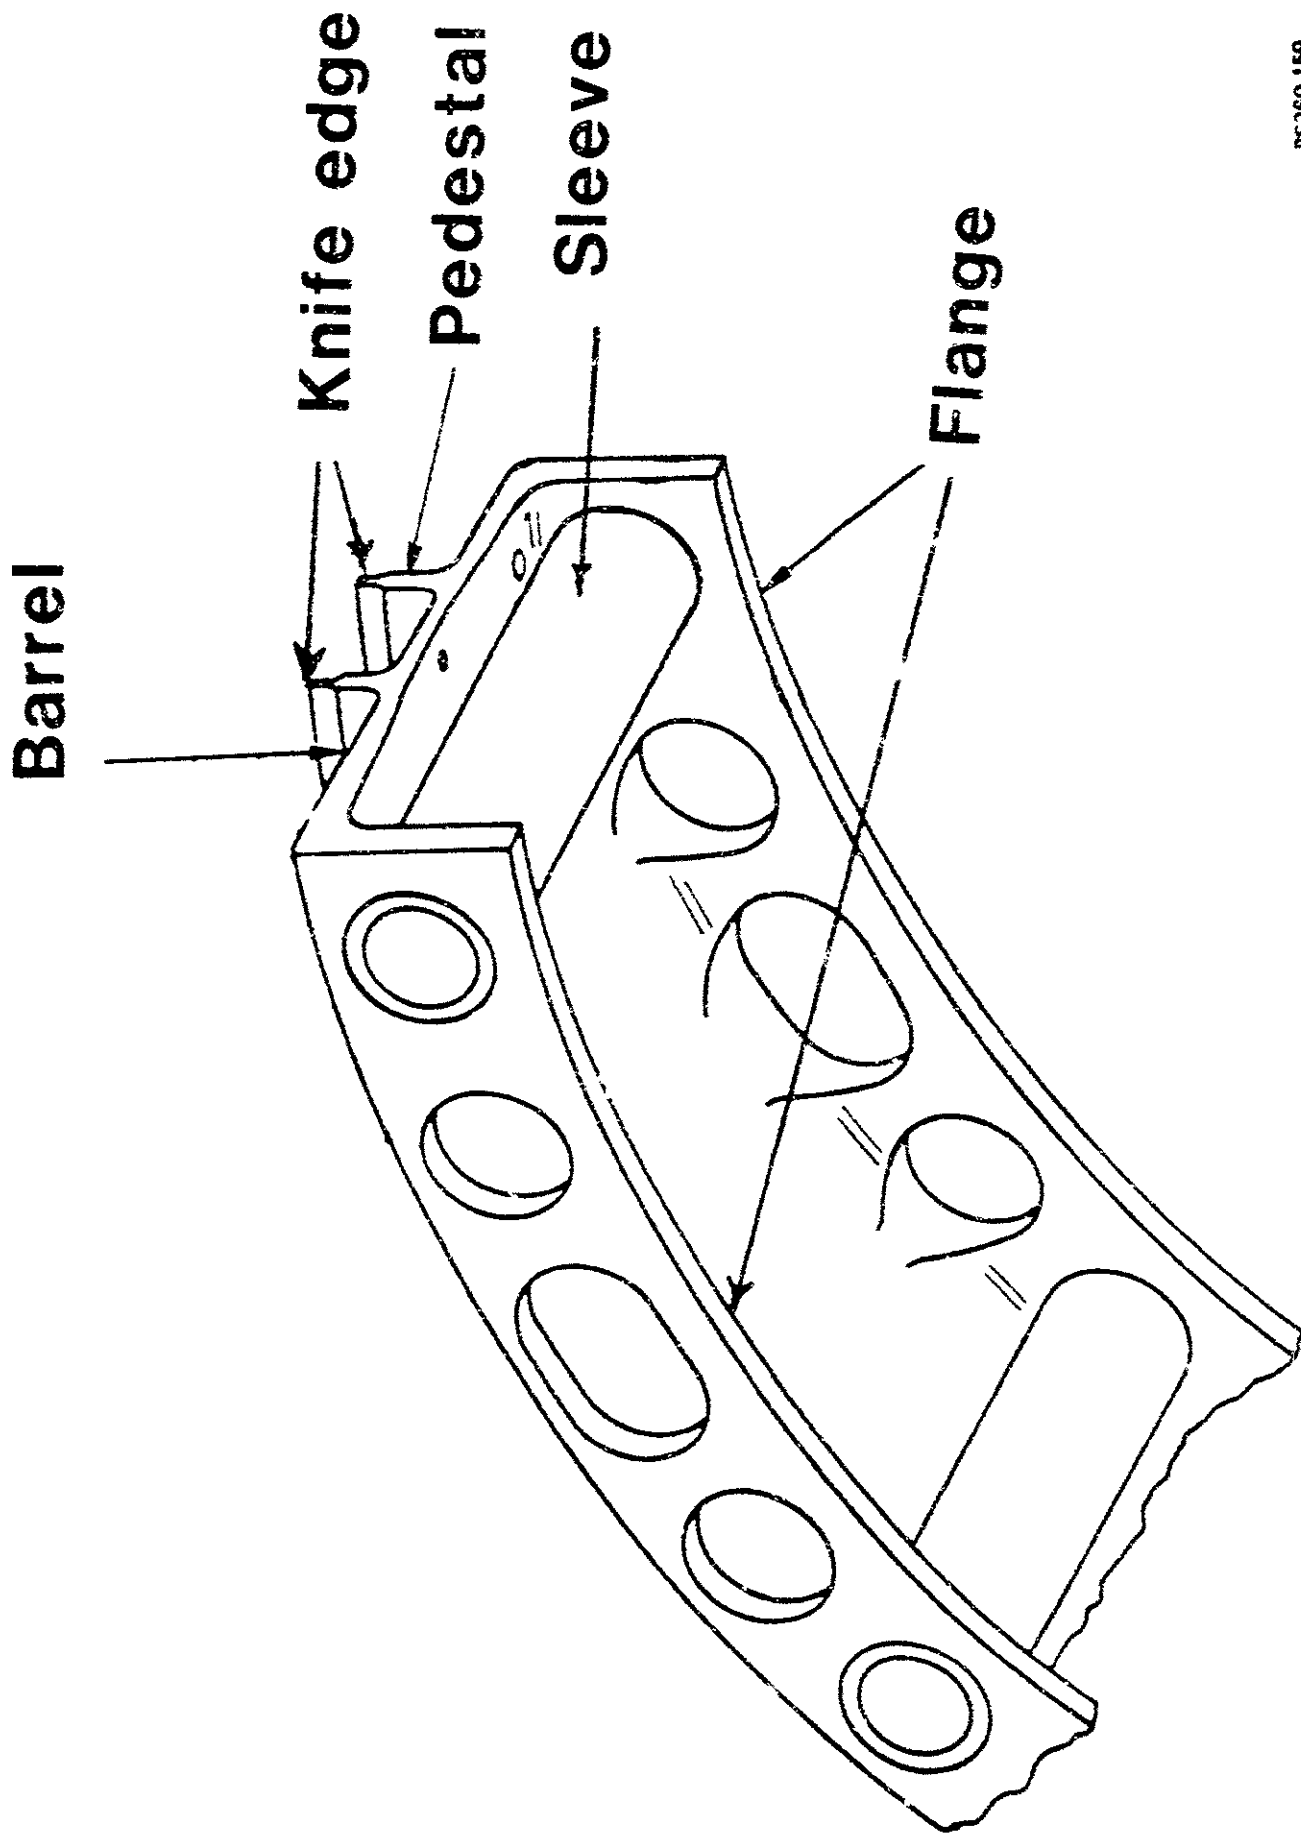
Figure 1.--Main features of a removable sleeve compressor or spacer.

The last recorded EHM of the right engine was performed at Air Carrier Engine Service (A.C.E.S.), now AeroThrust Corporation, in Miami, Florida, in September 1979. Engine records showed that the high pressure (H.P.) compressor 9-10 stage removable sleeve-type spacer (P/N 557340, S/N DAL 81374) from another engine (S/N P657255) was installed in engine S/N P654106 (later the right engine on N100ME) at that time. (See figure 1.) Engine records for the period before 1979 were not available to document the service history of the spacer; thus, the total operating time of the failed spacer was not known. The 9-10 stage H.P. compressor removable sleeve-type spacer is not a life-limited part.

A "Reject" stamp dated October 9, referred to a damaged knife edge airseal. The airseal was reworked by blending <sup>9/</sup> the damaged area. The tubes were removed and the spacer nickel cadmium (NiCd) coating was stripped. The inside diameter was grit-blasted. The spacer was then examined using fluorescent magnetic particle inspection (FMPI) equipment and passed inspection.

There was no record of the nature of the previous damage which had necessitated the rework. The specifications regarding airseal blending of the 9-10 spacer allowed machining down to the inside radius, above the pedestal, to a maximum width of 2 inches in one area, or a maximum width of 4 inches for all areas. There is no record of the amount of blending that was performed.

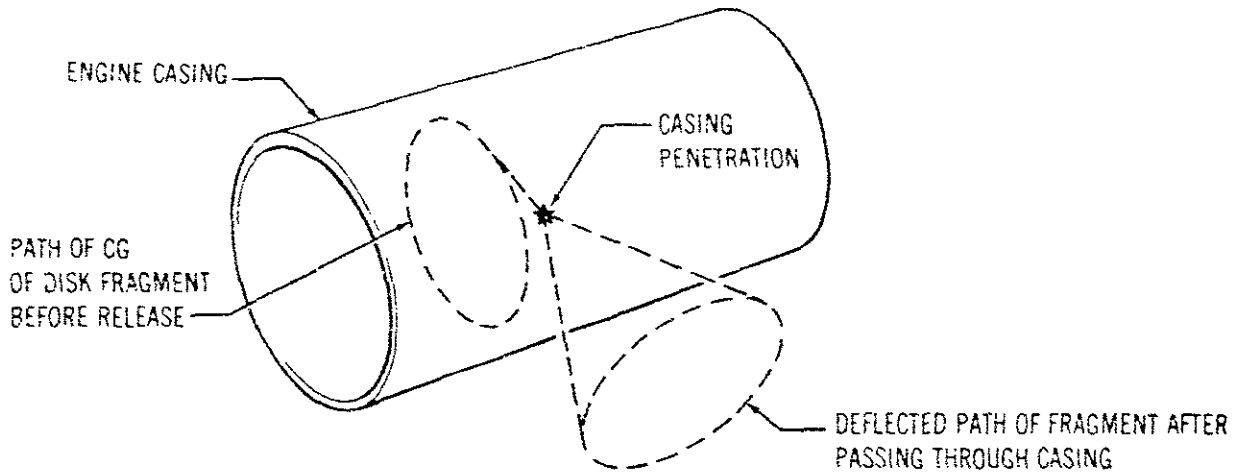
Figure 2.—Deflection path of uncontained engine parts.

Pratt & Whitney representatives testified at the public hearing that their experience had shown that the initial trajectory of uncontained rotating turbojet engine parts may be estimated by assuming that the parts (or fragments thereof) were initially ejected tangentially from their previous plane of rotation, through holes in the case and cowling. This is consistent with the aforementioned research findings. The initial trajectory path may be estimated by aligning a straight object, such as a broomstick, through the hole in the engine case from which the parts were ejected, to the outer diameter of the spacer or rotor that failed (the "broomstick" method). Pratt & Whitney

reported that its previous service history of uncontained compressor spacer failures in JT8D-7 and JT8D-1 engines revealed that in incidents where the fuselage was penetrated by ejected spacer pieces, the holes in the fuselage were nearly directly in line with the penetrations of the engine case and tangent to the outer edge of the failed rotating part.

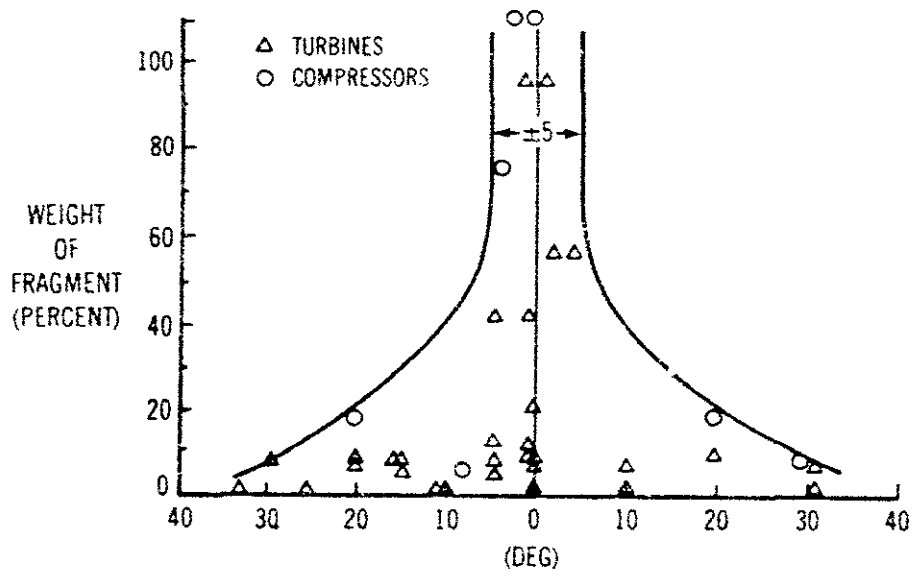
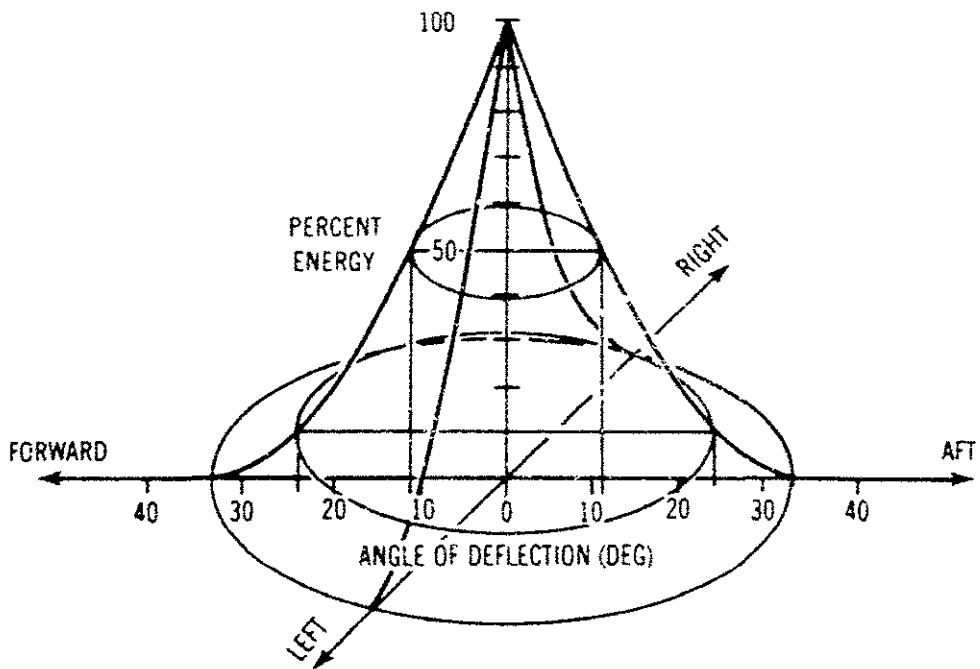
Figure 3.—Dispersion of uncontained engine parts.

The recovered spacer and compressor blade parts were measured to determine drag reference areas, using a factor of 0.635 <sup>20/</sup> to allow for tumbling of parts. Thus, the drag reference areas for the largest spacer part, weighing 1.03 pounds; a smaller spacer part, weighing 0.07 pound; and a compressor blade piece, weighing 0.035 pound were determined to be 0.138, 0.03, and 0.019 square foot, respectively. A flat plate drag coefficient of 1.0 was assumed. For the purpose of determining potential tangential velocities, initial ejection speeds between 0 and 800 feet per second (fps) were considered. (Pratt & Whitney determined that the rim tangential velocity of the operating high pressure compressor spacer had been 800 fps.)

The heaviest part would have been most sensitive to the exit velocity and angle. The lighter parts would have been more sensitive to wind factors. It was found that the predicted central point of ground impact would have been about 400 feet rearward and 200 feet left of the aircraft at the time the parts were ejected from the right engine, assuming that the parts were ejected while the airplane was about 450 feet above the ground, left of the runway centerline and at 168 knots. The calculated ejection point was consistent with the point at which parts were determined to have been ejected, based upon the timing of the "clunk" on the CVR tape; the correlation of FDR, CVR, and recorded radar data; and the locations of the recovered engine parts.

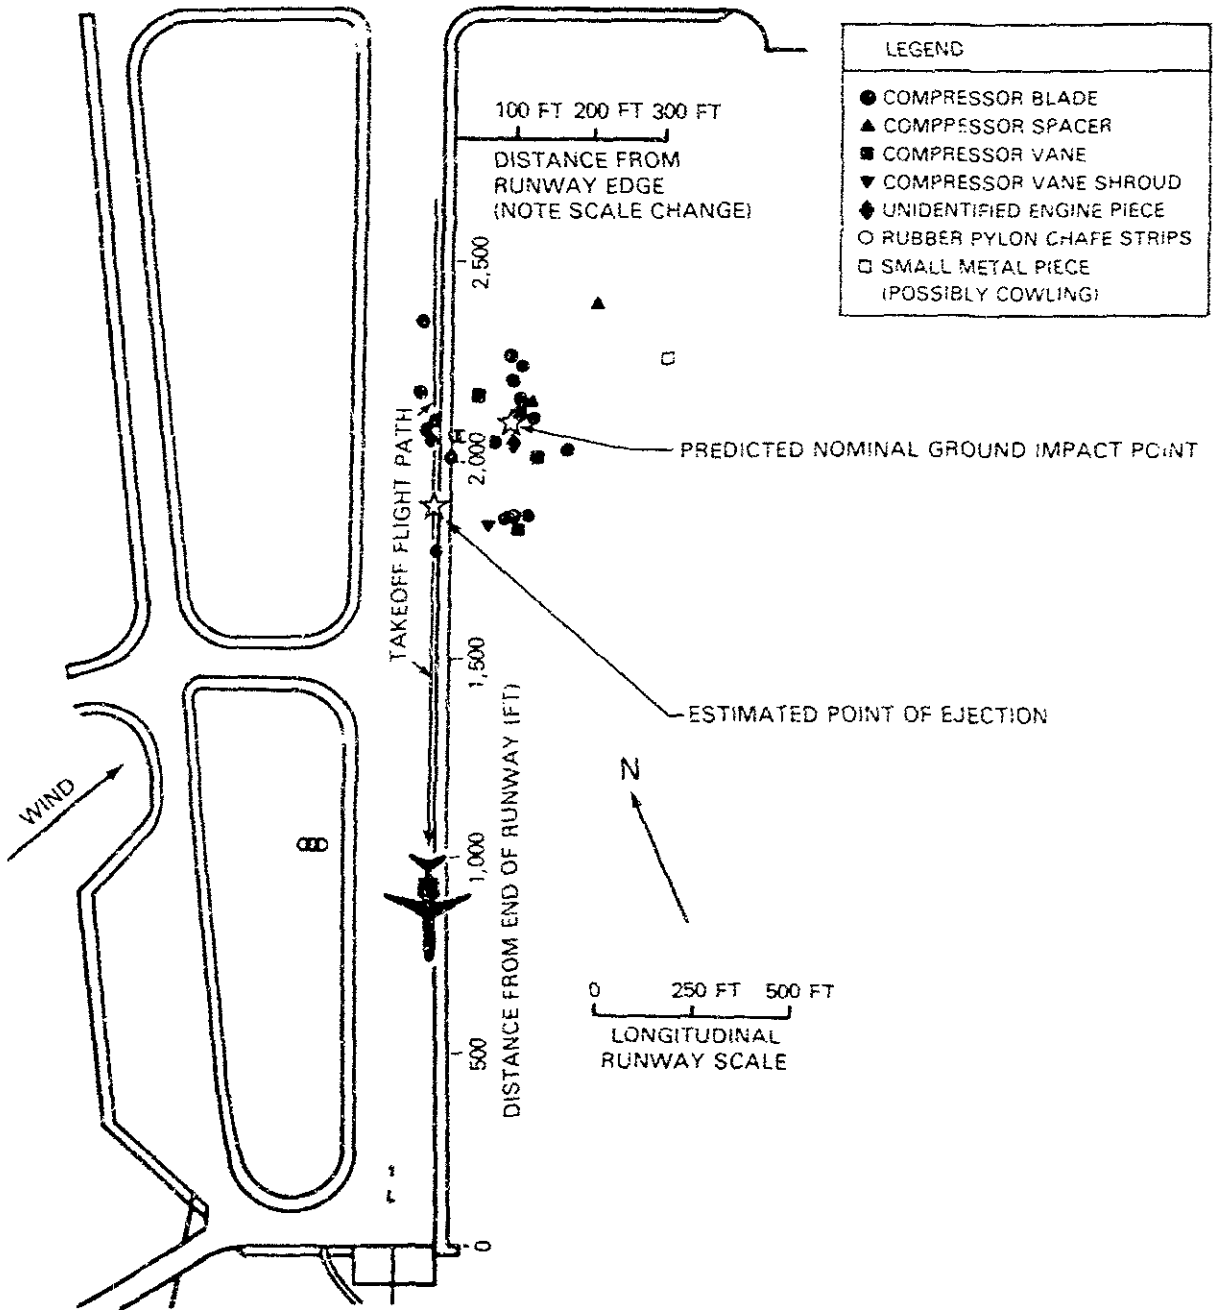
Figure 6.—Calculated nominal ground impact point and actual locations of engine debris adjacent to runway 19R.

Calculations showed that, from the point at which spacer parts were actually ejected from the right engine, the distribution of the parts found near runway 19R was as predicted for undeflected parts exiting the right engine. (See figure 6.) The ejection paths of a few spacer pieces and compressor blades pieces could not be resolved because those parts were not found. However, based on the paths of the recovered debris, the Safety Board concludes that part of the spacer was probably ground into tiny, harmless pieces during the rupture and that part of the unaccounted for spacer pieces and blades might have been missed, despite a thorough search for engine debris in the grass adjacent to the runway.

Calculations showed that the deflection of engine parts by the engine casing or cowling would have resulted in the absorption of energy of the deflected parts, thereby reducing the velocity substantially and limiting the potential to produce any damage of consequence to the fuselage or to the control systems. For example, engine containment tests have shown that ejected engine debris which is deflected more than 33° loses virtually all of its energy.

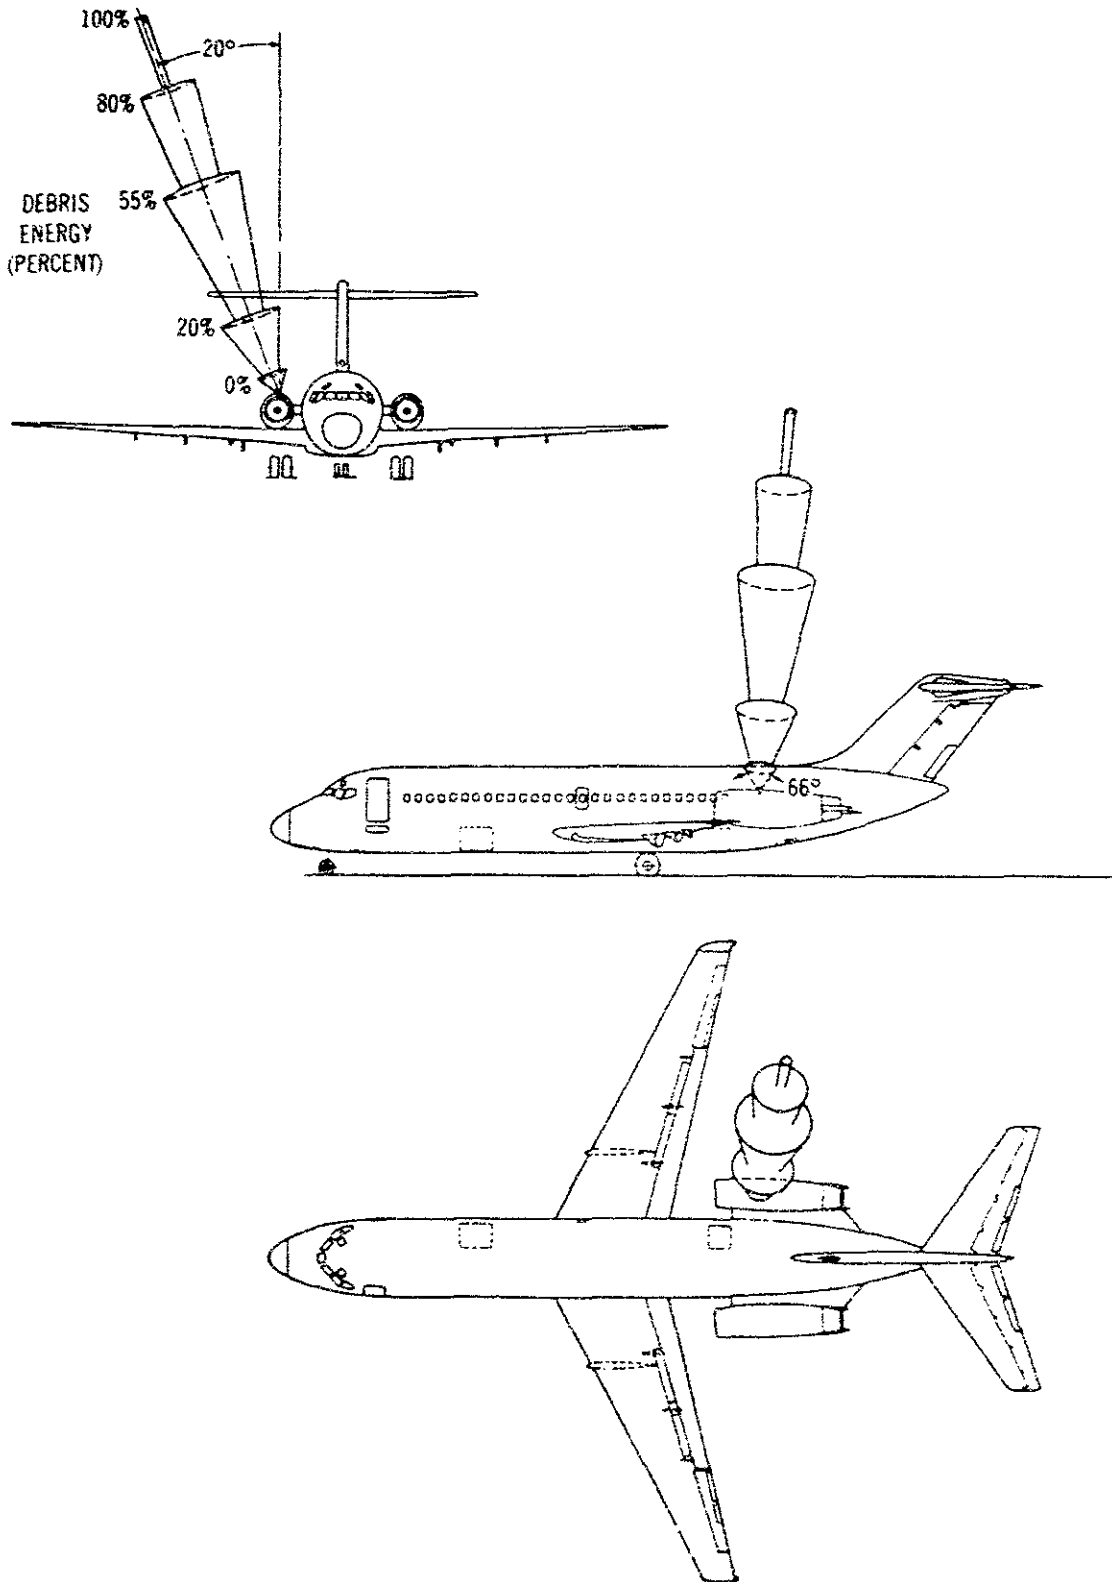
Figure 7.--Three-view drawing of a DC-9 series 10 airplane with various debris patterns and corresponding percentage of energy loss.

Figure 7 shows that undeflected parts are initially ejected in a direction approximated by the broomstick method; in this case, 20° outboard of vertical (away from the airplane fuselage) with high energy and speed. To have struck the Midwest Express fuselage, the parts would have had to have been deflected in excess of 65° and thus virtually all energy would have been lost.
