# **NATIONAL TRANSPORTATION SAFETY BOARD**

## **AIRCRAFT ACCIDENT REPORT**

**MIDAIR COLLISION OF  
NABISCO BRANDS, INC.,  
DASSAULT FALCON, DA50, N784B AND  
AIR PEGASUS CORPORATION  
PIPER ARCHER, PA28-181, N1977H  
FAIRVIEW, NEW JERSEY  
NOVEMBER 10, 1985**

**NTSB/AAR-87/05**

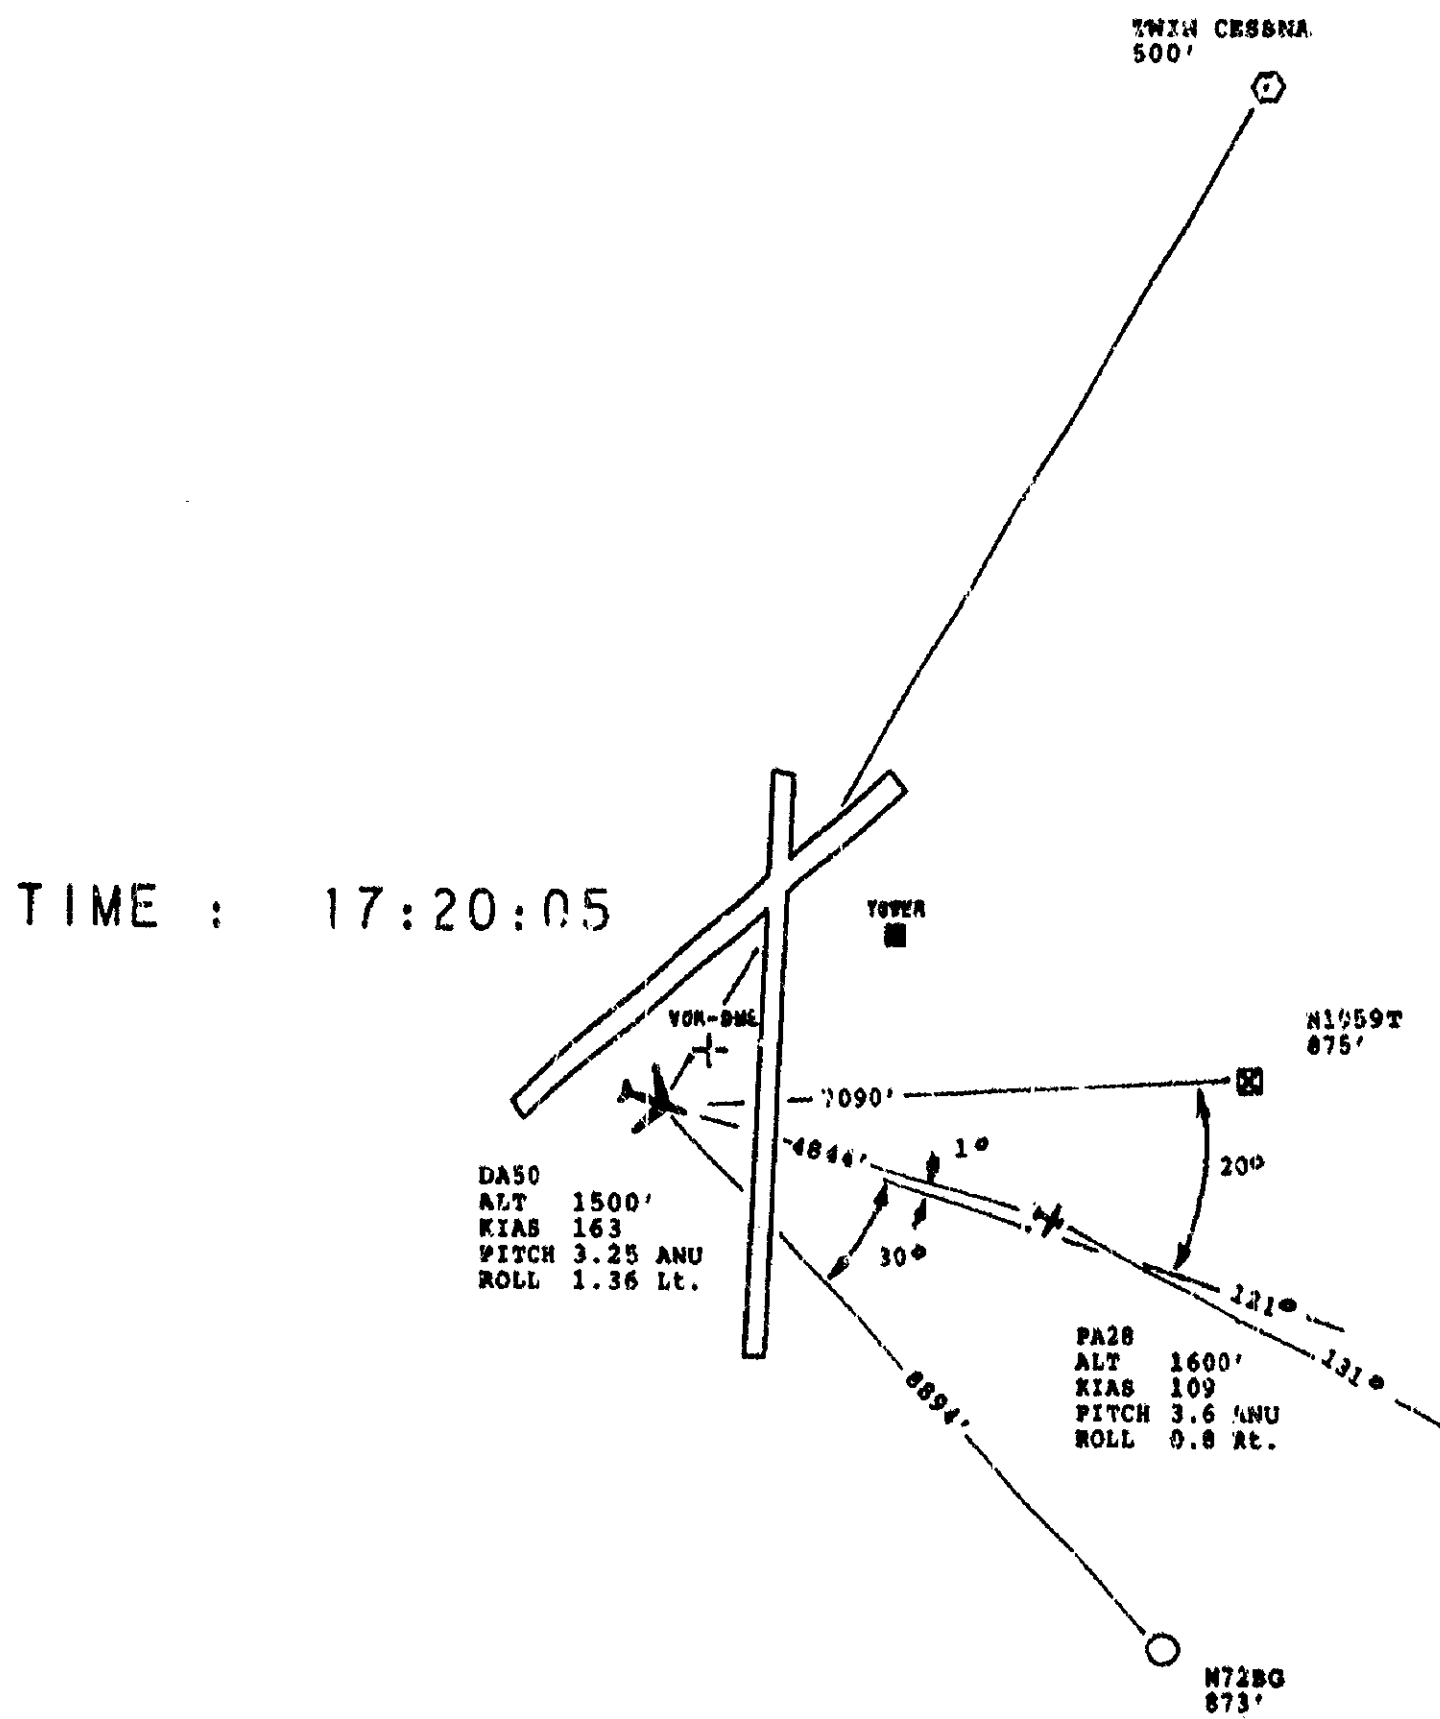
Figure 3.—Radar positions of aircraft at 1720:05.

At 1719:24, the captain transmitted, "...inside WANES. ah, inside CLIFO, airport's in sight." About the same time, N72BG requested, "...left downwind departure." However, the local controller did not immediately acknowledge either airplane's report, but transmitted, "Four six juliet is cleared for takeoff runway one niner." At 1719:38, the controller transmitted, "Bravo golf, remain east of the Hackensack River" and N72BG acknowledged. Immediately, N1959T reported overhead the airport and the local controller stated it was number two following traffic (Twin Cessna N68734) on a left base leg over route 80 but he did not state N1959T's aircraft type. At this same time the DA50 was in a 10° left bank at about 185 knots on a heading of 146° and the captain stated to the first officer, "Better slow it up Alan, we're following that guy." The first officer said, "Okay" and he called for flaps. (See figure 2.)

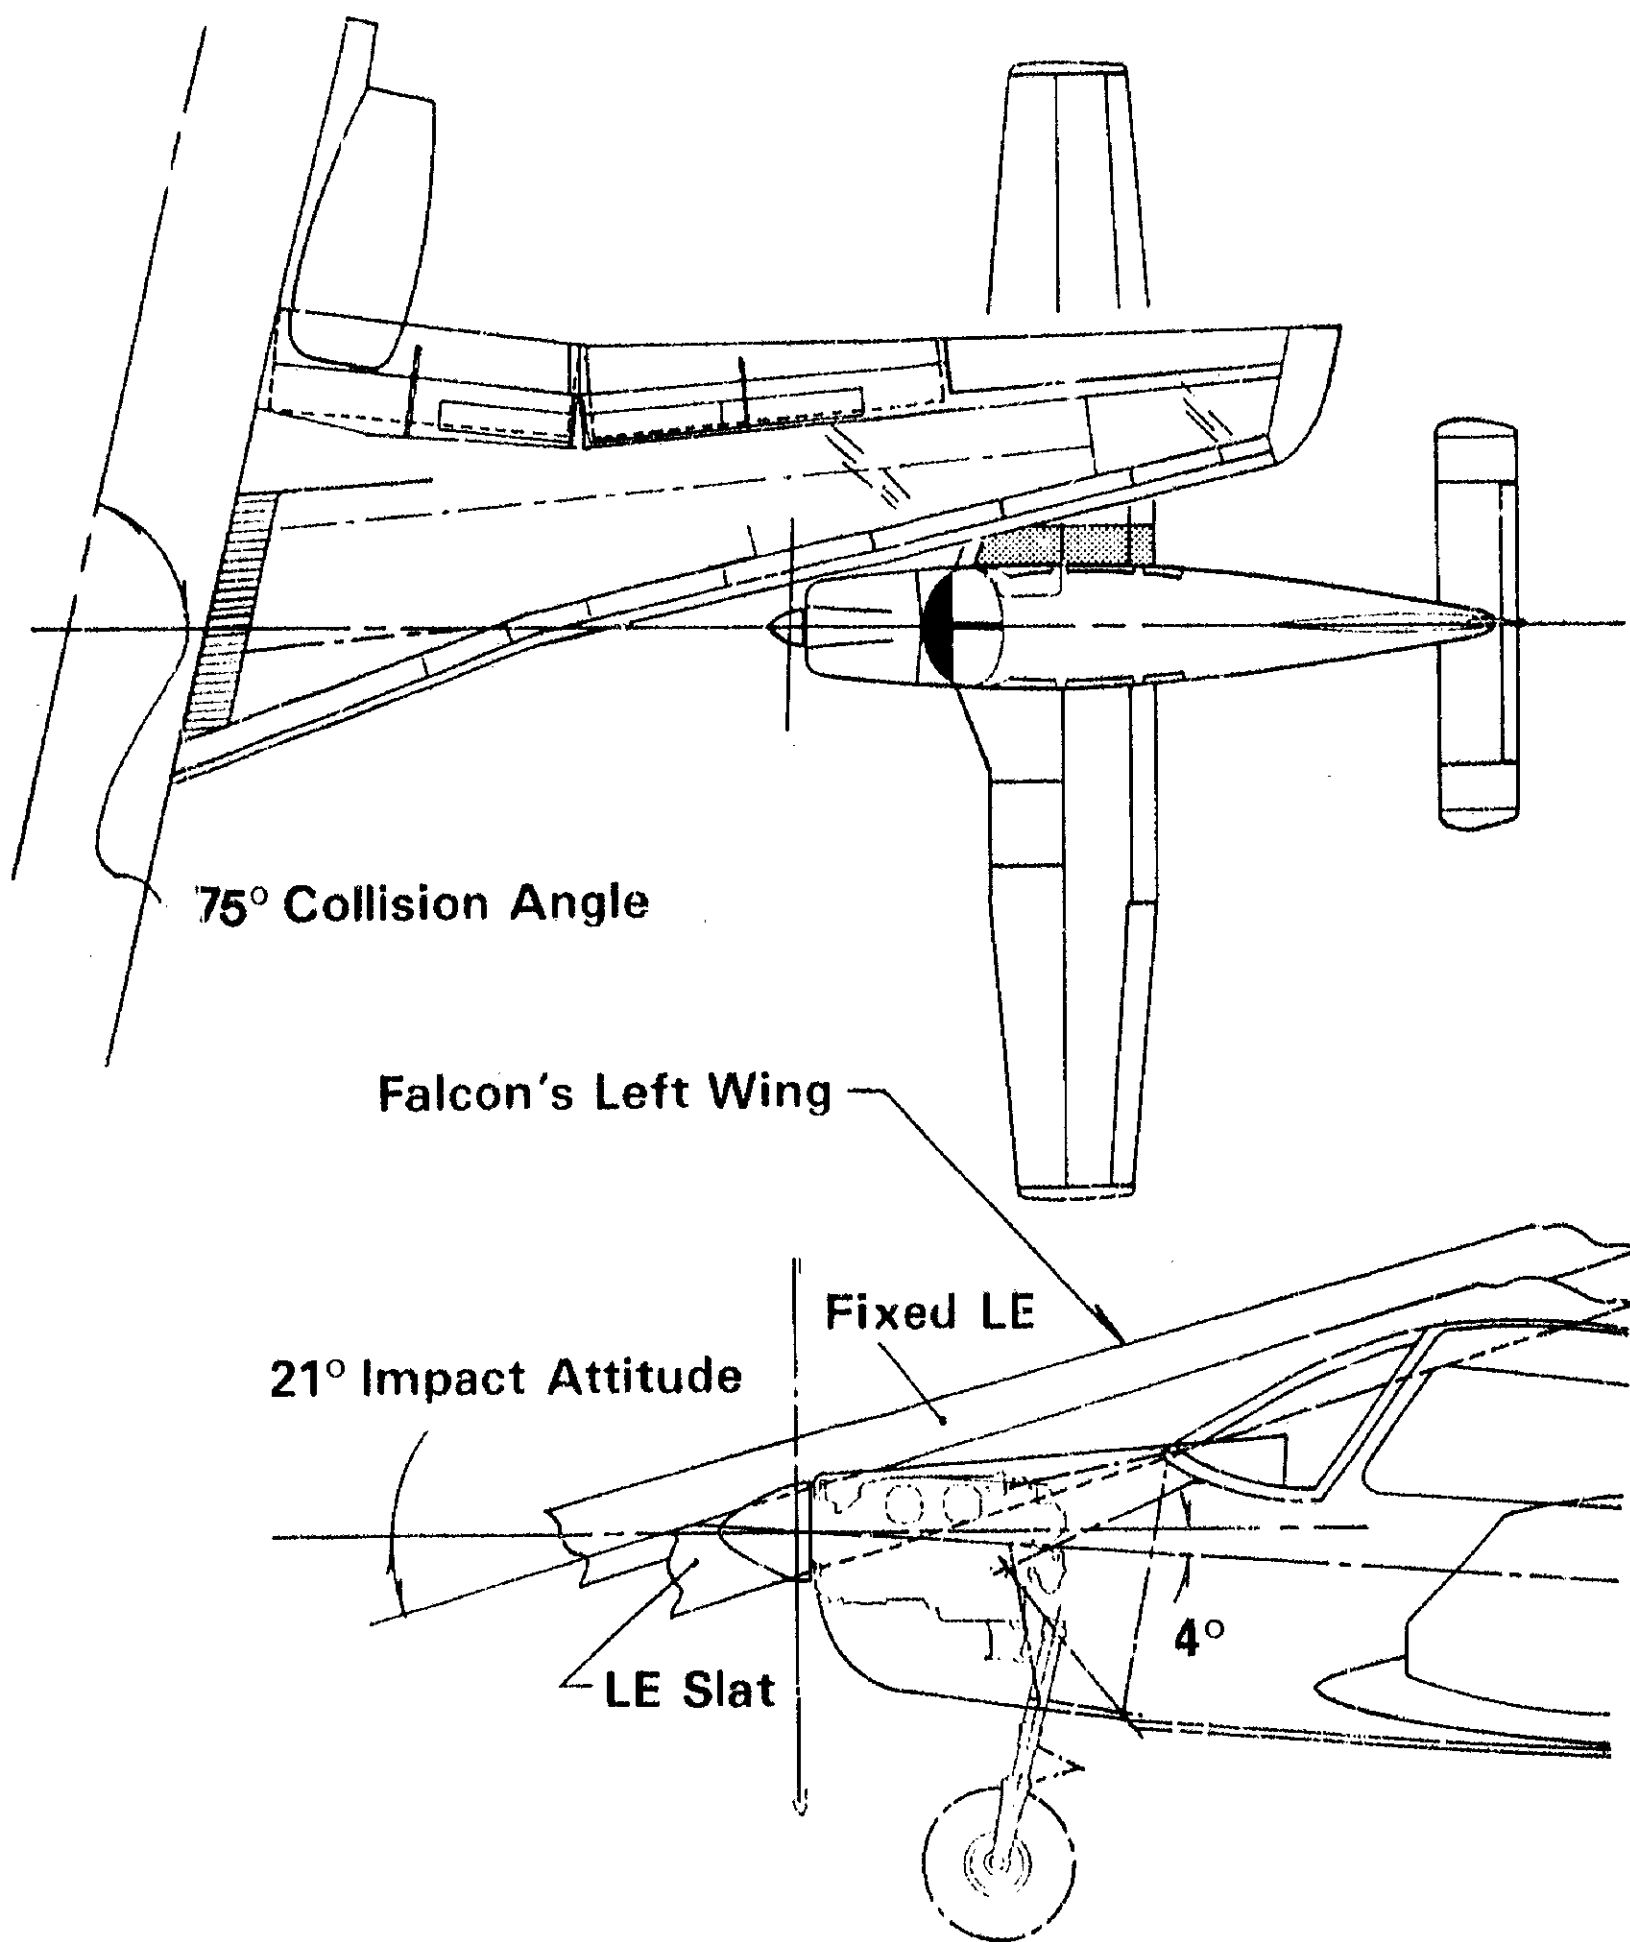
Figure 16.—Collision angle and relative impact attitude.

Damage to the right side cylinder rocker box covers of the engine in the PA28 was matched to the damage on the outboard left wing slat of the DA50. The propeller from the PA28's engine slashed through the DA50's left wing inboard of rib 12 at about a 75° angle. Black paint from the blade face (back of the blade) was found on the slat skin. The propeller cut through the front wing spar and one propeller blade separated 8 inches from the tip. The other blade struck but did not penetrate the upper center wing panel. Damage to the cabin door on the right side of the PA28 matched the outboard indentation in the left wing slat. The distance between the two separate slat indentations coincided with the distance between the PA28's engine and the top cabin door latch. Scratch marks on the lower surface wing panels and outboard flap of the DA50 indicated that the PA28 traveled under the DA50's left wing tearing off the outboard section of the outboard flap and destroying the top of the cabin of the PA28.

Since the radar data showed that the PA28 was in straight and level flight moments before the collision, it was estimated that it would have been in a 4°-noseup, wings level attitude. Based on the physical damage, the DA50 was in about a 21°-right bank relative to the PA28. The collision angle between the two aircraft, as indicated by the initial propeller slash mark, was about 75°. (See figure 16.)

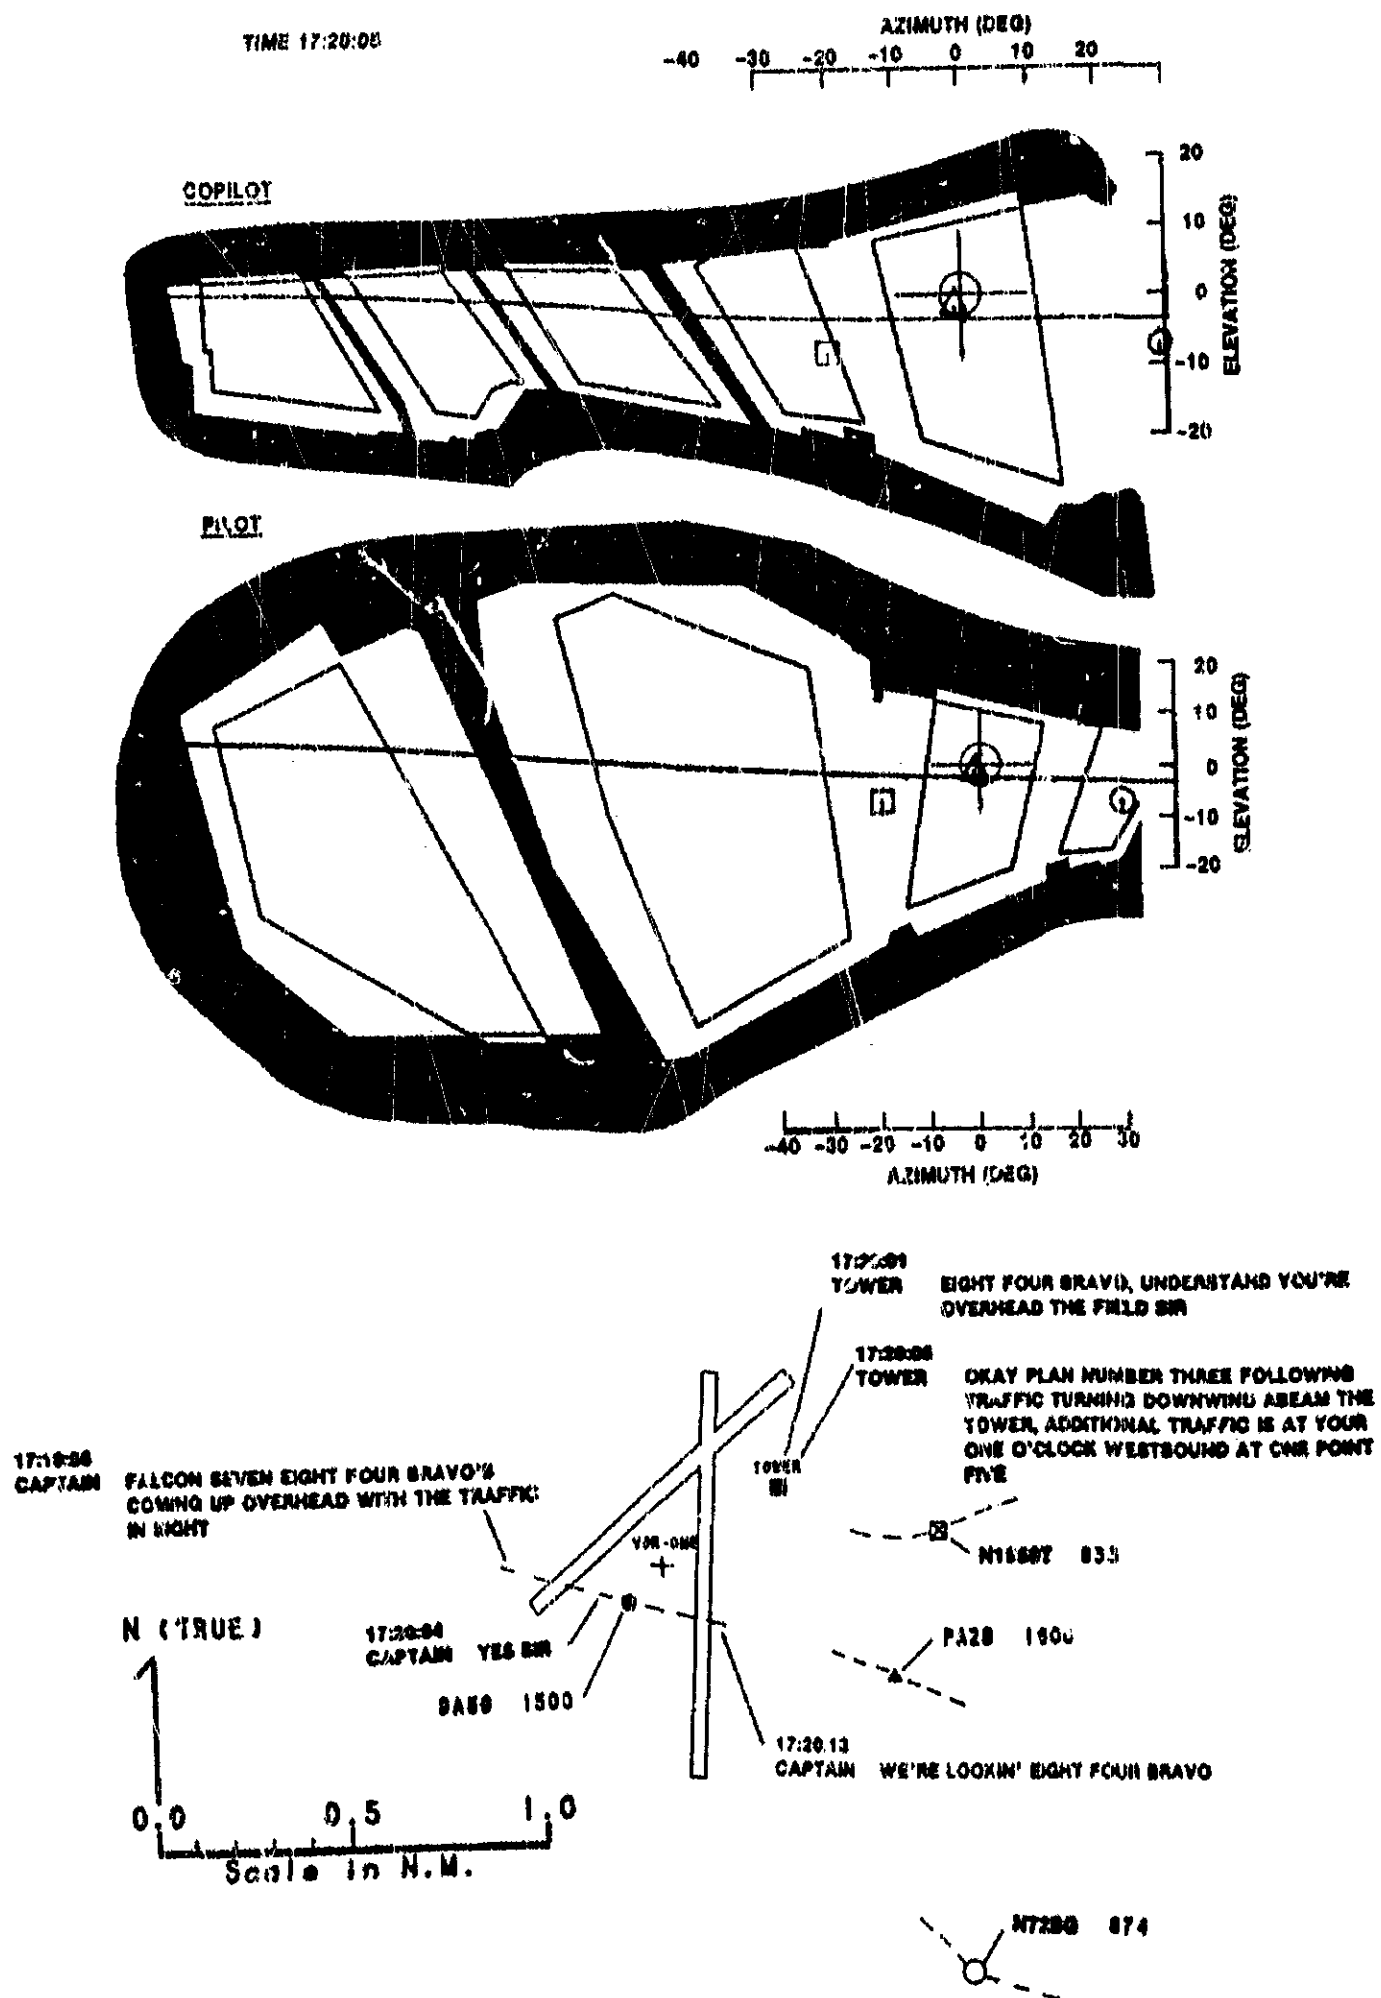
Figure 18.—Composite radar positions and cockpit visibility plot of aircraft at 1720:05.

Based on the radar data and cockpit visibility study at 1719:45, when the DA50 was about a mile west of the airport, the Twin Bonanza, N1959T, and the PA28 were passing over the airport in front of and in the DA50 flightcrew's view. (See figure 17.) N1959T was about 40° to the left at 900 feet and the PA28 was about 20° to the left of the crew's DER at 1,600 feet on the horizon. The Beech Baron, N72BG, which had departed to the east after takeoff from runway 19, was located slightly to the left of the crew's DER, and to the right of the PA28 and slightly below the horizon at 350 feet. At 1720:05, when the local controller told the DA50 flightcrew that they were to plan to be number three and there was additional traffic at the one o'clock position westbound at 1,500 feet, N1959T was about 20° to the left of the crew's DER, the PA28 was directly ahead at the 12 o'clock position, and N72BG was 1.5 miles ahead at 873 feet, 25° to 30° to the right of the DA50 crew's DER or in about a 1 to 2 o'clock position. (See figure 18.)
