Report 852-1056

Israel Aircraft Industries
1124 Westwind
VH-IWJ
Near Sydney, New South Wales

10 October 1985

BUREAU OF AIR SAFETY INVESTIGATION

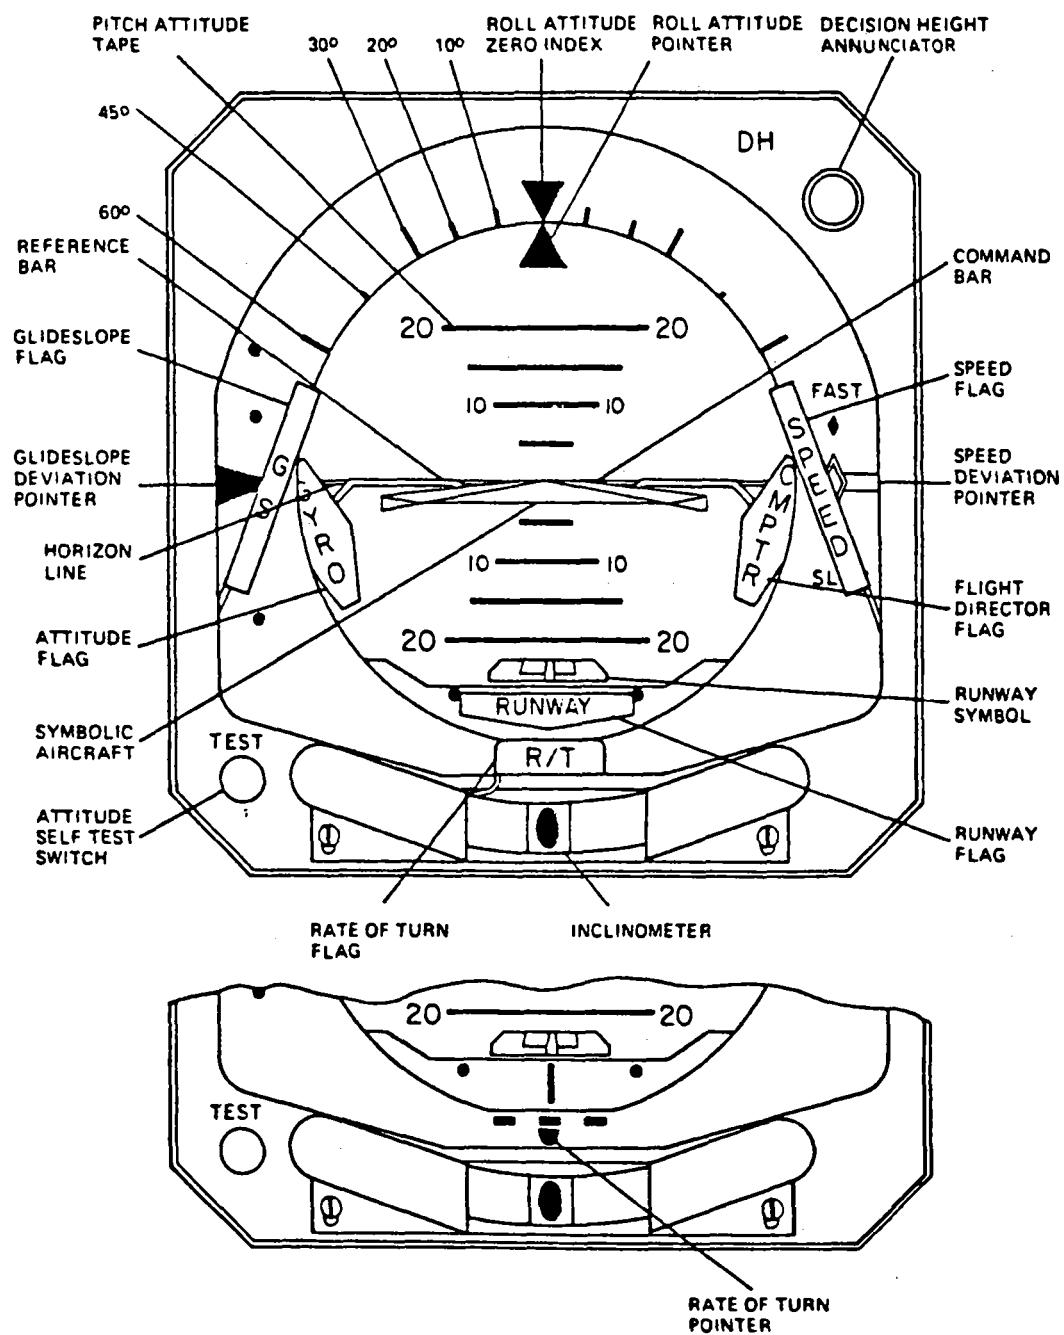
FIGURE 1

The rate of turn indicator, which formed part of the pilot's FAI, had first been reported as operating in the reverse sense on 23 October 1984. This report had been entered in the aircraft maintenance log by Mr Haskett. At that time the aircraft was being operated by Wings Australia Pty Ltd and had accumulated 1487 hours time in service since new. Maintenance personnel had been unable to isolate and rectify the fault, which was reported in the log on three further occasions.

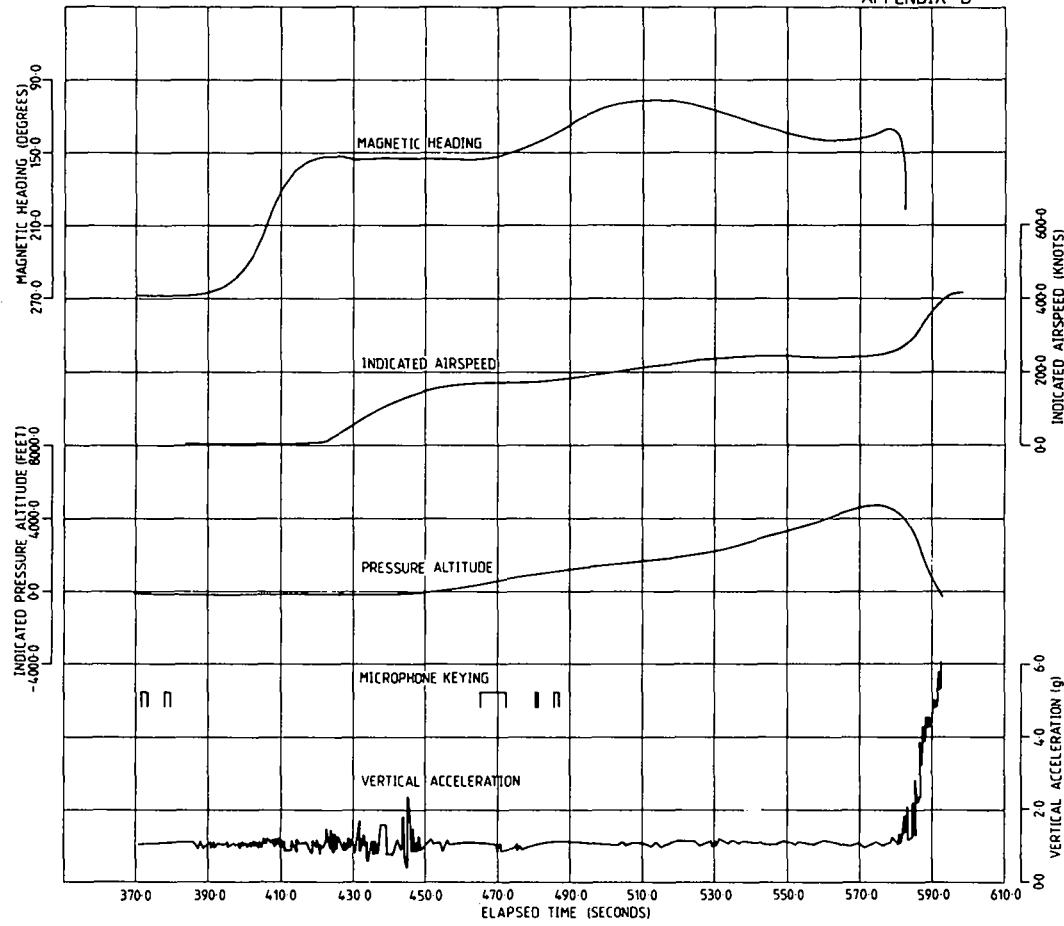
APPENDIX B

VH-IWJ FAIRCHILD 5424 F.D.R. DATA READOUT
FROM TAKE-OFF CLEARANCE TO IMPACT
