# NATIONAL TRANSPORTATION SAFETY BOARD

## AIRCRAFT ACCIDENT REPORT

EXECUTIVE AIR CHARTER, INC.,  
dba AMERICAN EAGLE, FLIGHT 5452  
CASA C-212, N432CA  
MAYAGUEZ, PUERTO RICO  
MAY 8, 1987

NTSB/AAR-88/07

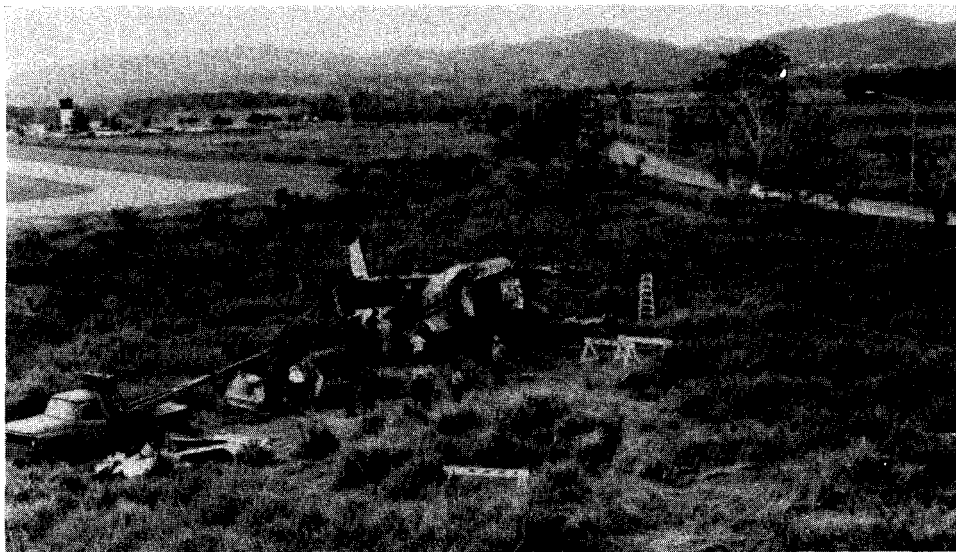
The right wing tip first struck the ground 643 feet short of the runway threshold and 67 feet to the right of the extended runway centerline. The airplane traveled about 100 feet after initial ground impact, and the nose of the airplane struck a chain-link fence and a ditch before pivoting about 180° and coming to rest upright. It cleared a 6-foot bank parallel to the airplane's flightpath about 75 feet before principle impact. Except for the cockpit, the fuselage remained relatively intact. There was substantial postcrash fire damage to the left wing and engine and minor fire damage to the right wing and engine. (See figure 1.)

**Figure 1.--The aircraft is facing the opposite direction of the approach to runway. The right engine was off at impact; the left engine was removed when the photograph was taken.**

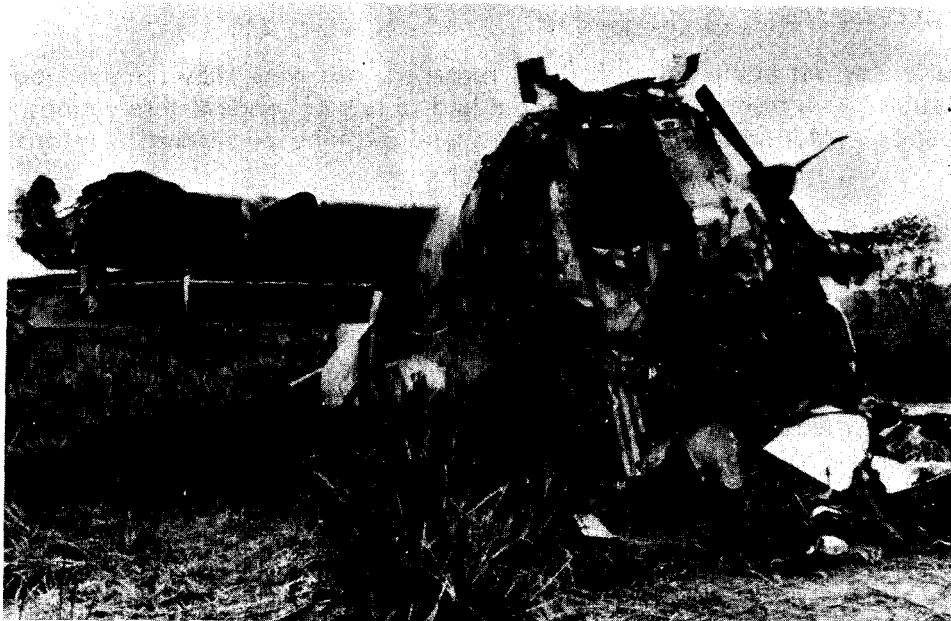
The cockpit was demolished up to the area of the forward cabin bulkhead. (See figure 2.) Except for some slight crushing of the bottom of the aft fuselage, the remainder of the center fuselage to the aft fuselage remained relatively intact. The right wing was separated about midspan. The wing tip was bent upward to about a 45°-angle; the inboard portion was damaged by fire from fuel spillage. The right engine had separated from the wing. Postcrash fire from fuel spillage burned the outboard 1/3 of the left wing; the left engine remained attached to the wing.

Figure 2.--View of the demolished cockpit.

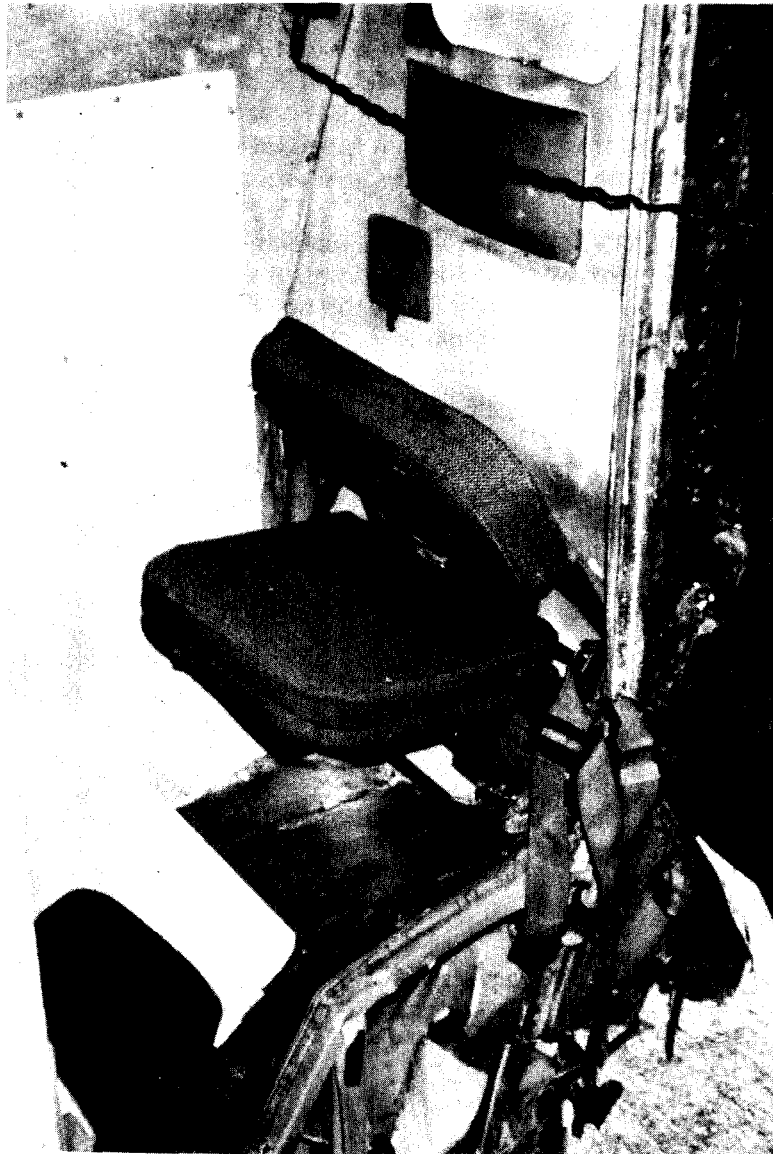
Both flightcrew seats remained attached to their floor tracks. The four-point restraint system remained normally attached to the anchorages. The shoulder harnesses did not show evidence of use. The flight attendant's jumpseat remained in place, but was found extended for use instead of retracted because the inboard spring retainer bar had separated from the seat. (See figure 3.) All of the 19 passenger seats, manufactured to Technical Standard Order C39A, remained attached to the cabin floor. Passenger seats 7B and 7C were installed adjacent to a Class III emergency exit. In this location, the armrests protruded into the pathway of the exit, as did the seatbacks if they were folded forward.

Figure 3.--Rearward facing jump seat remained in its original location.

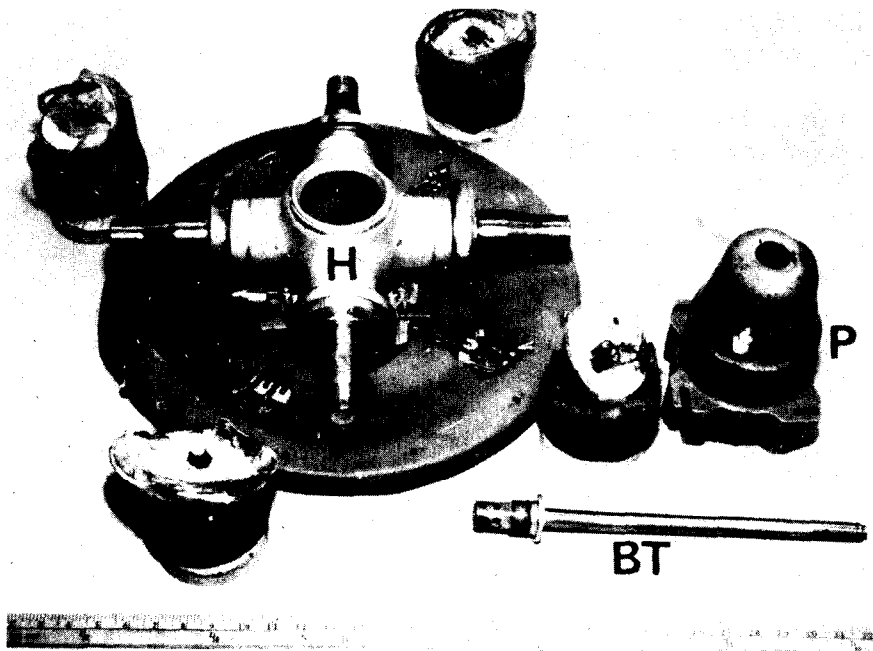
The right propeller sustained severe impact damage. The beta tube was bent, the dome assembly (piston, cylinder, and spring assembly) was canted about 13°, and the cylinder was stripped from the hub. The nose of the piston was crushed and gouged in a diagonal pattern; the deepest gouge was located between two of the blades. There was a 390°-spiral gouge on the inside of the

piston. A semicircular rub mark in the center bore of the hub corresponded to the beginning of the spiral gouge on the inside of the piston.

Figure 4.--Overall view of the right propeller components submitted for examination. 'H' indicates hub which is surrounded by the four propeller butt ends. "BT" locates portion of beta tube and "P" denotes the piston.

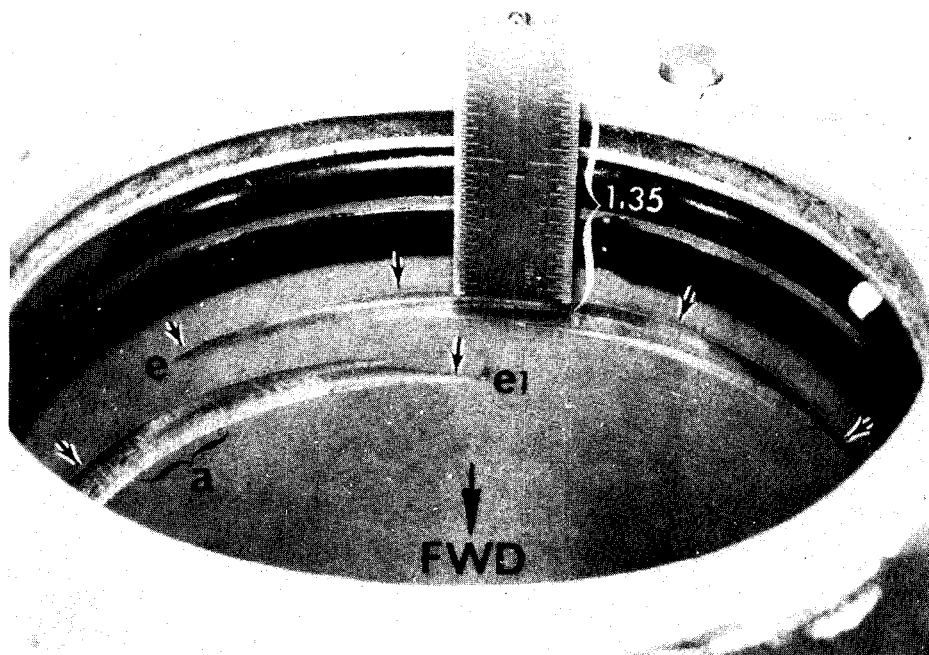
Metallurgical examination indicated that the spiral gouge mark on the inside of the piston of the right propeller was probably made when the propeller struck the ground, forcing the piston to contact the forward corner of the cylinder under impact forces.

Mechanical deformation of the gouge indicated that the piston had moved aft relative to the cylinder and had rotated slightly from the normal fixed position of the cylinder. (See figure 5.) There was no buildup of piston material at the forward edge of the gouge, but the aft edge contained numerous areas of buildup and a ridge as shown by the lower two arrows in figure 6. This buildup indicated that the piston had rotated and moved aft relative to cylinder and toward the feather position. Examination of a section cut through this gouge confirmed the aft movement, which produced extreme grain deformation transverse to the gouge as shown in figure 7. The position of the forward edge of the cylinder at the time it made the initial gouge in the wall of the piston corresponded to a 0°-blade angle.

Figure 5.--Oblique view looking into the inner cavity of the piston showing the spiral indent mark on the hole wall of the piston.

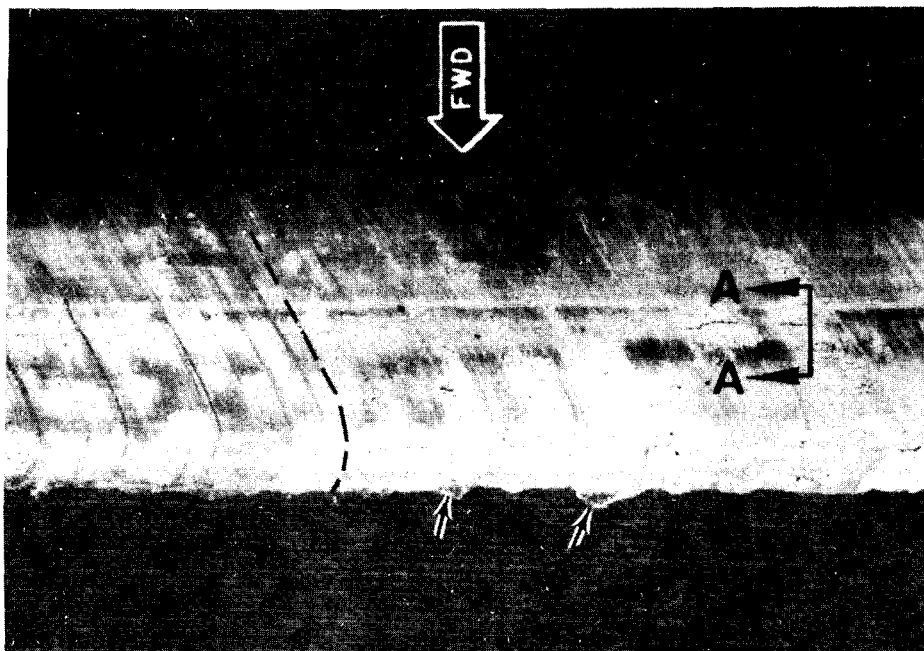
Figure 6.--Perpendicular view of the indent mark on the piston's internal wall in the area located by bracket "a," figure 5. (Magnified approximately X4.)

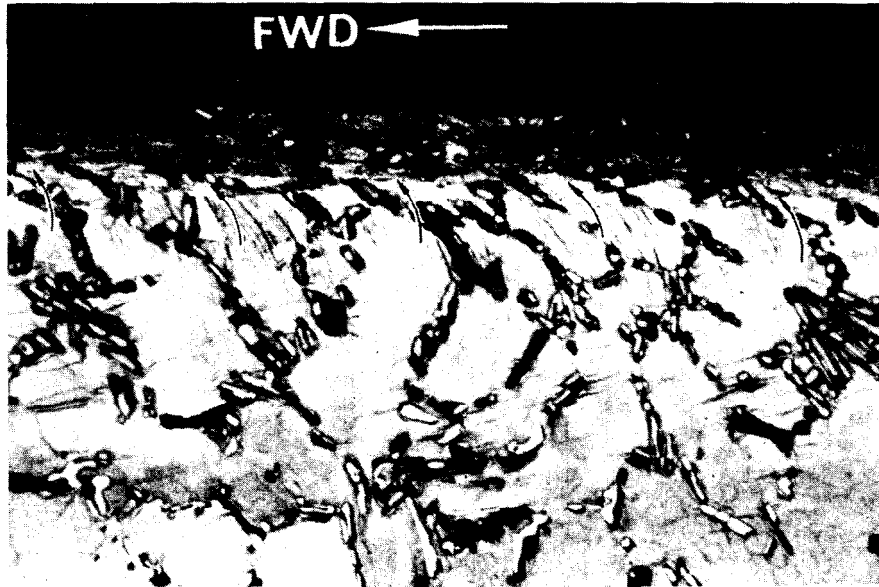
Figure 7.--Transverse to gouge metallographic cross section in the area of section A-A in figure 6. Small curved arrows denote direction of metal flow deformation. (Heavily etched Kellers reagent.)

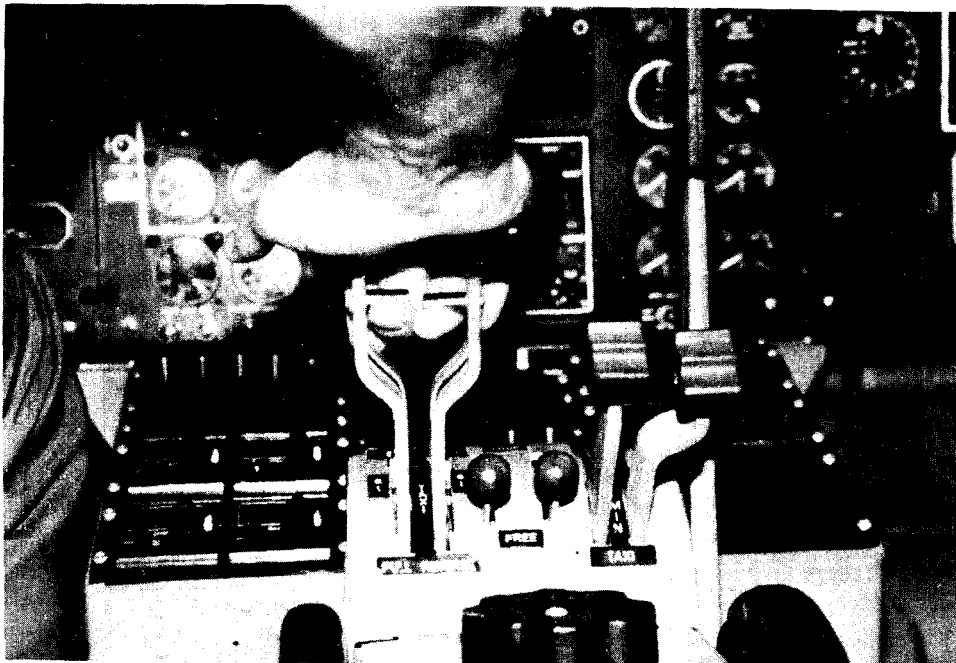
- When moving the PLs from the right seat, it was more difficult to actuate the latches because the PLs are further away. It required rotating the left hand forward in order to place the fingers underneath the latch arms.

Figure B.--Closeup of the PLs showing operation of the latch lever arms with the PLs in the full reverse position.
