AIRCRAFT ACCIDENT REPORT

MIDAIR COLLISION OF CESSNA-340A, N8716K,
AND NORTH AMERICAN SNJ-4N, N71SQ,
ORLANDO, FLORIDA
MAY 1, 1987

NTSB/AAR-88/02

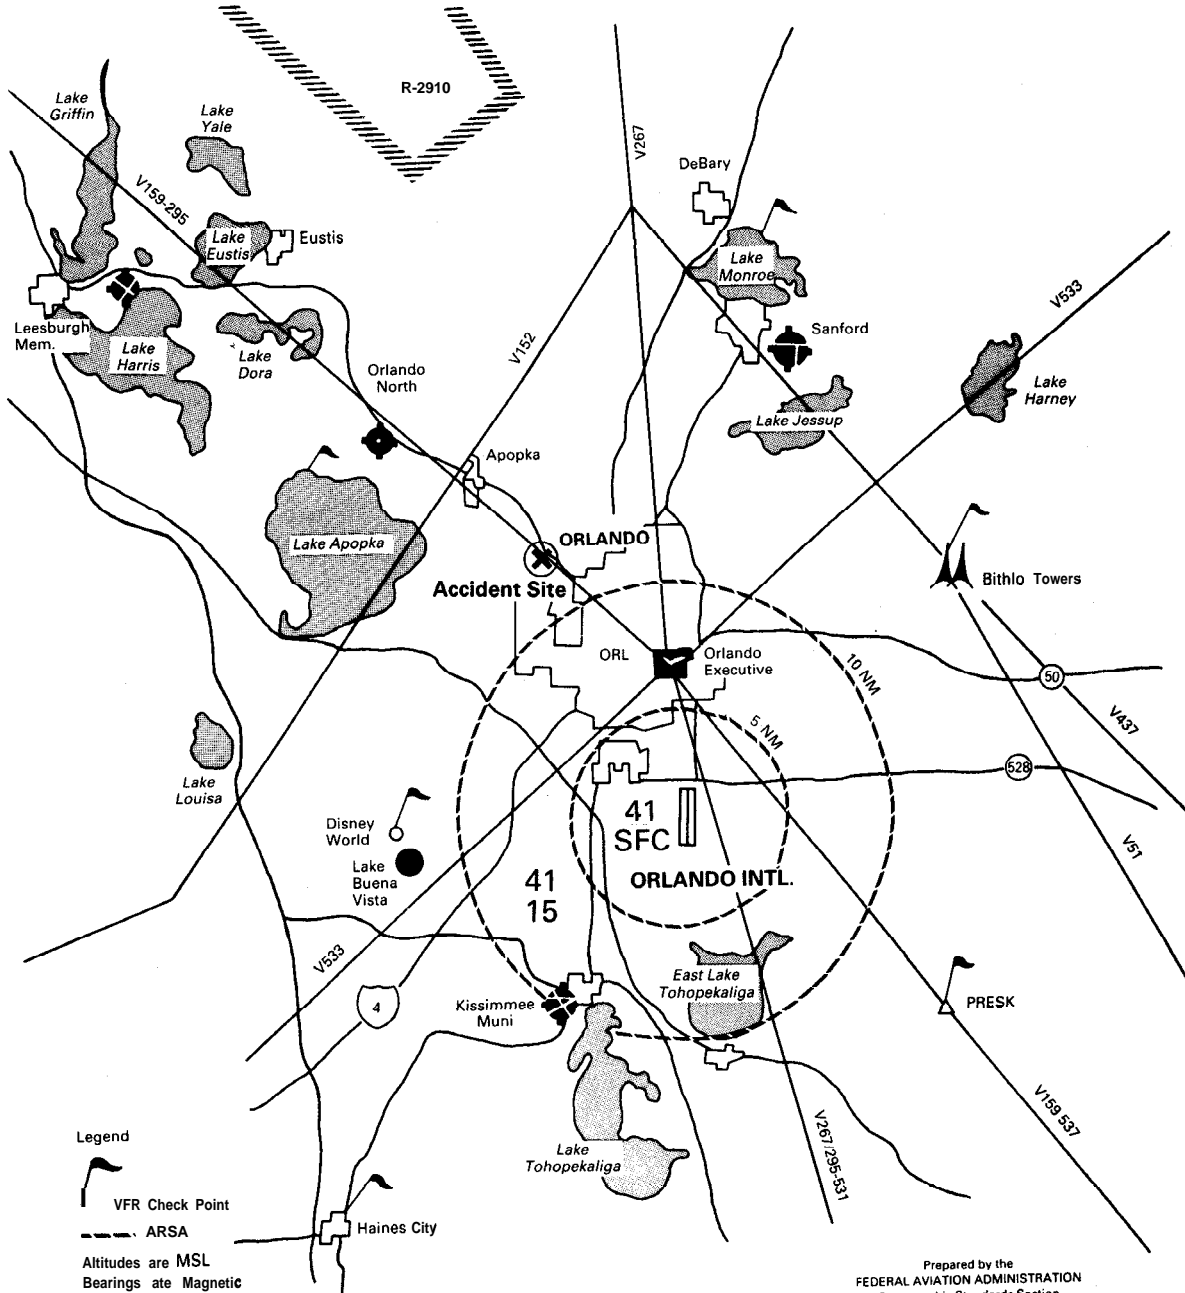
Figure I--Accident site.

Both airplanes struck a mobile home at 4316 Davy Street, Orlando, Florida, about 7 miles northwest of ORL (figure 1). Damage to the mobile home was extensive. The distribution of the main wreckage of both airplanes was contained in the backyard of the residence. The general orientation of the wreckage path was on a bearing of about 168 magnetic. The majority of the wreckage was scattered over an area about 125 feet long by about 50 feet wide. All major components of both airplanes were within these boundaries. Two distinct impact penetrations were observed in the mobile home: one was through the front and rear walls and the roof of the home; the other was through its roof and rear wall. Red paint was found on the interior surface of the home. The right wing tip of the SNJ was found inside the larger opening. The right elevator tip of the Cessna-340A was found in the roof of the second penetration.

There was a 3-foot-deep crater where the radial engine and forward fuselage of the SNJ-4 had come to rest. To the left of and parallel to the overall wreckage path was a 6-inch-deep concave ground scar that passed underneath the SNJ-4 right wing. This ground scar was in line with the second smaller penetration in the mobile home.

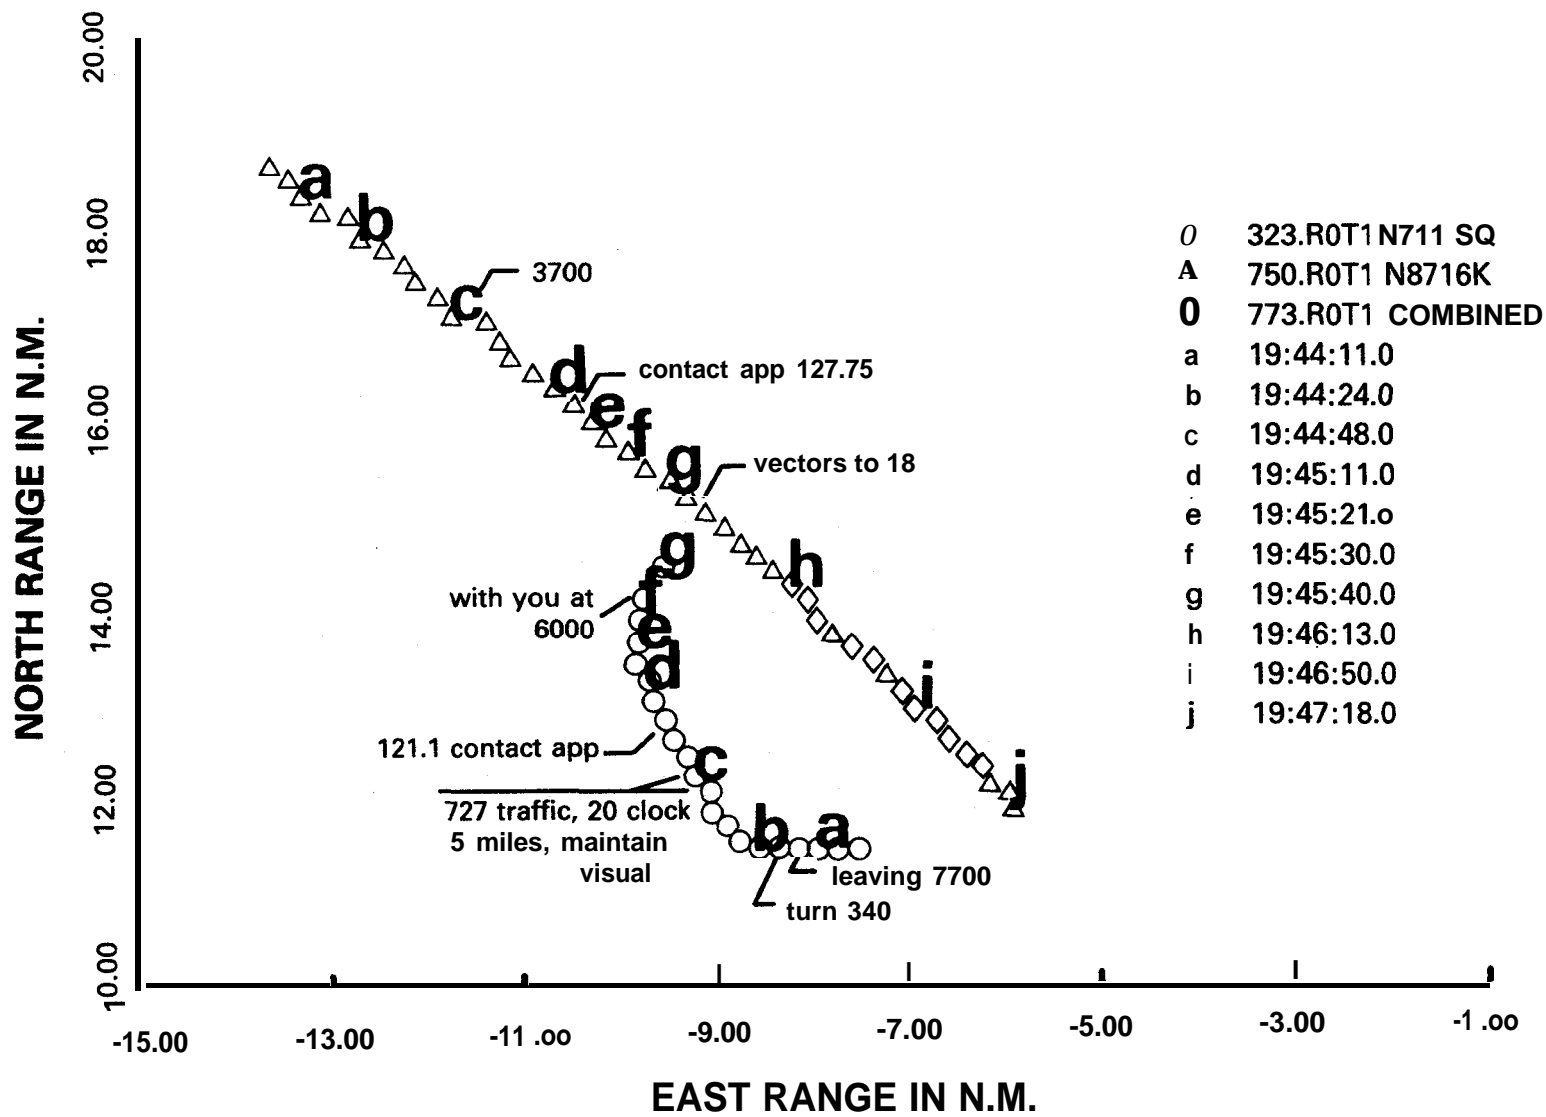
Figure 2-Radar ground track plots.

Radar data recorded by the Orlando Terminal Radar Approach Control (TRACON) radar site, located at MCO and air traffic control (ATC) communication transcripts were evaluated in order to determine the ground track and to establish the relative positions of the two airplanes during the accident sequence. (See figure 2.)

The recorded radar data provided by the Federal Aviation Administration (FAA) indicated that a primary target was about 2 miles to the left of their track northwestbound and parallel to the flightpath of N711SQ and N8716K while they were southeastbound just before the accident. The type of aircraft and its altitude and destination were not determined.

While N711SQ and N8716K were both southeastbound and close to each other, a new, separate beacon return was presented to the controllers that replaced the beacon codes assigned to N711SQ and N8716K.

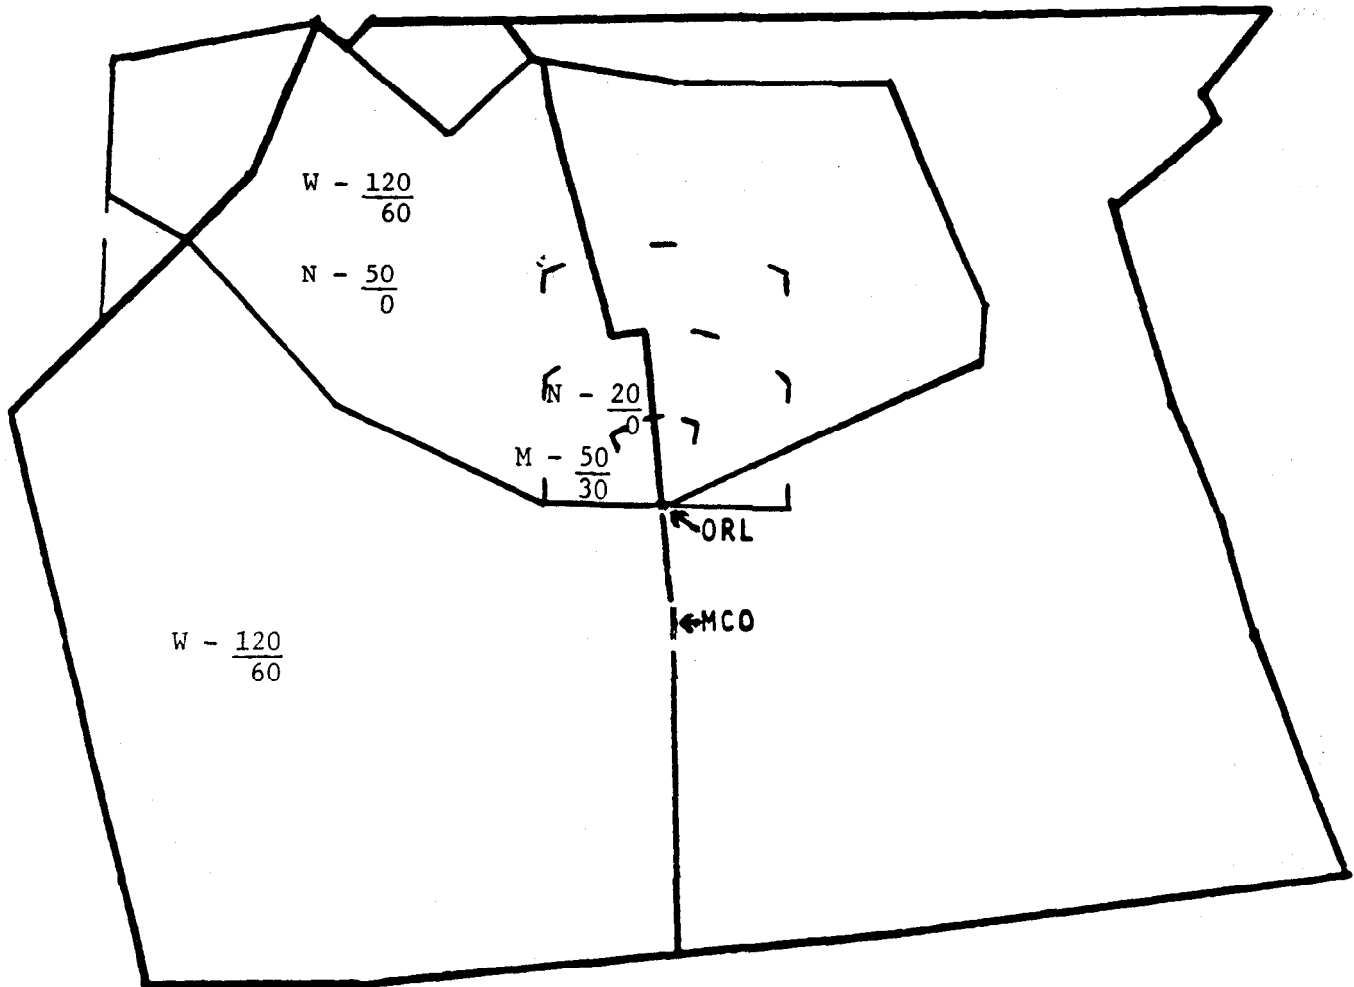
Figure 3--West, North, and Final Radar sector boundaries.

Orlando TRACON is delegated the airspace extending from the surface to 12,000 feet vertically and laterally within about 35 miles of the Orlando VORTAC. Within these boundaries the airspace is divided into six radar sectors. The radar sectors providing air traffic services to N711SQ and N8716K were designated Radar West, Radar North, and MCO Final (see figure 3).

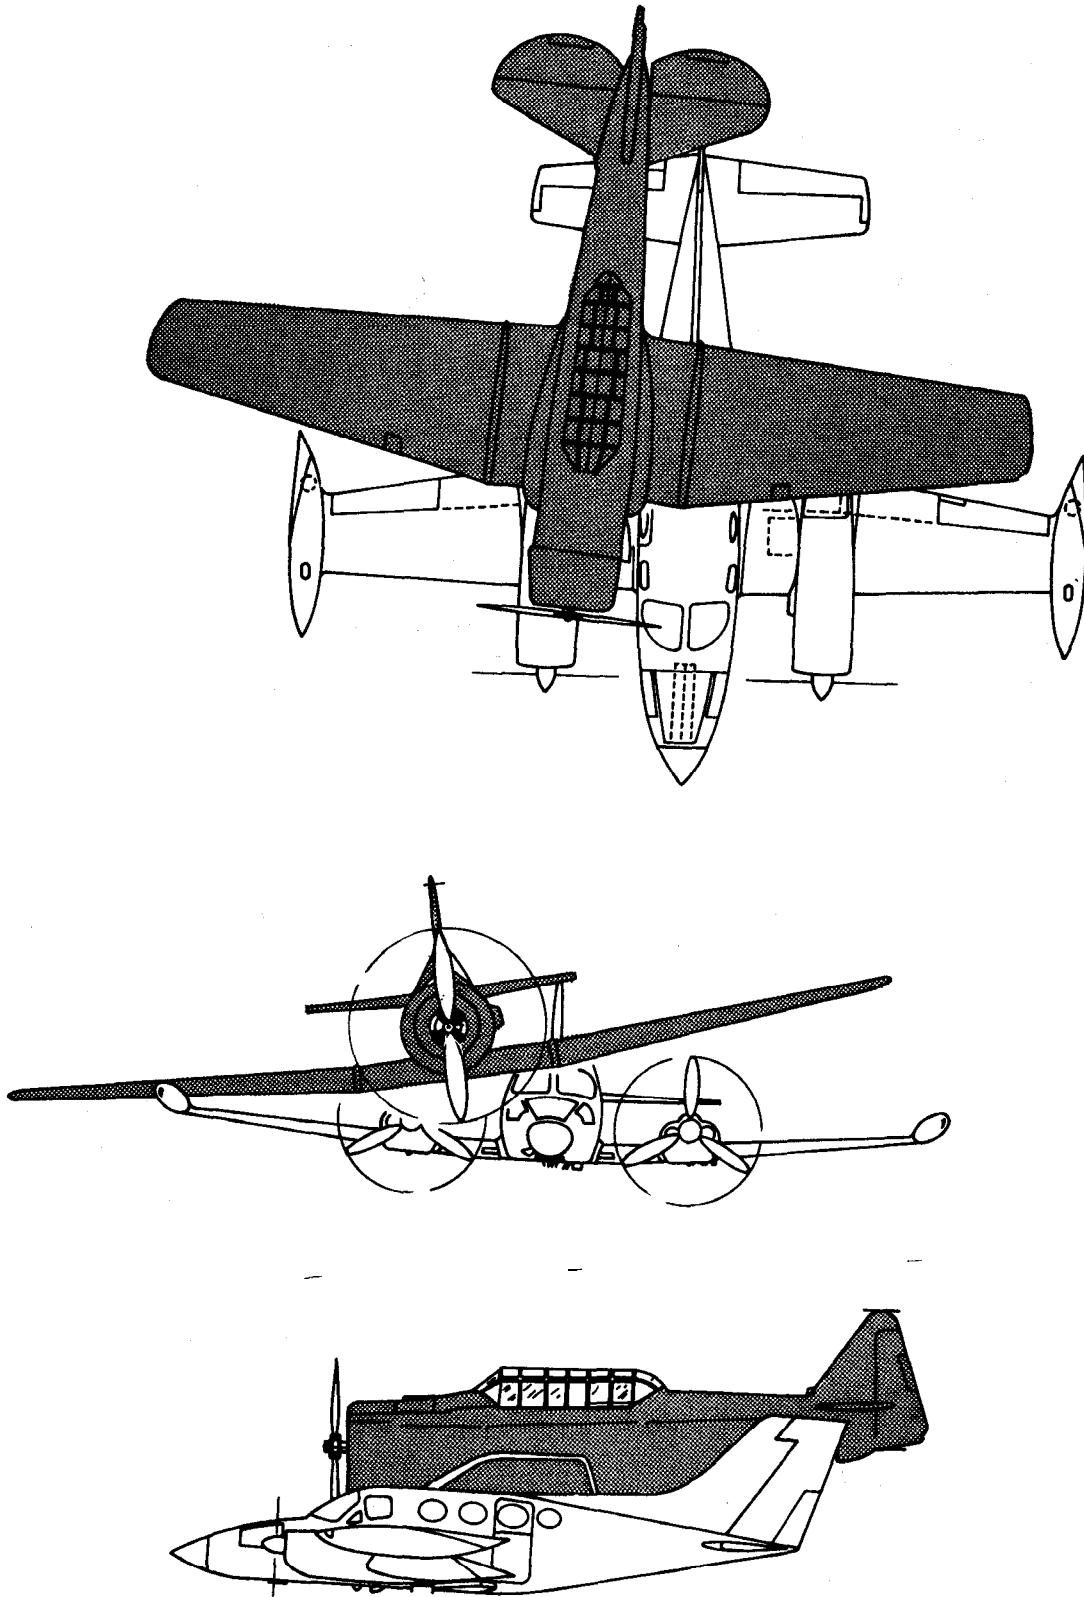
Figure 4.--Collision angle between SNJ4 and Cessna -340.

From 19:45:40 until the airplanes collided, the vertical separation angle was too great (the SNJ-4 was over the C-340A) unless the pilots performed unusual clearing turn maneuvers. It appears that the SNJ-4 pilot may have been able to see the C-340A before 19:45:11 had clearing turns been made. However, at that range, acquisition would not have been ensured. The C-340A would have seen a passing airplane until 19:45:11. Once the SNJ-4 turn started, the C-340A pilot had less than 20 seconds to see the SNJ-4, and then only by leaning over and looking up at a greater than normal angle.

During the last seconds of flight, the C-340A pilot could not see the SNJ-4 because it was above and to the rear of his airplane. Similarly, the SNJ-4 pilot could not see the C-340A because it was forward and below him. Therefore, the positions of the two airplanes during the last portion of the flight precluded either pilot from seeing each other because of cockpit and other aircraft structure restrictions.
