## AVIATION OCCURRENCE REPORT

**FRONTIER AIR LTD.  
BEECHCRAFT C99 AIRLINER C-GFAW  
MOOSONEE, ONTARIO  
30 APRIL 1990**

**REPORT NUMBER A90H0002**

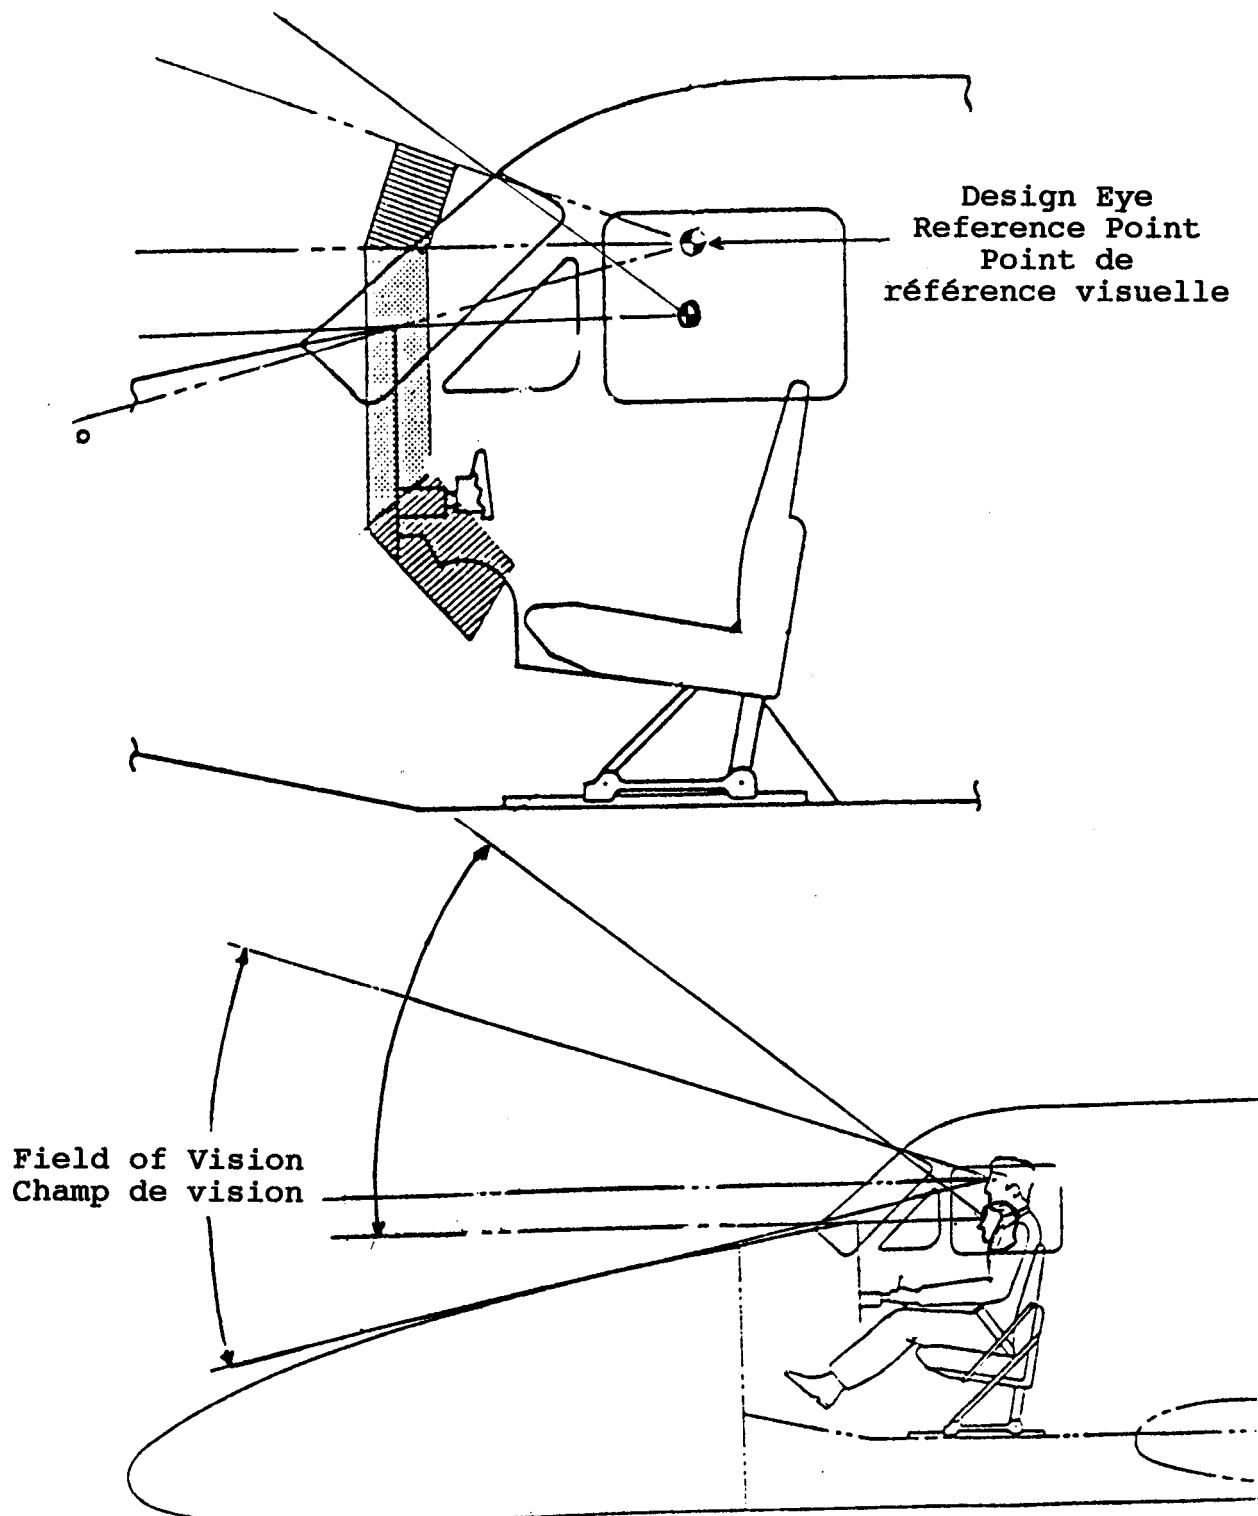
## Appendix B - Visibility Changes

### VARIATION IN FIELD OF VISION BASED ON EYE POSITION VARIATIONS DU CHAMP DE VISION SELON LA POSITION DES YEUX
