AIRCRAFT ACCIDENT REPORT

**RUNWAY COLLISION
OF EASTERN AIRLINES BOEING 727, FLIGHT 111
AND EPPS AIR SERVICE BEECHCRAFT KING AIR A100
ATLANTA HARTSFIELD INTERNATIONAL AIRPORT
ATLANTA, GEORGIA
JANUARY 18, 1990**

**ADOPTED: May 29, 1991
NOTATION 5458**

Abstract: This report explains the runway collision of an Eastern Airlines Boeing 727 with an Epps Air Service Beechcraft at the Hartsfield International Airport, Atlanta, Georgia, on January 18, 1990. The safety issues discussed in the report are air traffic controller procedures, conspicuity of airplane lighting, the "see and avoid" concept, and equipment and systems to prevent runway incursions. Safety recommendations concerning these issues were made to the Federal Aviation Administration.

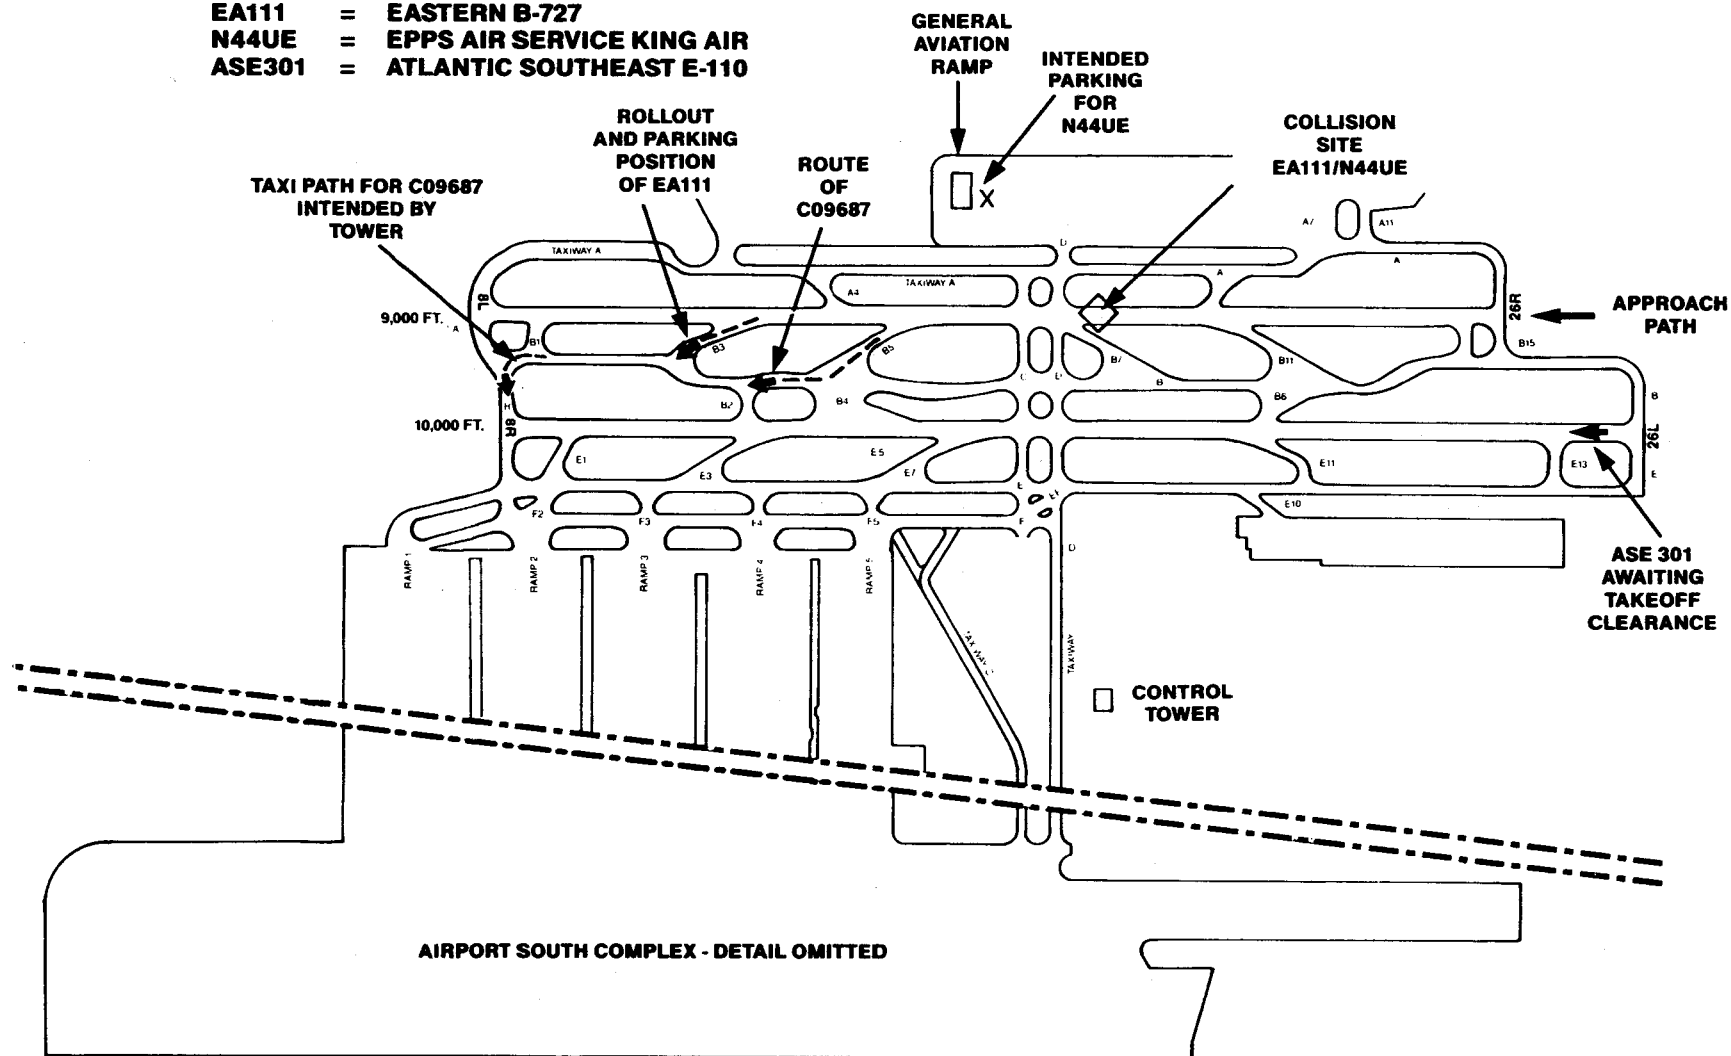
Figure 2.--Airport diagram with overlay of activity related to collision.

Grounds scars from the collision indicated that the King Air had moved to the right side of runway 26 at the time of the collision and was near taxiway "D," the primary taxiway for general aviation airplanes. The turnoff for taxiway "D" was about 3,800 feet from the approach end of the runway. The right wing of the B-727 struck the tail cone and structure of the King Air, separating the horizontal and vertical stabilizers from the fuselage and shearing the top of the fuselage/cockpit from the airplane. The King Air was destroyed. It came to rest at the turnoff for taxiway "D" with the engines still running. There was no postimpact fire. Airport Rescue and Fire Fighting (ARFF) personnel shut down the engines and secured the electrical system.

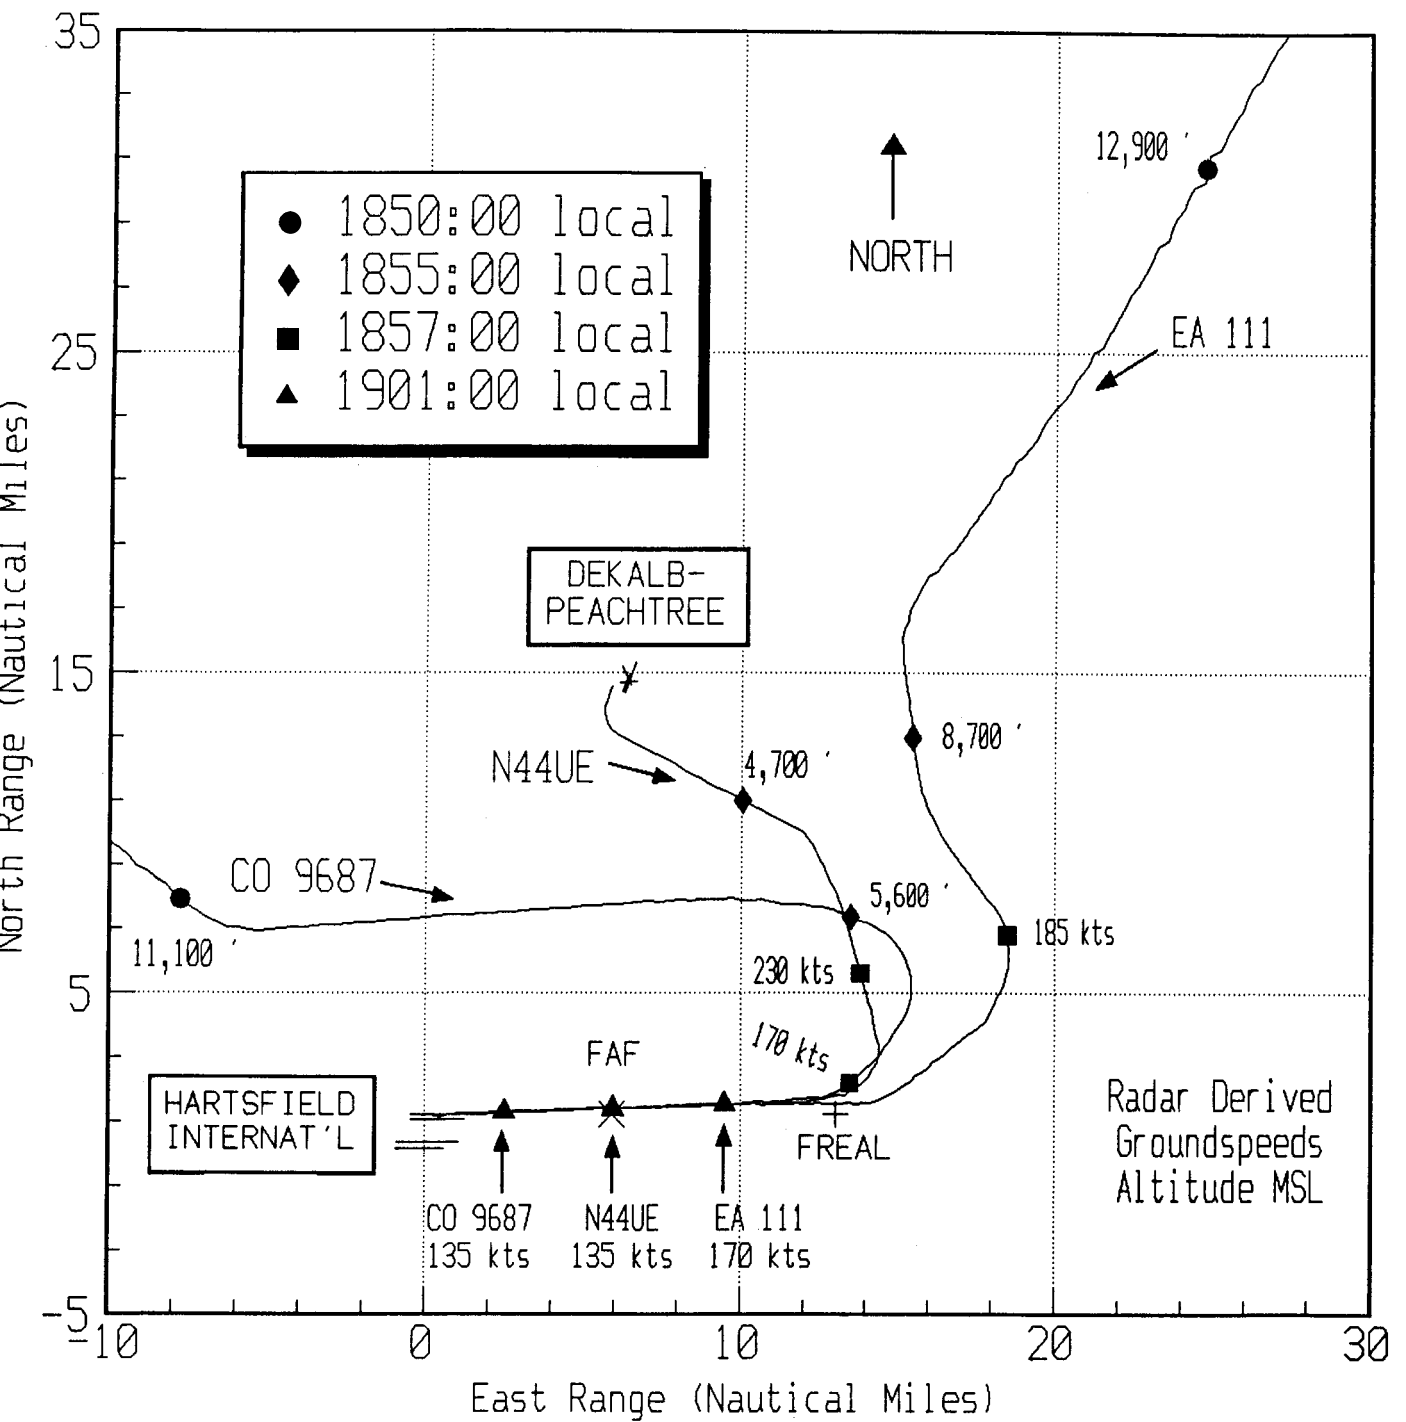
Figure 3.--Data showing landing sequence for runway 26 right.

ATC radar and communications data reveal that vectors were issued to three inbound airplanes to establish the landing sequence for runway 26 right immediately before the accident. (See figure 3). The three airplanes were CO 9687, a Continental Airlines DC-9; N44UE, the Beech King Air; and EA 111. A complete description of the air traffic actions is contained in paragraph 1.17.2, Air Traffic Handling.

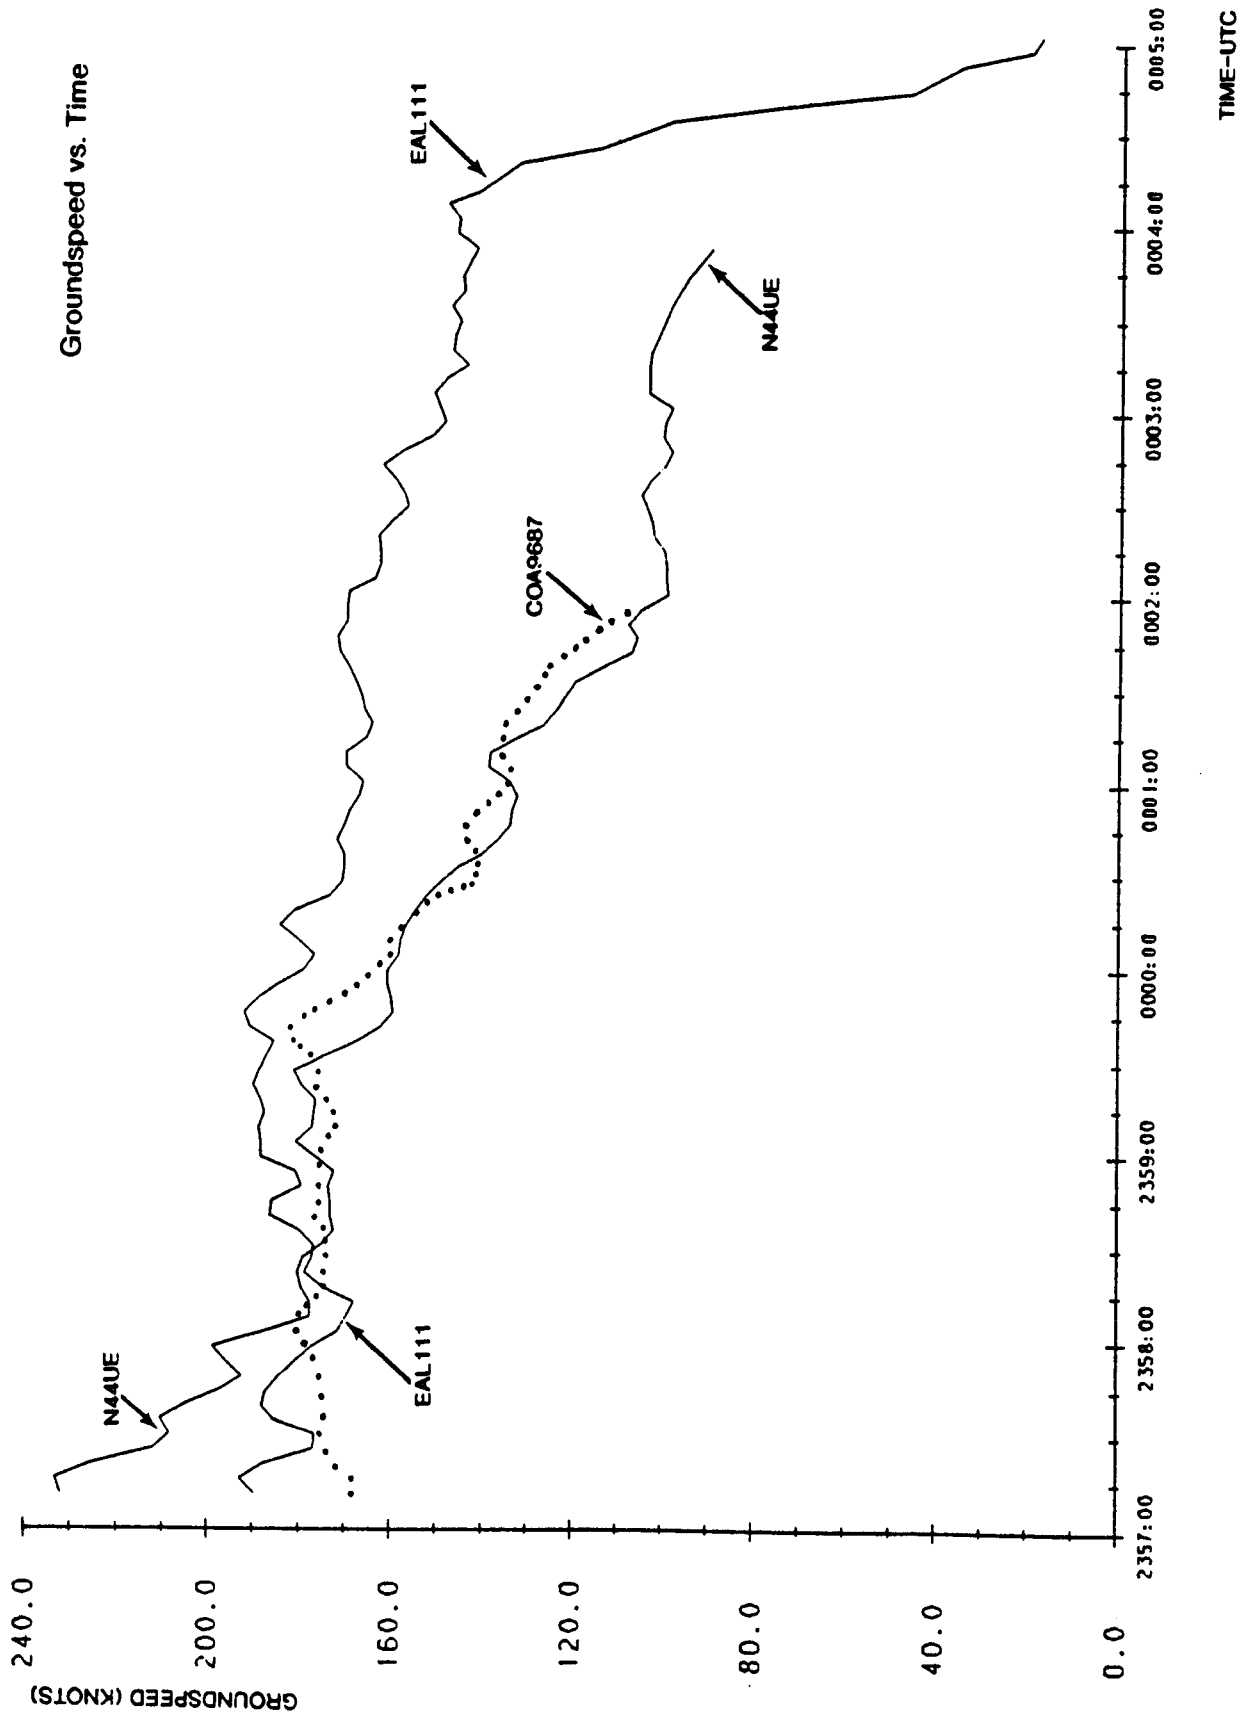
Plots of Calculated Groundspeed as a Function of Time
for EA 111, N44UE and CO, 9687.

The final controller could neither recall the ground speed of EA 111 nor the ground speed of N44UE, which he did not observe. However, he was aware that EA 111 was overtaking N44UE, but he did not believe that EA 111 was faster than any other jets he had observed that evening on final approach. When asked if he had issued traffic information to the flightcrew
