ACCIDENT INVESTIGATION REPORT

BASI REPORT B/911/1012

Gulfstream Aerospace AC 681 VH-NYG
Tamworth NSW
14 February 1991

Incorporating
Australian Aviation Occurrences Involving Fuel
Starvation and Exhaustion 1969-86 (Reprint and Update)

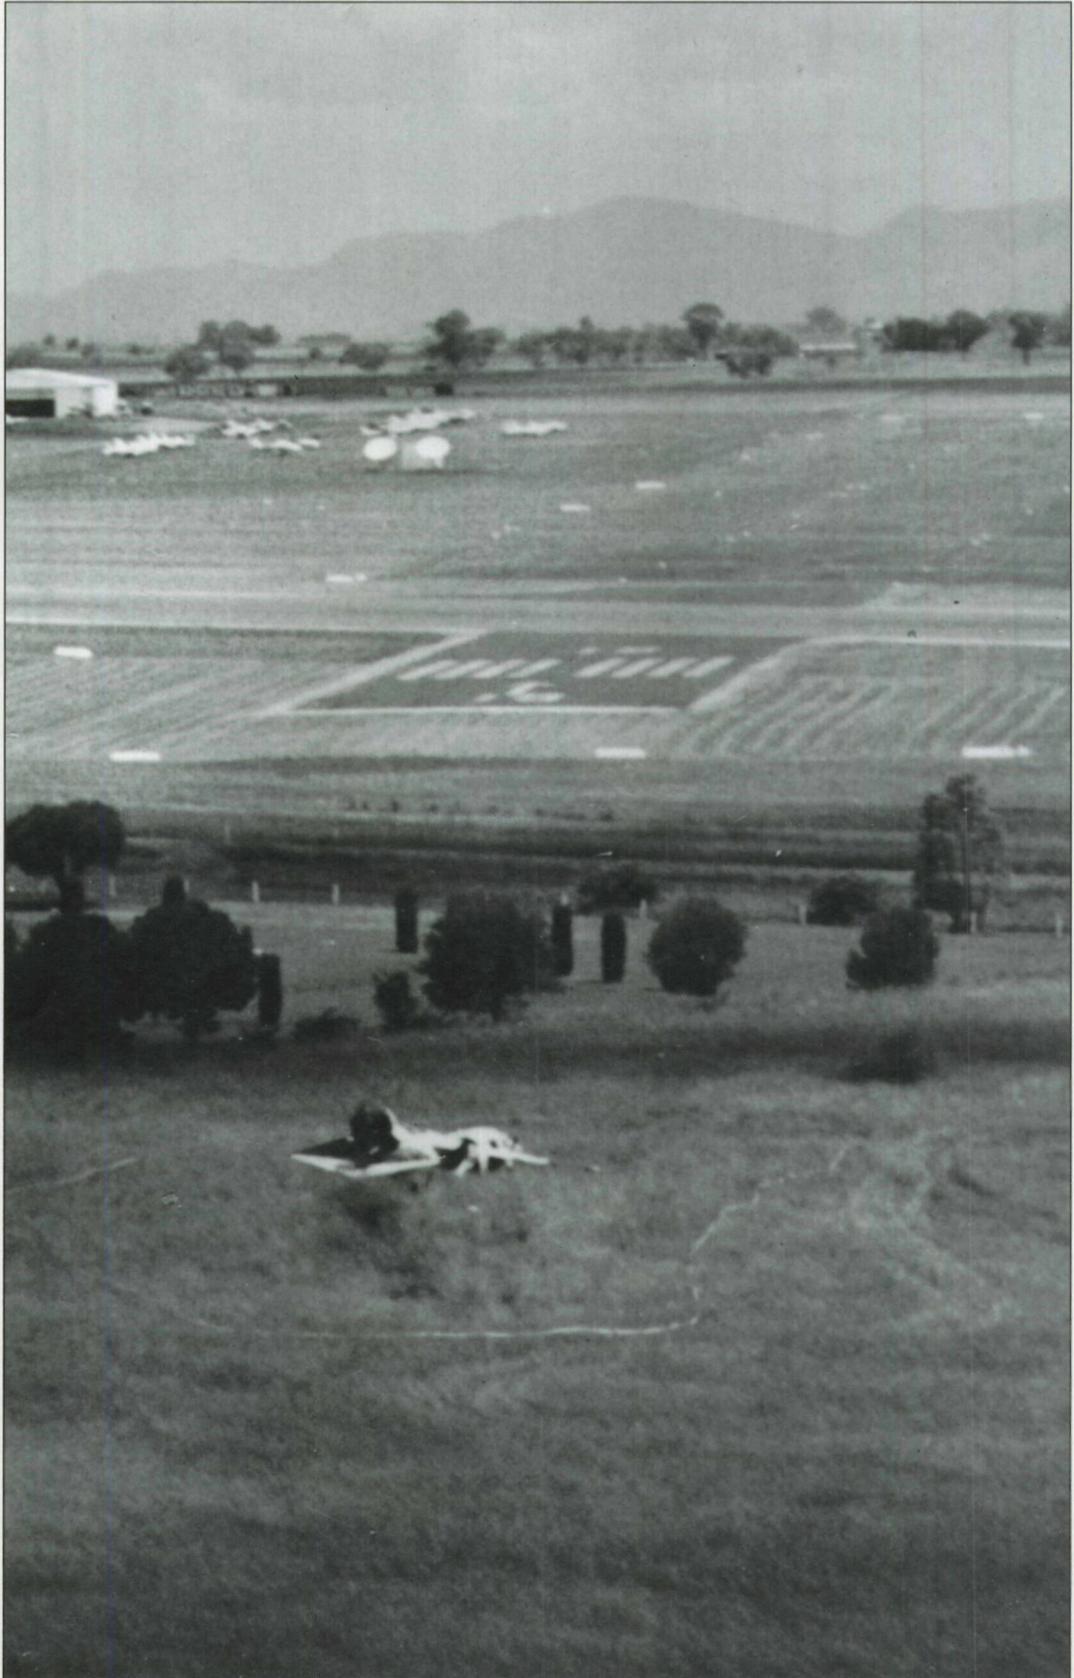
Aircraft came to rest approximately 300 m short of the threshold of runway 18 Tamworth.

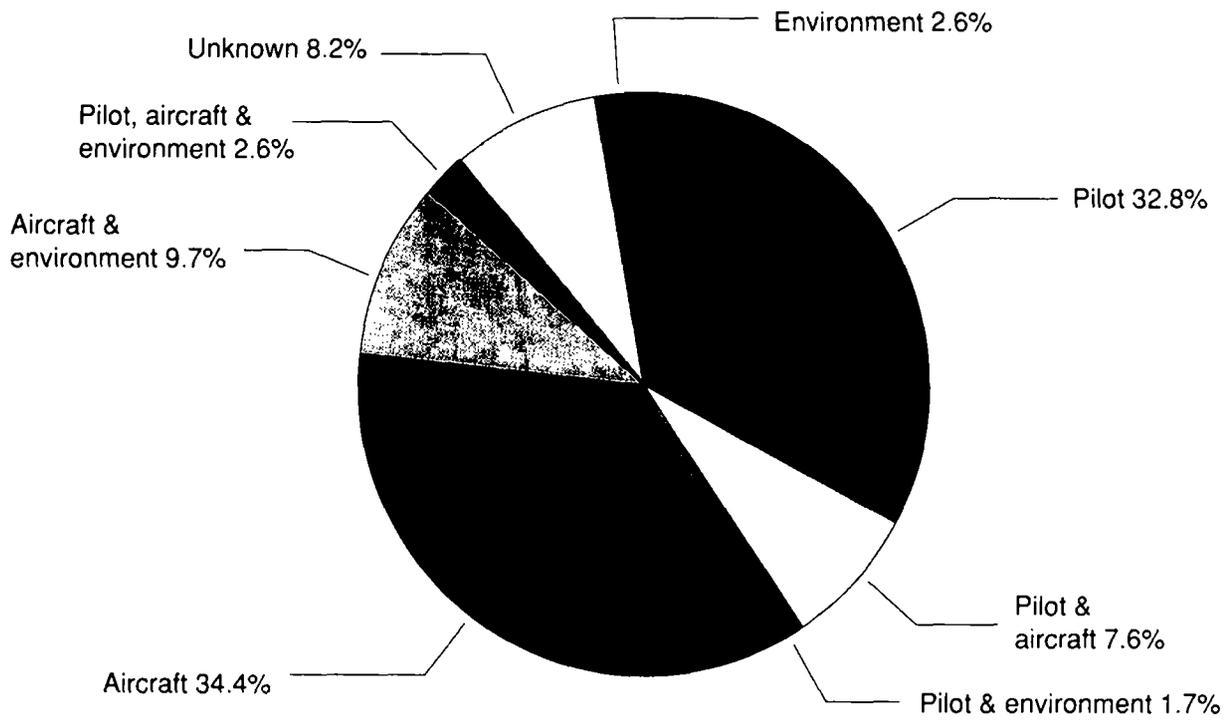
Figure 1 FACTORS – FUEL STARVATION

Figures 1&2 depict the balance found between pilot, aircraft and so-called environmental factors in fuel starvation/exhaustion. The contribution of each category alone is shown, as well as the major joint influences. It should be noted that aircraft factors denote malfunctions in either the fuel system or the engine instruments.

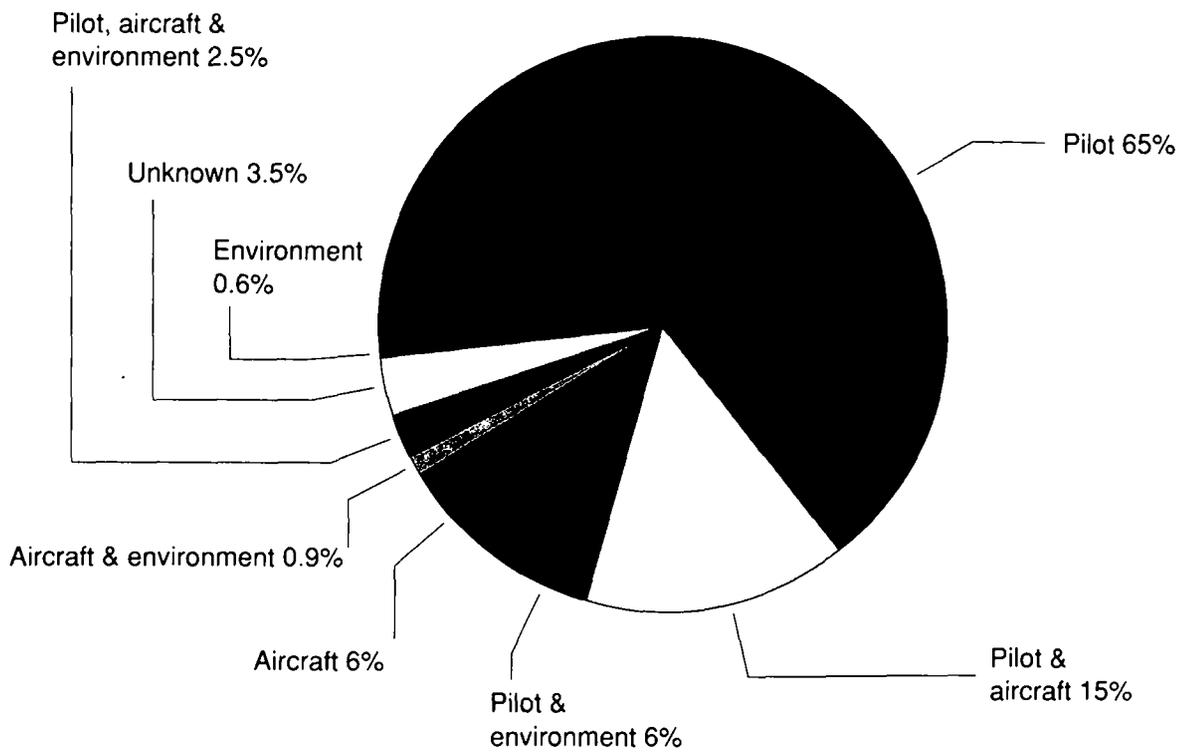
Figure 2 FACTORS – FUEL EXHAUSTION

There were a greater number of pilot – aircraft cases in fuel exhaustion than in fuel starvation (where, for example, the pilot contributed to a fuel system malfunction). There were also a greater number of pilot – environment cases in fuel exhaustion than in fuel starvation (where, for example, the pilot did not allow for the effect of strong headwinds). Fuel starvation, however, had more aircraft environment cases than fuel exhaustion (e.g. where maintenance personnel contributed to or overlooked a fault in the fuel system).
