PB92-910401  
NTSB/AAR-92/01

## AIRCRAFT ACCIDENT REPORT

L'EXPRESS AIRLINES, INC., FLIGHT 508  
BEECH C99, N7217L  
WEATHER ENCOUNTER AND CRASH  
NEAR BIRMINGHAM, ALABAMA  
JULY 10, 1991

**Adopted: March 3, 1992  
Notation 5558A**

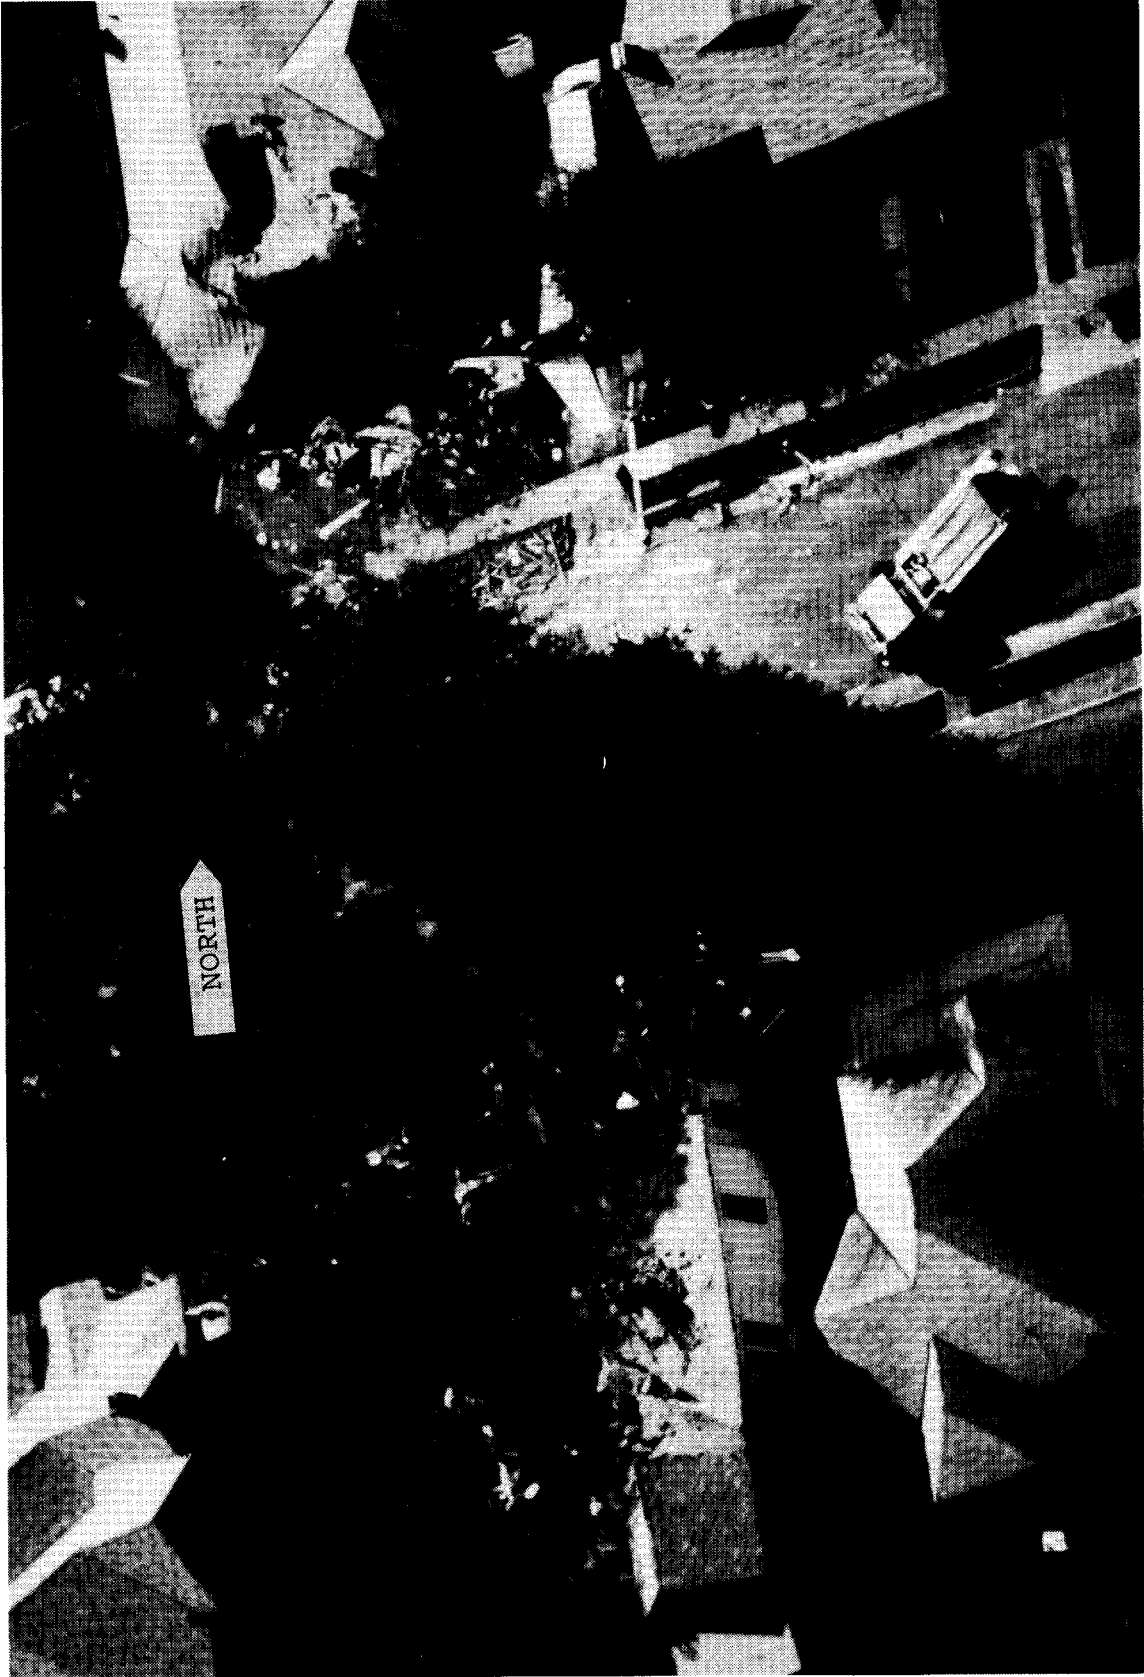
Figure 2.--Aerial photograph of wreckage.

The street pavement, 80 feet north of the first impacted tree and between the two destroyed houses, showed no evidence of metal or paint transfer. A 15-foot section of concrete curb on the north edge of the street in front of the second house at 2517 29th Place had been crushed by the airplane. Two automobiles parked on the street between the two houses were destroyed. The airplane was found partially imbedded in the front porch and front rooms of the second residence. (See figure 2).

The interior of the passenger cabin was extensively damaged by impact and fire. The nose section just forward of the cockpit was crushed. The top of the airplane from the cockpit area to just forward of the empennage was destroyed by fire. The fuselage belly skin suffered no fire damage but did show compression buckling. The empennage had broken from the fuselage, but it remained attached by control cables and some fuselage skin. The left and right horizontal stabilizer leading edges had numerous dents similar to tree strikes. The right horizontal stabilizer had partially separated from its attach points and was located about 6 inches from the empennage. Both the right and left elevators were found attached to the stabilizers. The vertical stabilizer was intact with the empennage and had damage to the top, sides, and de-ice boot. The rudder was attached to the lower three hinge points and its control system was intact within the empennage. The top hinge point was severed along with the rotating beacon and top trim cap.

The left and right wing root attach points were severely damaged and had evidence of exposure to extreme heat. All of the wing spar attach bolts and the outer wing attach fittings were examined for preimpact failures. No evidence was found that would indicate preimpact failures, fatigue cracking or necking of any wing attach points. The fuselage baggage pod attached to the belly of the airplane had sheared off upon impact with the first house.

The right wing had sheared from the airplane outboard of the right engine nacelle and showed evidence of having struck the first house. There was no evidence of heat or fire damage to this section of the right wing. The left wing remained attached to the left engine nacelle and exhibited heavy fire damage. This wing had evidence of dents and scratches indicating that it had passed through tree branches.
