Accident to Indian Airlines Boeing 737 Aircraft VT-EFL on
16th August 1991 Near Imphal, Manipur

**REPORT OF
THE
COURT OF ENQUIRY**

DECISION OF GOVERNMENT OF INDIA ON REPORT OF THE COURT OF INQUIRY OF THE ACCIDENT TO INDIAN AIRLINES B-737 AIRCRAFT VT-EFL NEAR IMPHAL ON 16.8.1991:

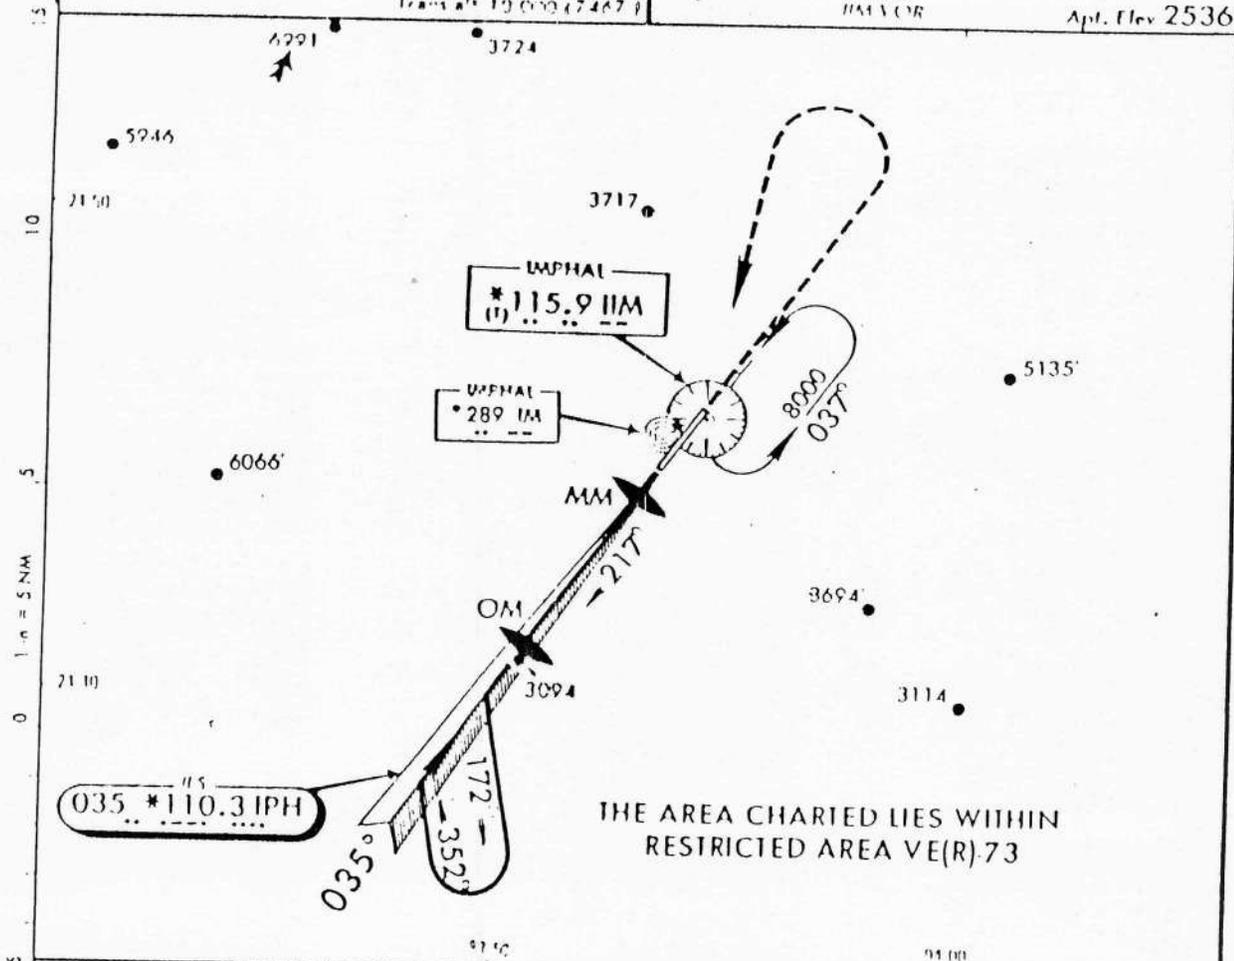
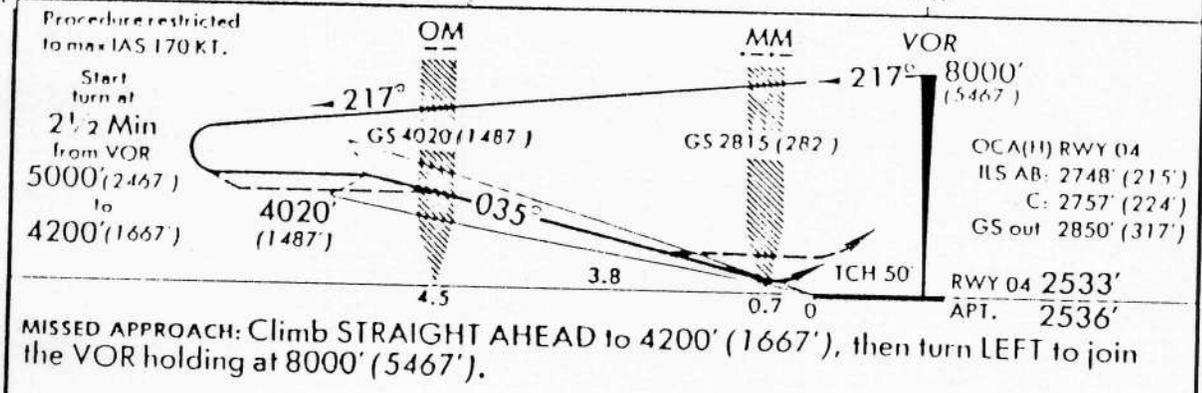
In the ILS let down chart it has been shown that there exists an obstruction immediately before the outer marker inbound at a level of 3094 feet above sea level and considering the elevation of the Imphal airport the obstruction height is to the extent of about 600 feet. The ILS let down chart provides the outer marker inbound level at 4,020 feet and considering the ICAO regulation of obstruction free distance being 984 feet the let down chart can not be described to be unsafe in any manner. The importance of obstruction free primary and secondary area however, can not be decided in any way but since a doubt has been expressed in regard to the same it would be better for all concerned to review the entire situation specially pertaining to the North Eastern Region Airports

The ILS let down chart as noted above categorically points out that upon obtaining the glide slope at 4,020 feet, the pilot should follow 035° heading and then land provided, however, the runway is visible at 224 feet above the runway level. In the event, however, the runway is not visible at the height mentioned above, the aircraft is supposed to do a missed approach procedure and climb straight ahead to 4,200 feet and then turn left to join the VOR holding pattern at 8,000 feet. Similar provision has been made in the chart in the event of the glide slope or the middle marker being not available, the aircraft in that event, however, cannot land unless the runway is visible from an height of 317 feet and the aircraft is to carry a missed approach procedure as noted above. The procedure laid down is elaborate and if followed question of the let down chart being unsafe does not and cannot arise.
