AIRCRAFT ACCIDENT REPORT 5/94

Air Accidents Investigation Branch

**Report on the accident to
Cessna 550 Citation II, G-JETB
at Southampton (Eastleigh) Airport
on 26 May 1993**

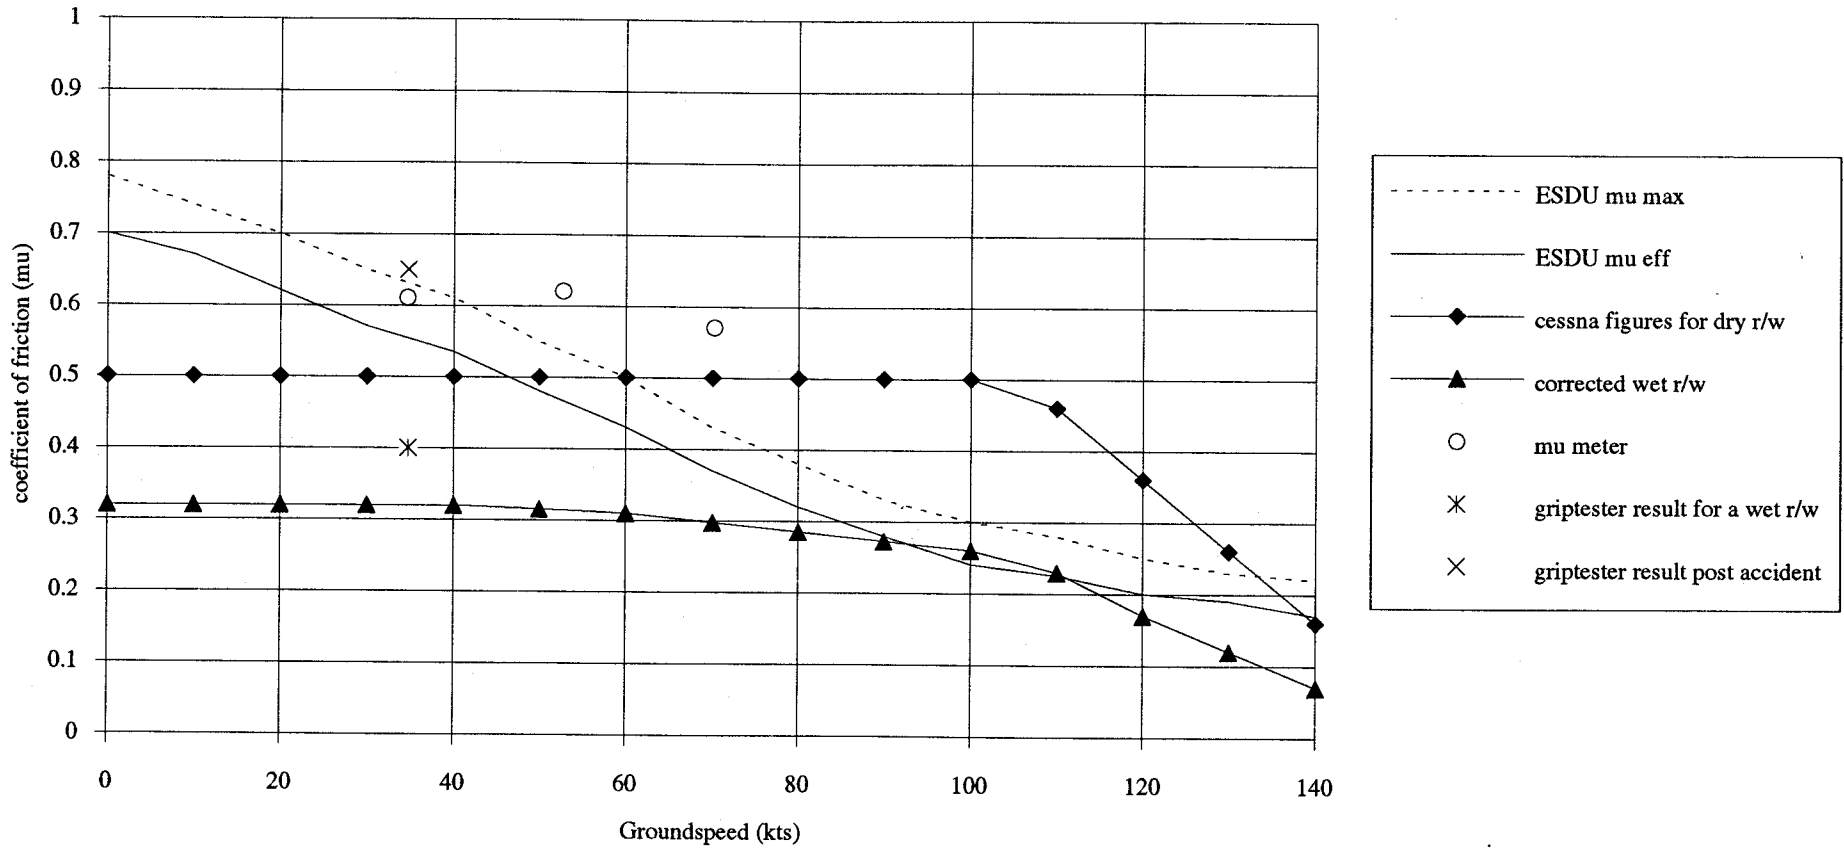
Figure C-1

G-JETB COMPARISON OF THEORETICAL AND MEASURED RUNWAY FRICTION

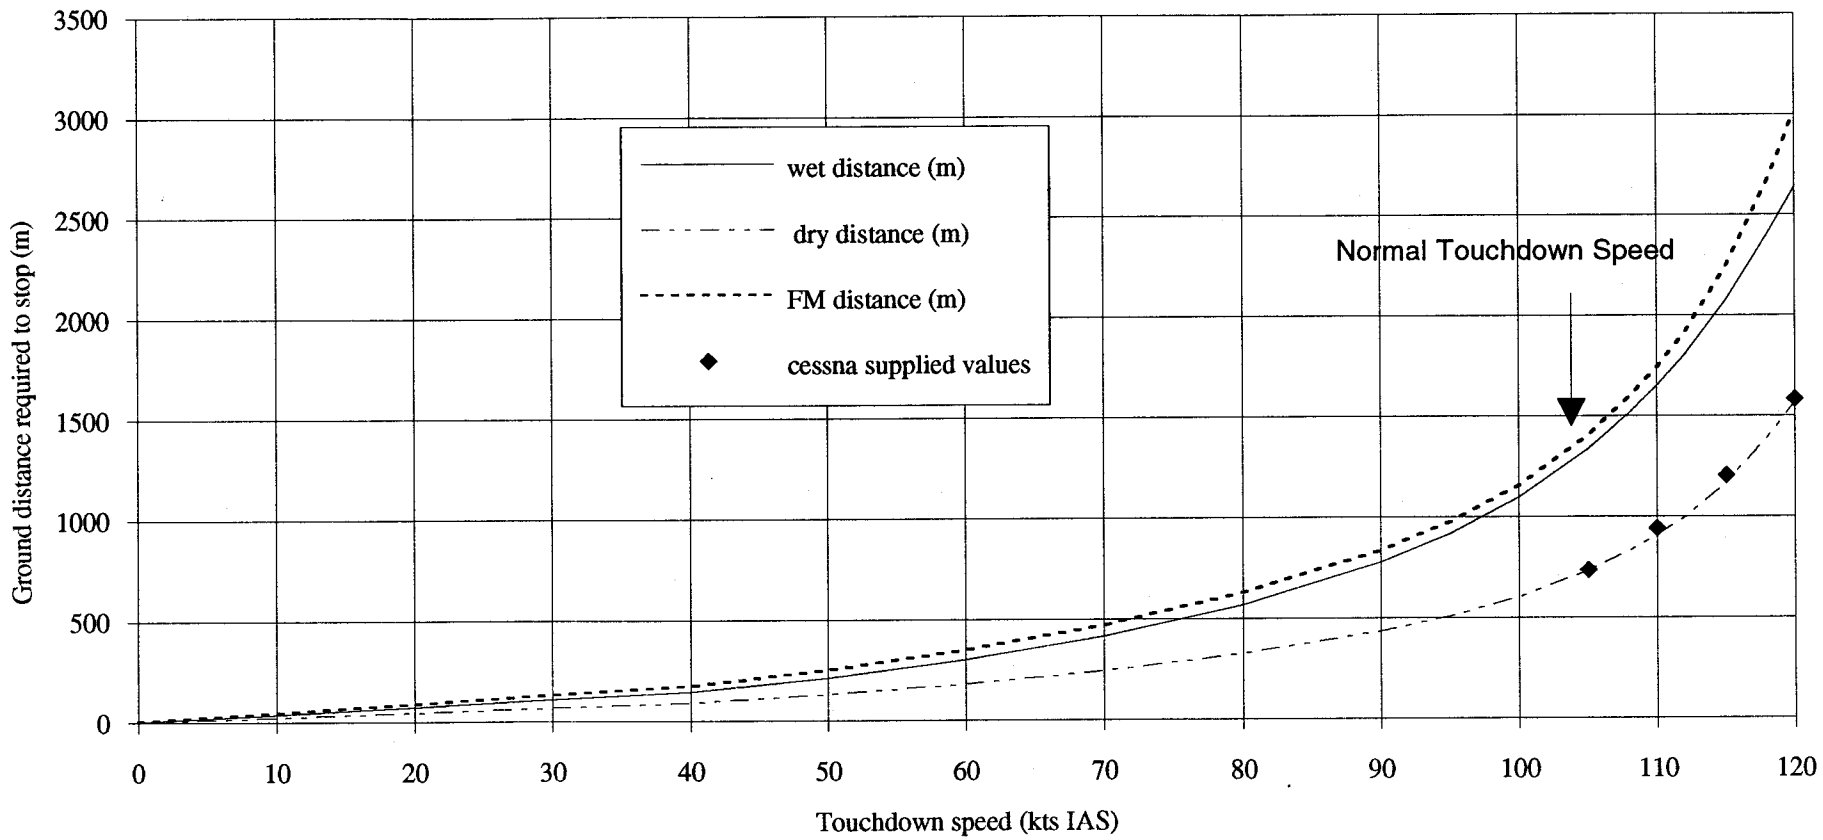
Figure C-2

Appendix C, Figure C-2, shows landing ground roll as a function of touchdown IAS in the conditions pertaining at the time. From this it can be seen that, for a touchdown speed of between 105 kt and 115 kt IAS, the distance required to reduce to 50 to 60 kt IAS is between 600 metres and 1,000 metres on a dry runway, and between 1,100 metres and 1,800 metres for a wet runway.

G-JETB GROUND DISTANCE REQUIRED TO STOP

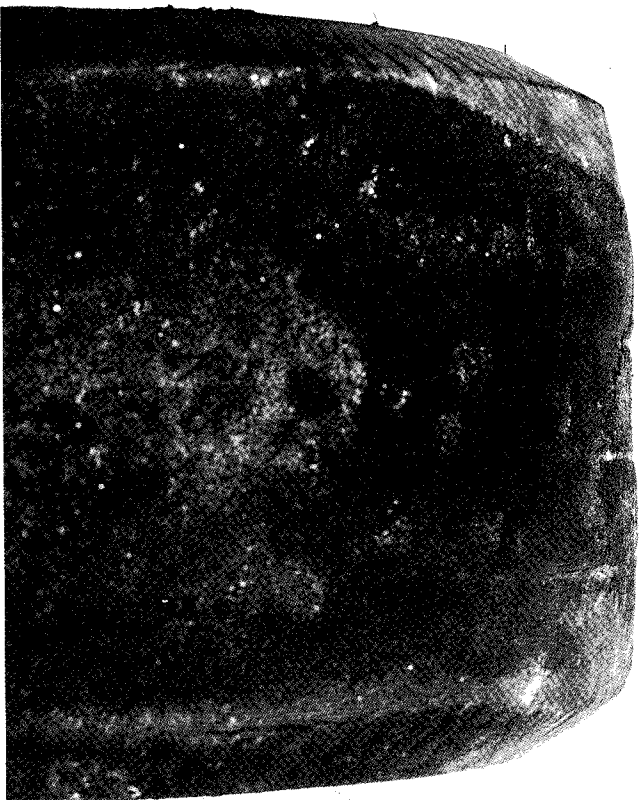
LEFT TYRE

The left tyre had suffered considerable fire damage, although it was apparent that it had been in a more advanced state of wear than the right. It was noted on one of the few unburnt sections that the radial grooves on the sidewall of this tyre were shorter than those on the right, due to the tread wearing down to beyond the ends of the grooves. This observation resulted in an estimate of the tread groove depth remaining being no more than 1 to 2 mm at the time of the accident.

The worn condition of the left tyre is more difficult to quantify in terms of its effect on the stopping distance of the aircraft. Allowing for the effects of the fire, the amount of tread groove depth remaining was assessed as being no more than 1 to 2 mm, and was probably worn in excess of the limits described in Airworthiness Notice No 5. Research into hydroplaning has indicated that there is a marked reduction in braking action when the tread depth is below 2.5 mm. In addition, the hydroplaning speed would have been around 94 kt from consideration of the typical tyre pressures. Thus, as the tread grooves filled with water in the deeper puddles on the runway, there would have been a tendency for hydroplaning, resulting in a reduction in wheel RPM followed by the anti-skid system releasing brake pressure. In such conditions, it is the most worn tyre that is the dominant influence on the braking action.

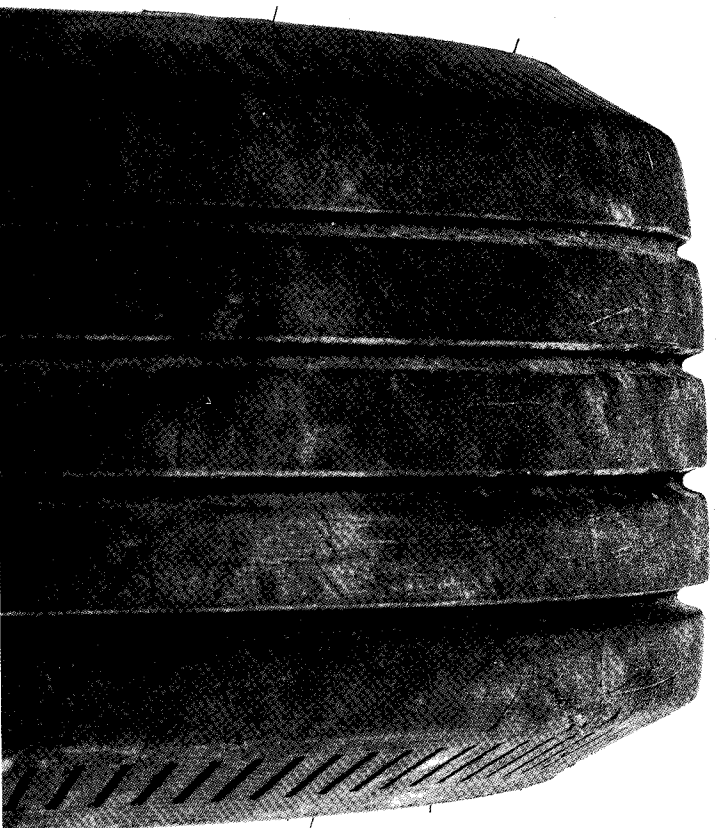
RIGHT TYRE

Photographs of the mainwheel tyres are presented at Appendix D. The right tyre had escaped the worst effects of the fire due to the right leg becoming detached. The examination, which was conducted in the presence of a representative of the tyre manufacturer, showed that this tyre had been in good condition, with no evidence of it having been run in an under-inflated condition. As is typical with this type of aircraft, the tyre had worn slightly more on the inboard side, such that the depth of the tread grooves varied from approximately 5 mm to 8 mm across the tyre width.
