**AIRCRAFT ACCIDENT REPORT 3/95**

**Air Accidents Investigation Branch**

**Report on the accident to  
Vickers Viscount 813, G-OHOT  
near Uttoxeter, Staffordshire  
on 25 February 1994**

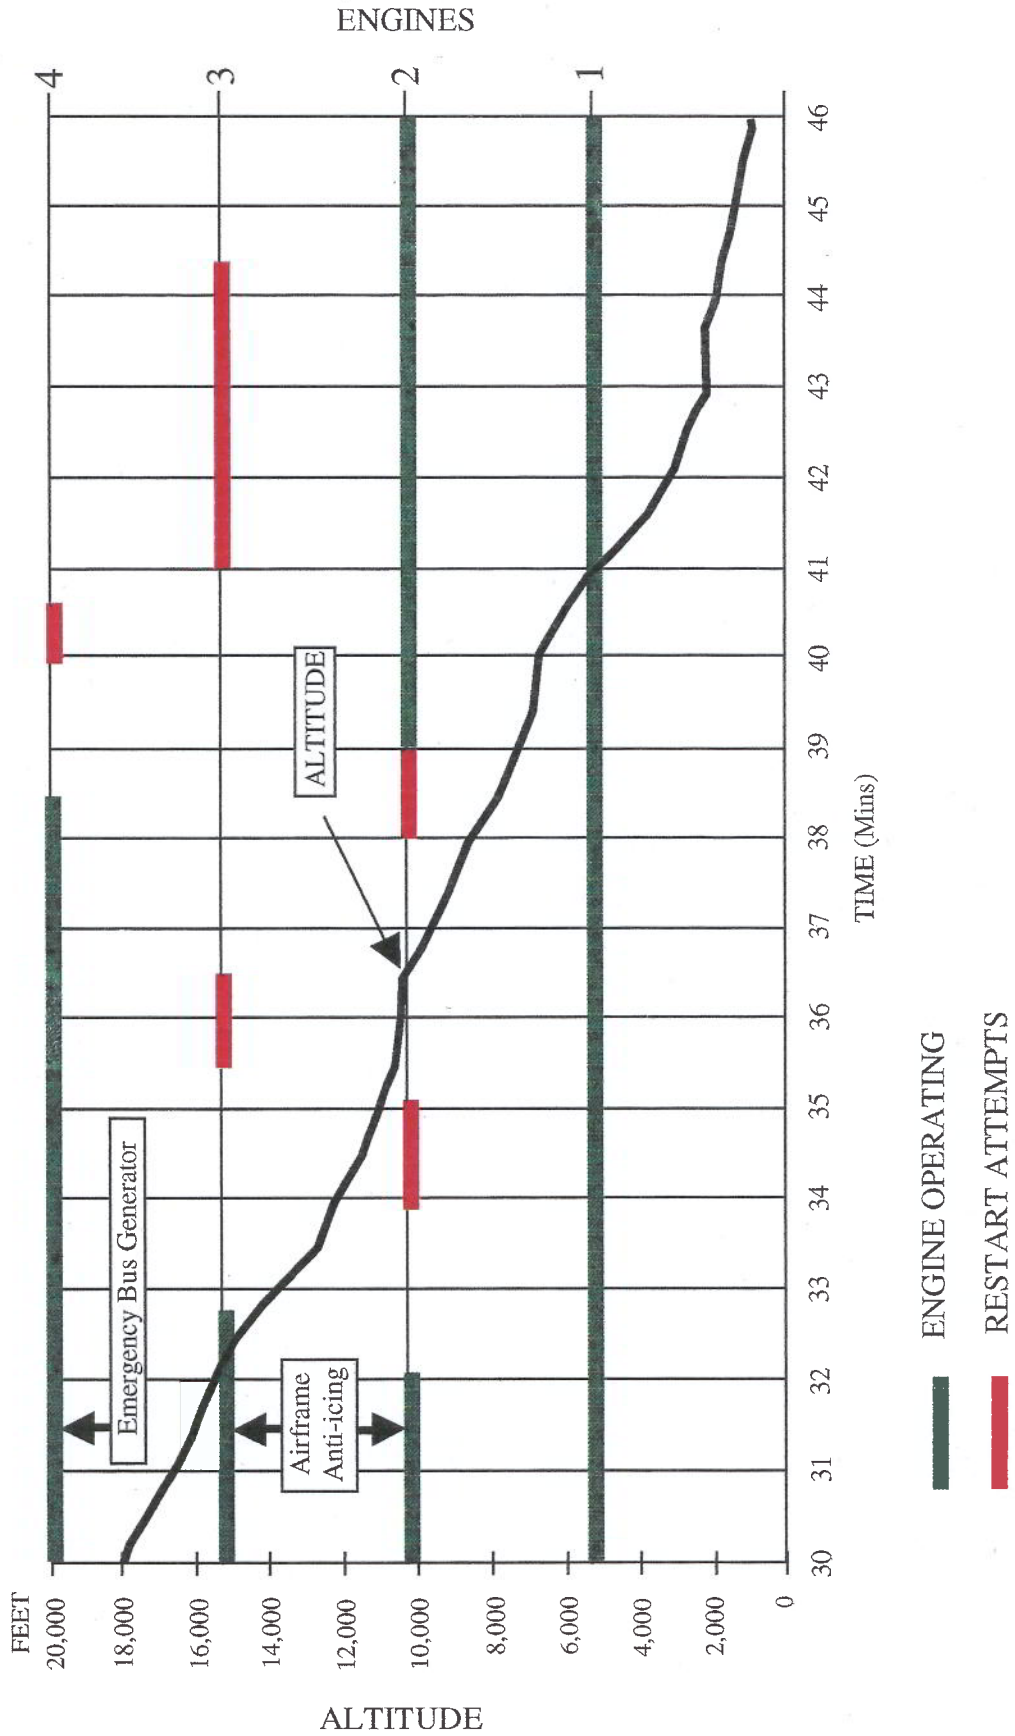
# ENGINE FAILURE SEQUENCE

At 1932 hrs, as the aircraft approached FL 150, the No 2 engine failed and the propeller blades automatically feathered. Less than a minute later, when the crew had just completed the shutdown drills on No 2 engine and the first officer had stated that he was selecting Nos 1 and 3 engine igniters ON, the No 3 engine started to run down. At 1933 hrs the first officer stated that he was going to switch Nos 1, 2 and 4 igniters ON. At that time the commander instructed the first officer to "GET AN IMMEDIATE DESCENT" and to "DECLARE AN EMERGENCY". The first officer transmitted "MANCHESTER MANCHESTER THIS IS BRITISH WORLD FOUR TWO SEVEN TWO WE'VE JUST HAD A DOUBLE ENGINE FAILURE DUE ICE REQUEST IMMEDIATE DESCENT PLEASE AND RADAR VECTORS". He did not declare an emergency or use the pro-words 'MAYDAY' or 'PAN PAN'. At the time the aircraft was 16 nm south of Manchester Airport, descending through FL 140. Manchester immediately cleared the aircraft to descend to FL 70 then to FL 50 on a continued heading of 150° and, at 1934 hrs, passed control of the aircraft to Birmingham radar. At this point the failure of Nos 2 and 3 engines had deprived the aircraft of its only source of wing and tail de-icing. The respective airframe de-icing switches are required to be selected to OFF. This checklist item was apparently not performed.

At 1938 hrs, as the aircraft descended through FL 84, No 4 engine failed. Almost simultaneously, a successful attempt was made to re-start No 2, but it is believed that in the short period between No 4 engine failing and No 2 engine

starting there was a momentary loss of all generated electrical power. The automatic electrical switching which would result from these losses are described later in the report. During the subsequent descent, attempts were made to re-start No 3 and No 4 engines, but these were unsuccessful. A diagram of the sequence of engine failures is at Appendix C.

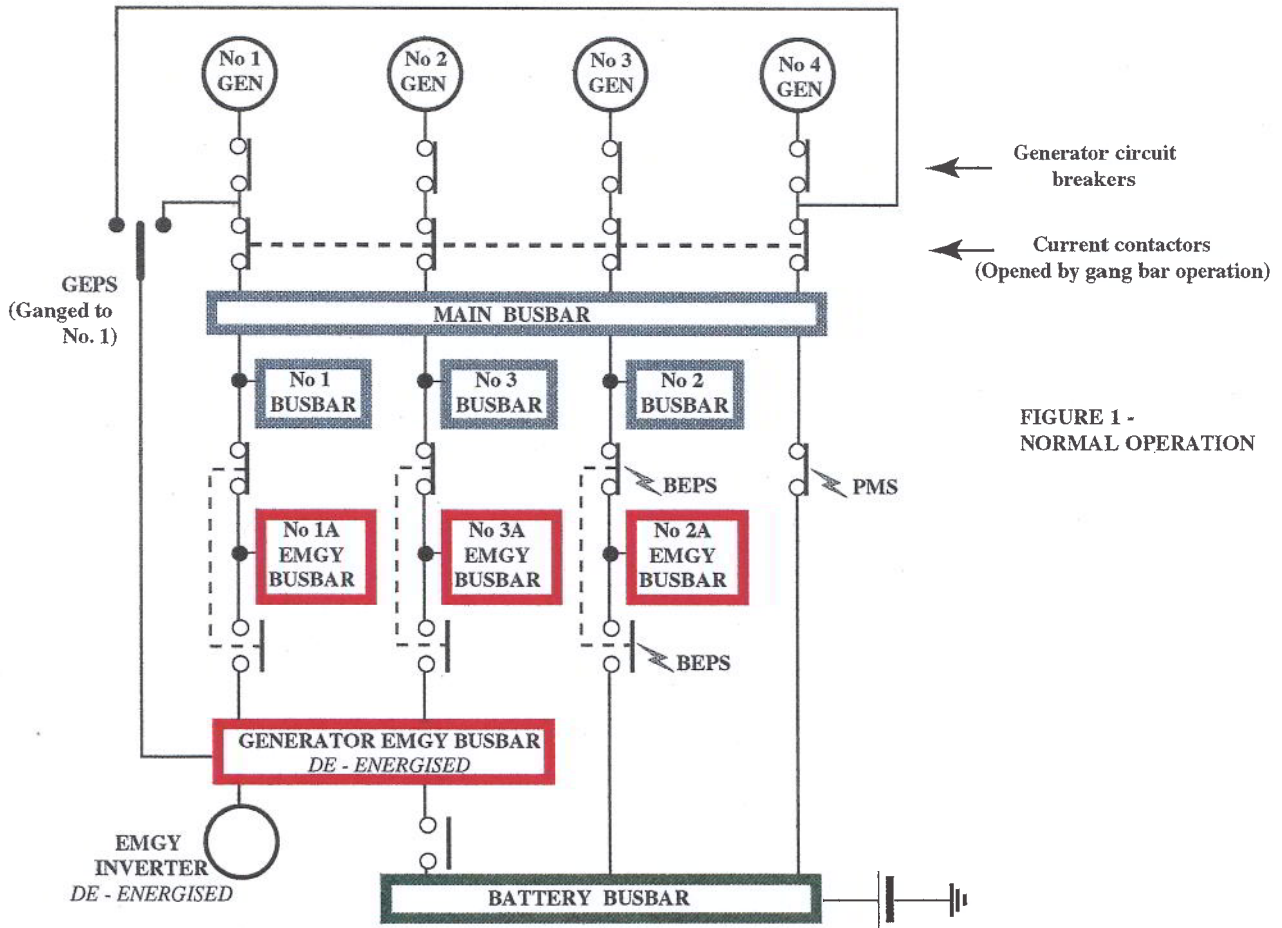
FIGURE 1 - NORMAL OPERATION

The DC distribution system (Appendix D, Figure 1) comprises a Battery Busbar, a Main Busbar, which feeds Nos 1, 2 and 3 Busbars, and three Emergency Busbars, 1A, 2A and 3A. The batteries receive charge from the Main Busbar, via the Battery Busbar. There is also a Generator Emergency Busbar (GEB), which is automatically energised, initially by the batteries (see below), if the Main Busbars fail. Under emergency electrical operating conditions, the selection of the Generator Emergency Power Switch (GEPS) to either No 1 or No 4 will allow the selected generator to power the GEB.

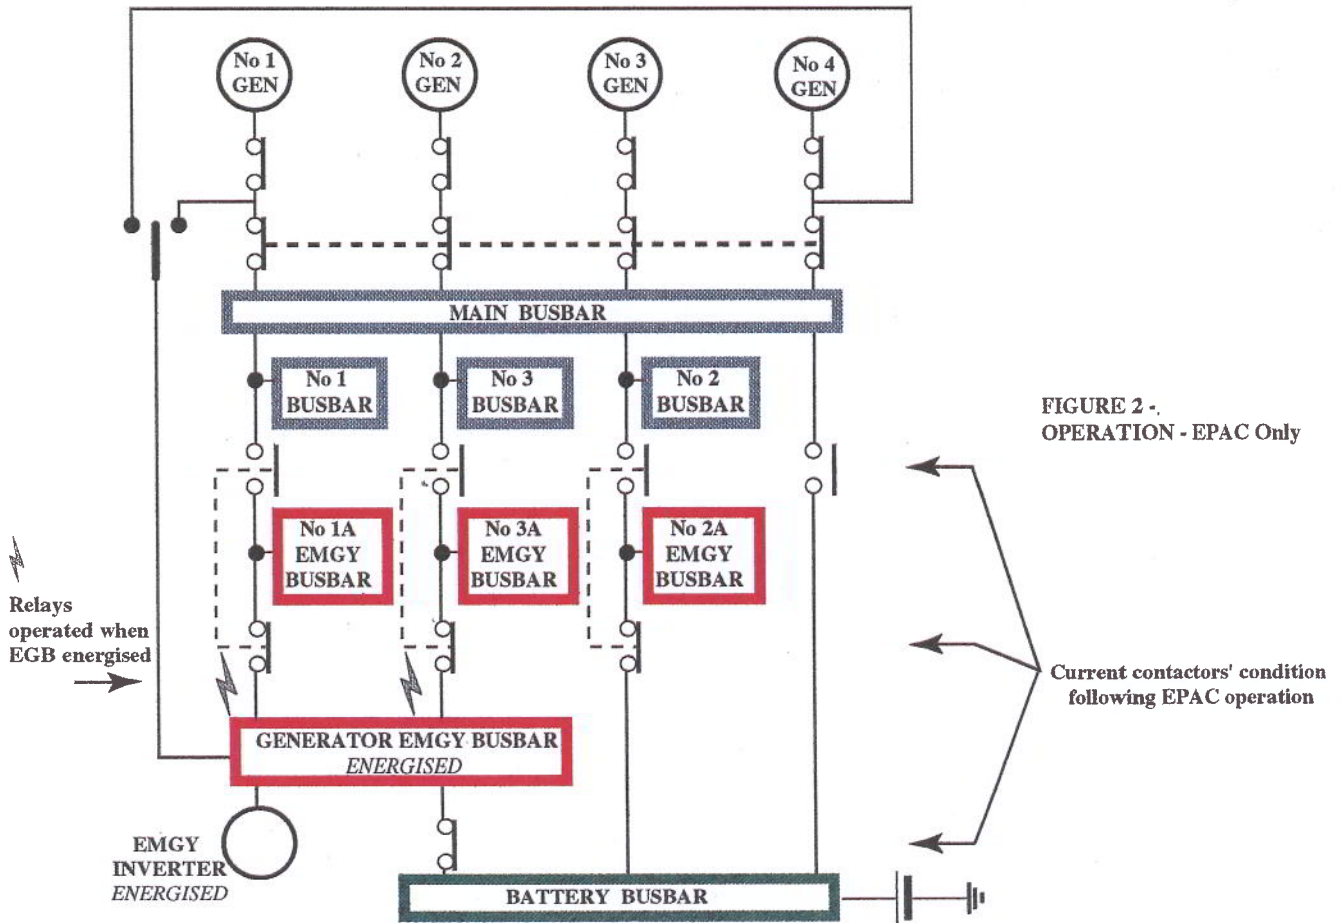
FIGURE 2 - OPERATION - EPAC Only

The sequence of engine failures reduced the generated power, firstly to two generators, then to one at which point the EPAC relay appears to have been energised (see paragraph 1.11.2.1). For a brief period, following the failure of No 4 engine, there was no generated supply until No 2 engine was restored. The first officer recalls that, during this sequence, he did not operate the gang bar or the GEPS.

The weather radar switch was found in the STANDBY position but, from the start of the CVR recording until the failure of the No 3 engine at 1932 hrs, only one inverter frequency was recorded on the CVR indicating that only one inverter was running. For the weather radar to be ON or at STANDBY it was necessary for the Auxiliary and Main inverters to be running as described in paragraph 1.6.7.2. After the failure of the No 3 engine two inverter frequencies were recorded on the CVR and comparison with recordings from other Viscount aircraft show that neither of these was from the inverter powering the radar. It is therefore evident that the weather radar was not powered during the course of the CVR recording or presumably during any stage of the flight. This also shows that it was the emergency inverter that started to run after the failure of No 3 engine, that the GEB was live and that the EPAC relay had been energised at that time.
