**BUREAU OF AIR SAFETY INVESTIGATION
REPORT**

Investigation Report 9302851

**Piper PA-31-350 Chieftain VH-WGI
Launceston Tasmania
17 September 1993**

November 1995

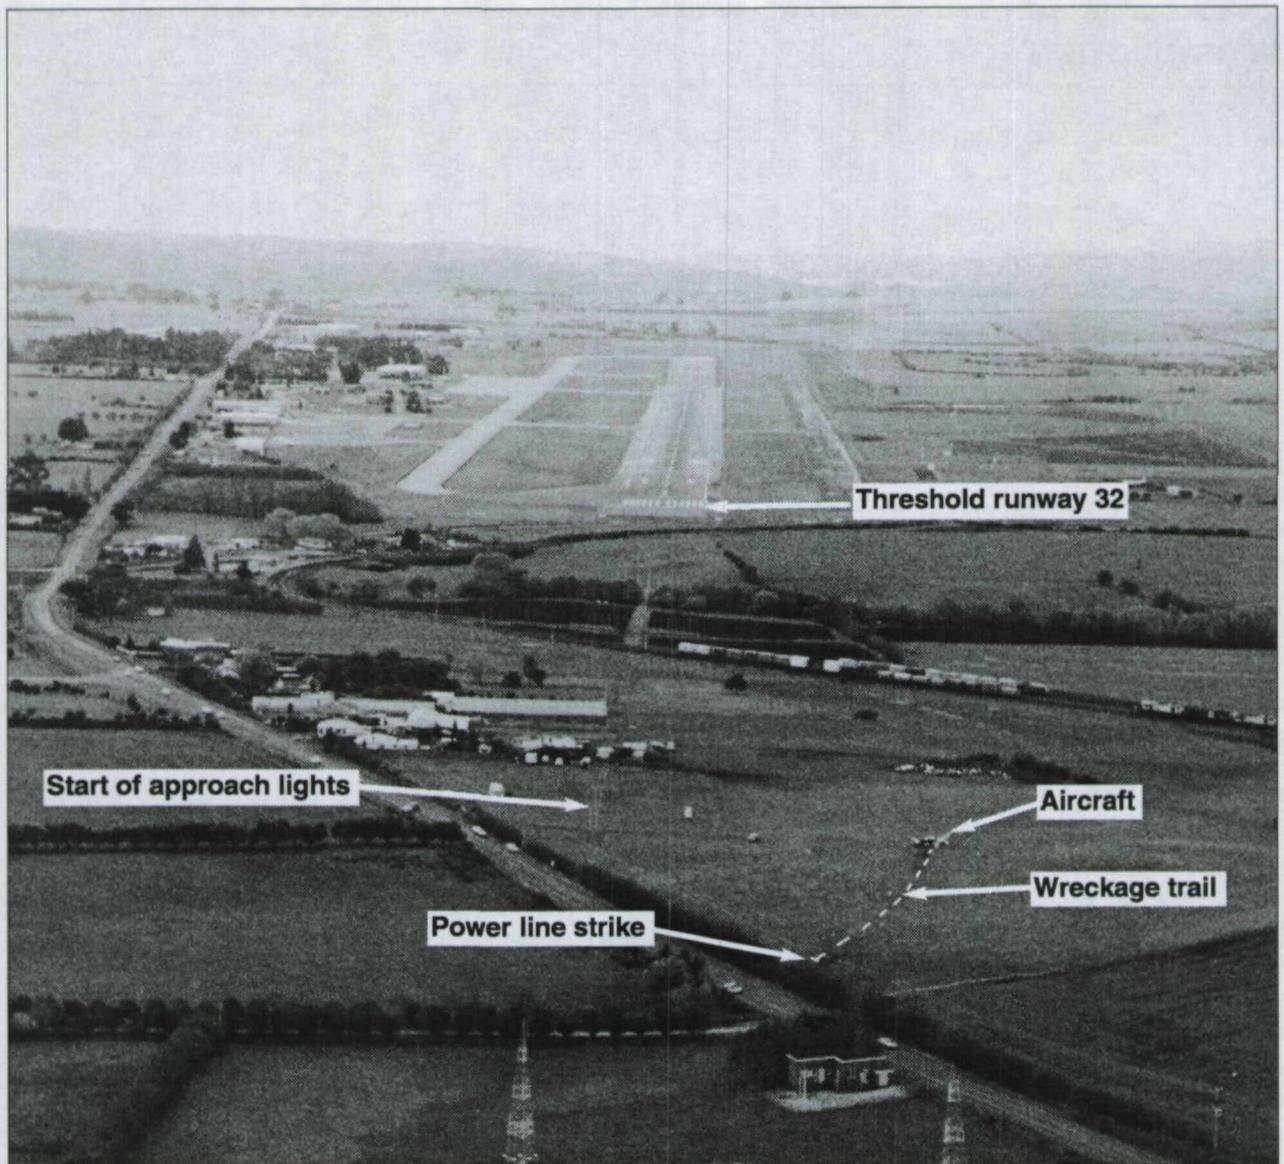
Figure 1 View towards threshold of runway 32, the NDB antenna towers are in the foreground. The aircraft had been flown on a left base leg but crashed while turning onto final approach. For a diagram of the approximate flight path see fig. 5.

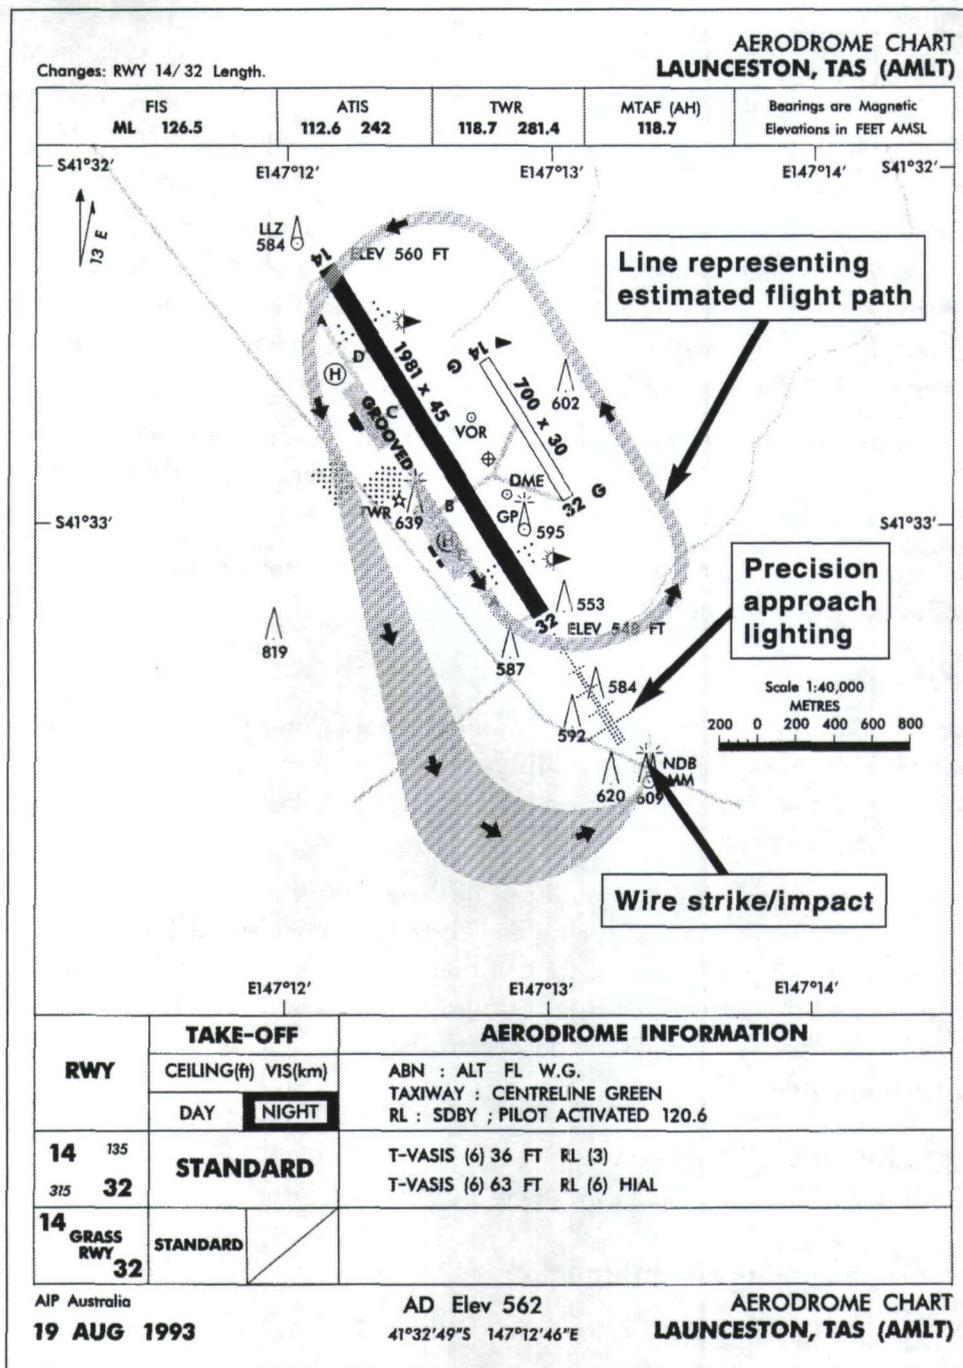
Figure 5 Launceston Aerodrome Chart and diagram of approximate flight path at Launceston of VH-WGI, 17th September, 1993.

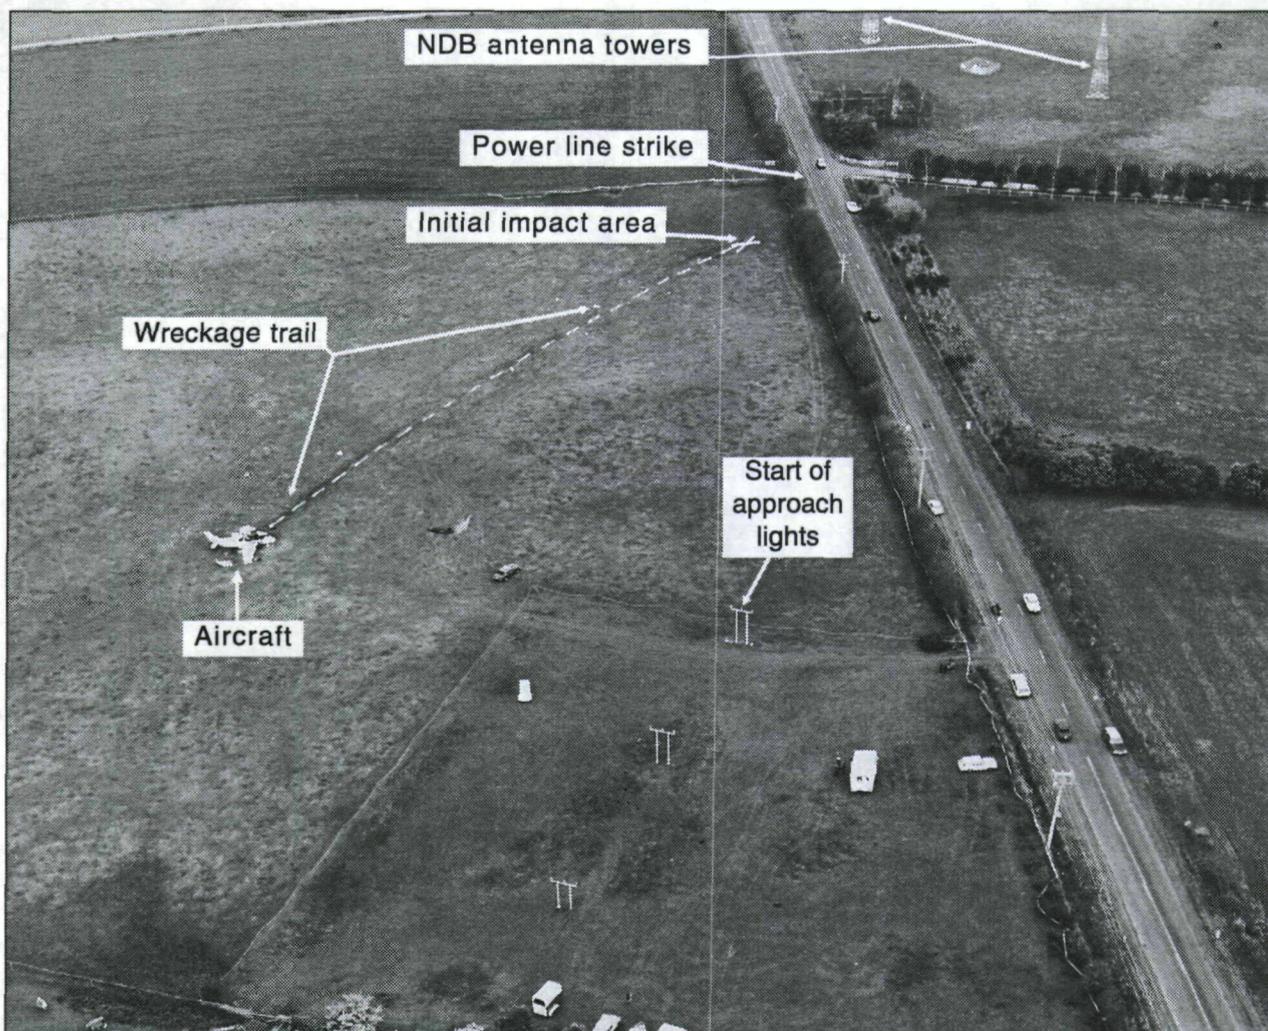
The accident site (see fig. 6) was located on a property adjacent to the Evandale Road, Launceston, Tasmania. The main body of the wreckage was situated about 900 m from the threshold of runway 32, on a bearing of 138°. It lay in the middle of a relatively flat grass field which was free of any trees or other obstacles. The geographic coordinates of the accident site were: latitude 41°33.5'S, longitude 147°13.3'E.

Figure 6 Aerial view of the wreckage trail.

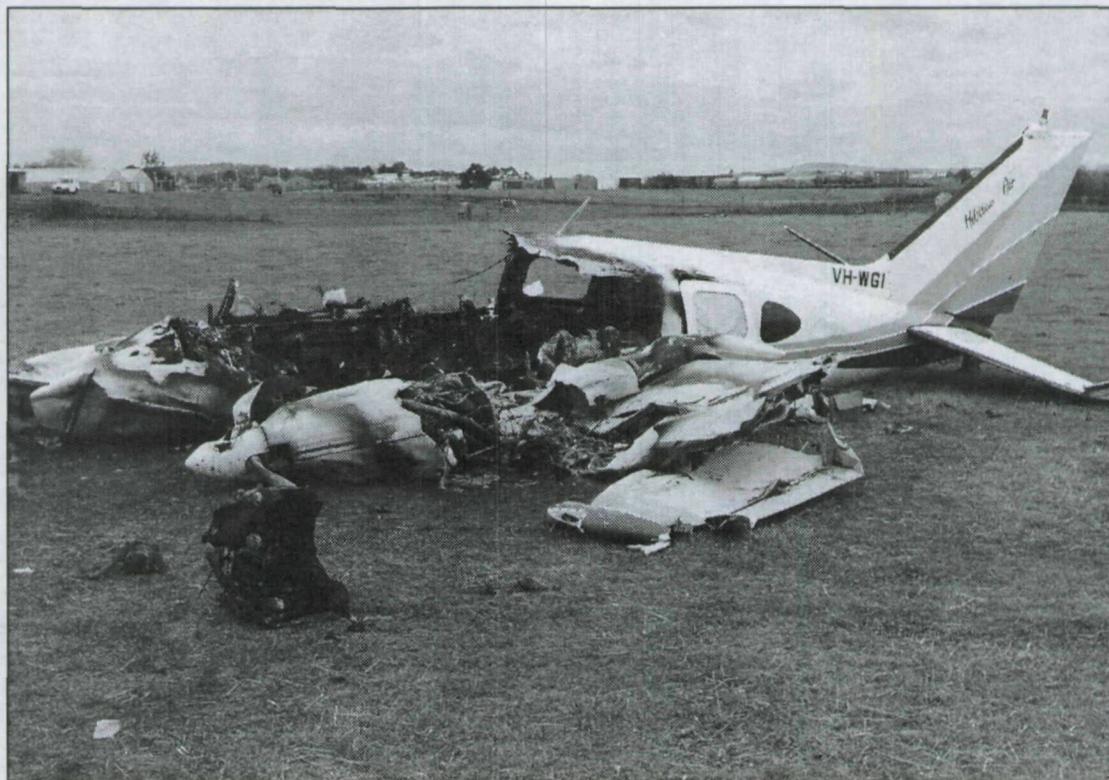
The main structure and control surfaces were accounted for on the site. Fire had severely damaged the cockpit and cabin areas and destroyed the top of the cockpit and cabin. The damage was consistent with the application of excessive loads during the impact sequence and the effects of the subsequent fire (see fig. 7). No pre-existing defects likely to have contributed to the accident were found. There was no evidence that any of the aircraft doors had been open prior to the impact.

Figure 7 View of wreckage showing extent of fire damage to the cabin area.

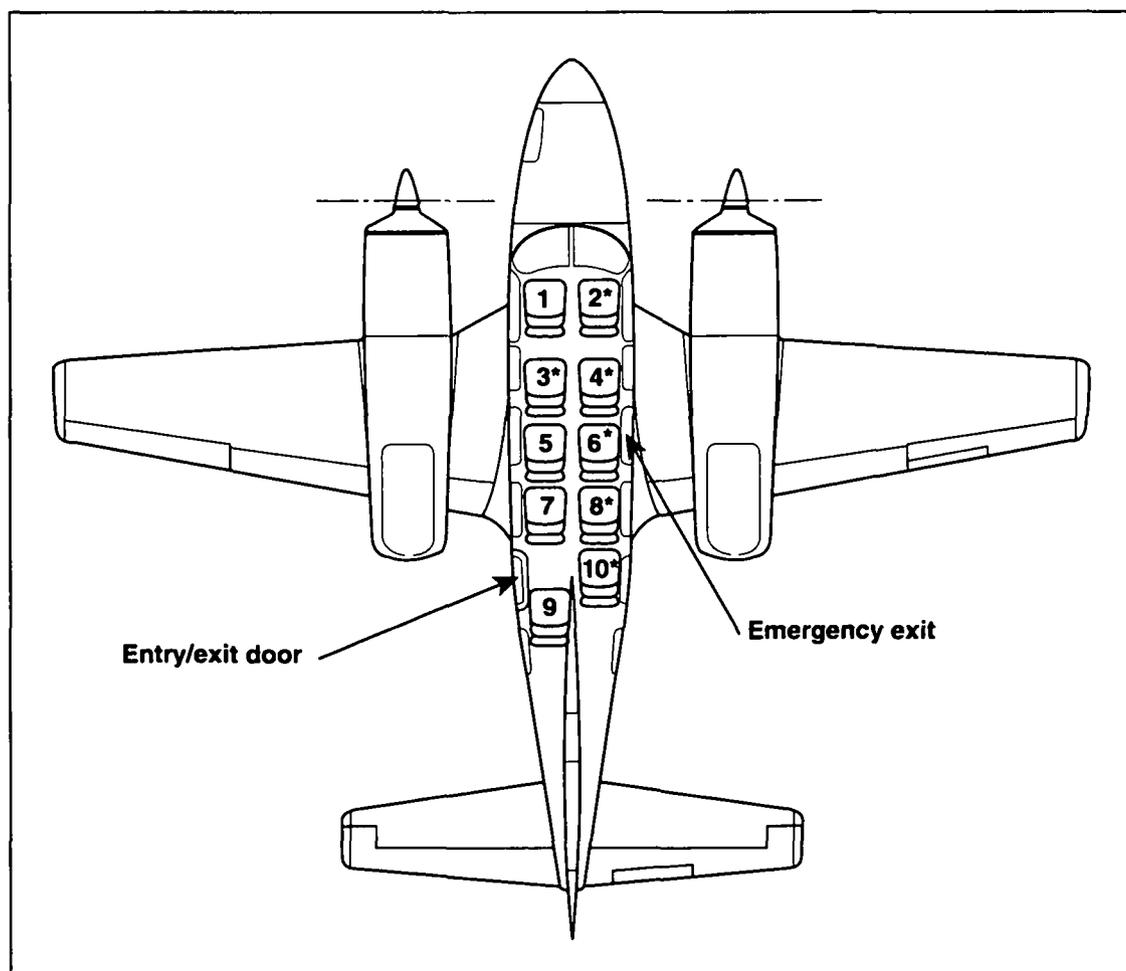
Prior to departure, the pilot conducted a briefing on the use of seat belts and the location and operation of the normal exit door and the emergency exit. In addition to the normal entrance door at the left rear side of the fuselage, an emergency window exit was located at the third side window from the front on the right. A diagram of the aircraft showing the approximate location of the seats and the exits is included at fig. 8.

Figure 8 Plan view of the aircraft showing the location of the normal and emergency exits. Seat numbers are also shown. Positions occupied by the deceased passengers are indicated by an asterisk.
