A V I A T I O N O C C U R R E N C E R E P O R T

NO. 93-014

GOVERNMENT AIRCRAFT FACTORIES N22 NOMAD

ZK-NOM

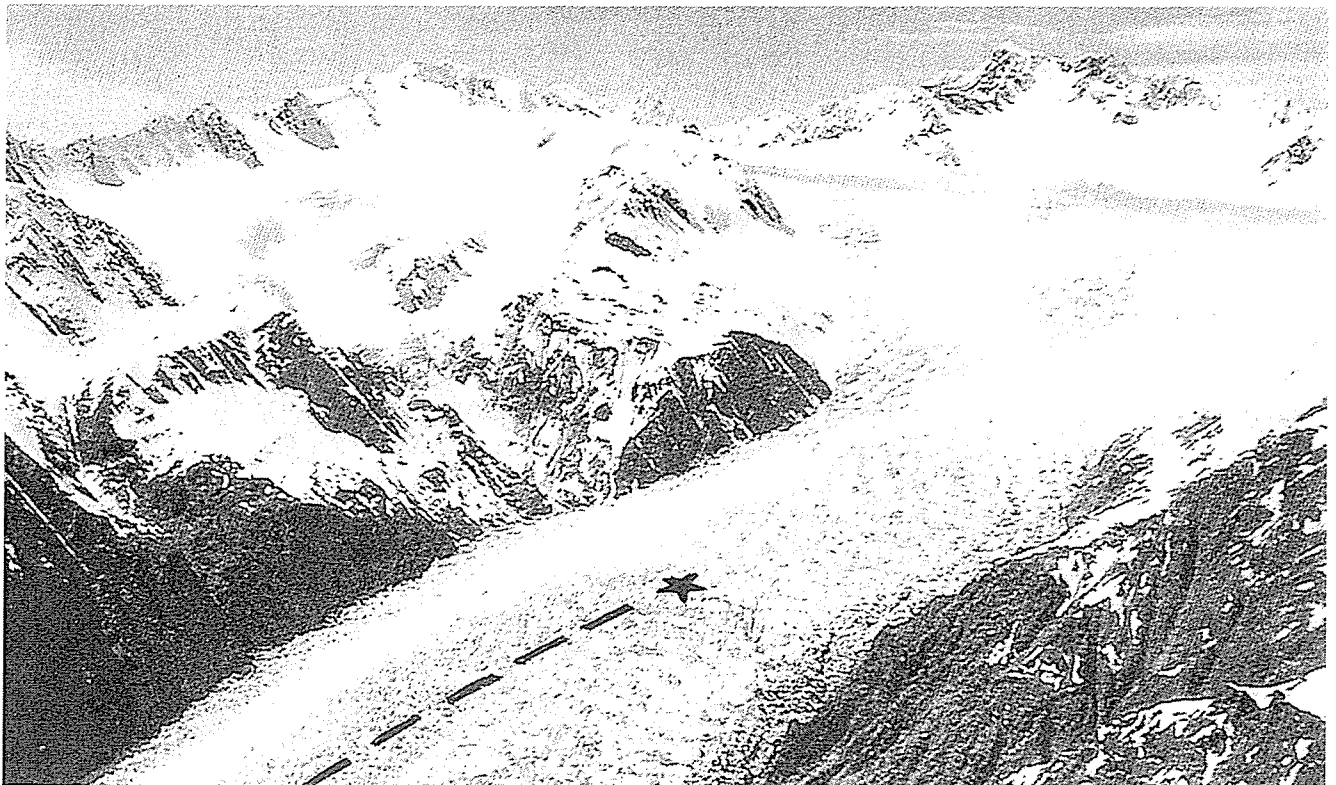
Approximate final flight path and accident area ZK-NOM

1.12.1 The wreckage of ZK-NOM was located approximately in the centre of the upper ice-fall of Franz Josef Glacier. The accident site, at an elevation of 4,500 feet, was in an extremely split and cracked region close to the brow of the steep glacial flow known to glacier guides as the "Top Ice-fall". The surface comprised an imposing array of seracs and pinnacles of ice interspersed with deep crevasses, slots, and melt holes, covered to a varying degree by drifted snow. The vast scale of the ice-fall, and its contorted surface, was difficult to appreciate unless reference was available to an object of known size such as an overflying aeroplane or helicopter.
