In-flight Separation of Right Wing  
Flying Boat, Inc. (doing business as  
Chalk's Ocean Airways) Flight 101  
Grumman Turbo Mallard (G-73T), N2969  
Port of Miami, Florida  
December 19, 2005

NTSB/AAR-07/04

# **Aircraft Accident Report**

**In-flight Separation of Right Wing  
Flying Boat, Inc. (doing business as  
Chalk's Ocean Airways) Flight 101  
Grumman Turbo Mallard (G-73T), N2969  
Port of Miami, Florida  
December 19, 2005**

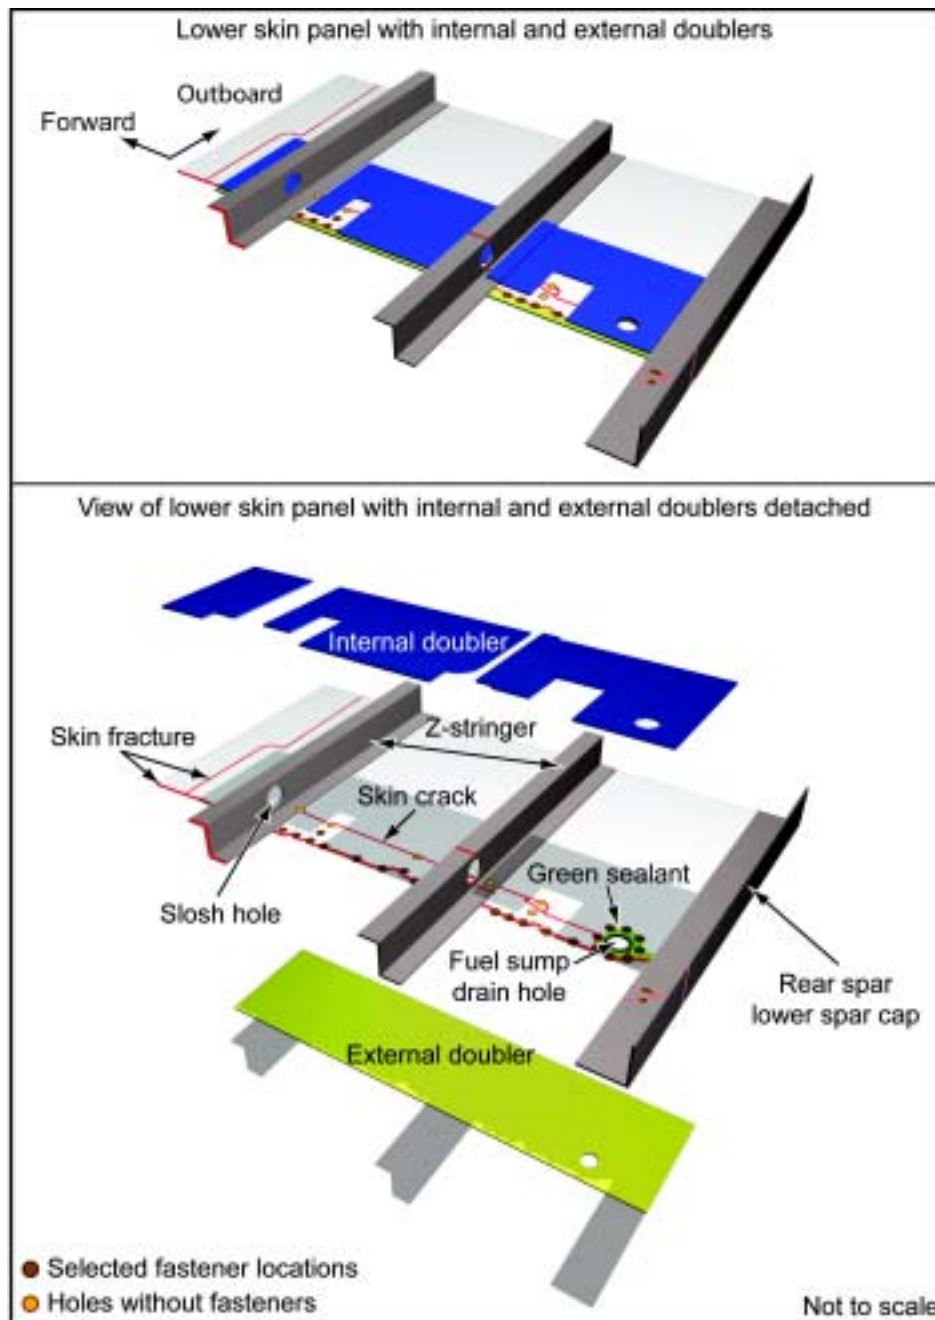
**Figure 2.** Locations of Fractures Near Right Wing Station 34

The upper part of figure 2 shows an overall view of right WS 34, including the locations of the rear spar lower spar cap, rear Z-stringer, the chordwise fracture in the lower skin, the crack (approximately parallel to and outboard of the chordwise lower skin fracture) in the lower skin, and the external and internal doublers. The lower part of

figure 2 shows a view with the doublers detached. Fatigue fracture features were found in the rear spar lower spar cap, rear Z-stringer, skin fracture (inboard), and skin crack (outboard).<sup>43</sup>

<sup>43</sup> Overstress fracture features were found on the entire fracture surfaces of the middle Z-stringer, forward Z-stringer, and forward spar lower spar cap at right WS 34.

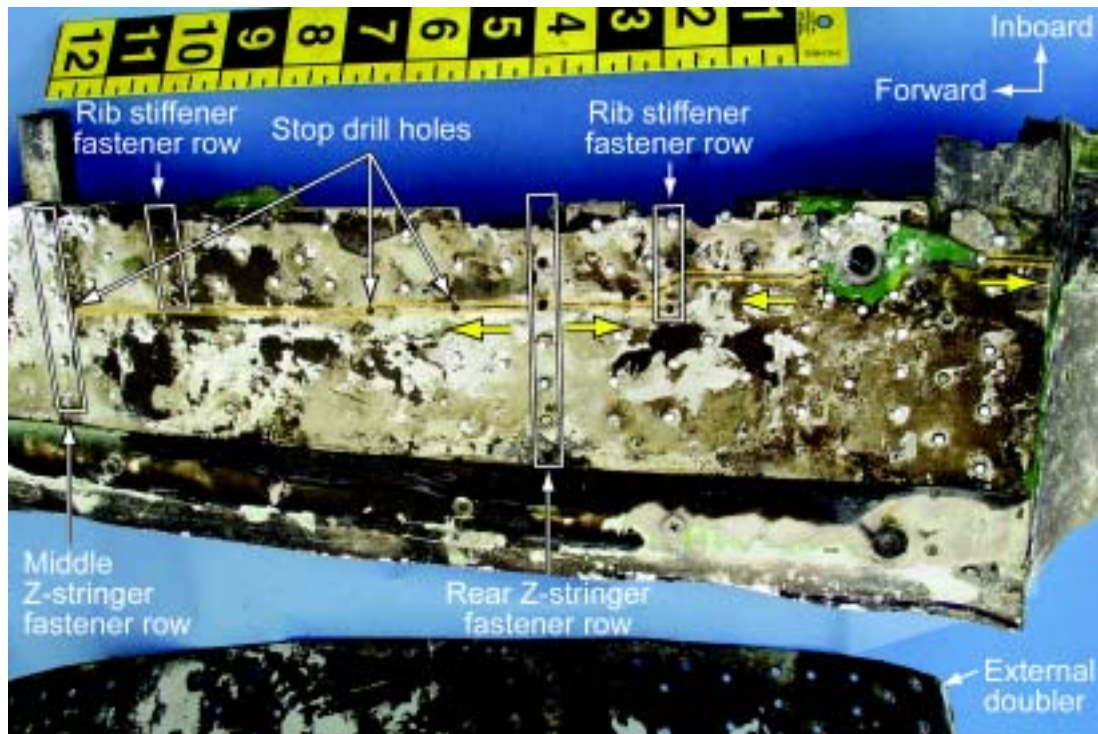
**Figure 4.** Lower Skin Crack in the Area That Was Covered by the Doublers Adjacent to Right Wing Station 34

The skin crack under the doublers at right WS 34 (see figure 4) intersected three unfilled machined holes in the skin that exhibited features consistent with stop drill holes.<sup>44</sup> These holes were located about 7, 9, and 16 inches forward of the skin trailing edge. Several fasteners at the inboard end of the doubler were inserted through hard green sealant around the fuel sump drain.

The skin crack under the doublers at right WS 34 had an aft segment with fatigue features emanating from the area of corrosion around the fuel sump drain and a longer forward segment with fatigue features that initiated from a fastener hole adjacent to the rear Z-stringer fracture.

The lower skin chordwise fracture (inboard of the skin crack) at the separated area intersected the fastener holes at the inboard edge of the doublers. Regions of fatigue emanated from several of the fastener holes. Sliding contact marks consistent with repeated opening and closing of the chordwise skin fracture were observed on the surface of the external doubler between several fastener locations in the inboard fastener row for the doubler.

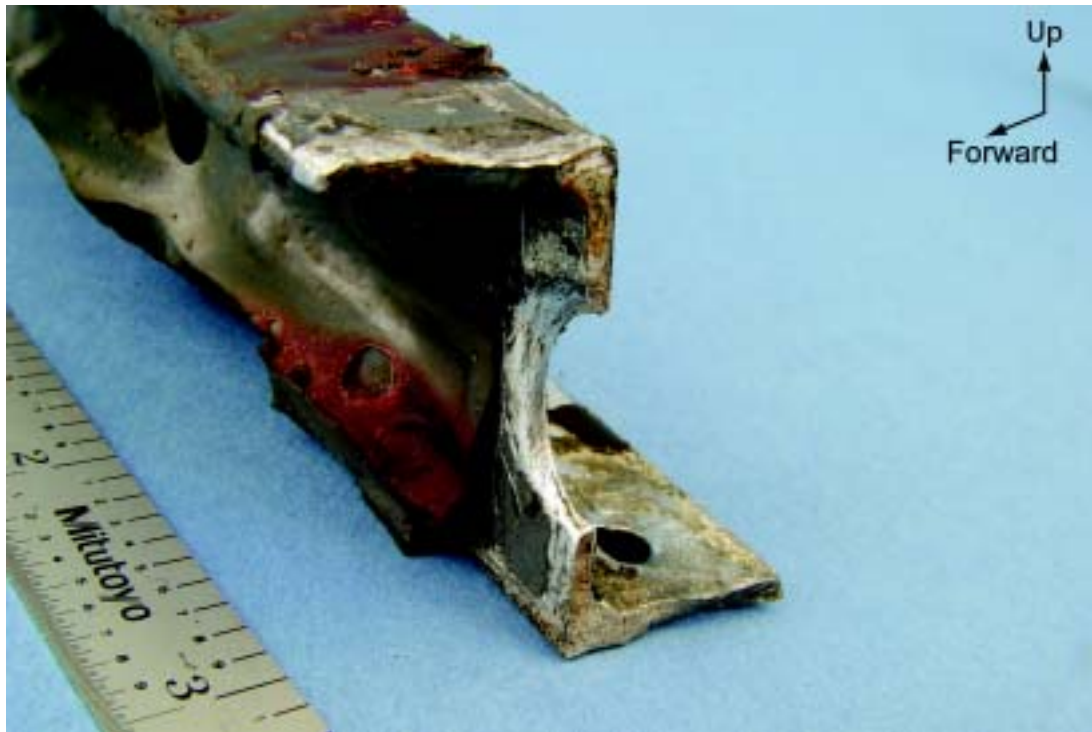
**Figure 5.** Right Wing Rear Z-Stringer Fracture

The fractographic examination at right WS 34 found that fatigue in the rear Z-stringer initiated from the slosh hole in the Z-stringer located about 1.5 inches outboard of right WS 34, as shown in figure 5. Sanding marks were observed under the sealant around the edge of the slosh hole, and sealant was observed on the fracture surface. In the sanded area, deformed material was observed curled over onto the edges of the fracture surface.

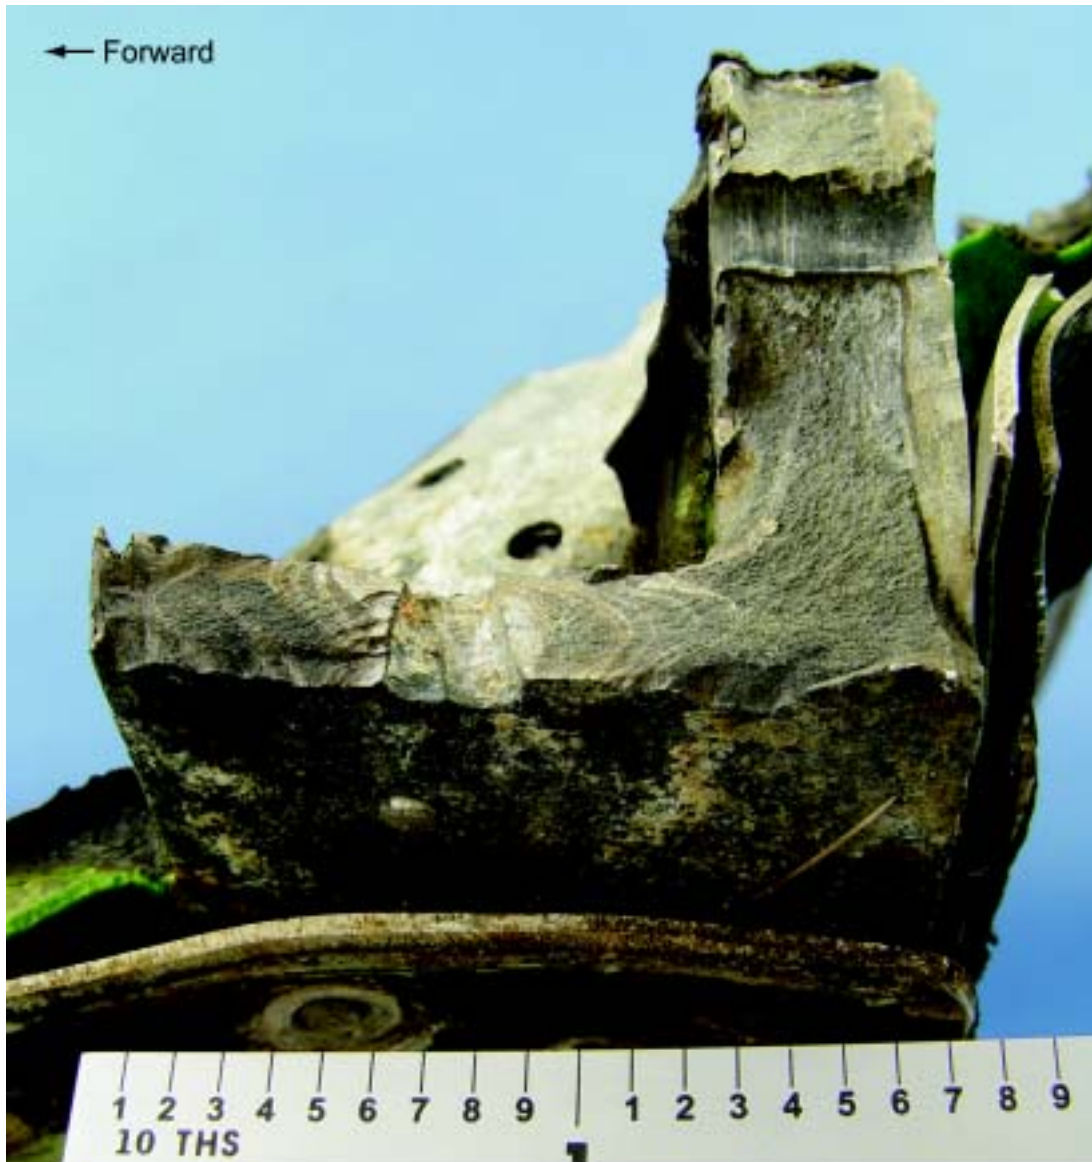
**Figure 6.** Right Wing Rear Spar Lower Spar Cap Fracture

Fatigue in the rear spar lower spar cap initiated from a double-drilled hole for a threaded fastener in the horizontal flange of the spar cap located about 1 inch inboard of right WS 34, as shown in figure 6. Multiple fatigue origins were observed along the double-drilled hole through the thickness of the horizontal flange. Relatively flat regions with large numbers of crack arrest positions, indicating slower growth fatigue cracking, emanated from the fatigue origin areas both forward and aft of the hole. The remainder of the fatigue regions had a mixture of curving flat regions (indicating areas of relatively slow crack growth) with crack arrest positions separated by rougher regions without crack arrest positions (indicating relatively fast crack growth or overstress regions). The portion

of the crack aft of the hole propagated from a length of 0.07 to 0.44 inch in about 11 increments of rapid crack growth.
