## Accident report

B 2/1996 L

### Aircraft accident at Oulunsalo, Finland 20. December 1994

**N-911SG**  
**Beech Duke B 60**

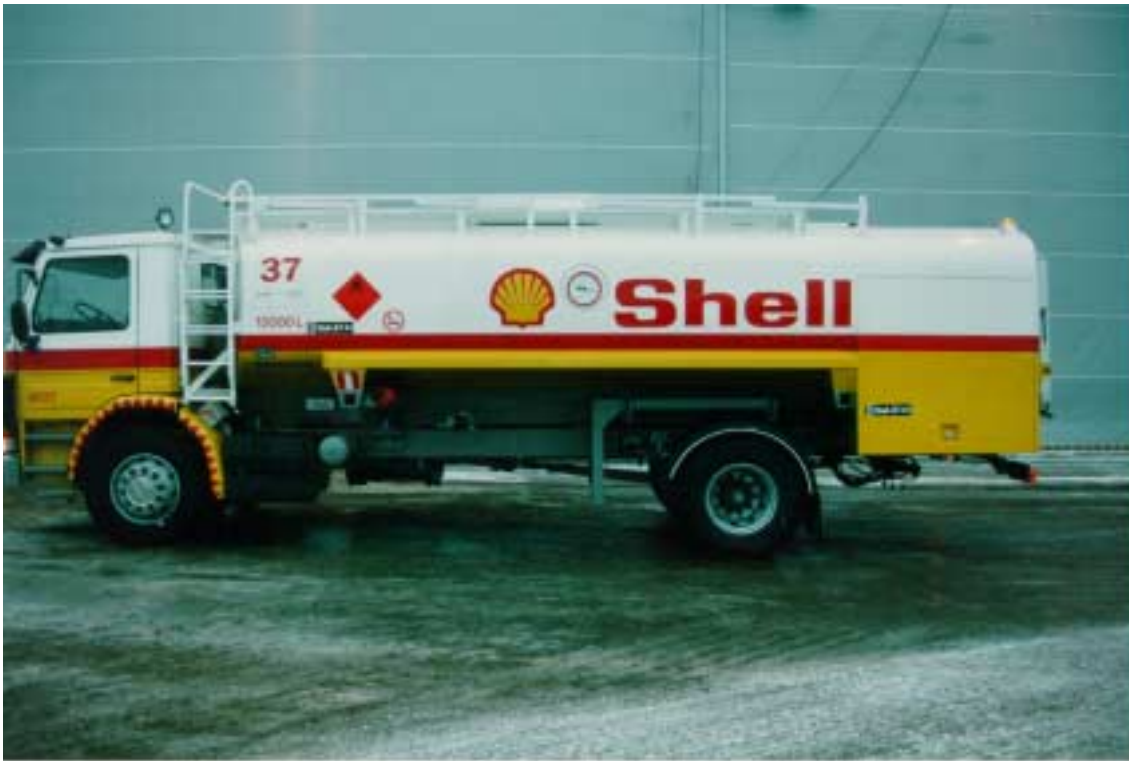
Markings on the left side

Fuel type markings on the Shell tanker car No. 8037

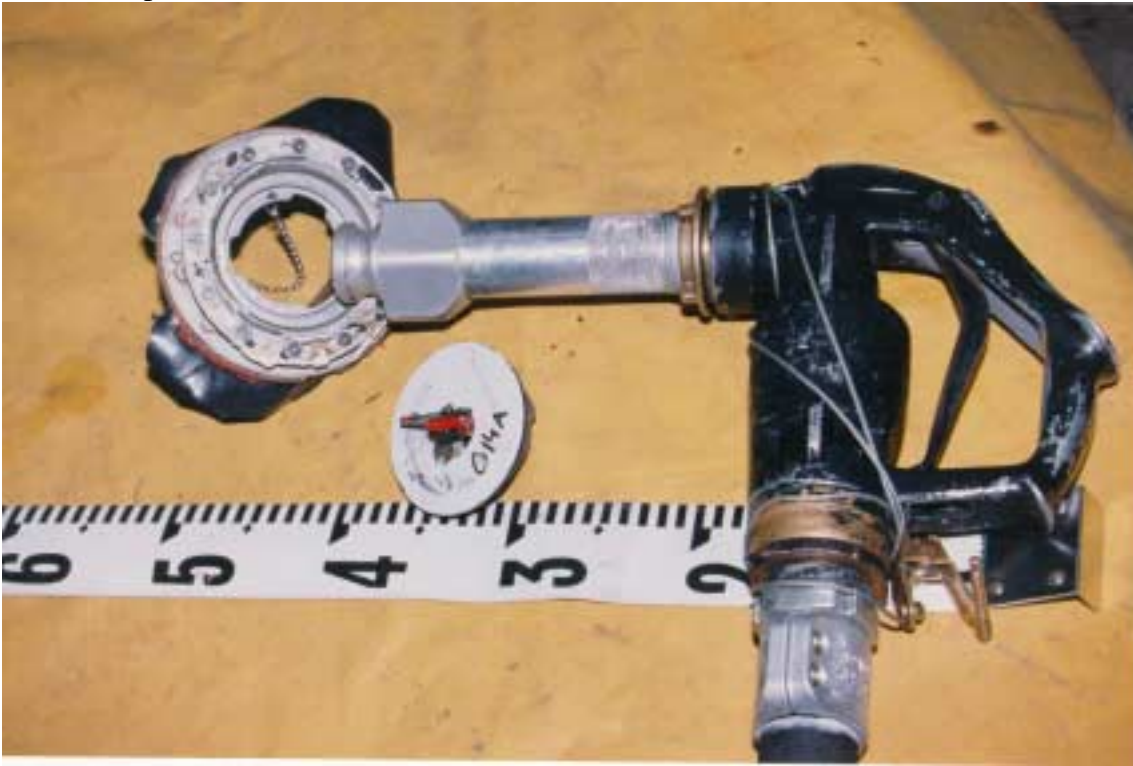
JET A-1 replenishment nozzle of the Shell tanker car No. 8037

The purpose of the shaped expansion, the dimensions of which were 50 x 70 mm, was to prevent the nozzle intended for JET A-1 refuelling from fitting into the reduced filling orifices of aviation gasoline tanks, not more than 60 mm in diameter. The expansion should go into the filling orifices of aircraft using jet fuel. In practice, however, there are aircraft running on jet fuel in which the fuel tank filling orifices are smaller in dimension than recommended in the above mentioned standards, and into which the expanded jet fuel nozzles do not fit.

The original design of the replenishment nozzle was in accordance with the recommendations given in Shell Airport Operations Manual and in the standards cited above. However, after the expansion the tip of the nozzle was smaller in dimension and fitted into the reduced filling orifices of the accident aircraft, which made it possible to fill the tanks with JET A-1 instead of AVGAS 100LL.
