Report 95-011

de Havilland DHC-8

ZK-NEY

9 June 1995

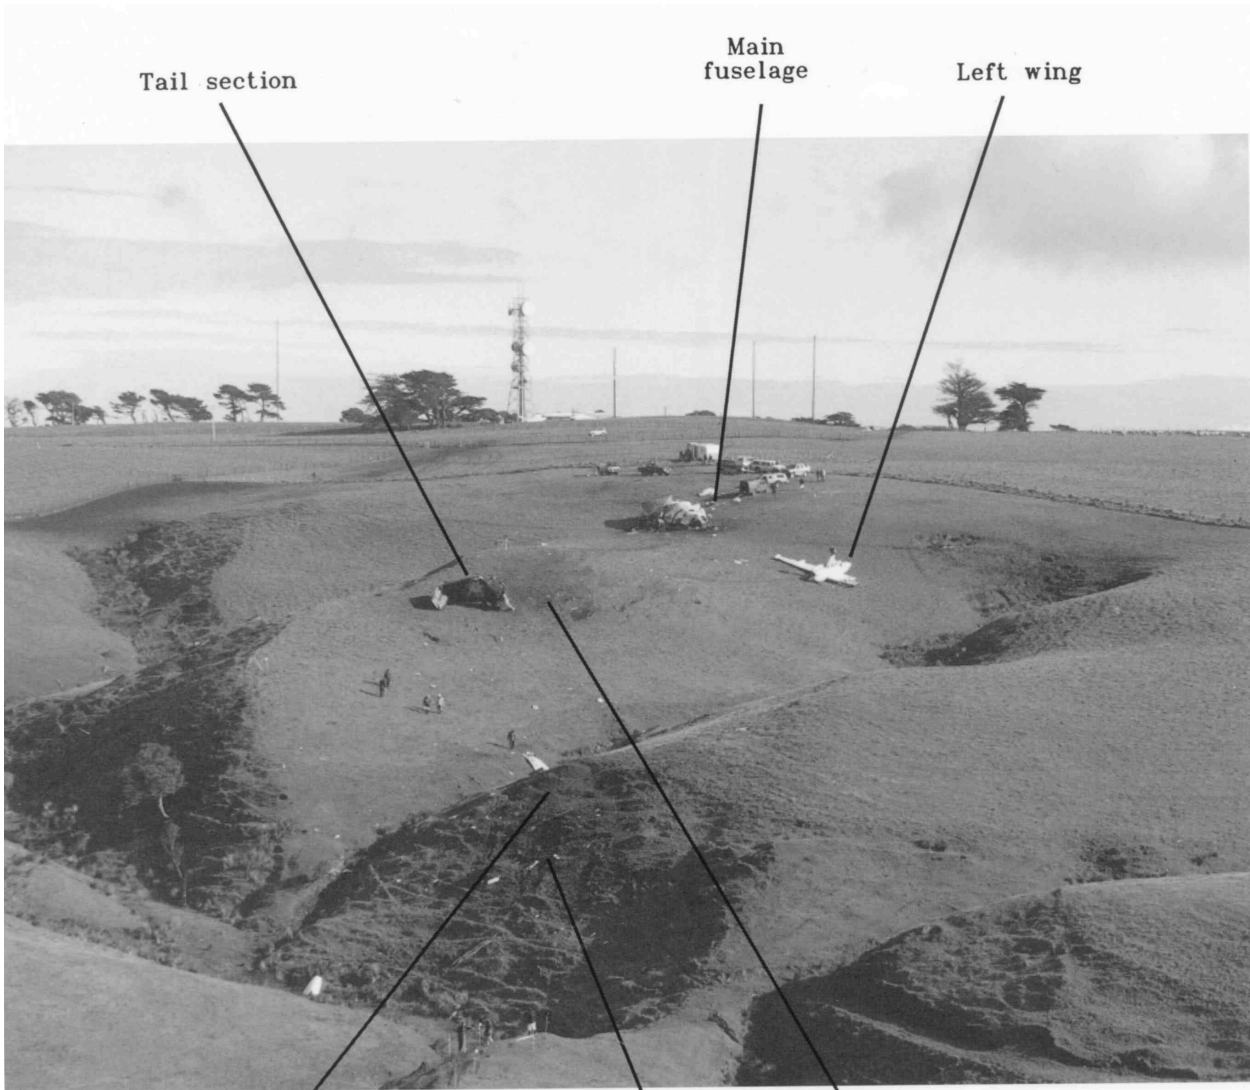
Accident Site - General View

Initial impact

First major impact area

Second major impact area

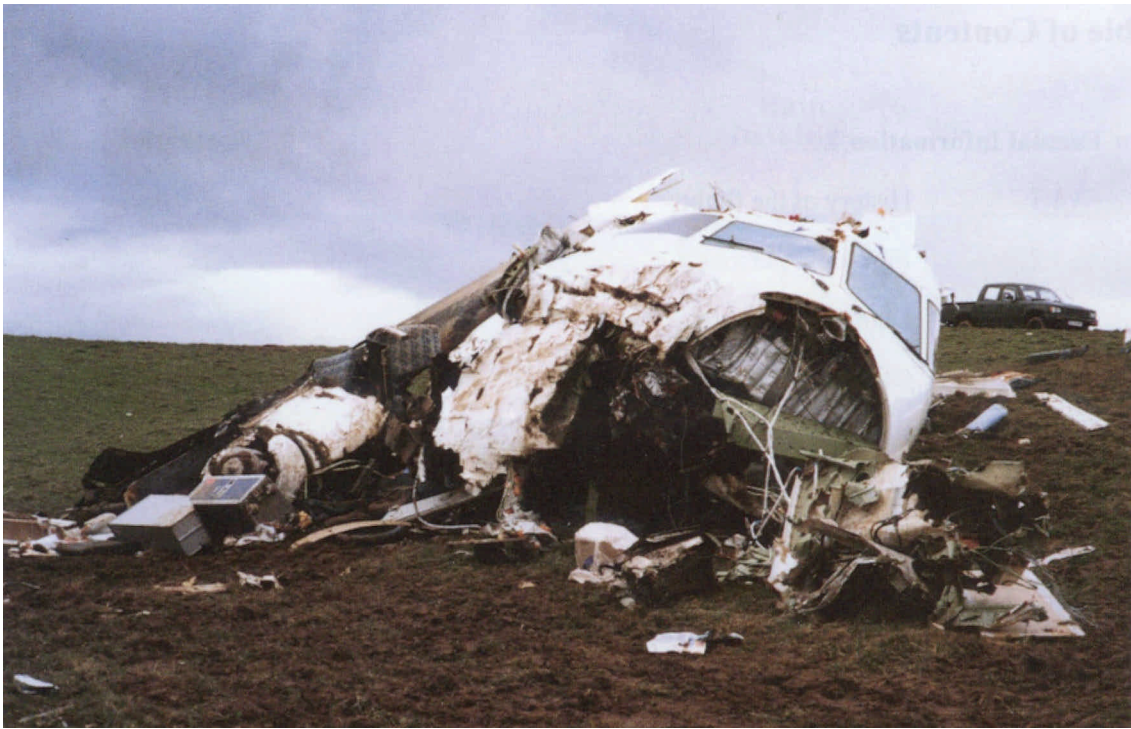
ZK-NEY looking aft

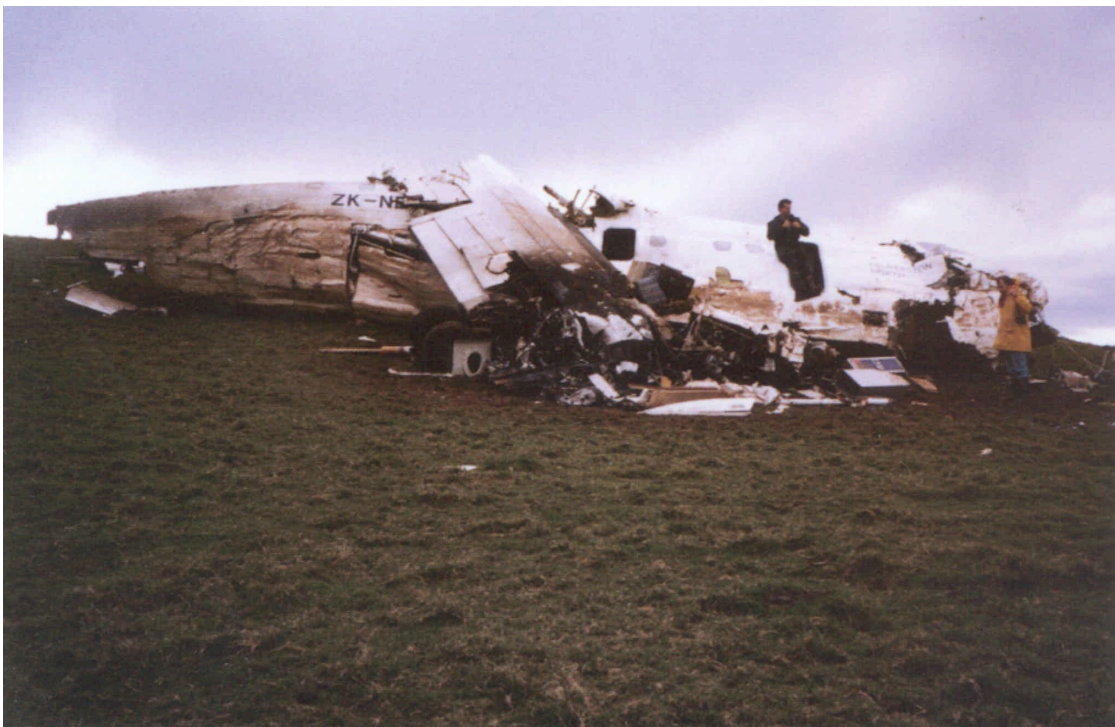
ZK-NEY right side

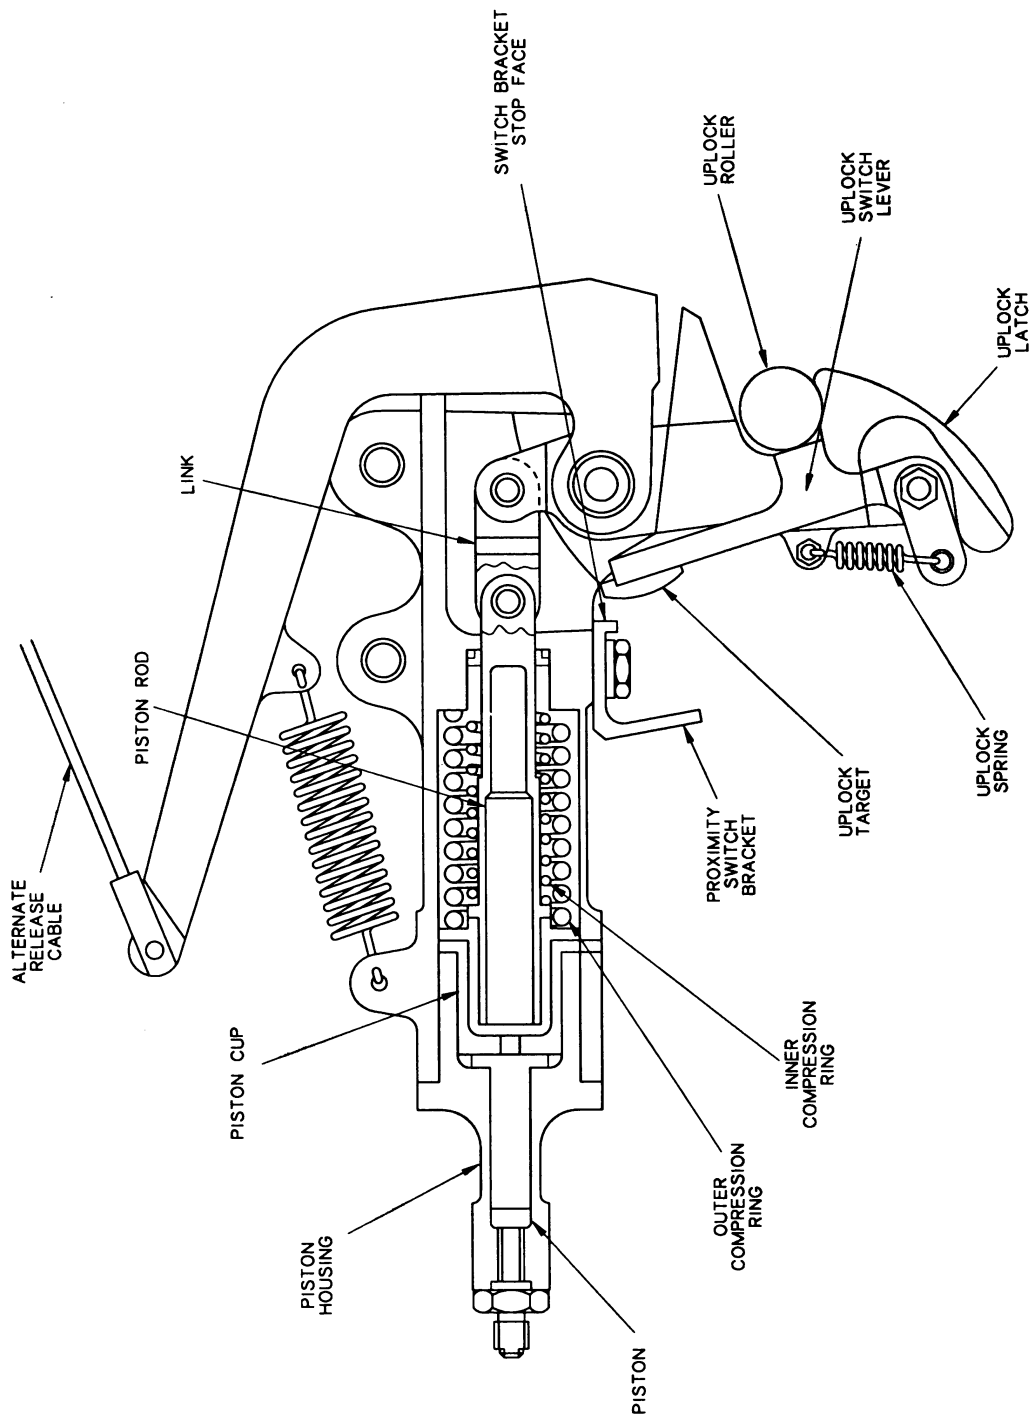
Figure 2
 Uplock assembly view
 (Not to scale)

1.6.24 The main undercarriage uplocks fitted to the Dash 8 aircraft were designed to restrain the respective undercarriage leg in the retracted position under all flight conditions without the aid of hydraulic pressure. They comprised a latch assembly installed within the rear of the engine nacelle which engaged with a roller mounted on the undercarriage leg when the undercarriage was fully retracted, thus mechanically holding the undercarriage leg in the “UP” position. (See Figure 2.) With the uplock latches engaged and the forward, centre and aft doors closed, the solenoid selector valve was de-energised to isolate hydraulic pressure from the system.

- 1.6.47 The AOM also advised that pre-modification 8/1828 (SB8-32-98) or 8/1764 uplocks were sensitive to latch wear and that worn uplocks tended to show progressive operational problems which might start with a single main undercarriage releasing late or with a bang. If left uncorrected this might result in the affected main undercarriage failing to release using the normal system.

- 1.6.42 Service Bulletin SB8-32-98 Mod 8/1828 which was issued by de Havilland Canada dated 14 August 1992 introduced a re-designed uplock actuator assembly to overcome the problem of main undercarriage “hang-ups” due to failures of the original uplock to disengage after a normal “DOWN” selection. The new uplock unit was designed to minimise the hang-up problem and eliminate spurious indications that the main undercarriage had failed to lock down.

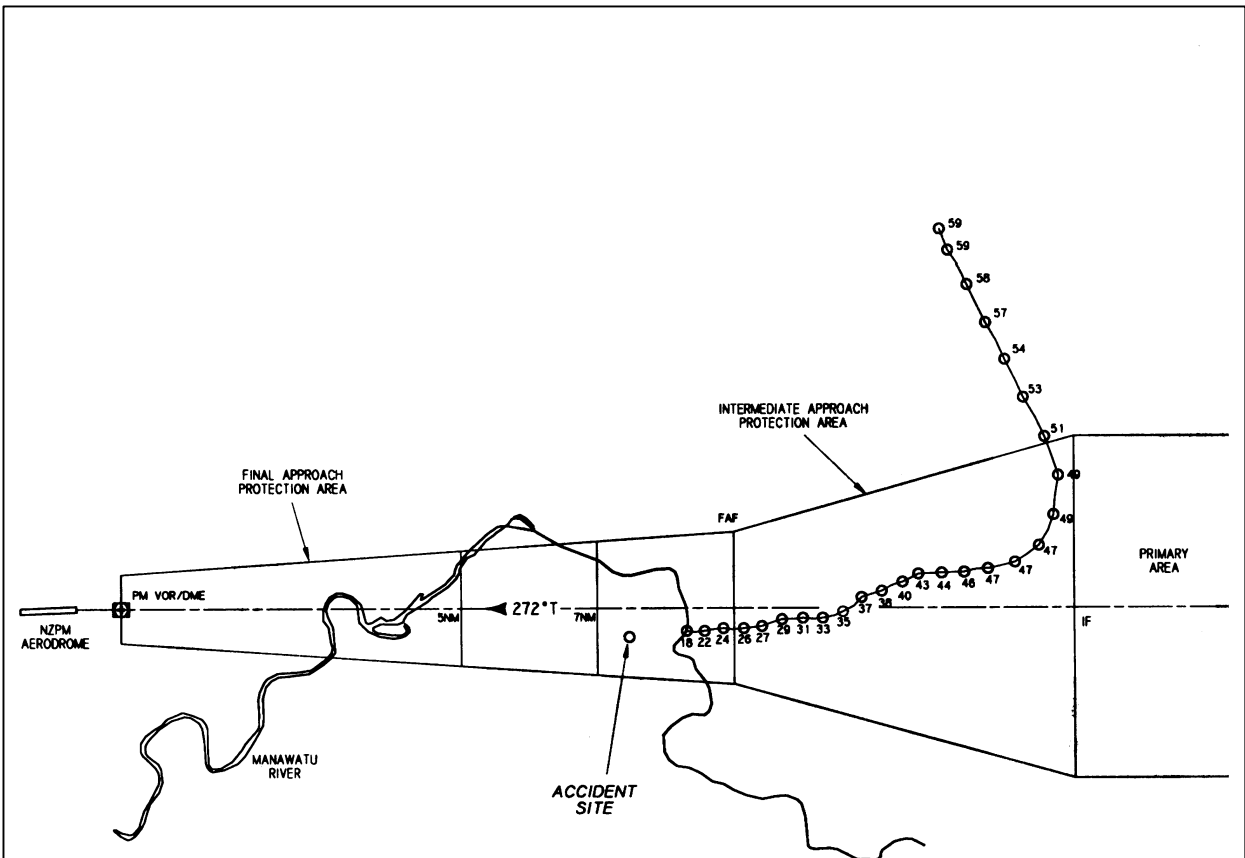
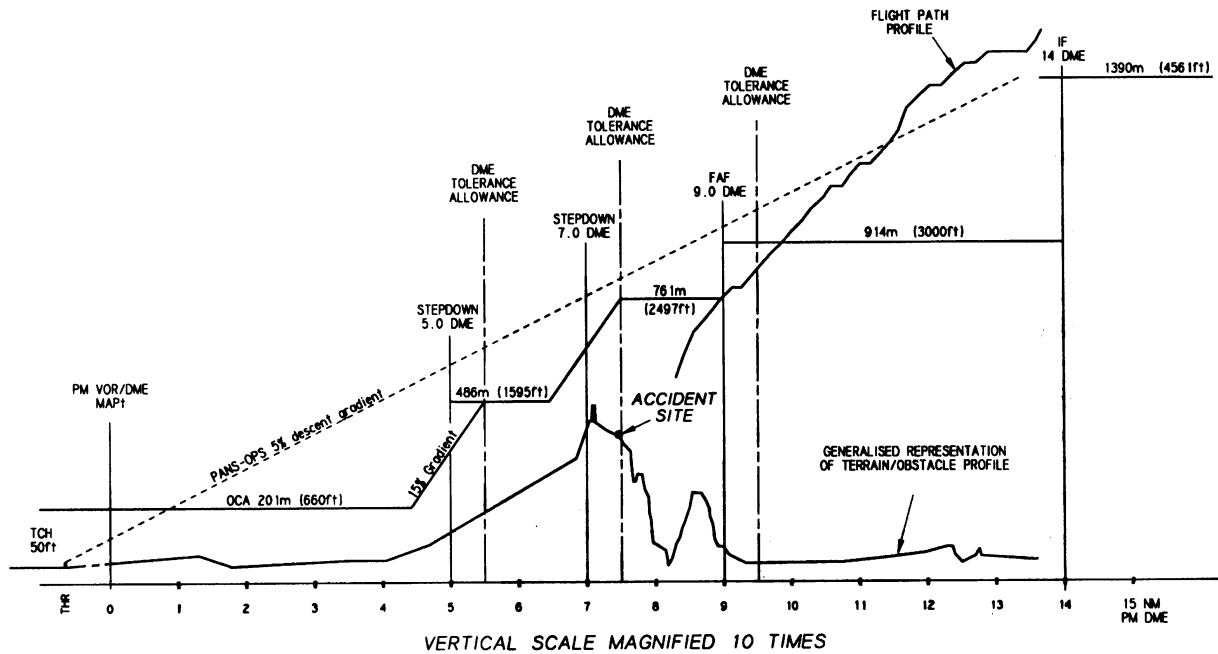
Figure 3
Copy of simplified procedure design
with radar data overlaid

- 1.8.18 The radar recording included Mode C data, identifying the aircraft and adding time and transponder altitude to each return.
- 1.8.19 The printout of the radar recording (see Figure 3) showed that the aircraft had descended around the 14 DME arc and had turned to intercept the final approach track normally at 5100 feet, at 0919.12 hours. On the final approach the aircraft was left of the specified track of 250° M to the VOR, being initially about one degree right of track, then crossing and maintaining about two degrees left of track to the last return. The Mode C altitude data showed a continuous descent through 2500 feet at 9 DME, to 1800 feet at the last return.

- 1.8.20 The study of the radar recording after the accident showed that the Mode C altitude data on the final approach, in conjunction with the aircraft’s position, could have enabled a radar controller to monitor the aircraft’s compliance with the instrument approach procedure while it was being carried out.

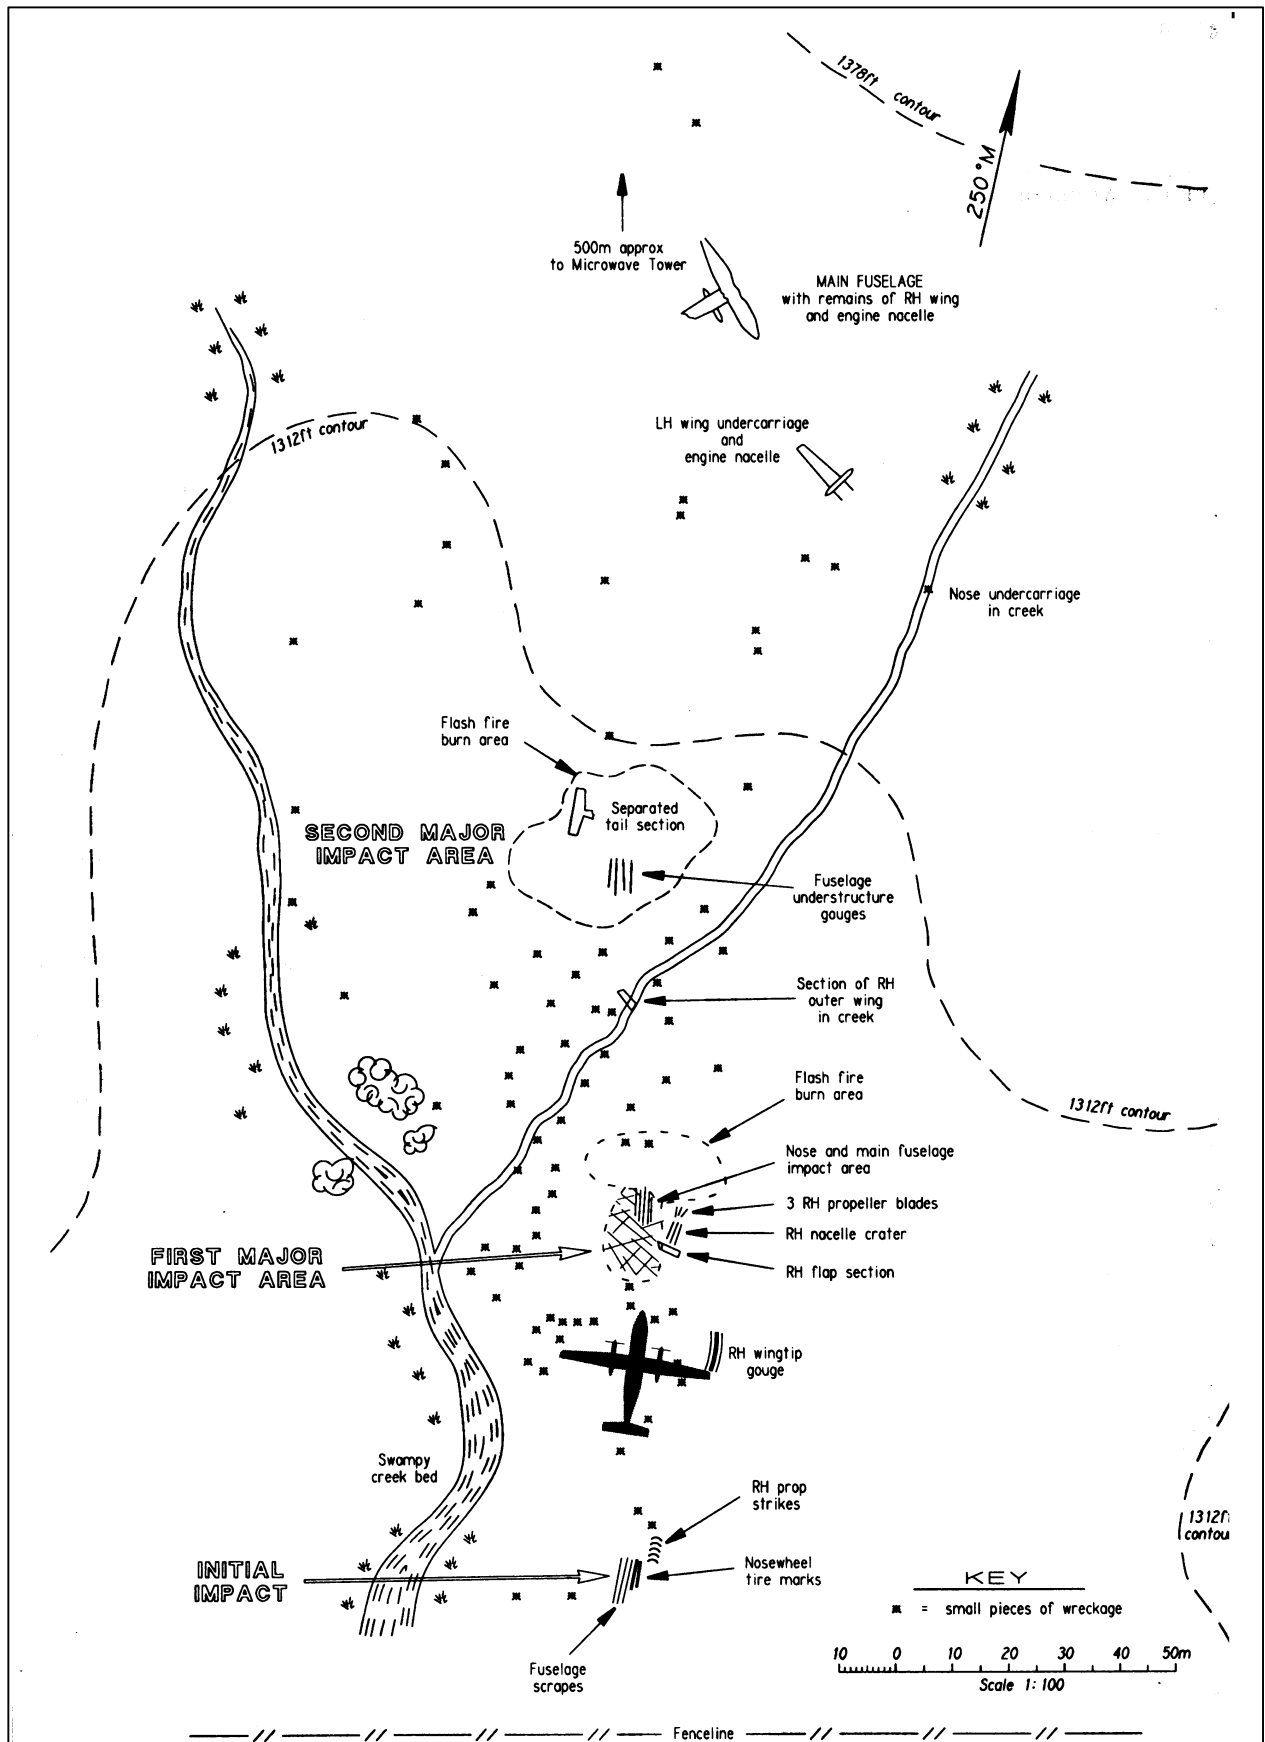
Figure 5
Impact and wreckage diagram

- 1.12.4 The initial ground impact occurred as the nosewheel of ZK-NEY contacted a gently rising grassy knoll which had an overall up-slope of about 5°. The aircraft was approximately level laterally at the time.

- 1.12.13 Approximately 28 m further on and 70 m beyond the grass knoll, the aircraft struck a terraced grass spur which had an upslope, in the impact area, of about 30°. The orientation of the spur was such that the major impact was absorbed by the aircraft's fuselage, right engine and right wing assembly. Three of the four already damaged right propeller blades detached from their hub and a four-metre-long section of the right outboard wing flap, together with smaller portions of other components from the lower fuselage and right side of the aircraft, were strewn over this impact area.

- 1.12.17 The damaged fuselage section comprising the flight deck and cabin, with the remains of the right wing and right engine installation loosely attached, continued uphill until brought to rest against a bank on the hillside, having traversed a total distance of about 235 m from initial impact. The fuselage was slewed through some 150° and lay across the slope on a heading of 040°M partially rolled onto its left side, at an elevation of 1345 feet amsl.

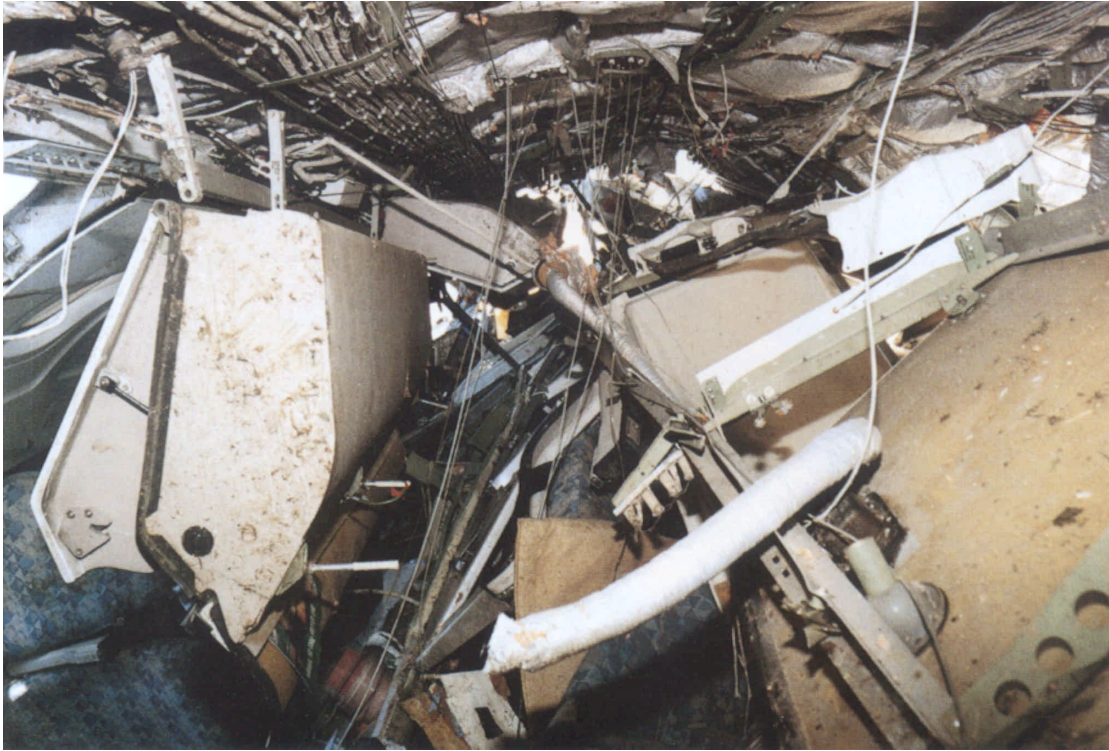
Figure 6a
View of passenger cabin looking aft

- 1.15.22 Exit from the aircraft was impeded by debris from loose seats, and by the collapse of the roof section in the mid-cabin area. This situation resulted in some passengers being trapped in the aircraft for 30 to 60 minutes after the accident.

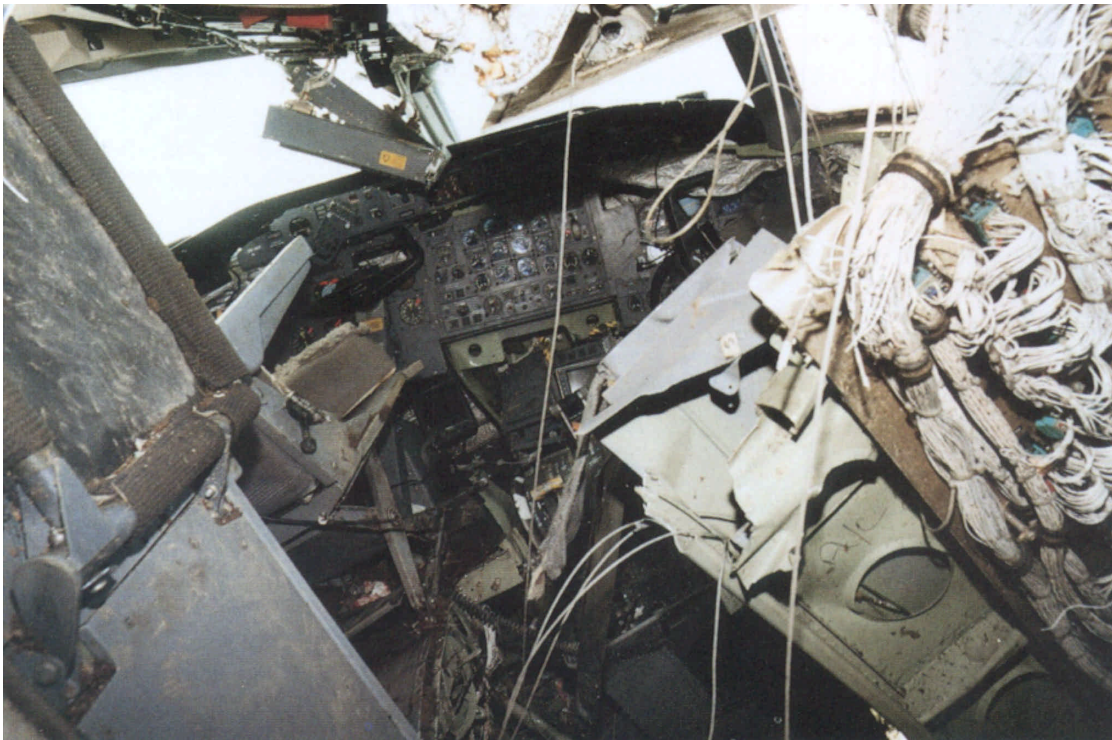
Figure 6b
View of flight deck
