Air Accidents Investigation Branch

**Report on the accident to
Gates Learjet 25B, EC-CKR
at RAF Northolt, Middlesex
on 13 August 1996**

(EW/C96/8/6)

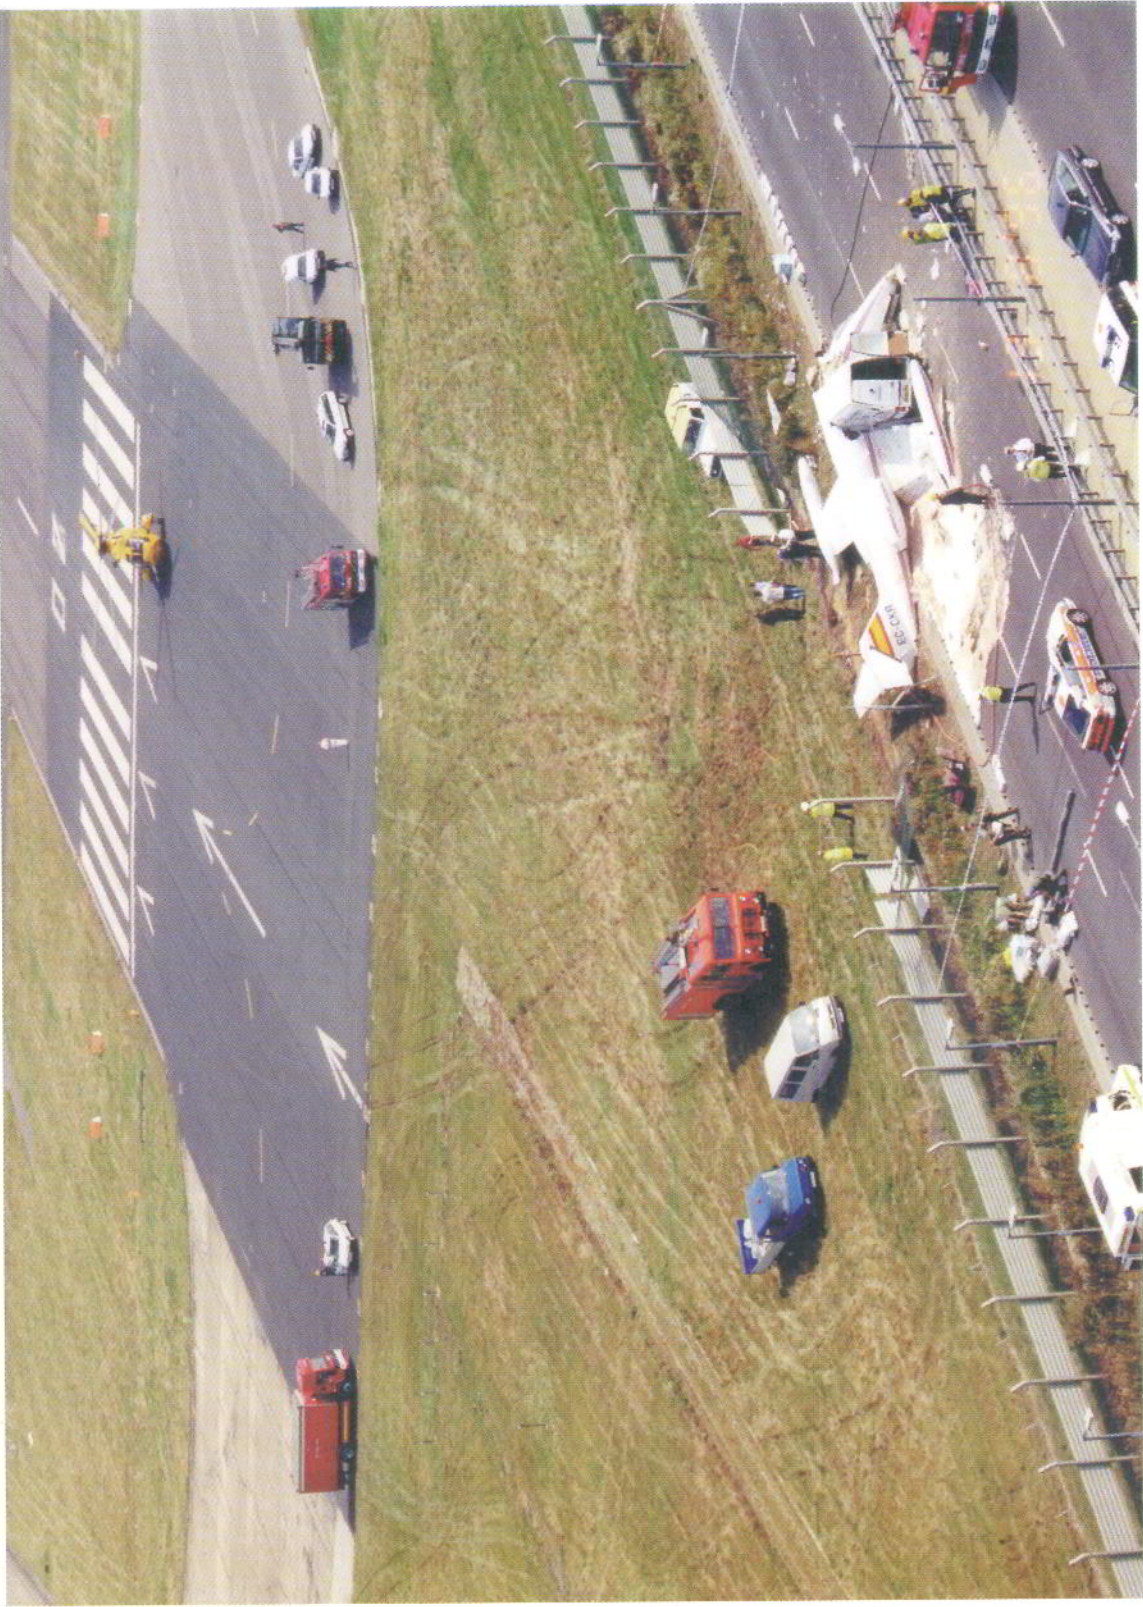
LEARJET ON THE A40 DURING RESCUE

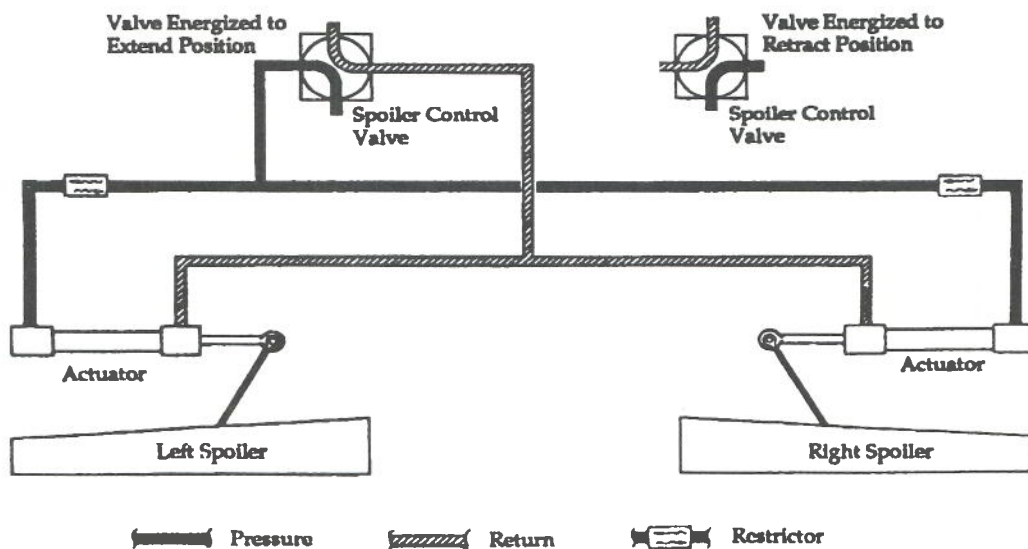
Spoiler System Hydraulic System Schematic
Figure 2

In photographs taken a few minutes after the accident, the spoilers were retracted. The spoilers, like the flaps, are controlled from an electrical switch on the flight deck. The system is shown in diagram form in Appendix 3. This operates a control valve on the wing, which directs hydraulic pressure to the extend or retract side of the spoiler actuators. The spoiler actuators contain mechanical locks which prevent the spoilers extending unless hydraulic pressure is available. The spoilers can run back without hydraulic pressure and the last part of the retraction movement will cause the mechanical locks to re-engage as the spoilers fair with the wing but this requires additional forces to be applied to the spoilers to overcome the forces in the lock mechanisms. Although these forces are minor, the spoilers will not enter the locks under inertial forces unless they are caused to fall back rapidly. It was found that they fell back freely when there was little fluid in the system, but quite slowly when the system contained fluid. Initial attempts to extend the spoilers by pressurising the extend line were unsuccessful as a fitting in the extend line had been broken adjacent to the top attachment of the right main landing gear retraction jack. This had occurred during the gear collapse, as the aircraft entered the road. The bay in which the extend line was broken, which is at the centre line of the aircraft and behind the right gear, is normally completely enclosed, access being via a cover plate. Although testing spilled fluid in the bottom of the bay, elsewhere it was clean and the cover plate and retraction jack fitting, which had been removed earlier, were not contaminated by fluid, thus indicating that the extend line had not been pressurised when it was fractured by the collapse of the landing gear. With the extend line repaired, the spoilers functioned normally.

The tests showed that, even with the spoiler extend line broken, the spoilers could retract only quite slowly and that this was insufficient to allow them to re-enter the internal locks and to fair fully with the wing profile. Further, once the spoilers had partly retracted, internal stiffness prevented further retraction due to gravity, even after many hours. The electrical status of the servo control valve made some difference to the rate of retraction but only in that, with the valve in the null de-energised position, the retraction tended to be slower. Following each test significant and sustained pressure was required to fully retract each spoiler.
