## **AIRCRAFT ACCIDENT INVESTIGATION REPORT**

**ETHIOPIAN AIRLINES B767 (ET-AIZ) AIRCRAFT ACCIDENT  
IN THE FEDERAL ISLAMIC REPUBLIC OF THE COMOROS,  
IN THE INDIAN OCEAN ON NOVEMBER 23, 1996**

**ETHIOPIAN CIVIL AVIATION AUTHORITY  
FLIGHT SAFETY DEPARTMENT  
P.O.Box 978  
ADDIS ABABA - ETHIOPIA**

**ETHIOPIAN AIRLINES B767-260ER, ET-AIZ AIRCRAFT ACCIDENT IN THE  
FEDERAL ISLAMIC REPUBLIC OF THE COMOROS, IN THE INDIAN OCEAN  
ON NOVEMBER 23, 1996. REPORT NO. AI-3/96 RELEASED  
BY CIVIL AVIATION AUTHORITY, ETHIOPIA**

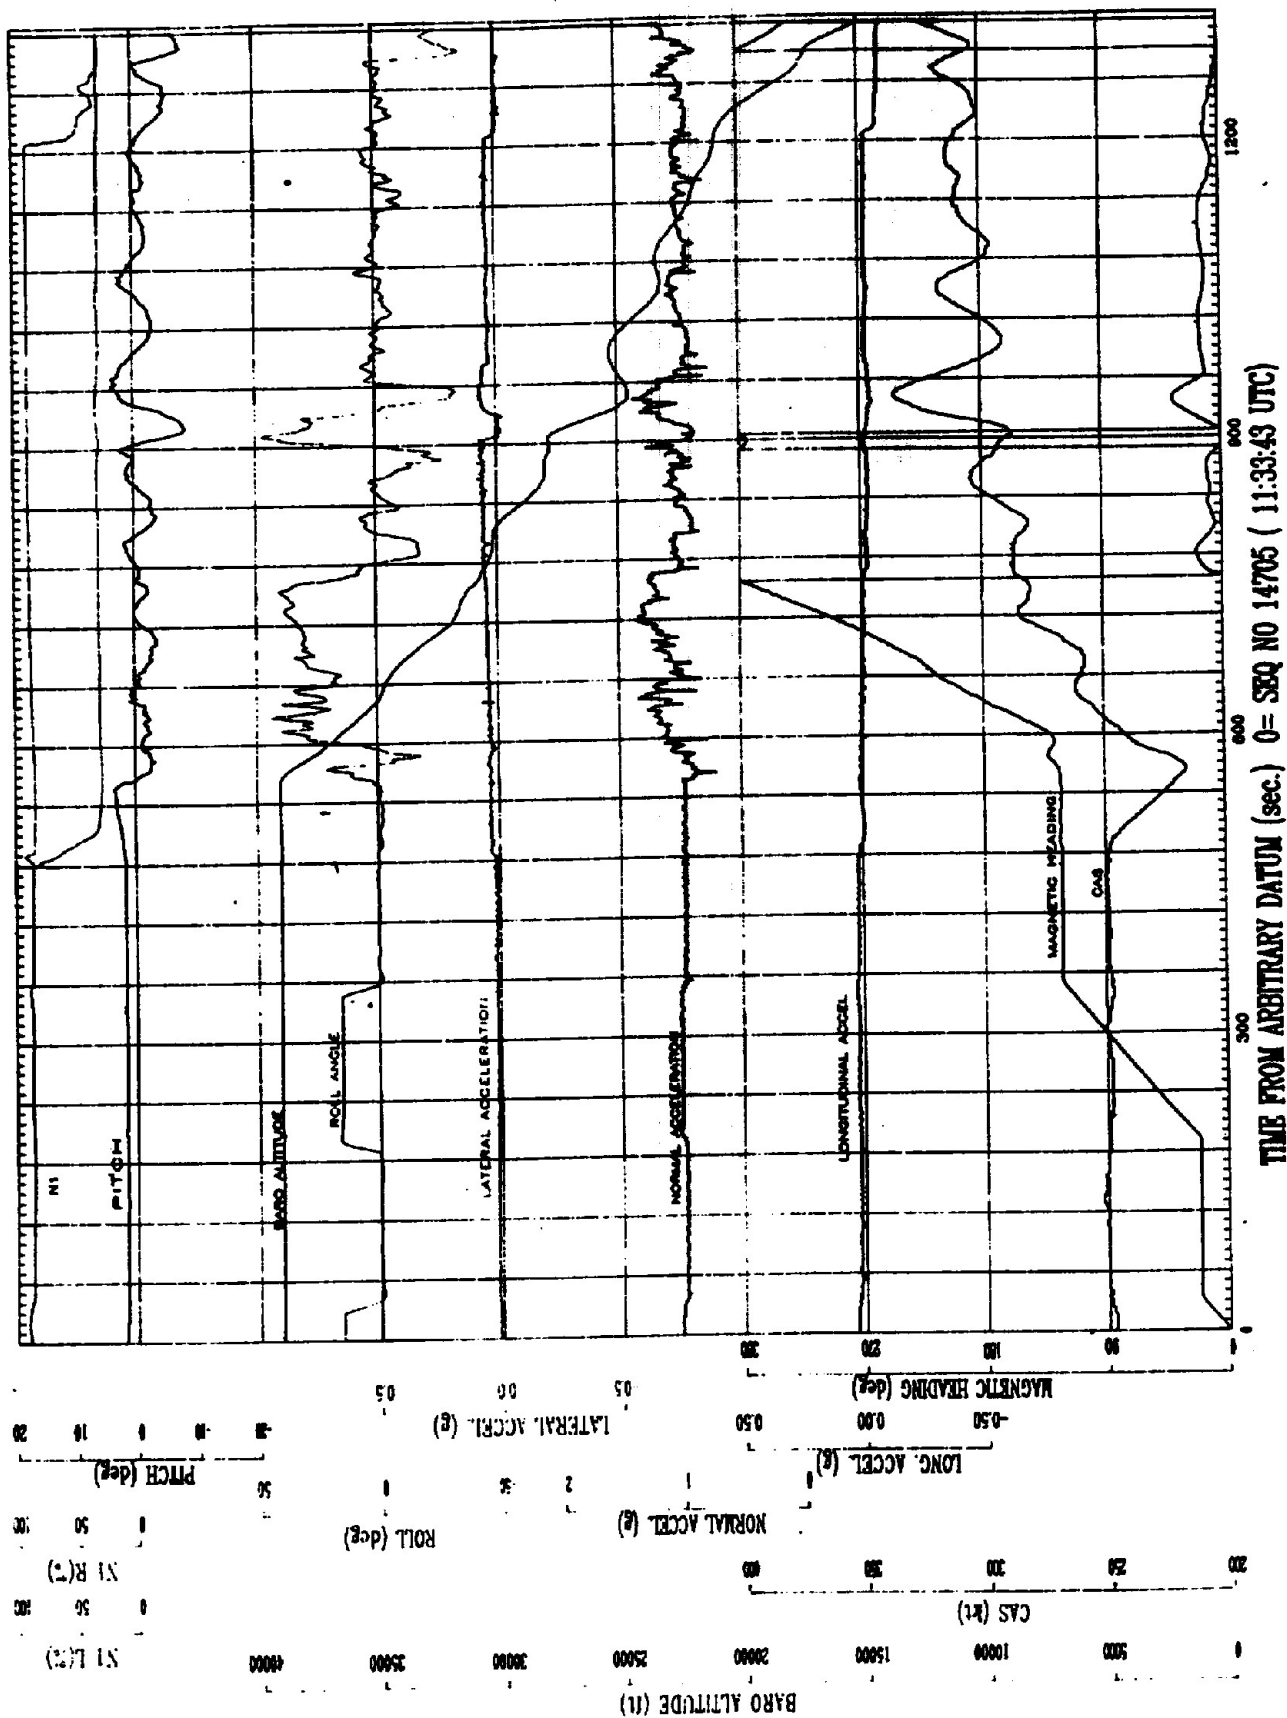
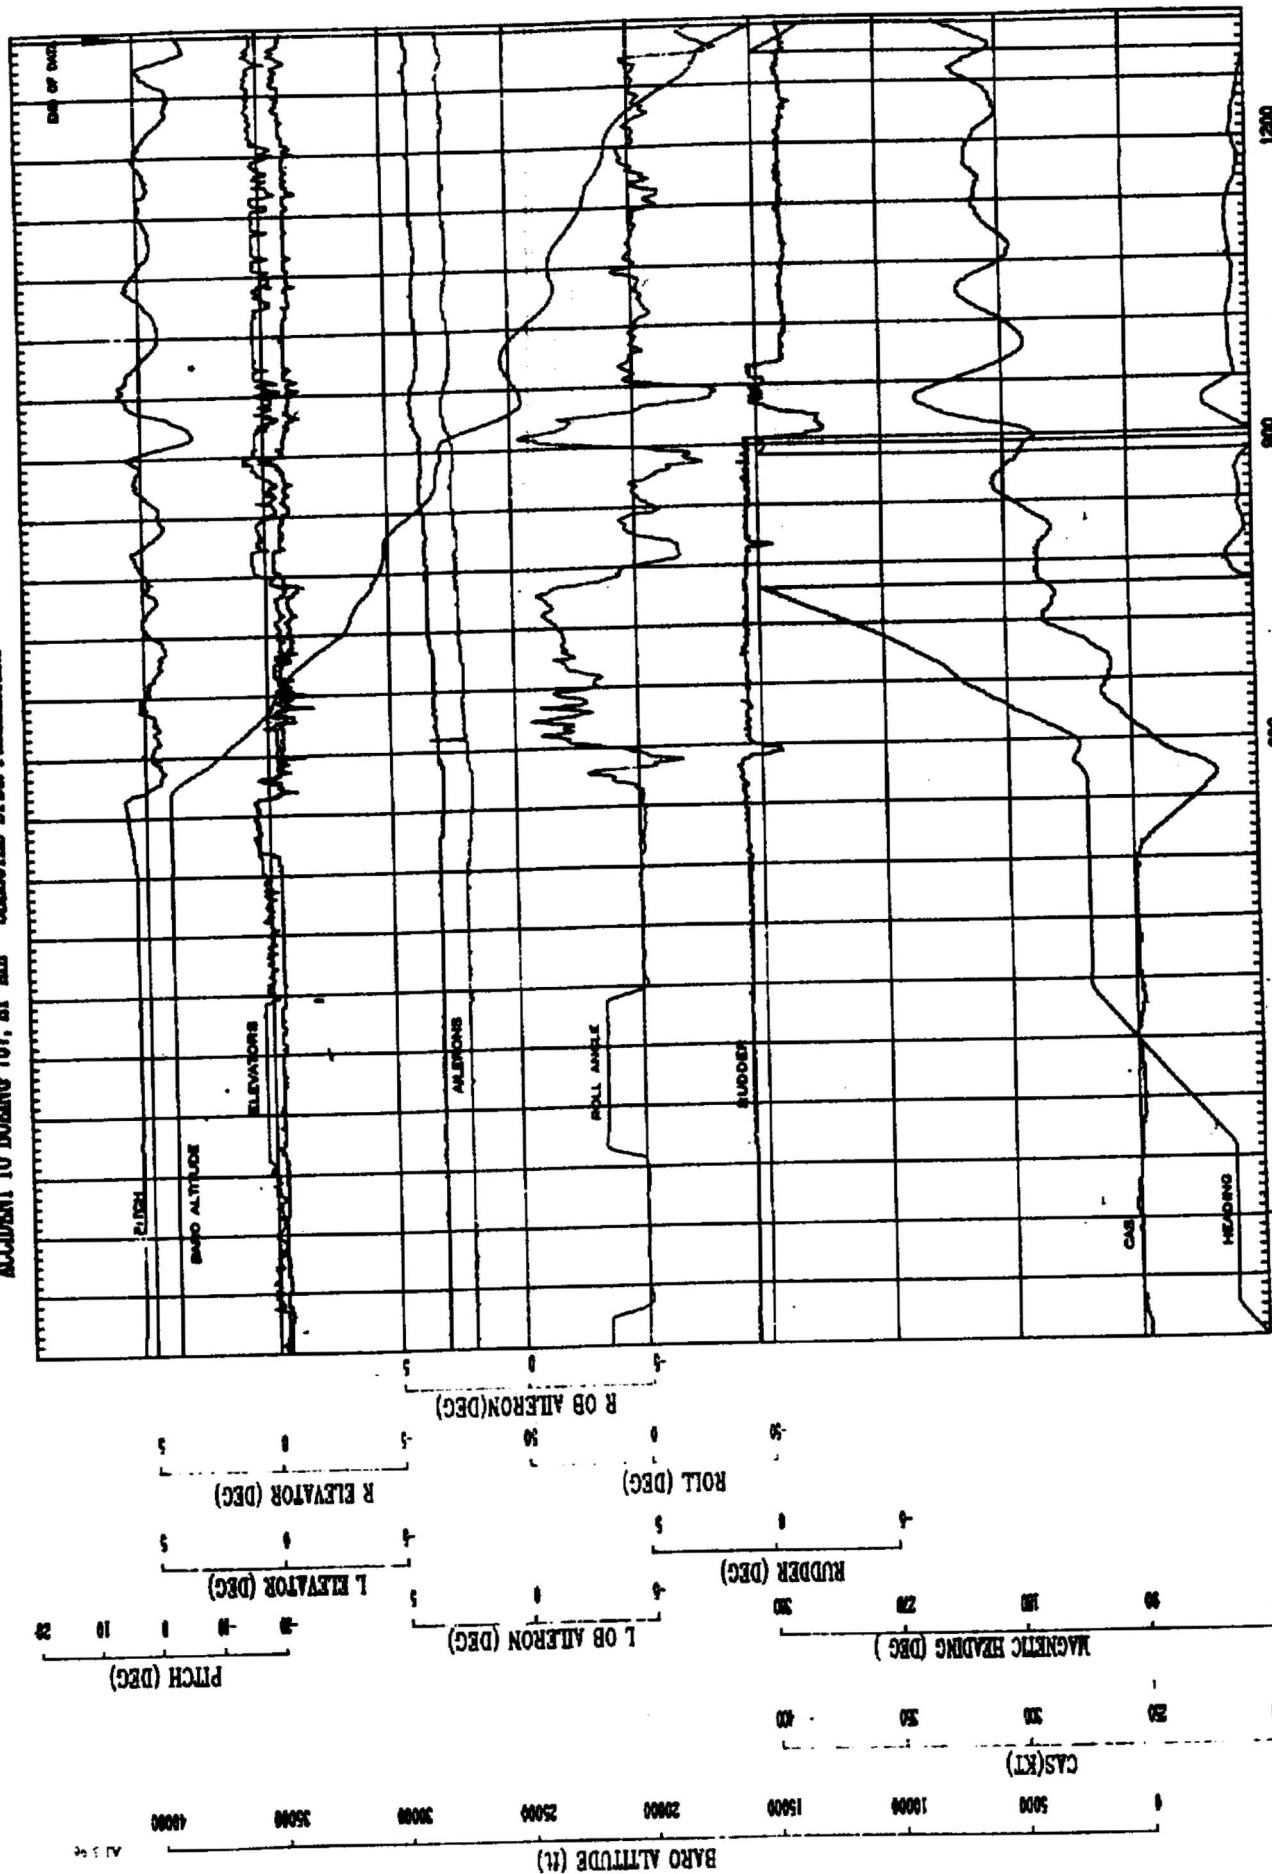
At 11:07:43 a race track-like pattern to the left was begun. The APU was started at 11:15:19. The right aft fuel pump indicated low pressure at 11:39:15, followed by a similar indication of the right forward fuel pump at 11:41:39. Some 4 seconds later at 11:41:43 the right engine ran down to windmilling speed. The aircraft gradually increased pitch to maintain altitude as the speed decayed to 216 kt, at which point the aircraft started to descend and increase speed. The autopilot was inadvertently disconnected by the hijacker at this time. Some 11.5 minutes after the right engine failed, the left aft fuel pump indicated low pressure followed 8 seconds later

During the descent, after the first engine failed, the flight was erratic with air speed varying between 216 kt and 336 kt. The altimeter reading did not show a steady descent, but indicated a temporary increase in altitude.

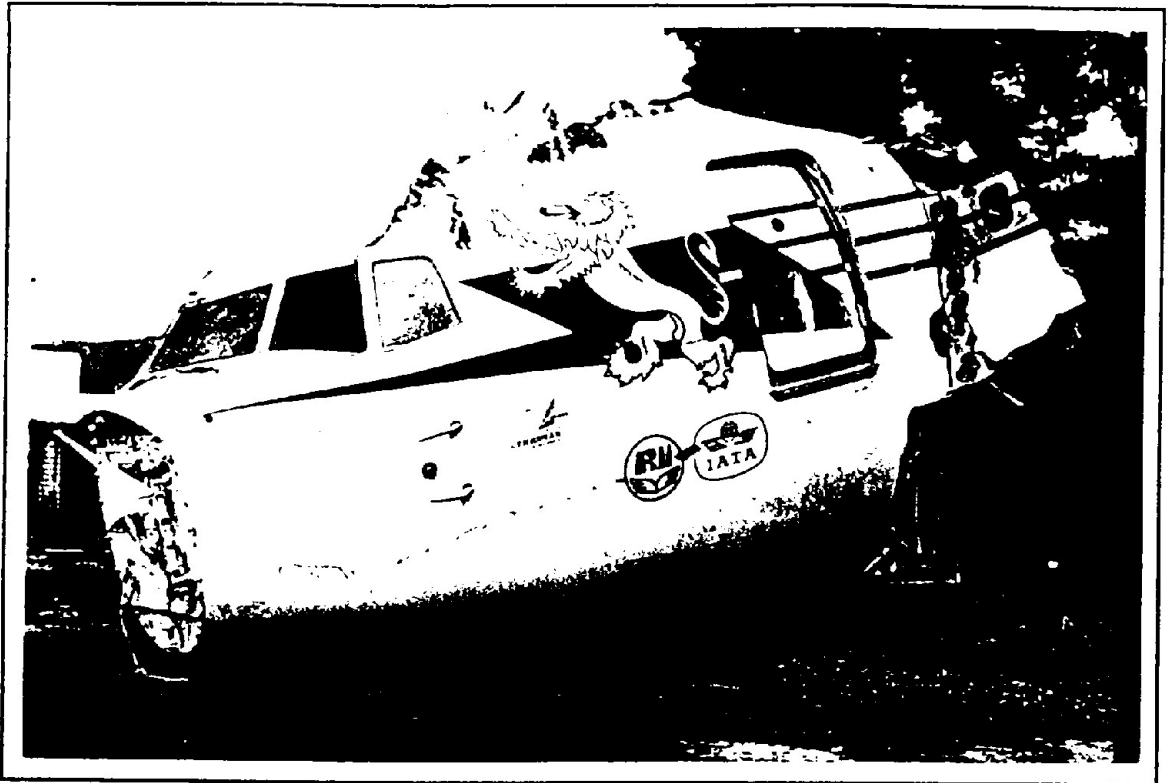
Figure 1. Left side of cockpit.

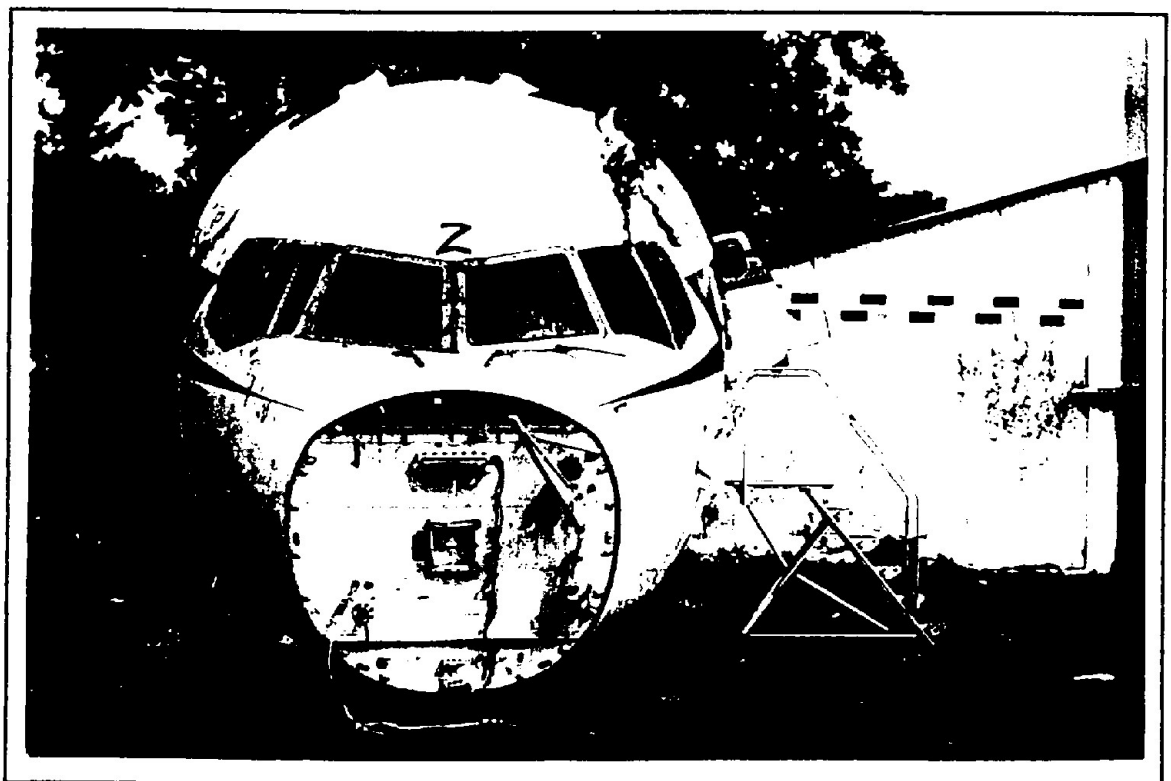
Figure 2. Front side of cockpit.

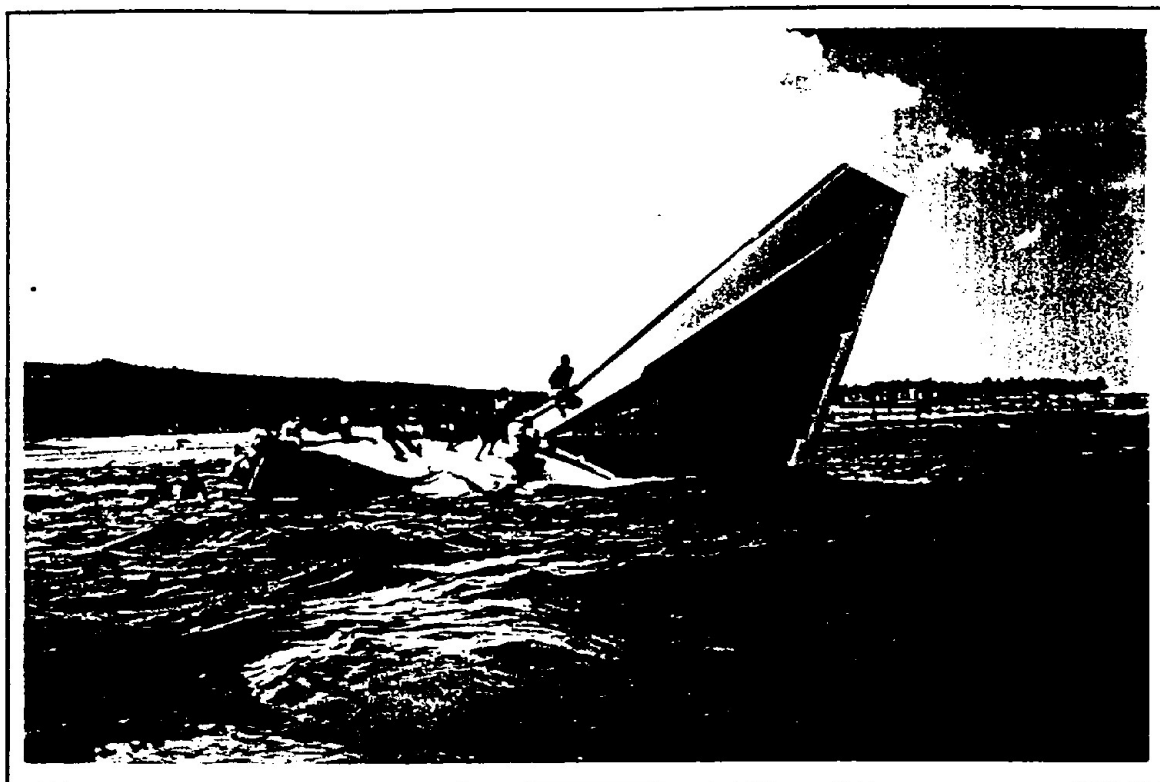
Figure 5. Tail section.

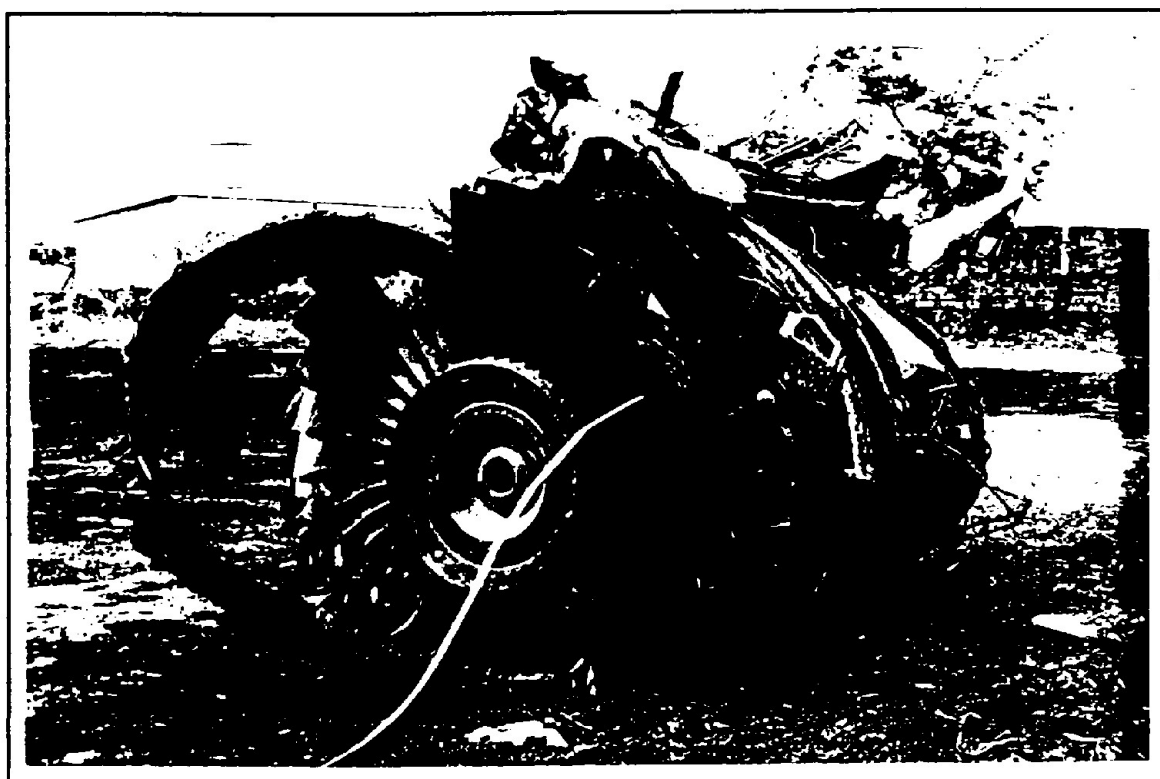
Figure 6. Left engine.

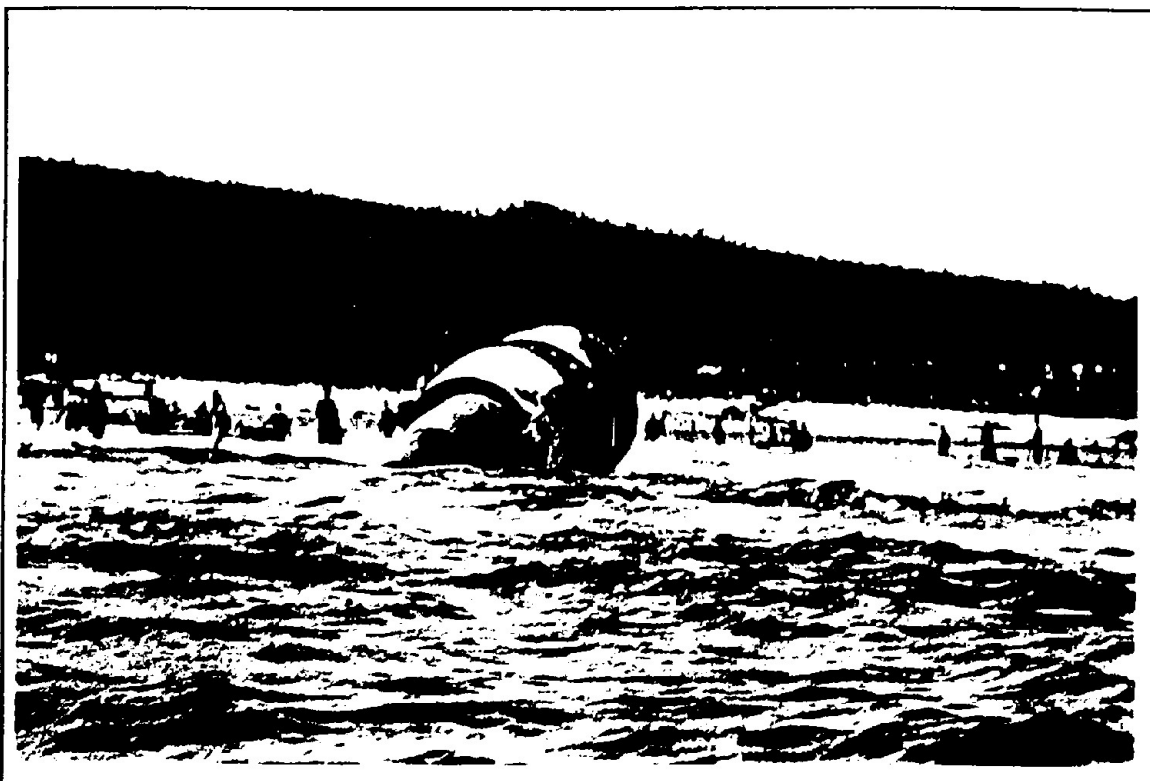
the wing, were found in an area of 400 meters in radius, at the edge of the reef. The right engine was later recovered from the sea. The part of the aircraft from station No. STA 360 up to 615 was not recovered. At the time of the impact, the landing gears were in a retracted position with the doors closed. The RAM Air Turbine was deployed. The wing flaps were up.

Figure 7. Right engine.

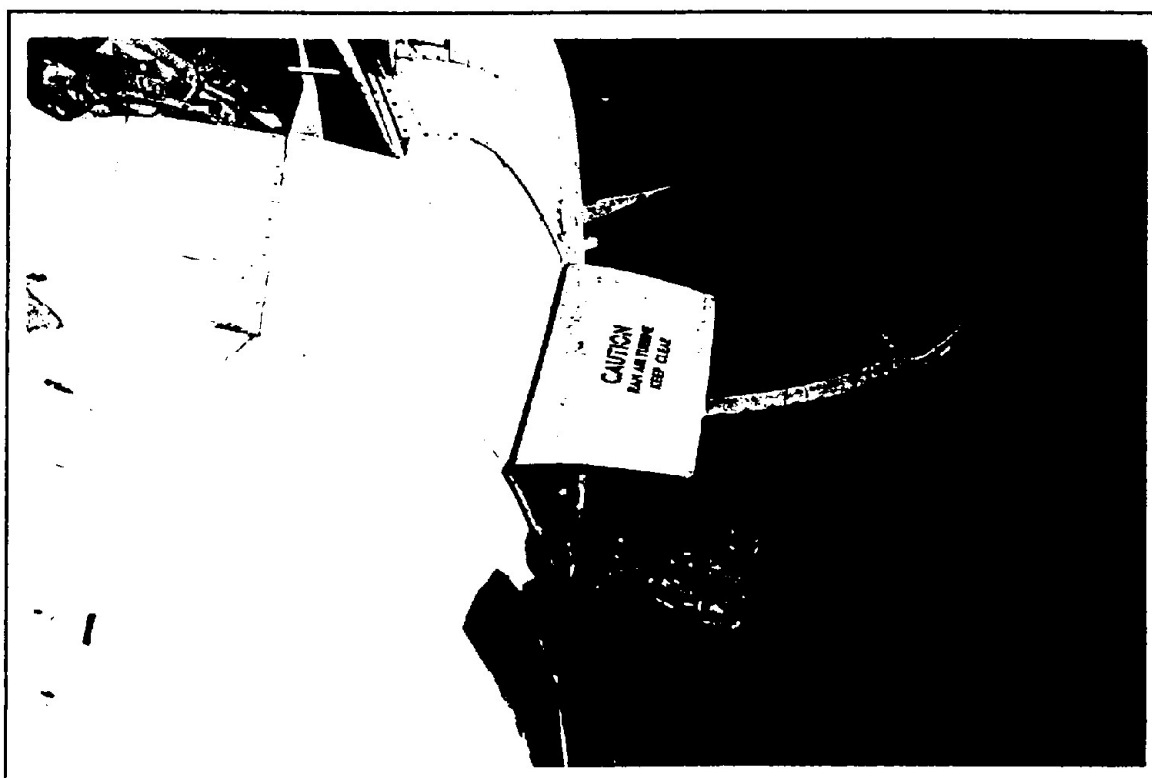
Figure 8. Ram Air Turbine deployed.
