NATIONAL TRANSPORTATION SAFETY BOARD

AIRCRAFT ACCIDENT REPORT

**RUNWAY COLLISION
UNITED EXPRESS FLIGHT 5925
AND BEECHCRAFT KING AIR A90
QUINCY MUNICIPAL AIRPORT
QUINCY, ILLINOIS
NOVEMBER 19,1996**

Abstract: This report explains the accident involving United Express flight 5925, a Beechcraft 1900C, and a Beechcraft King Air A90 that collided at the intersection of runway 13 and runway 04 at Quincy Municipal Airport, near Quincy, Illinois, on November 19, 1996. Safety issues in the report include the importance of emphasizing careful scanning techniques during flight training, Beech 1900C certification standards and compliance with requirements on door jamming, the certification of small airports used by scheduled commuter airlines, and aircraft rescue and fire fighting protection on scheduled commuter aircraft having 10 seats or more. Safety recommendations concerning these issues were made to the Federal Aviation Administration.

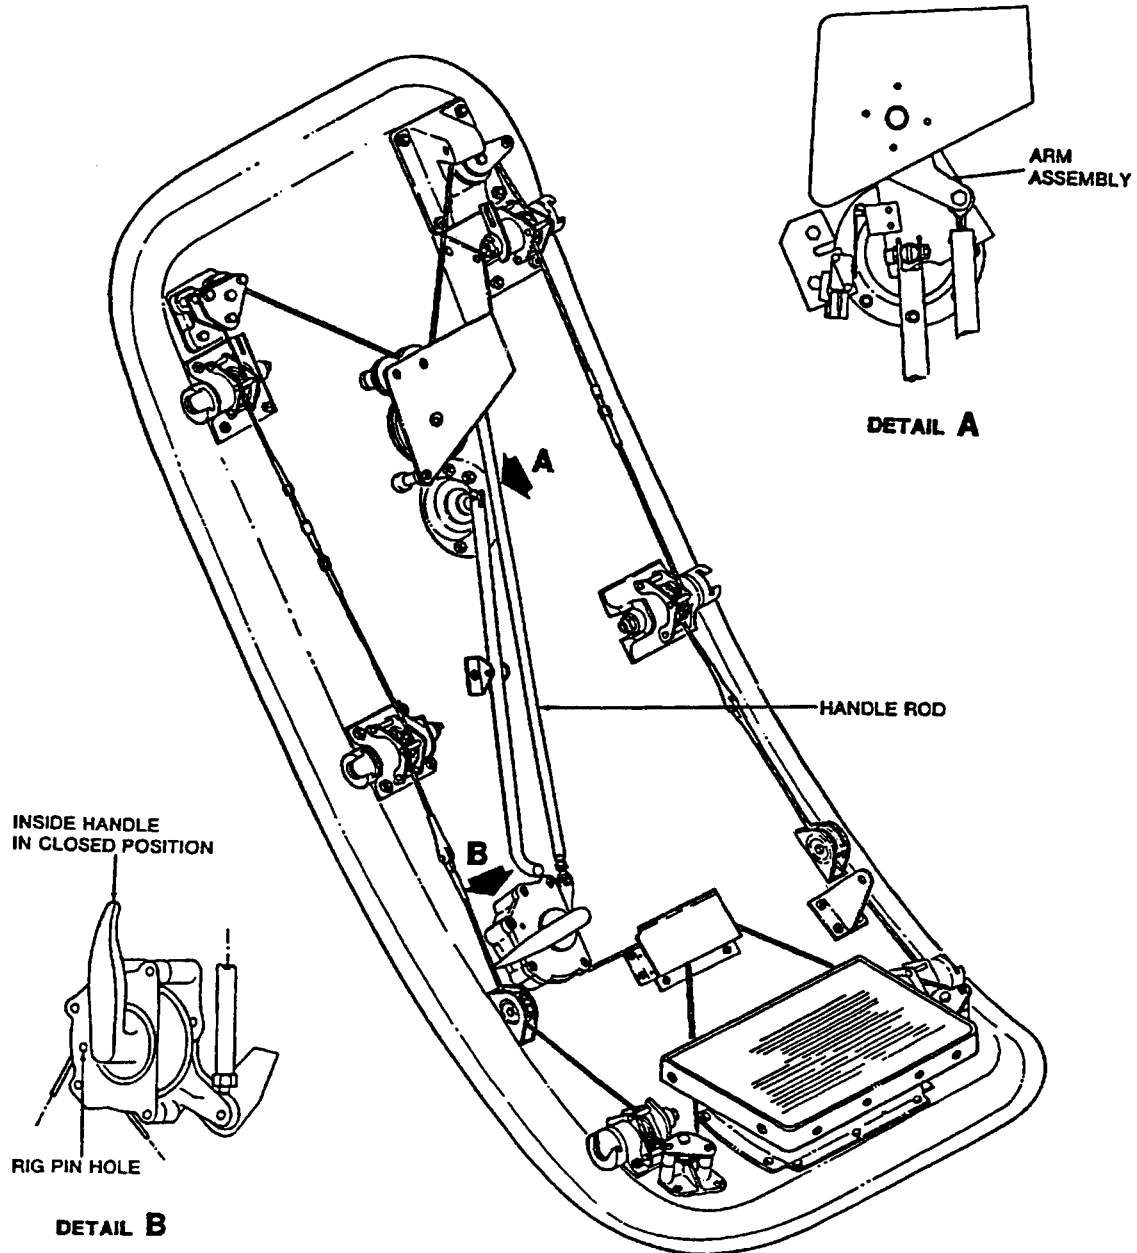
Figure 4.—Beech 1900/1900C air stair door and latching mechanism.

The FBO pilot stated that he found the forward air stair door handle in the 6 o'clock (unlocked) position.²⁹ He said that he attempted unsuccessfully to open the door by moving the handle in all directions and pulling on the door. He said that he did not see any instructions for opening the door, but he was able to rotate the handle upward to the 5 o'clock position but no further. The United Express pilot stated that he then intervened because he believed that the FBO pilot probably did not know how to open the door. The United Express pilot stated that he depressed the button above the handle while rotating the handle from the 3 o'clock position downward to the unlocked position. He stated that the handle felt "normal" as he rotated it. However, he was unable to open the door. The FBO pilot then tried again to open the door by rotating the handle upward, but he was again unsuccessful.

1. All cams were either fully or partially latched;
2. The exterior door handle was frozen in the latched position with aluminum melted around it;
3. The position of the interior door handle assembly could not be determined because there was no frame of reference to compare it to surrounding structure;
4. The door control cable was attached at both handle assemblies and was fractured at both turnbuckles. The metallurgical examination of the turnbuckle fracture surfaces revealed a topography typical of copper alloys subject to static failure influenced by high temperatures and steady state strain rates.

On February 24, 1997, the FAA responded to Safety Recommendation A-97-1, stating that it had issued Priority Letter AD 97-04-02, which refers to Raytheon's SB No. 2741, to require the installation of new exterior operating instructions, markings, and placards for the air stair door, cargo door and emergency exits. Based on the FAA's action, the Safety Board classified Safety Recommendation A-97-1 "Closed—Acceptable Action" on April 25, 1997.
