**REPORT ON ACCIDENT
TO
ELBEE AIRLINES
F-27 AIRCRAFT VT-SSA
AT MUMBAI
ON
03.07.97**

**INVESTIGATION REPORT ON ACCIDENT TO ELBEE AIRLINES
F-27 AIRCRAFT VT-SSA AT MUMBAI ON 03.07.97**

Type : F-27
Model : MK-200
Engines : RR DART 552-7R
Nationality : Indian
Registration : VT-SSA

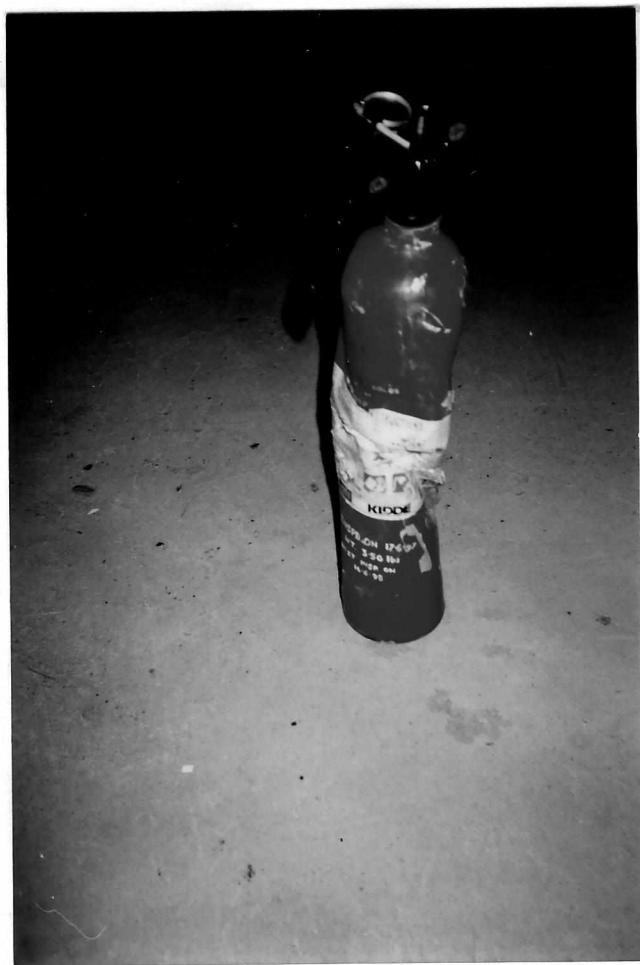
Some pieces of floor board and also some debris of the cargo was collected from the Mudh-island beach, which was washed off after the aircraft crashed into the sea. The floating debris included one Halon fire extinguisher in a deformed condition, wing root top rear panel near flap

CABIN FIRE EXTINGUISHER

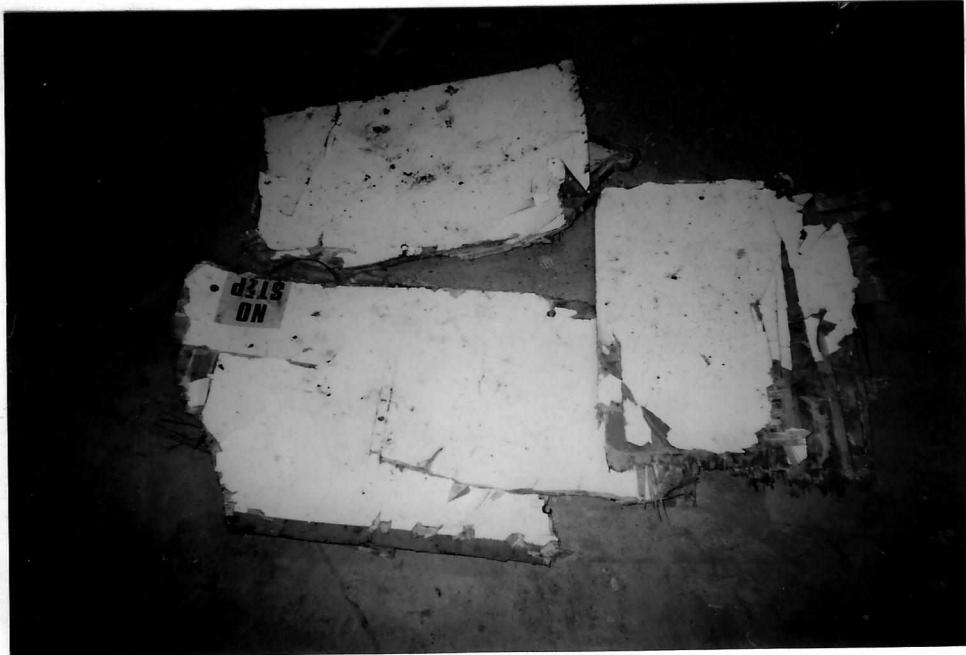
PORTION OF WING SURFACE SHOWING 'NO STEP'

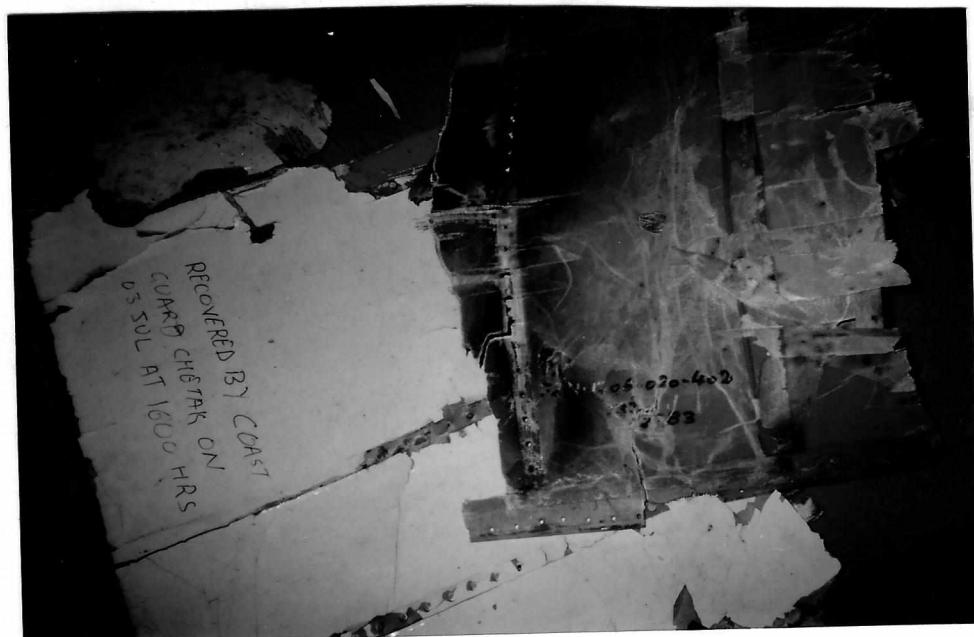
PIECES OF FLOOR BOARD AND A PORTION OF AVIONICS BAY PANEL

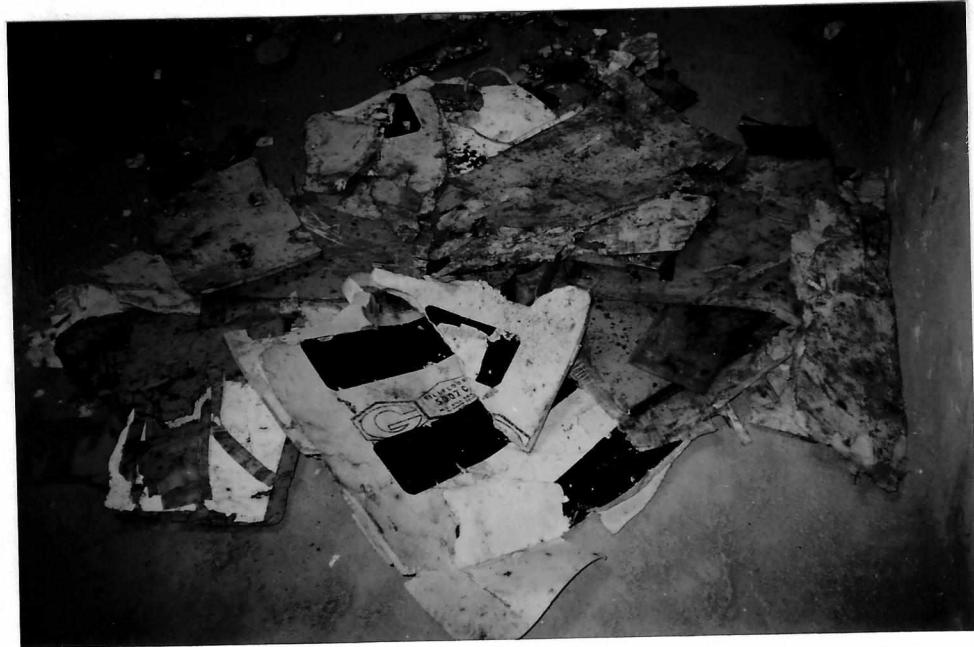
PIECES OF FLOOR BOARDS AND SOUND PROOFING MATERIAL

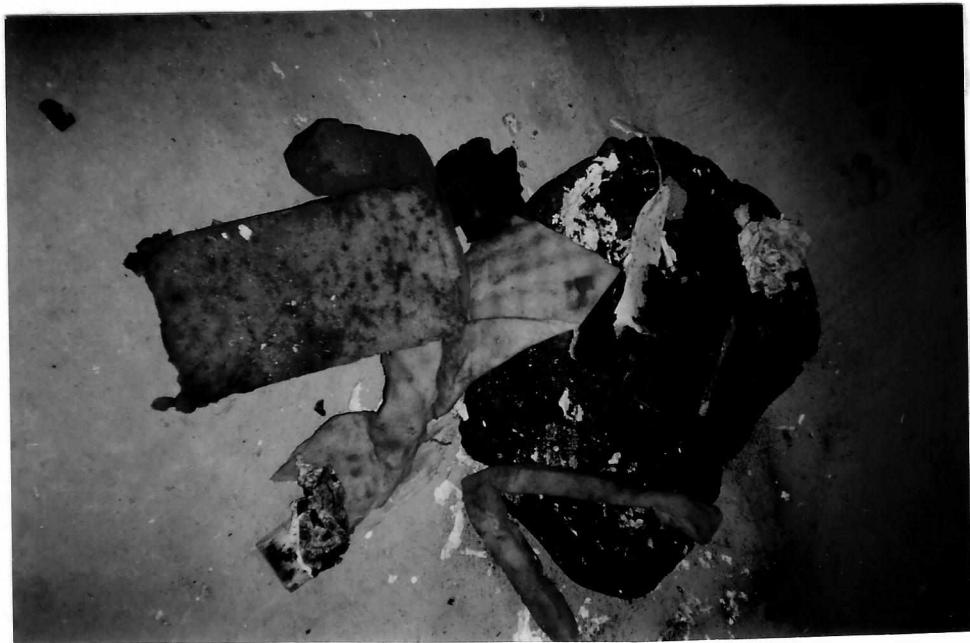
SEAT CUSHION AND SOUND PROOFING MATERIAL

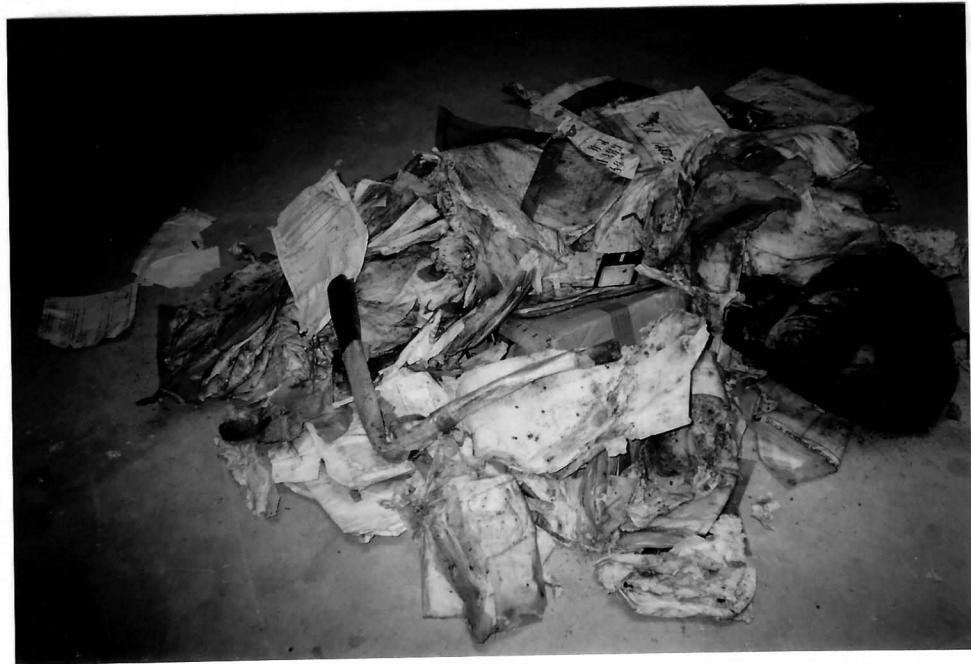
structured failure of the aircraft. A portion of the courier mail was also collected which was washed ashore the Mudh Island. However, since the entire wreckage including the mail could not be recovered, the possibility of loss of control due to giving away of the lashing can not be conclusively proved.

PORTION OF COURIER MAIL
