Air Accidents Investigation Branch

**Report on the accident to
Fokker F27-600 Friendship, G-CHNL
Near Guernsey Airport, Channel Islands
on 12 January 1999**

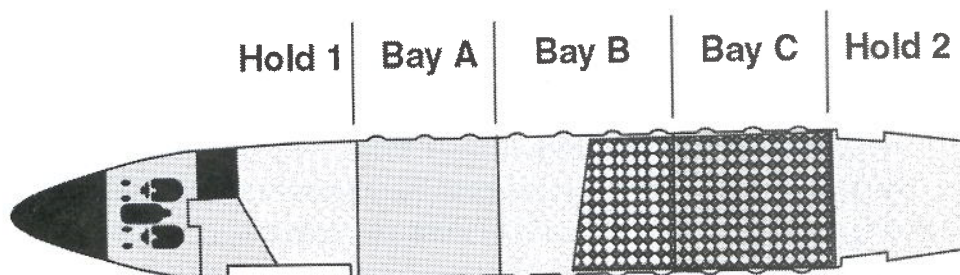
The most obvious clues to the root cause of the accident were the absence of any cargo in Bay A, which according to the loadsheets should have contained 800 kg, and the elevator trim position, which was close to fully nose down. The forward half of the cargo was contained within the netting which had distorted under impact loads but was generally still restrained by its lashings. However about 20% of the cargo had been liberated at the rear of the aircraft. No cargo had been loaded into Hold 2 but 229 kg had come to rest there. Some 315 kg of liberated newspapers were distributed on top of the cargo netting in Bay C. The dynamics of the aircraft's impact with the ground would have thrown loose cargo upwards and forwards so liberated newspaper bundles must have migrated rearwards into Hold 2 in flight and then forwards into Bay C at ground impact. It was not possible to determine when migration to Hold 2 took place but it would not have occurred if the cargo had been adequately restrained at the rear of the aircraft.

The distribution of the load as shown on the loadsheet completed by the pilots at Luton bore little resemblance to the actual loading. Detailed reconstruction of the loading, based on a combination of physical and witness evidence, revealed that all the cargo had been placed in Bays B and C as shown below:

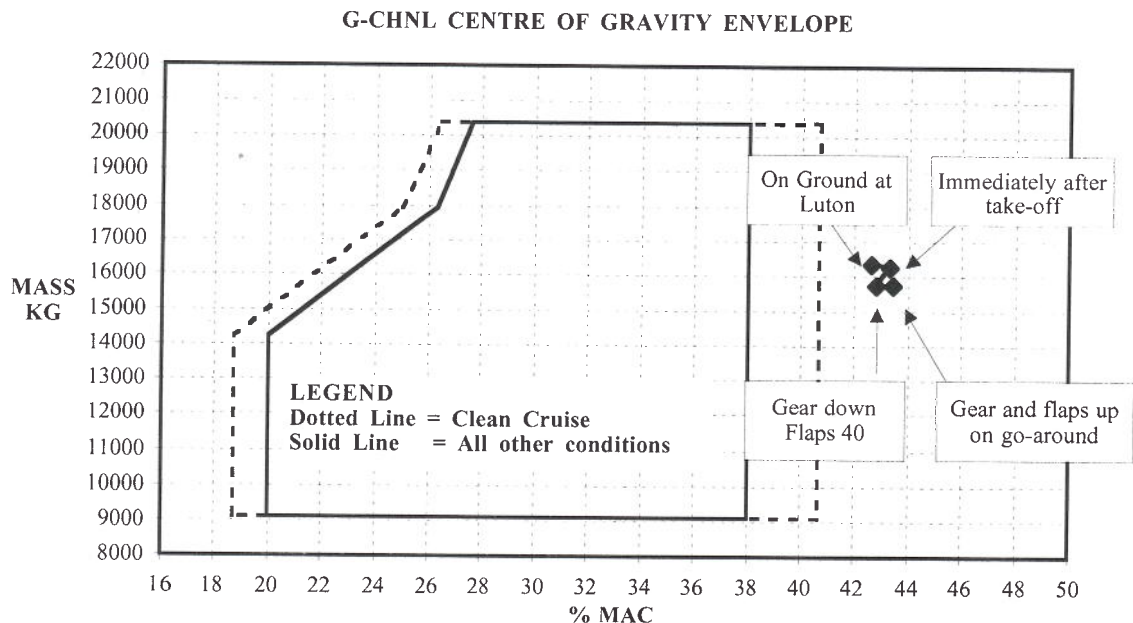
Calculations indicated that the loaded aircraft centre of gravity was significantly aft of the aft limit of 38%. The positions of the centre of gravity during flight are illustrated on the graph below.

In flight there is a small movement of the centre of gravity arising from fuel consumption but the main changes occur when the gear is raised and lowered.

The graph assumes that cargo migration did not start until after control was lost and the aircraft pitched-up to a near-vertical attitude. However, migration could have occurred earlier. The rear face of the stack of newspaper bundles was essentially vertical but their rearward motion was restrained solely by tension in the net from one side of the cabin floor to the other. If, whilst the aircraft taxied or flew, vibration dislodged one or more bundles, the overall tension across the rear of the net would have been reduced enabling more bundles to slip out. If migration in this manner took place before control was lost, the change in centre of gravity during flight would have produced a more extreme aft centre of gravity position.

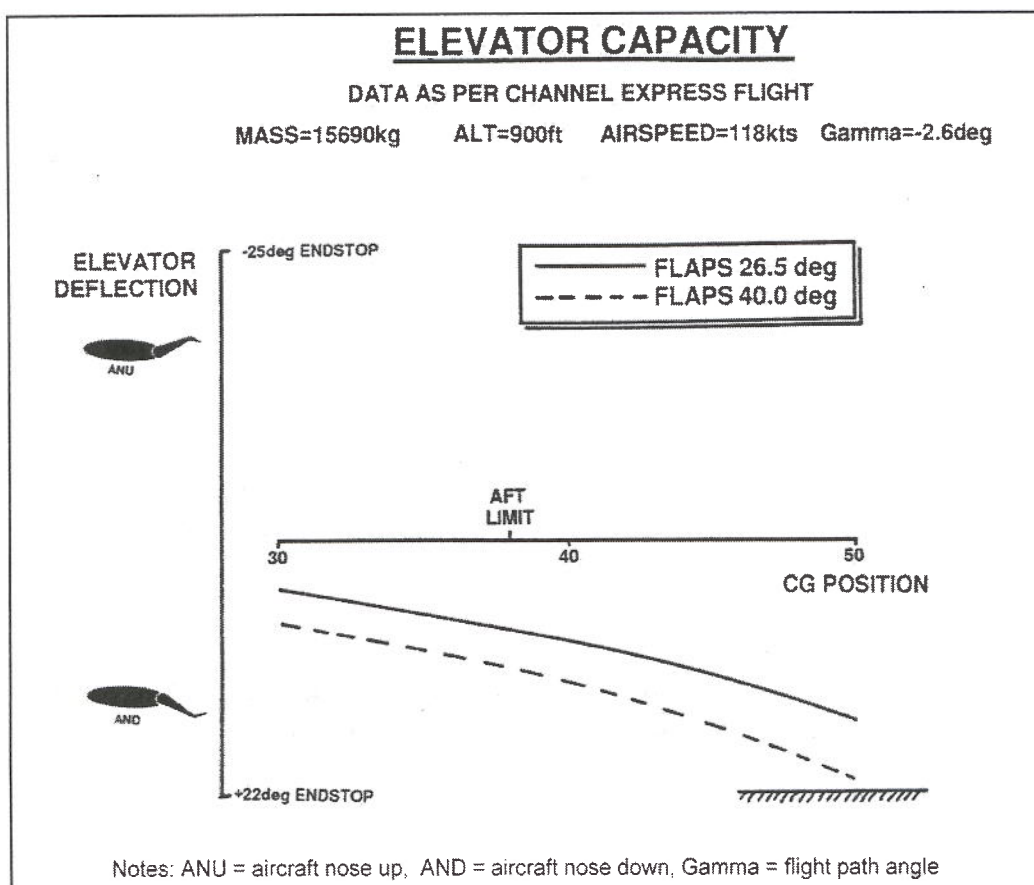
The diagram shows that lowering full flap (40°) requires more nose down elevator than approach flap (26.5°). It also shows that as the CG moves further aft towards 50% MAC, the elevator position approaches the end stop of 22° . Moreover, although the diagram indicates that the endstop is not reached until the CG position reaches about 50%, the lines indicate an equilibrium position. In practice, more elevator travel is necessary for adequate control margins and to allow for aerodynamic disturbances such as turbulence.

Finally, the diagram does not show the likely effect of increasing engine power from low power to high power. The increase in power moves the neutral point forward which requires still more nose-down elevator to counteract the aircraft's tendency to pitch up. Consequently, there is a range of CG positions in which the aircraft flies reasonably normally until full flap is lowered and/or power is significantly increased.
