**INSTITUTO NACIONAL DE AVIAÇÃO CIVIL  
PORTUGAL**

**REPORT ON THE ACCIDENT TO ANTONOV AN-12BP,  
REGISTRATION LZ-SFG  
OCCURRED AT LAJES AIR BASE, AÇORES  
ON 04-FEBRUARY-1998**

REPORT No. 04/ACCID/GPS/98

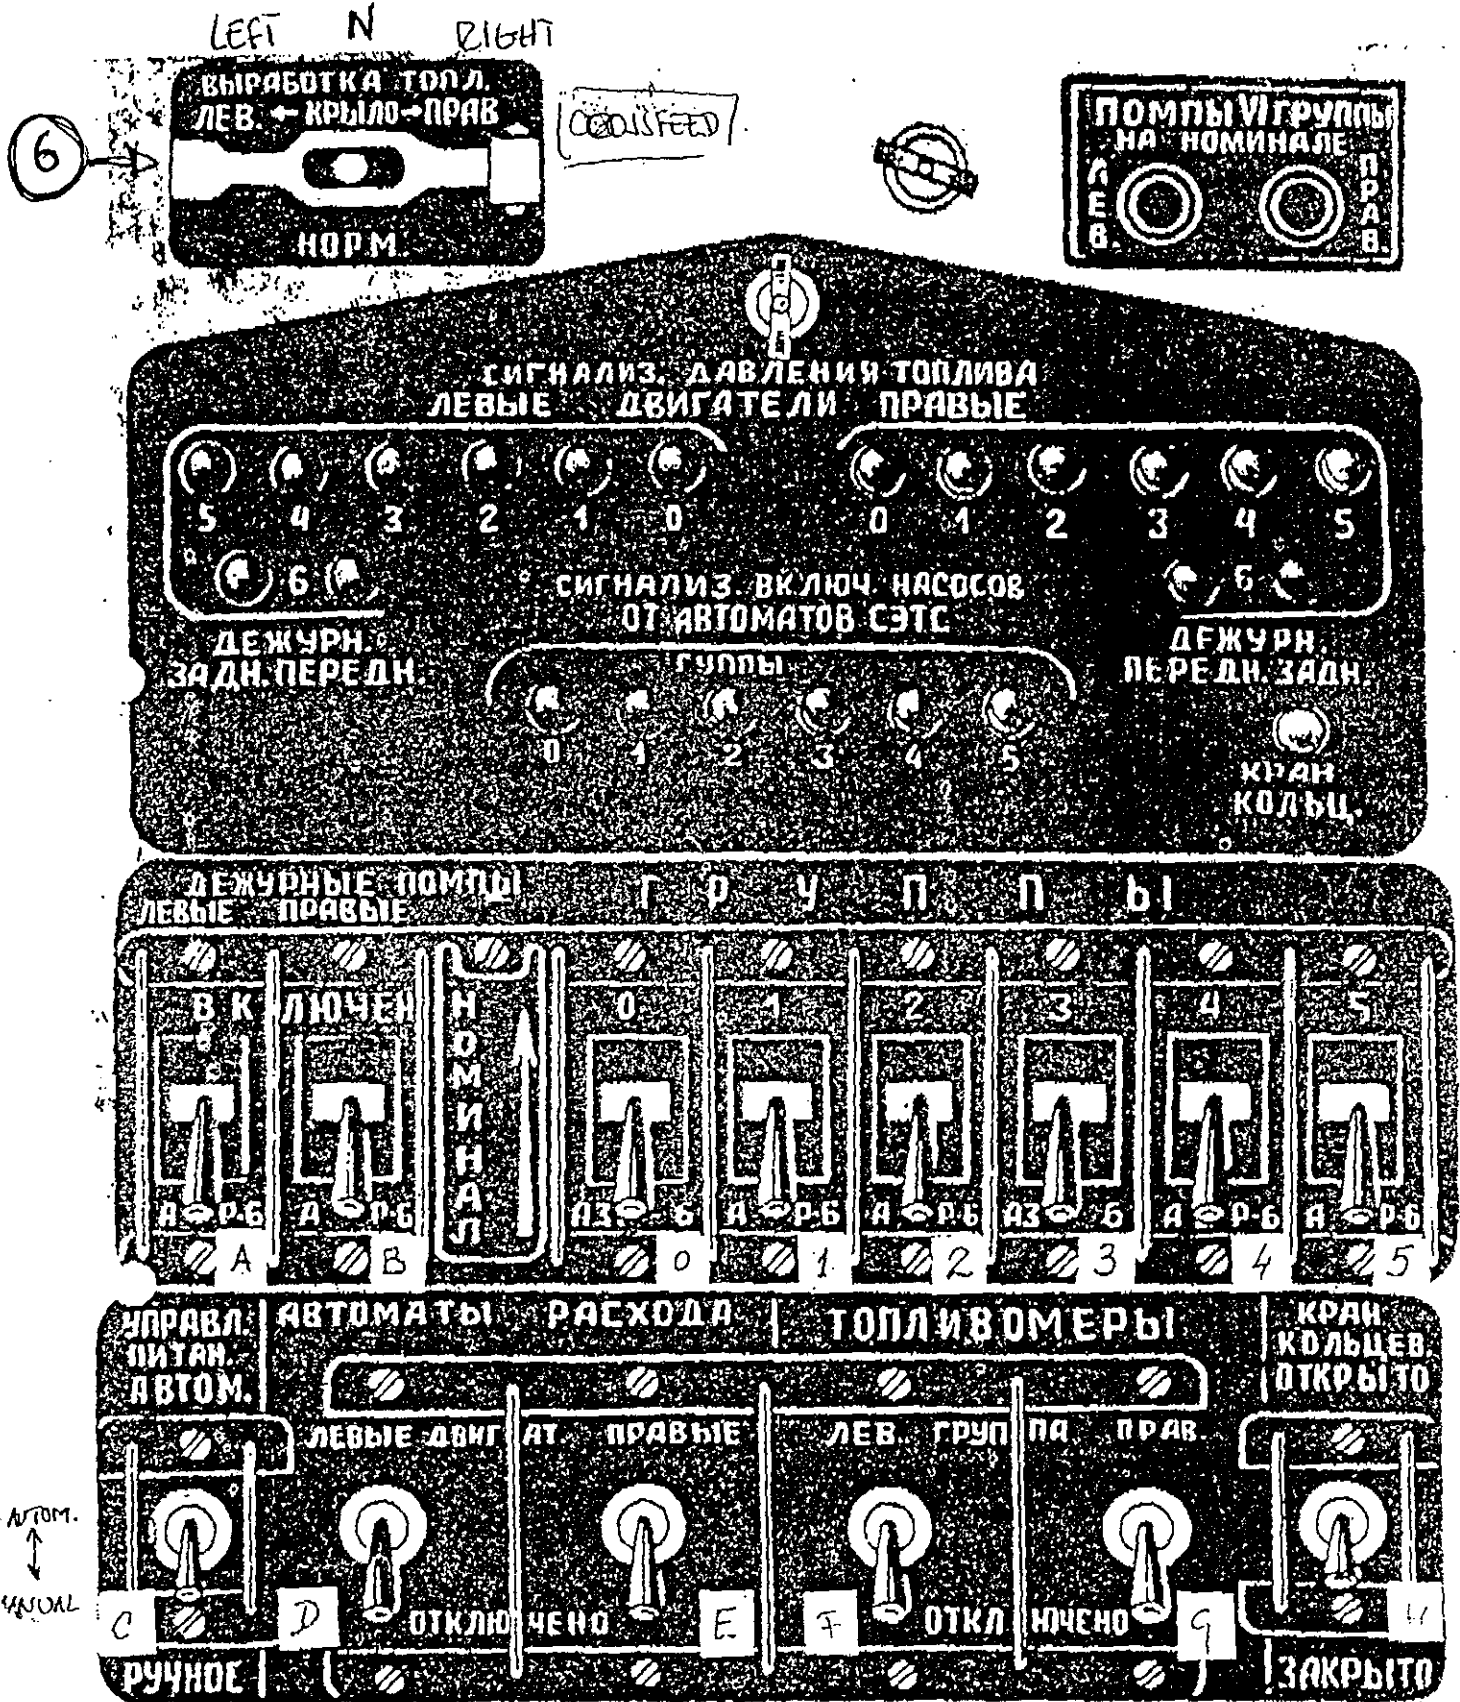
# FUEL CONTROL PANEL AN 12

The Fuel System Control Panel was recovered from the aircraft wreckage seriously damaged, with some of its components missing and evidencing having sustained high temperatures, resulting from the fire.

It was verified that the control switches were in the following positions:

- Mode Control - ON position (Automatic).
- Group 0 Control - ON position.
- Group 1 Control - Toggle switch ON position.
- Group 2 Control - Toggle switch OFF position.

The fuel system control panel recovered from the aircraft wreckage was seriously damaged, with some of the components missing and showing evidence of having been subjected to high temperatures resulting from the fire.

It was observed that the heat causes the contacts to open even if the mechanism is blocked on **OFF**.

Since the panel was found buried, the switches mechanisms may have blocked due to the presence of earth, which might explain the disagreement between the position of the mechanisms and the contacts of some of the switches.

The Commission verified that the fuel selection executed by the crew was not correct, because in the Fuel System Control Panel the selection of AUTOMATIC MODE, procedure recommended for take-off, was not activated because the fuel pumps control switches of Group 6 tanks were not ON. (Necessary condition to operate the AUTOMATIC MODE of fuel consumption.)

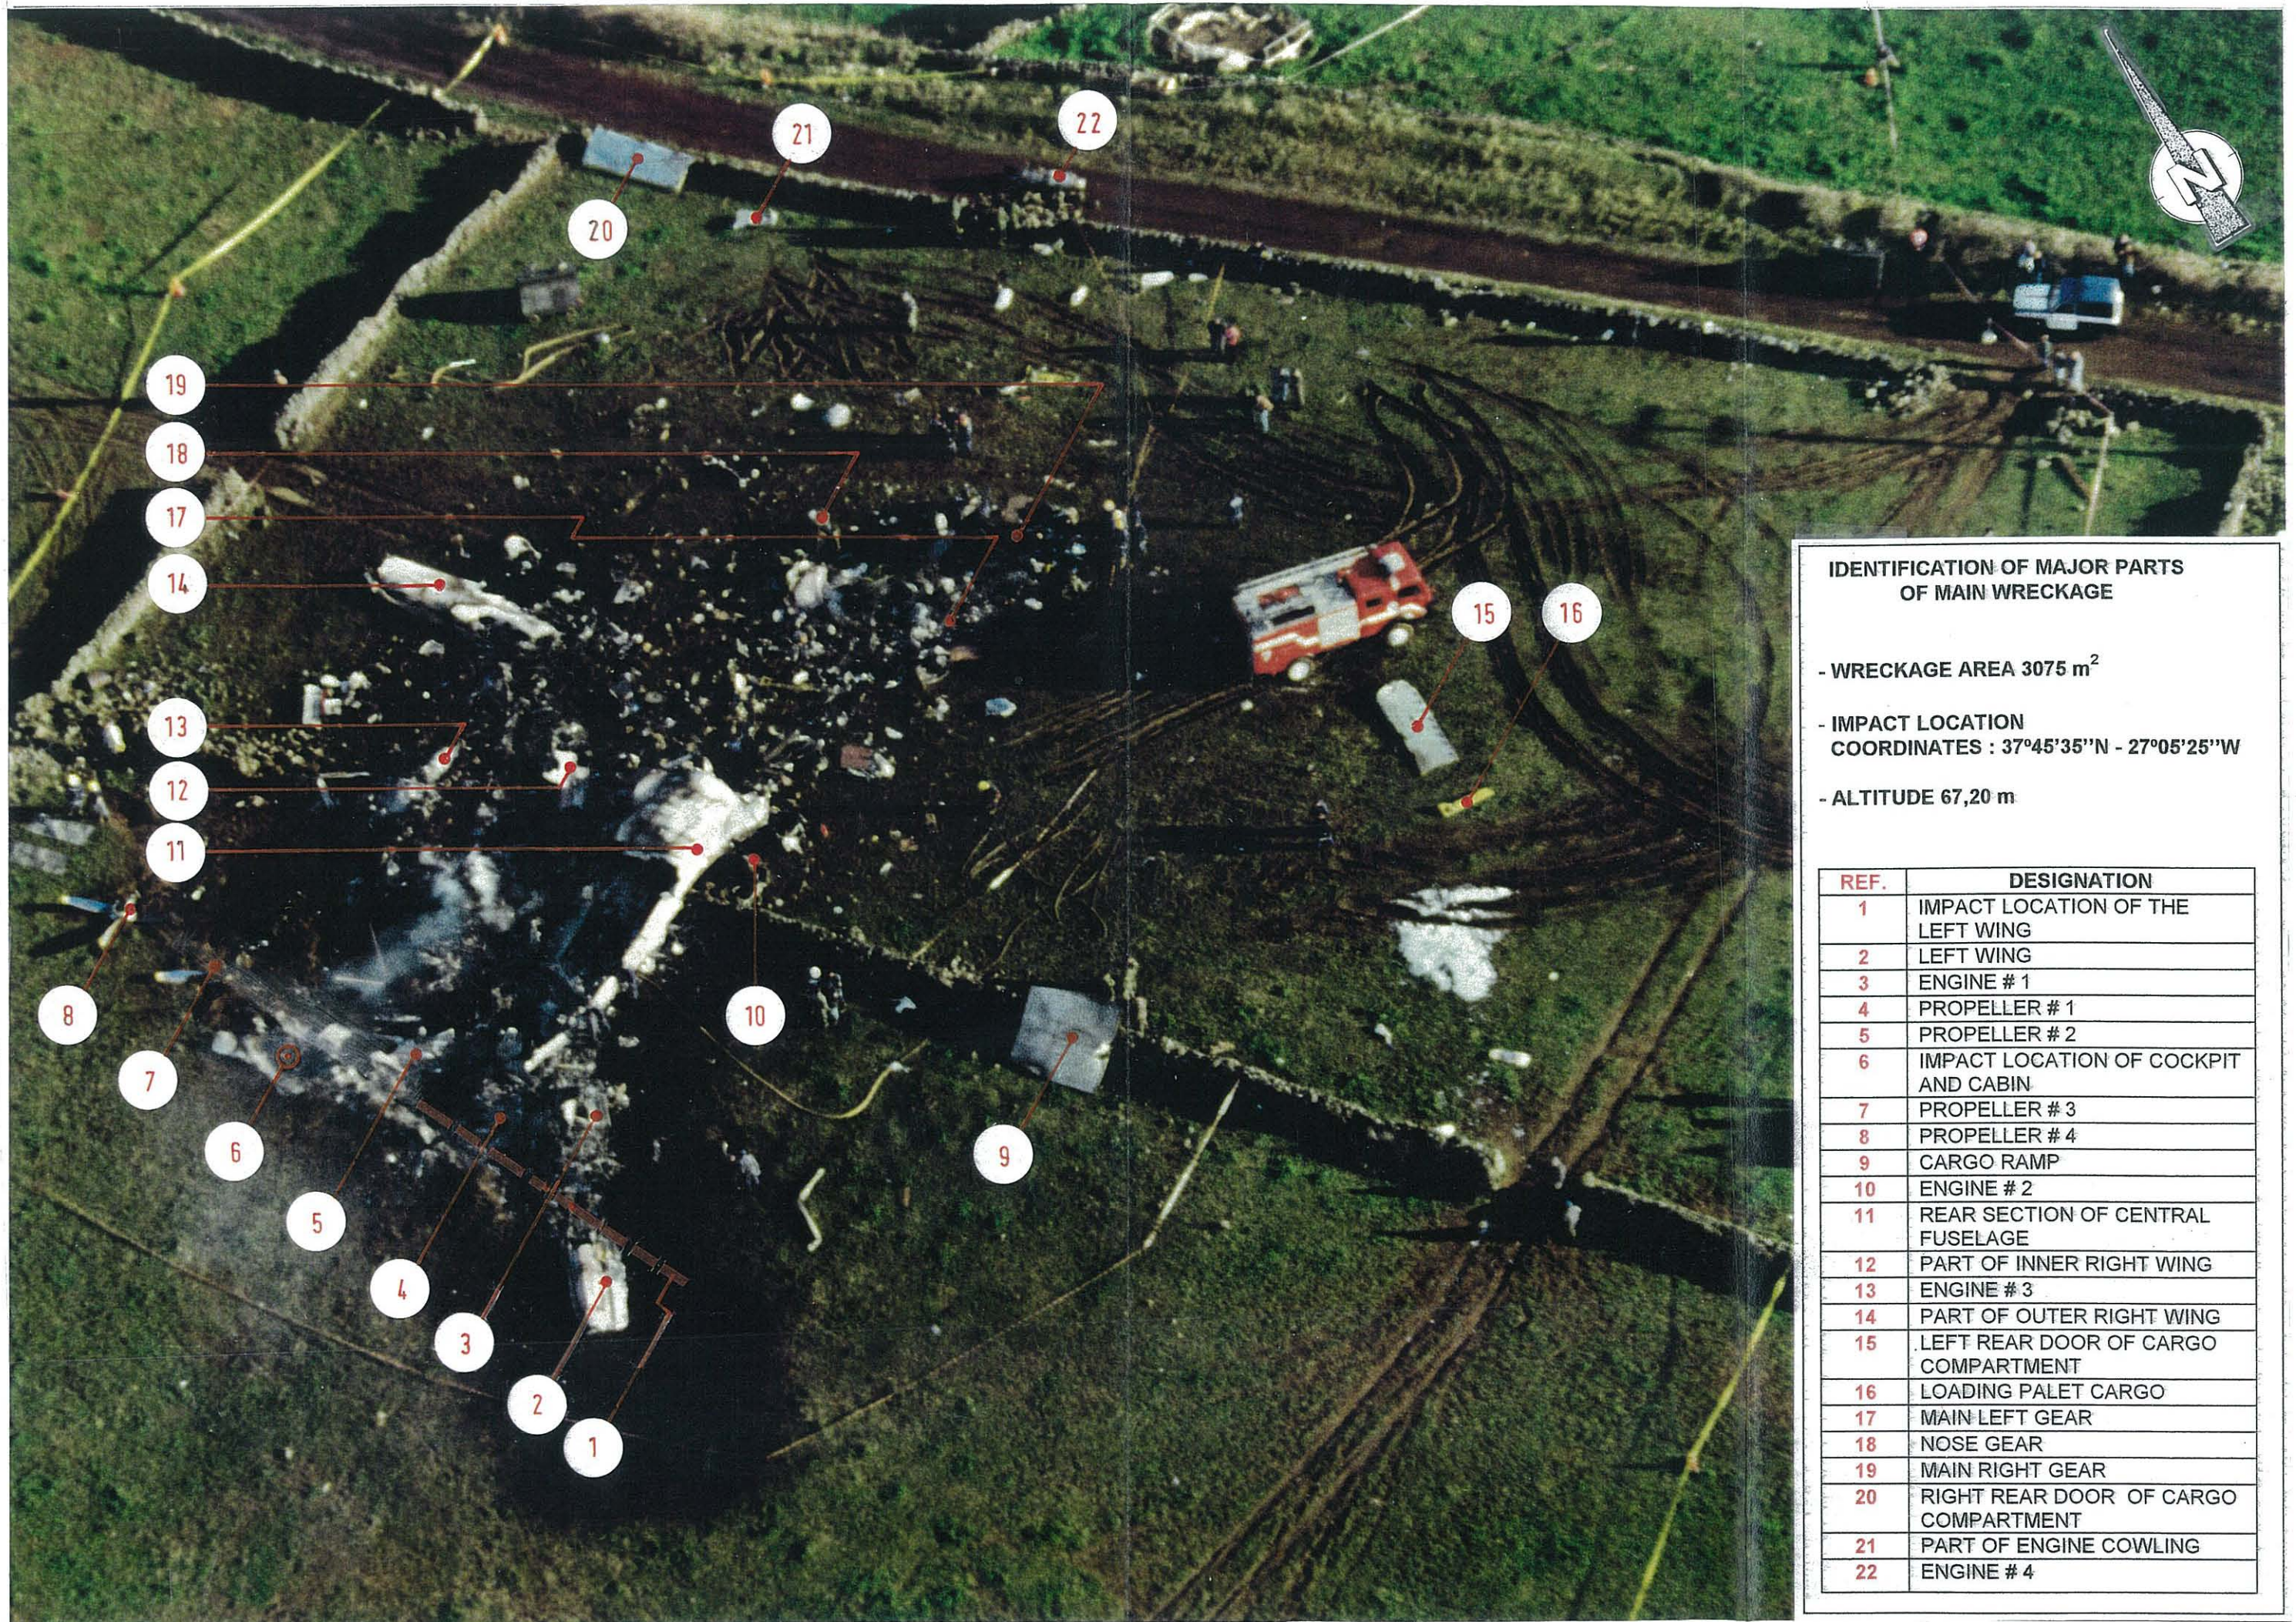
**IDENTIFICATION OF MAJOR PARTS OF MAIN WRECKAGE**

Engine #1 and the left wing were found to the right of the place of first impact and in the direction 360°. Propellers #1 and #2 were found on the place of initial impact buried into the ground and covered by debris.

Ahead of the site of impact and in the direction 070°, part of the rear section of the central fuselage was found over a stone wall in a downward position with its forward part oriented to 070°.

Engine # 4 was found on a road 52 meters away from the initial impact site and near the stone wall of the yard.

Engine #3 was found near the two sections of the right wing and oriented in the direction 220°.

Propellers #3 and #4 were found to the left of the impact point, half buried and with the blades feathered.
