AVIATION INVESTIGATION REPORT

A98P0303

CONTROLLED FLIGHT INTO TERRAIN

CESSNA 208B CARAVAN N9352B

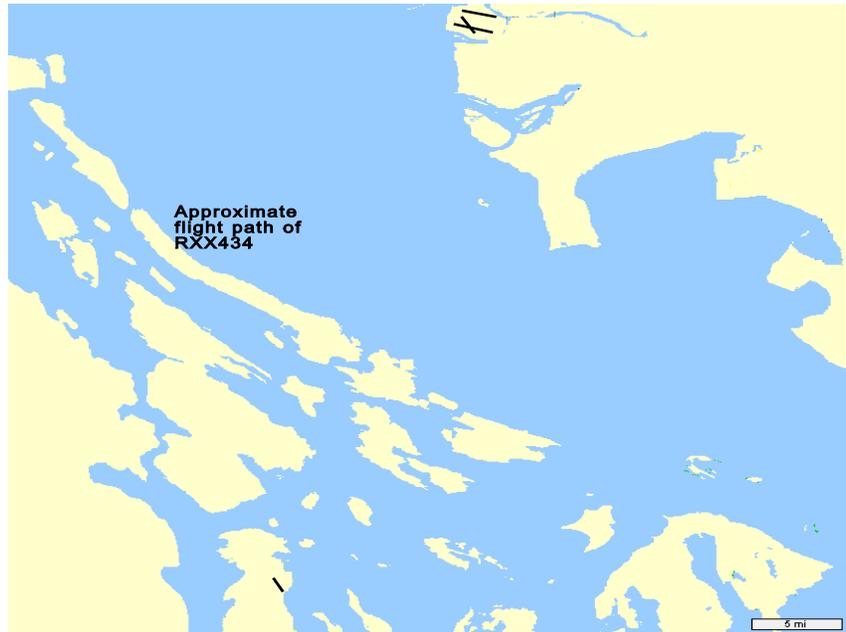
As the aircraft approached Active Pass, the crew made a radio call to inform any traffic in the Victoria area of their intention to join left-base for a landing on runway 09 at the Victoria airport. Several minutes later, the crew made a second report indicating that they were 10 nm back, for a landing on runway 09. The last position report was made as they approached Beaver Point, at the south-east end of Saltspring Island. Recorded radar data then showed the aircraft made a noticeable turn to the right, in the vicinity of Beaver Point, and began to track towards high ground north of the Victoria airport (solid line depicted on Figure 1).

At 0026, the aircraft began a gradual, descending turn to the left onto a south-easterly heading, before striking trees near the peak of Mount Tuam on the southern end of Saltspring Island. Information gathered at the crash site indicates that the aircraft was in level flight when it first contacted the trees and that its flight path was lined up with the east side of the Victoria airport (dotted line depicted on Figure 1).

The debris trail was 400 to 500 feet in length, orientated on a magnetic bearing of 123 degrees, and was in line with the east side of the Victoria airport. (See dotted line on Figure 1.)
