*Accident
on 2 May 2000
at Lyon-Satolas (69)
to the Learjet 35A
registered G-MURI
operated by
Northern Executive Aviation Ltd*

REPORT
g-ri000502a

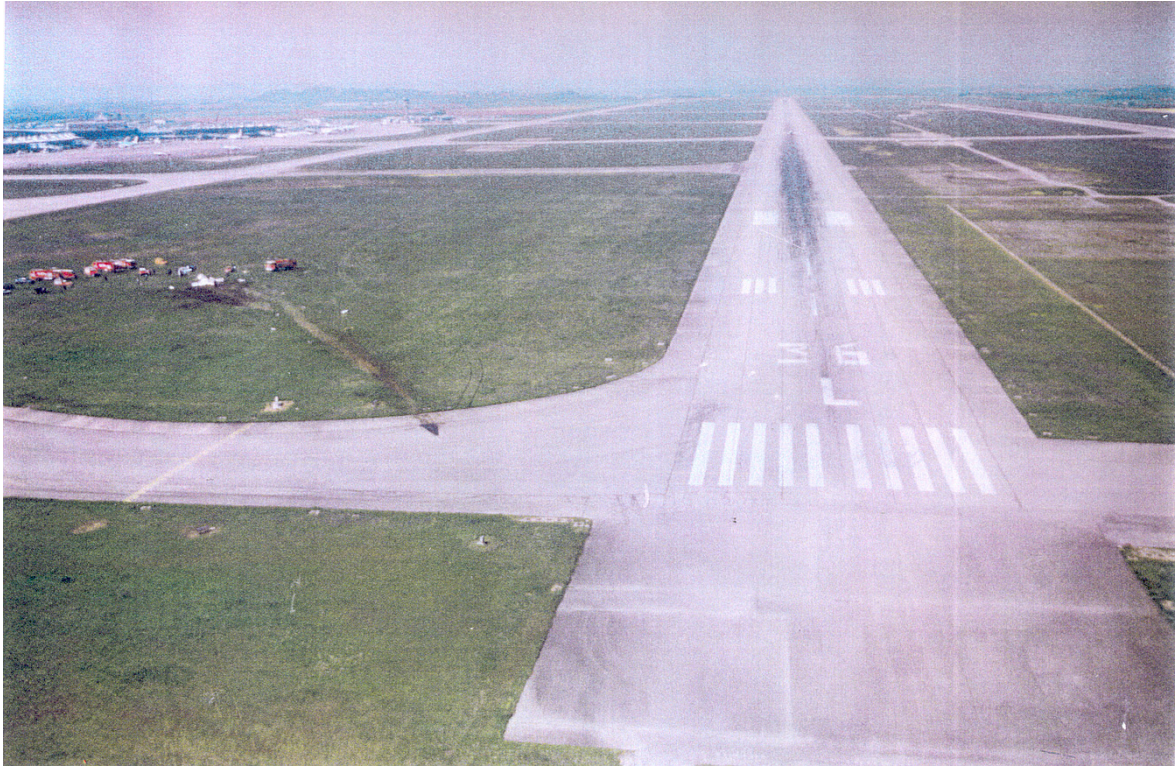
Aerial Photo

Many pieces were spread out on the ground from the point of impact up to the main wreckage: debris from the left wingtip tank, windshield fragments, and various parts of the cockpit.

The seats from the cockpit were found to the right of the main wreckage: the left seat was about ten metres away while the right seat, whose back was separated from the seat, was at the base of the main wreckage.

The front of the fuselage was destroyed. The fuselage was damaged on its lower side. The ventral fin was torn off the aircraft. The cockpit was completely crushed and was only attached to the fuselage by some pieces of floor and electrical wires. A piece of the cockpit ceiling was hanging off the right side of the airframe.

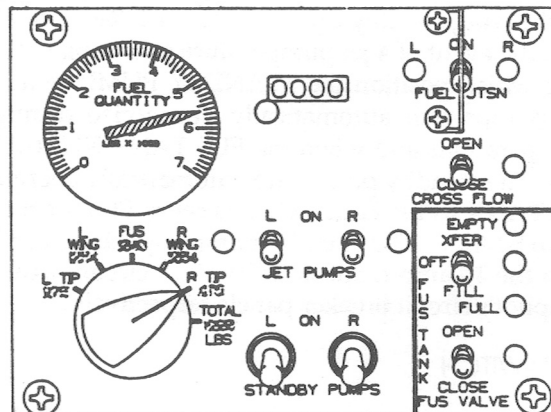
Illustration of the fuel management panel

The Learjet 35A's fuel system includes two wingtip tanks with a capacity of 1,150 lb each and a fuselage tank of 1,340 lb. Fuel consumption occurs through transfer from the wingtip tanks to the wing tanks. Transfer from the fuselage tank to the wing tanks normally takes place by positioning the TANK XFER-FILL switch on the XFER position. The wing tank crossfeed valve opens and the transfer pump begins to operate. During this activity, temporary illumination of an amber light on the fuel control panel indicates transit to the appropriate operating position. Permanent illumination indicates that the valve is not in the selected position.

The positions noted on the valves, fuselage transfer open and cross-feed closed, allows two hypotheses to be considered to determine the fuel balance. Either these positions resulted from a malfunction leading to incorrect positioning of the cross-feed valve during the transfer procedure, or the incorrect positioning of this valve resulted from the impact.
