*Accident
on 25 May 2000
at Paris Charles de Gaulle (95)
to aircraft
F-GHED operated by Air Liberté
and
G-SSWN operated by Streamline Aviation*

REPORT

This report presents the technical conclusions reached by the Bureau Enquêtes-Accidents on the circumstances and causes of this accident.

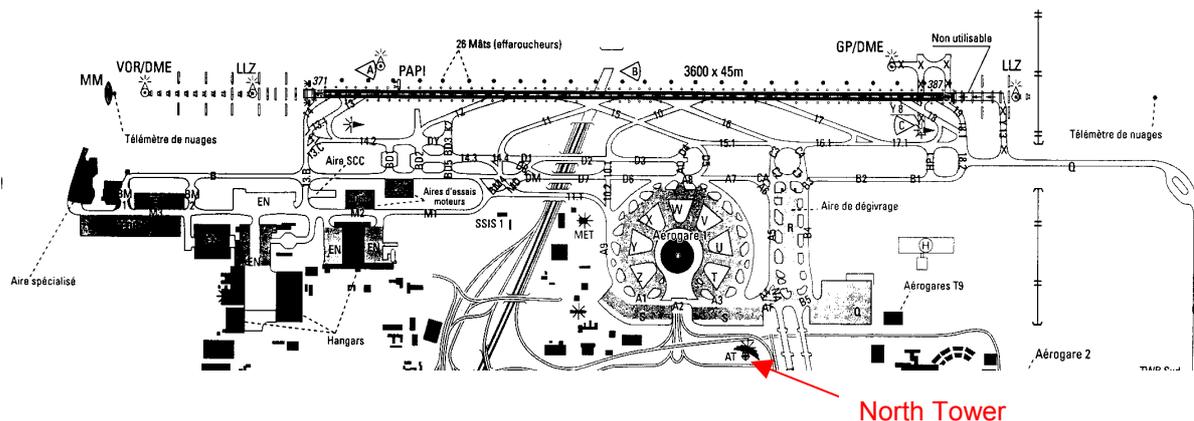
Runway 09/27 was handled by the North control tower situated at a distance of 1,800 m from runway threshold 27 and 1,450 m from the crossing point between emergency access taxiway 16 and the runway (there is a second South tower, which was not in service on the night of the accident). The tower is 82 metres high.

Observations made by the accident investigators showed that, at a height corresponding to that of the Shorts 330 cockpit, there were no fixed obstacles blocking visibility of the runway threshold from taxiway 16.

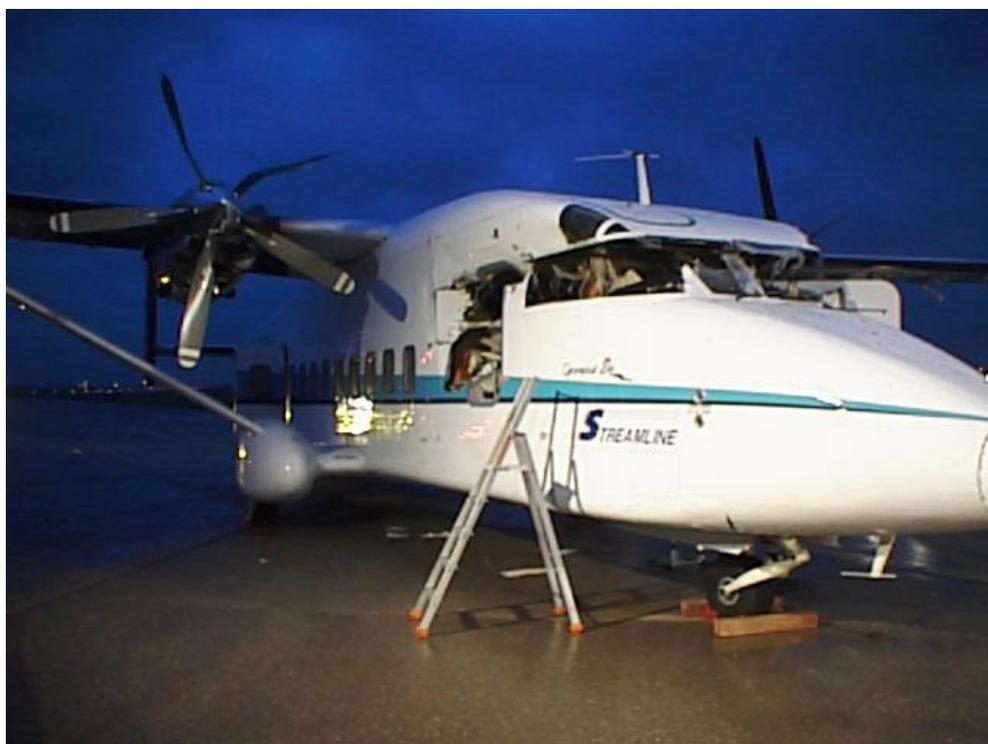
On the starboard engine nacelle, the lower part of the cowling was damaged, and the air inlet situated 2.8 meter from the ground was torn and pushed upwards. Two of the propeller blades were damaged. The propeller cone was undamaged.

The point of impact with the cockpit was situated above the window line, approximately fifty centimetres to the rear of the right-hand forward door frame. This door was torn off and pushed to the inside of the fuselage. The opening

Inside the cockpit, the seat backs were not damaged. The MD 83 wing cut through the central column located between the two seats. It then cut into the left-hand side approximately fifty centimetres into the back of the rear left side window. The windscreen was broken and its uprights cut through.

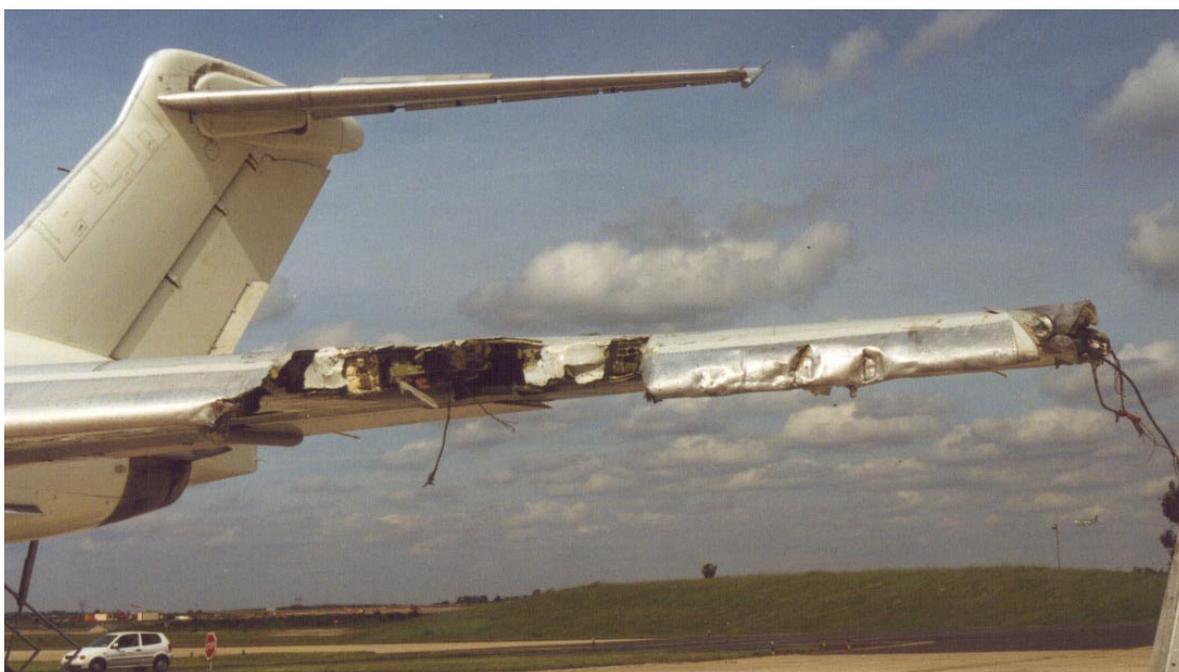
The tip of the left wing was missing and the last rib was almost completely in place. The wing tip, found on the ground, bears traces of white paint and marks from the rivet heads on the brace of the Shorts 330.

The wing leading edge is equipped with five slats. The outside slat was damaged: it was torn and the section situated 1.30 to 2.35 m from the last rib was missing. A large piece of this slat was found on the runway. Under the damaged slat, there were two pulleys with two cables broken under load, and shearing due to the impact. The two cables were connected to the leading edge slat control.

The end of the upper wing surface bore the mark of a propeller blade impact. The trailing edge was slightly damaged in the wing sweep area. This section of the wing does not have any flight control surfaces.

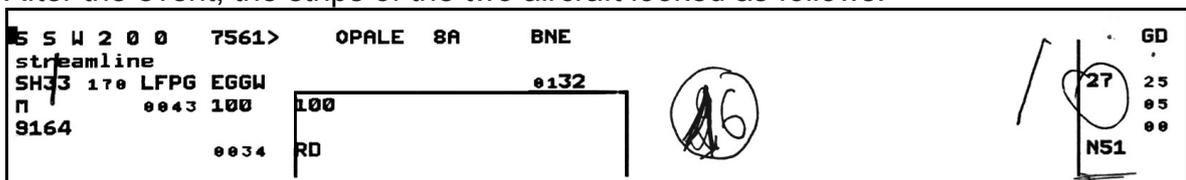
Shorts Strip

The Shorts strip was not processed specifically. It was transferred to the LOC controller without co-ordination or any special mention.

After the event, the strips of the two aircraft looked as follows:

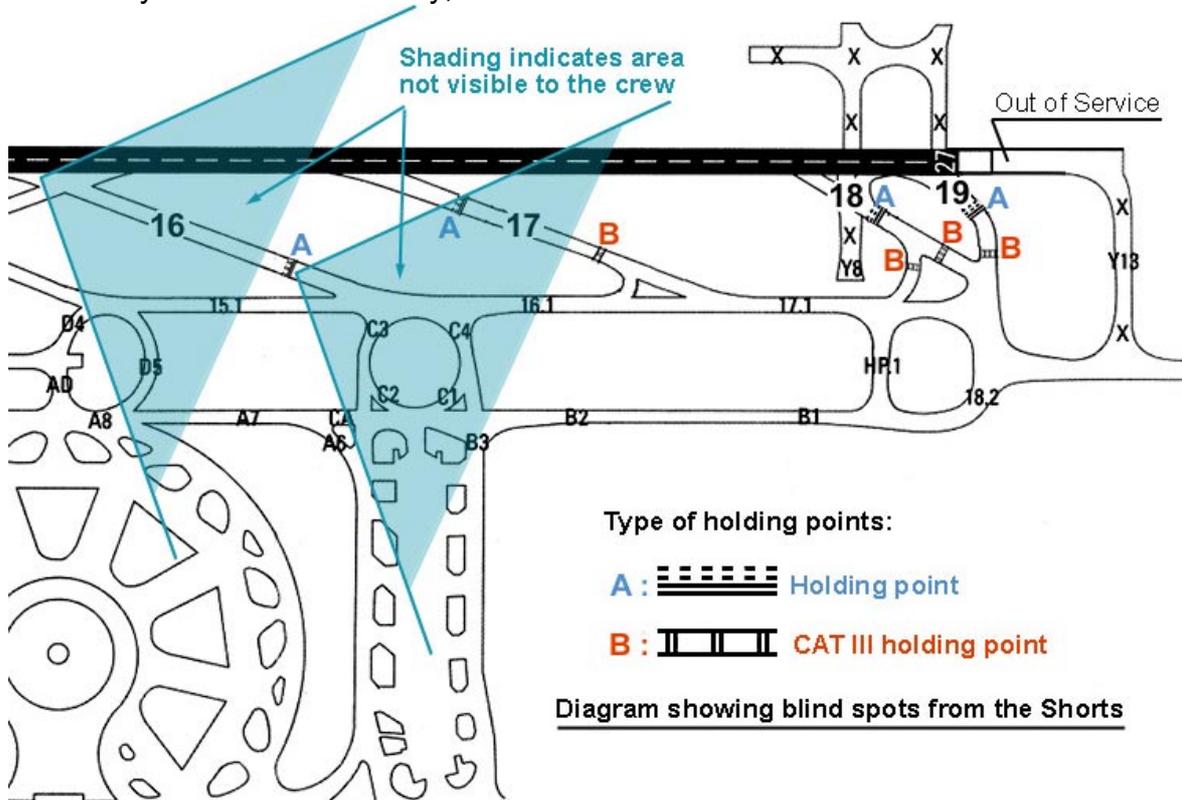
Before lining up it is usual for a pilot to perform a visual check to ensure the absence of any traffic on final or on the runway. However, taking into account the vision angles and the orientation of taxiway 16, the crew of the Shorts could not at any time have been in visual contact with the aircraft taking off. They could only have seen it after a right turn of at least 60°. Because of this, they could not check for the absence of aircraft before entering the runway. While looking for aircraft “number one”, they nevertheless tried to carry out a final check, but this was done when they were on the runway, and was thus too late.

Lining up from a high speed exit does not allow a crew to observe the upper end of the runway. Since they cannot, as a result, note the possible presence of an

aircraft landing or on the takeoff roll, a safety factor is eliminated.
