Aviation Safety Council

Accident Investigation Report

ASC-AAR-00-11-001

MD-90-30 cabin explosion and fire

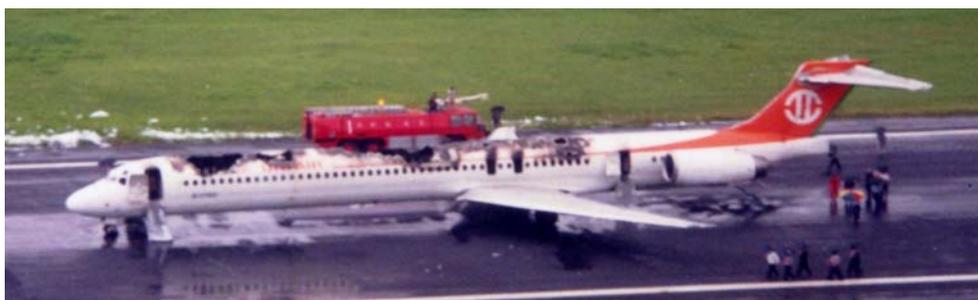
Of the 4 holes found on the fuselage, 3 were located on the left side. One was located in the front section (a large opening of 337.82cm in length), another was between rows 5~7 (a longitudinally hole of 144.78cm in length that is ripped off along the rivet line), and the third was on the rear part of the aircraft (an opening of extended space measuring 1320.80cm in length). The one hole fused out on the right side of the fuselage was found between rows 7 and 9 and above the *UNI AIR* insignia. Fragments of the keel beam, over the 7th row on the left side, were found among the debris scattered about the end of the runway. (See Pictures 1.12-1 and 1.12-2)

Fig. 1.12-1 The damaged aircraft (left side)

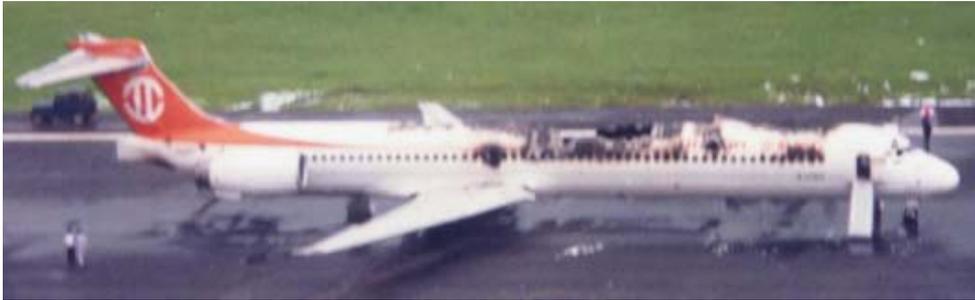
Fig. 1.12-2 The damaged aircraft (right side)

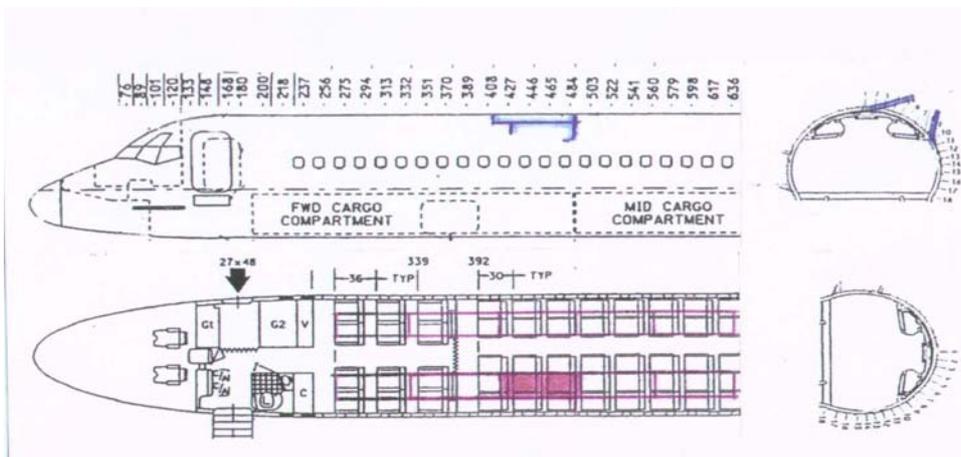
The area of the explosion is found between frameworks FS408 and FS484 of the fuselage. A sectional view shows that the explosion covered the longitudinal beams 1 through L10 on the left side, right above the carryon luggage bin over rows 5, 6 and 7 on the left side, as shown in Fig. 1.12-3.

Fig. 1.12-3 Layout of the explosion area

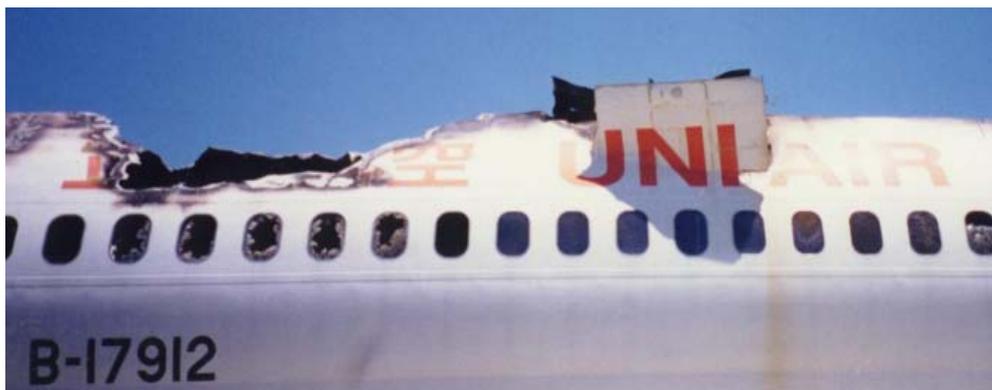
An area of ripped-off skin, within the explosion area, demonstrates an opening along the rivet perforation. Both cracks pointed upwards from the rivet perforation line, and tend to aim towards the lower left side. Also, the crack located on the left framework FS.484 stretches from L6 to L10 (some 56.9cm) and the crack on the left framework FS.427 develops from L6 through L9 (approximately 40.7cm). A part of the skin along the rivet perforation and the mid-upper section shows missing paint (indicated by the arrow, in Picture 1.12-4). The structural drawing of the aircraft shows that the ripped-off skin is located above the overhead carryon, bin above rows 6~7.

Fig. 1.12-4 The ripped-off cover

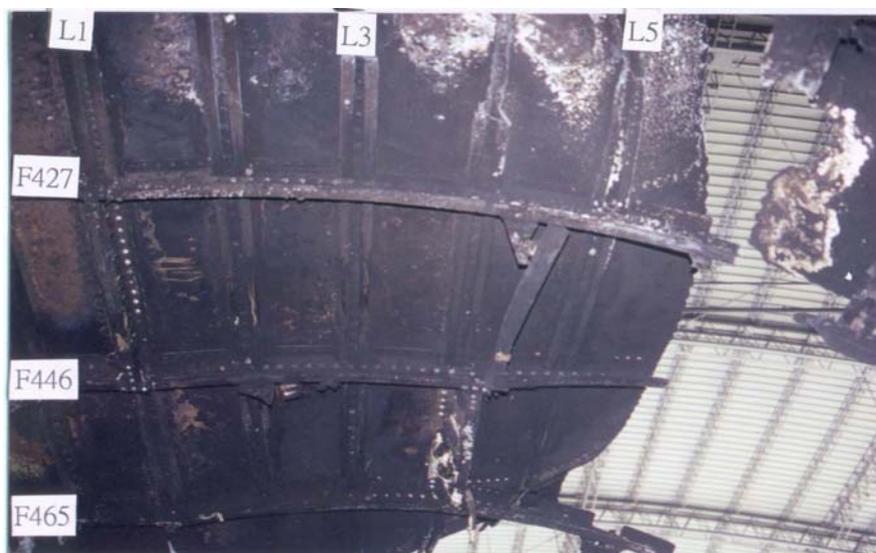
All FS.408, FS.427, FS.446, FS.465 and FS.484 frameworks of the fuselage and the 8 sections of the keel beam ranging from L1 through L8 were severely damaged by the fire. The explosion ripped off the skin along the rivet perforation of section L6 of the keel beam, with extension toward the top and the side. Section L6 of the keel beam (FS.408 through Fs.484) broke off in the explosion. The lining cover of the inner structure in the vicinity of fuselage frameworks FS.408 and FS.427 was also torn off from L6 through L13, displaying the deformed skin and the bent

section of the keel beam. Sections L4, L5 and L6 of the keel beam broke off at FS.408. (Picture 1.12-5)

Fig. 1.12-5 Ripped-off structural skin in the vicinity of the framework

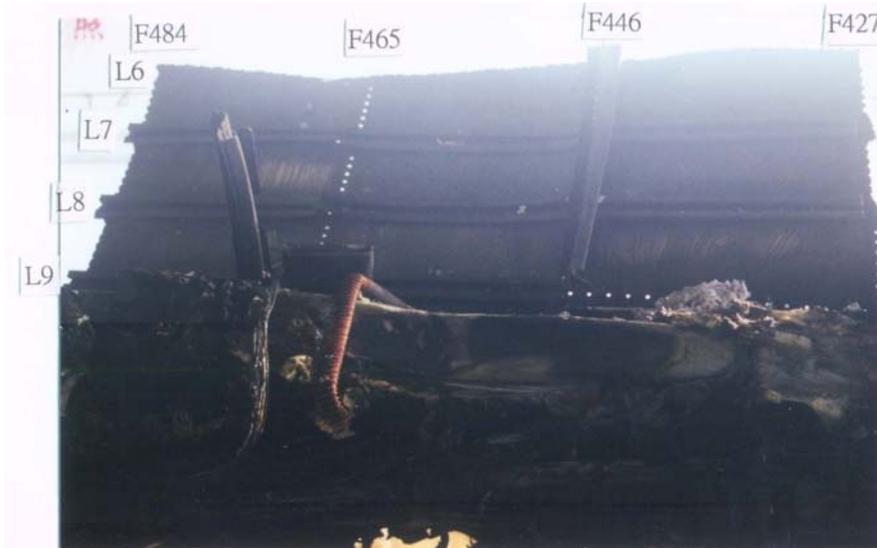
1.12-7 shows how the condition of the air duct as seen from the outside. There is a large burnt area from the bottom to the top.

Fig. 1.12-7 Damaged air duct showing burns from the bottom to the top

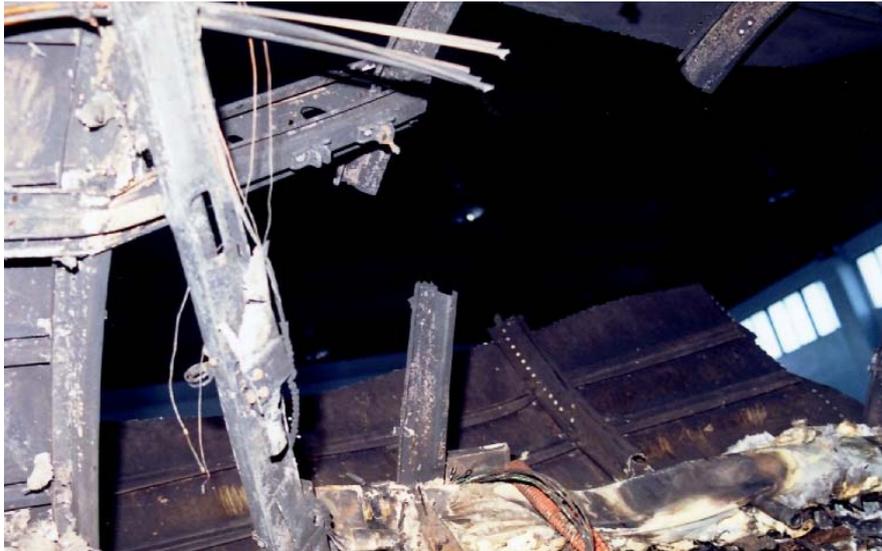
Fig. 1.12-8 Breaking point of the longitudinal beam

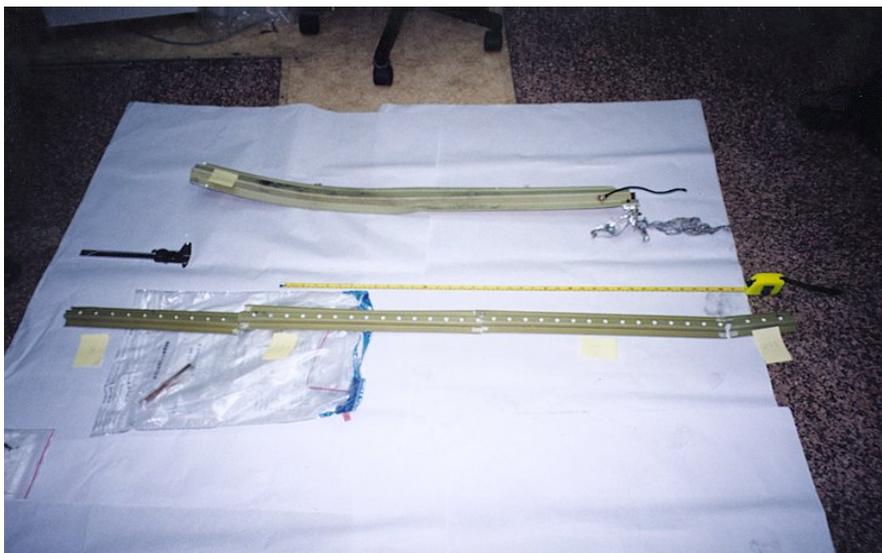
Fig. 1.12-9 Fragments of longitudinal beam and bin rail tie rod found on the runway (showing no burn signs)

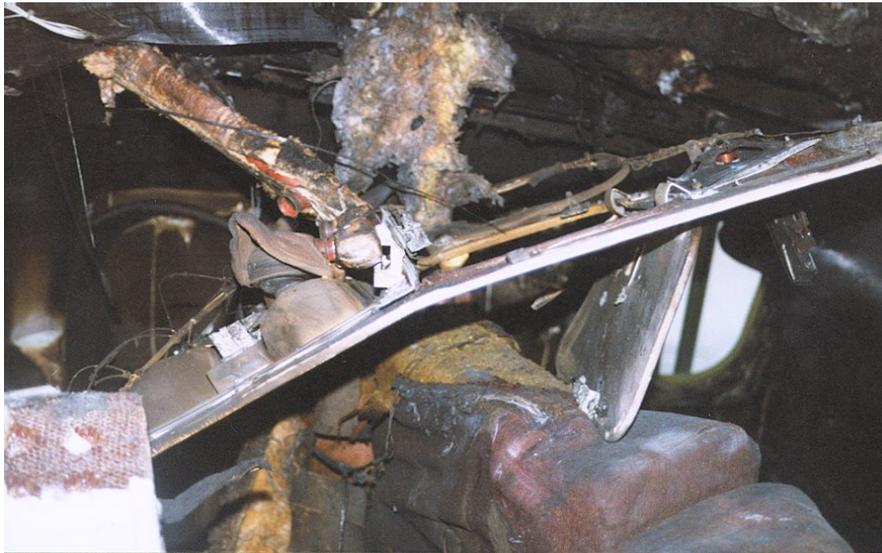
Attached to the air conditioning duct, though it has been split into 2 pieces was found fallen on the seats in row 6 (Fig. 1.12-13). Another PSU was found on the seats in row 5, showing no visible smoke marks or burns.

Fig. 1.12-13 Condition of the PSU

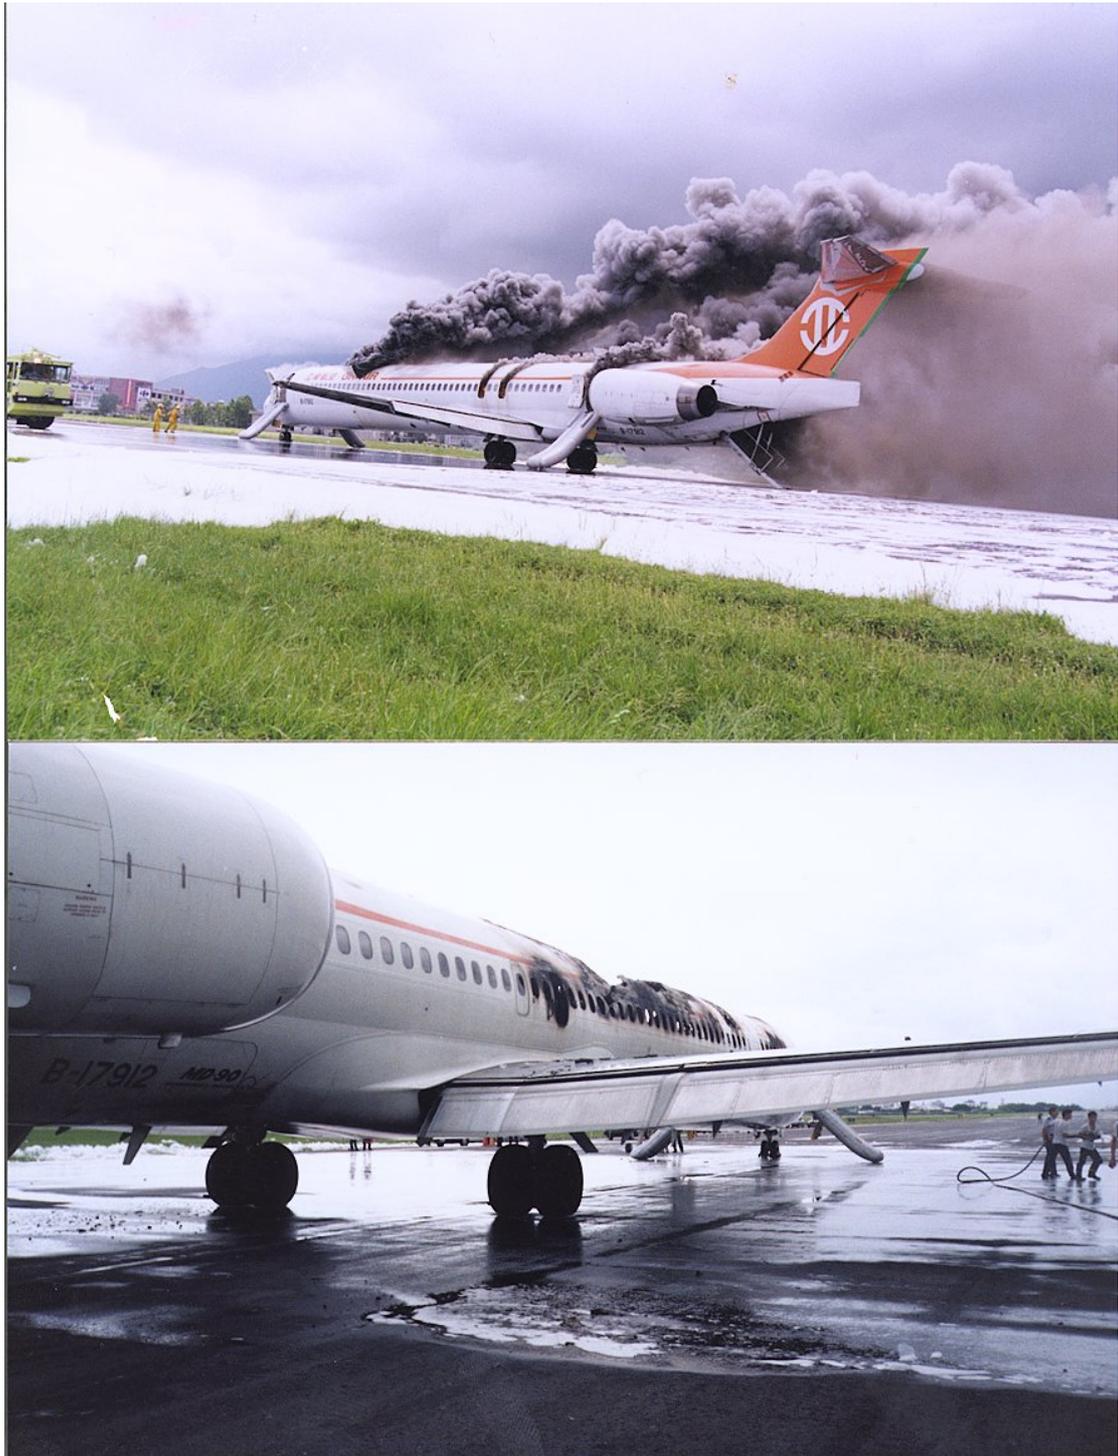
The 3 emergency exits L1, R1 and L4 remained unaffected by either smoke or fire. The 3 overwing hatches on the right side, L1, L2 and R1, were found open. Only one hatch was found on the seats inside the aircraft, while 2 others were missing. The R3 overwing hatch was not open (Fig. 1.12-14).

Fig. 1.12-14 Overwing hatches on the left and right (R3 is not open)

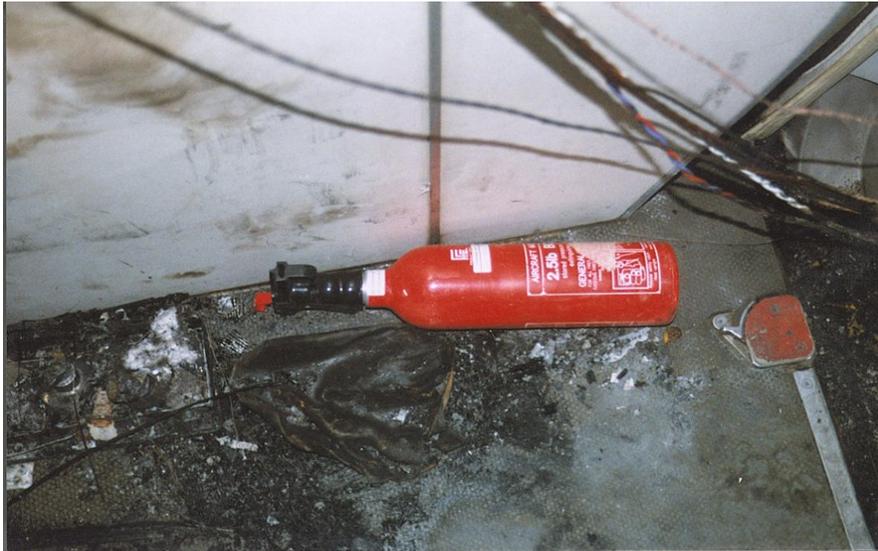
The labels on the equipment indicated that all the emergency equipment remains effective. The fire extinguisher located behind the rear of the co-pilot was found to have been used and was discovered near the L1 door (Fig. 1.12-15). The fire extinguisher in the doghouse behind row 37 was not used and was found in the aisle near the passenger seat in front of the L4 exit. The emergency equipment in all other doghouses was found in its original position, and found to have not been used. A melted speaker was found on the floor, beneath its original position. The evacuation indication light was found on the floor burned beyond recognition.

Fig. 1.12-15 A used fire extinguisher

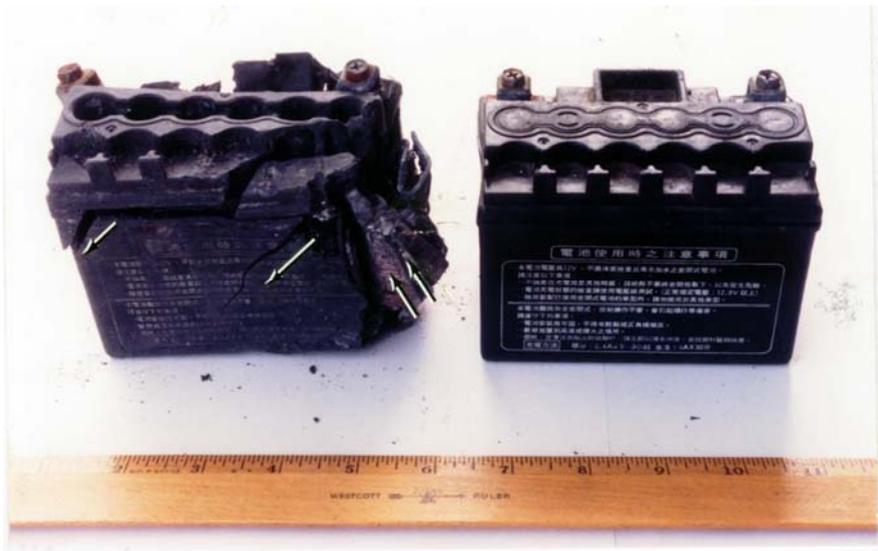
Fig. 1.14-1 On the left is the battery found under seat 5C. An intact battery of identical type is shown on the right.

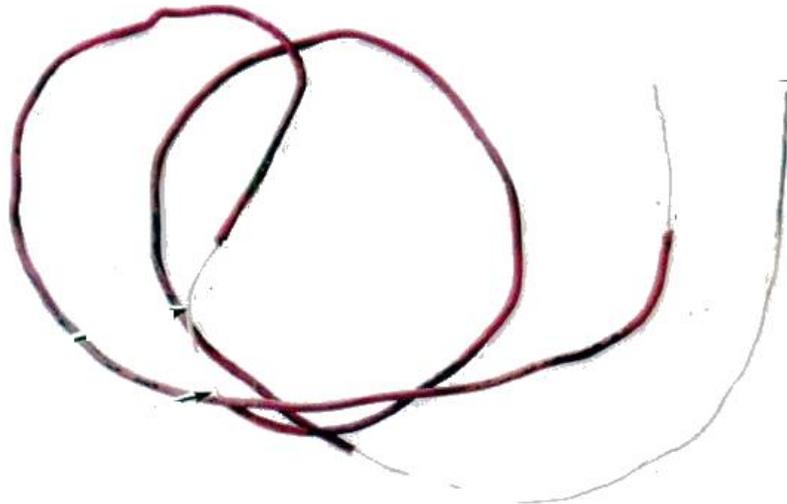
Fig. 1.14-2 The mono-core metal conductor of evidence No. 219

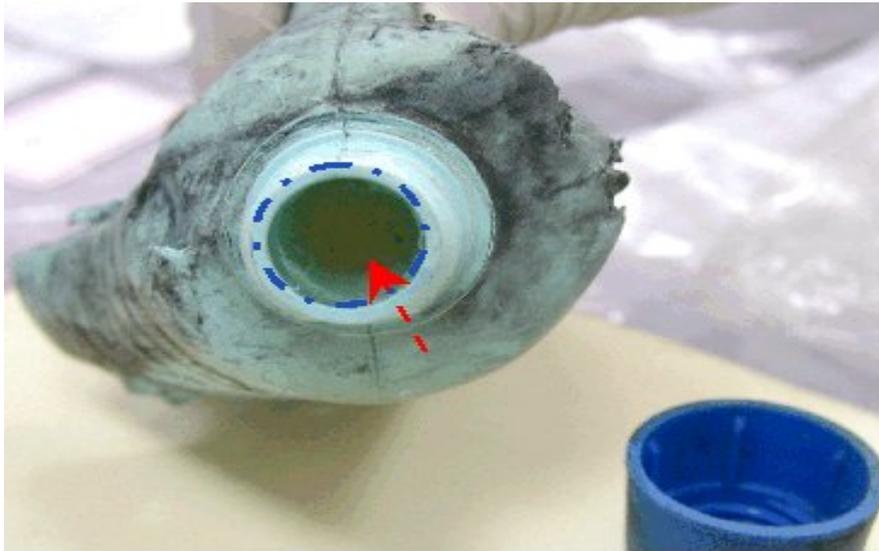
3. Evidence No. 219, found on the runway, and evidence No. 585, found on the floor under seat 7C of the main cabin, both belong to the upper part of the blue-colored bottle containing bleaching liquid. Soft and semi-transparent material is located on the inside of the bottle's neck and gasoline was detected on the inner wall (Fig. 1.14-3 and 1.14-4).

Fig. 1.14-3 A view from the mouth to the bottom of the bottle, semi-transparent material evident on the neck of evidence No. 210.

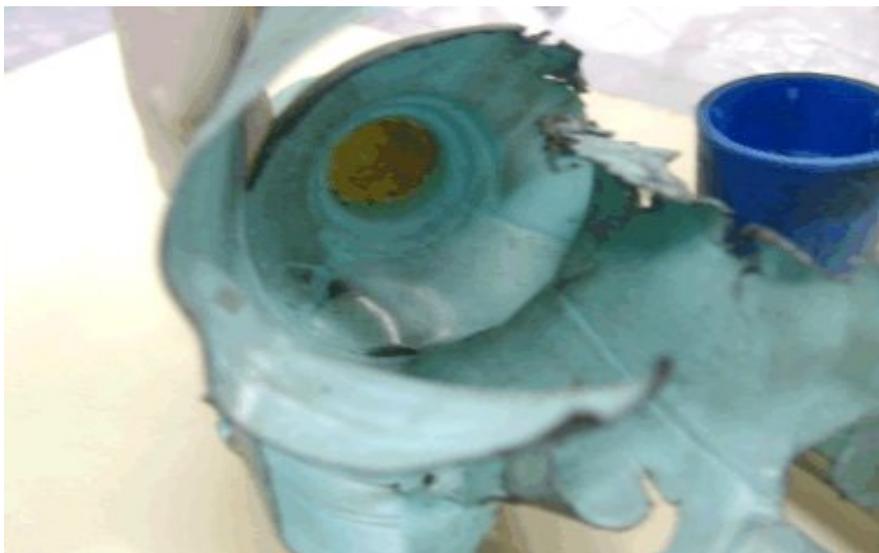
Fig. 1.14-4 A view from the fractured bottle opening, evidence No. 585 showing semi-transparent material.

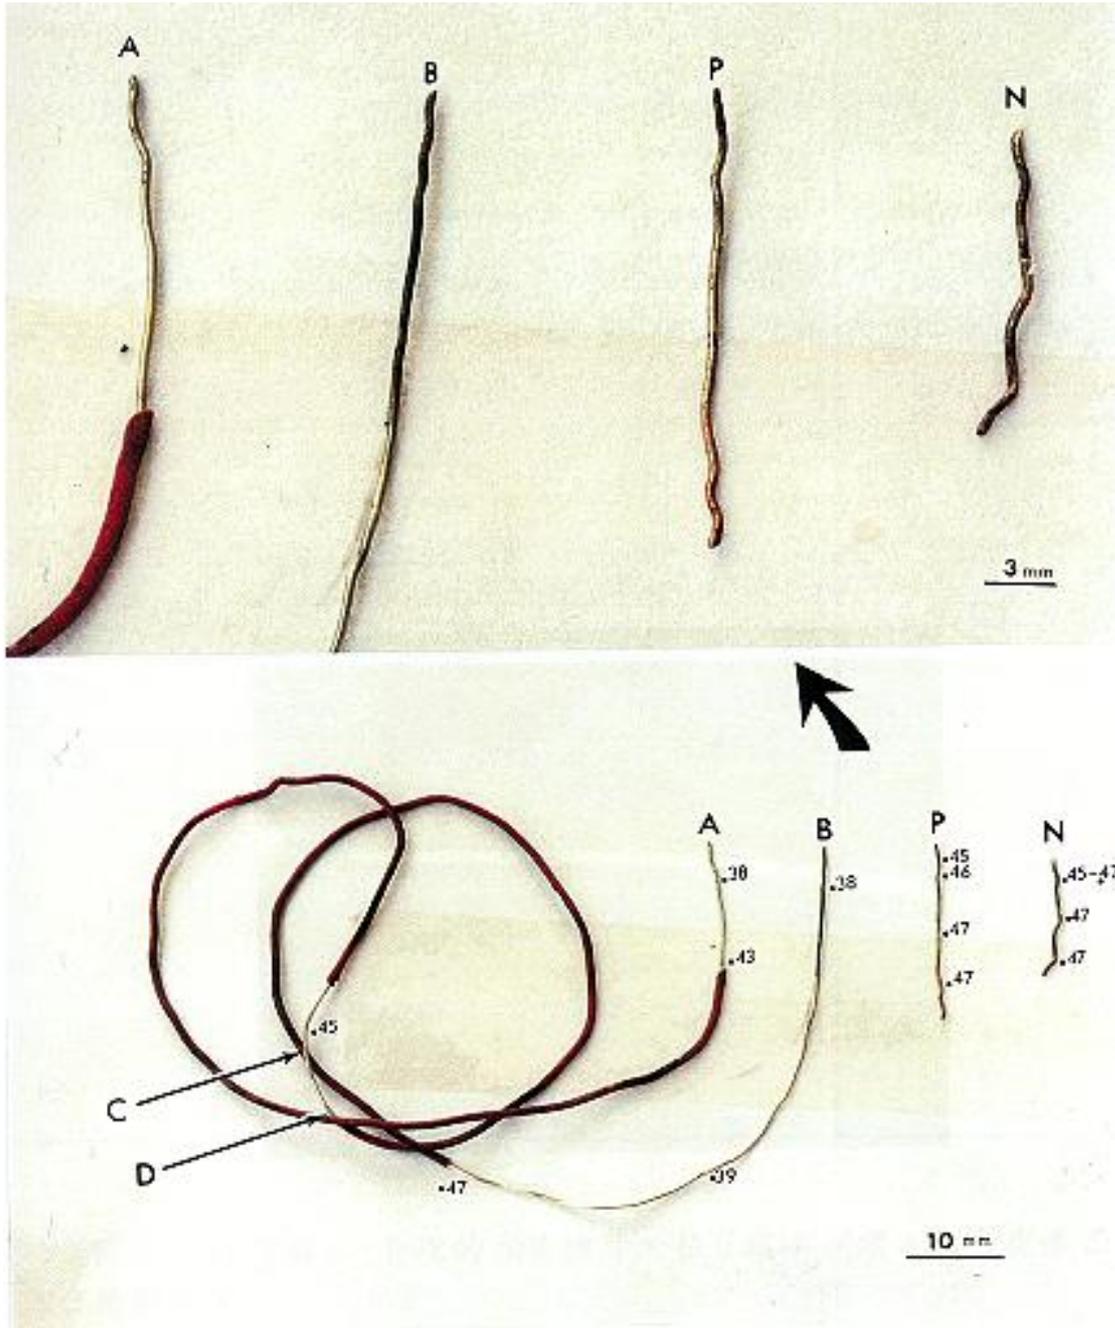
- 1) The tests demonstrate that the wire gather from the runway is the same material as the two wires connected to the positive and negative battery terminals. It is a round copper wire 0.47 mm diameter between AWG#24 and AWG#25.
- 2) The broken wire from the runway has one end that appears to be the same as that of the negative wire. The contaminated fracture surface of the negative wire is difficult to verify the both wires have identically connection.
- 3) Melting, burns and discolor at the P end of the positive wire suggests that there was a short circuit and arcing before the battery was destroyed.
- 4) The simulation demonstrated that connecting the two terminals with one copper wire would create a short circuit or arcing and melt the contact.

Figure 1. The mage of the three wires and their diameters. From left to right, there is the #1 wire gathered from the runway, the battery positive and negative wire. Most of the plastic shields of the #1 wire are red and the others are charred black. The broken end of A, B, P and N wires are a silver color and others are a red brass. The B and P ends turned dark brown.

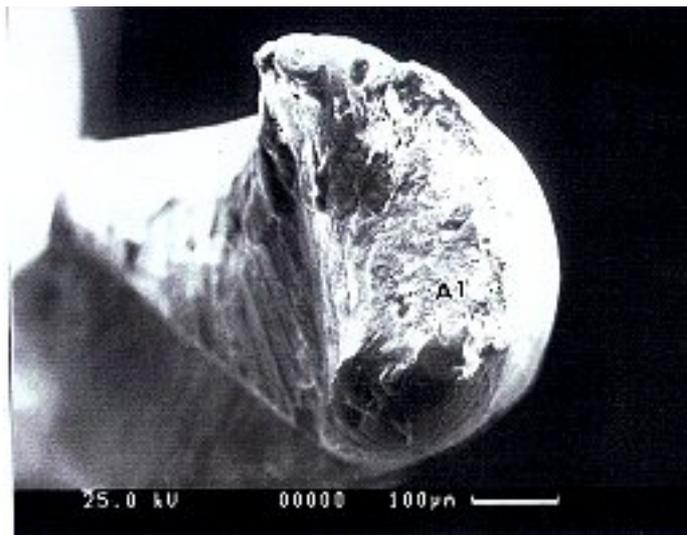
Figure 9. The SEM image shows A fracture surface of the #1 wire. The fracture surface is half-moon shaped with the left side squeezed into a spiral form.

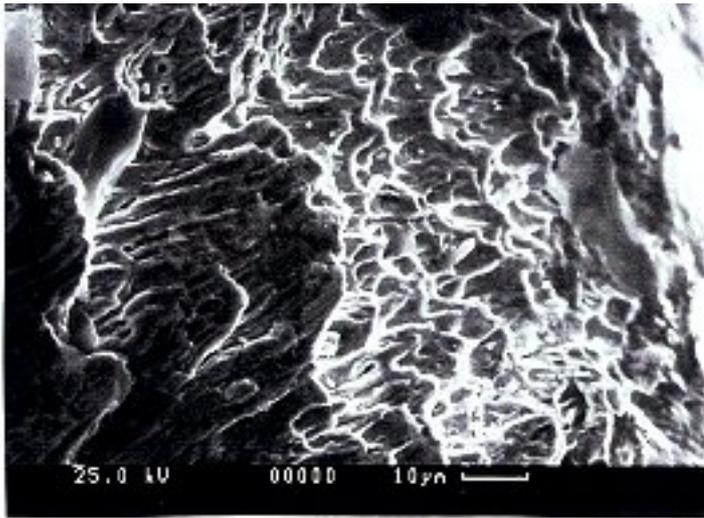
Figure 10. The SEM image shows the fracture surface of A1 in figure 9. The fracture surface is clean with sharp dimples, result by overstress.

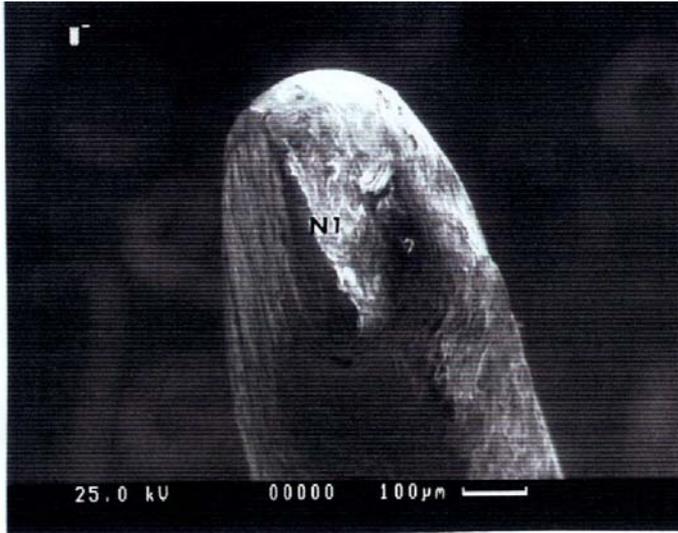
Figure 20. The SEM image shows the N fracture surface of the negative wire. The fracture surface shows it squeezed flat into an almost triangle form.

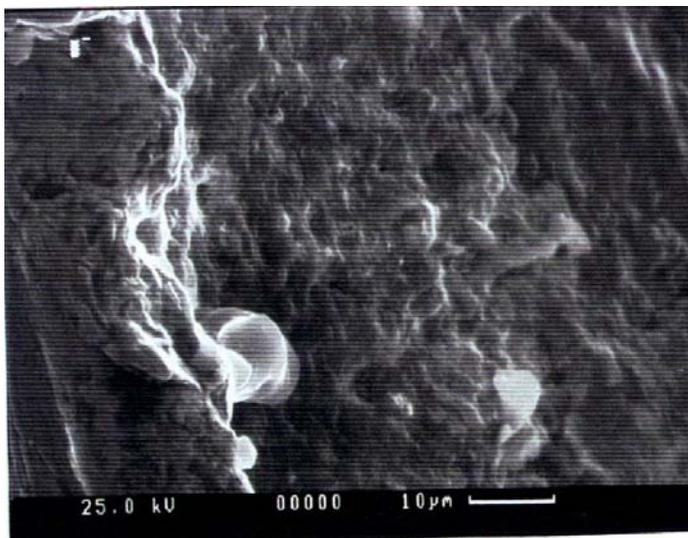
Figure 21. The SEM image shows N1 fracture surface in Figure 20. The fracture surface shows dimples, result by overstress.
