# **Investigation Report No. u1923**

to the aircraft Cessna C 500 Citation I/SP, EC-HFA

on 7 April 2003

at Zurich-Kloten Airport

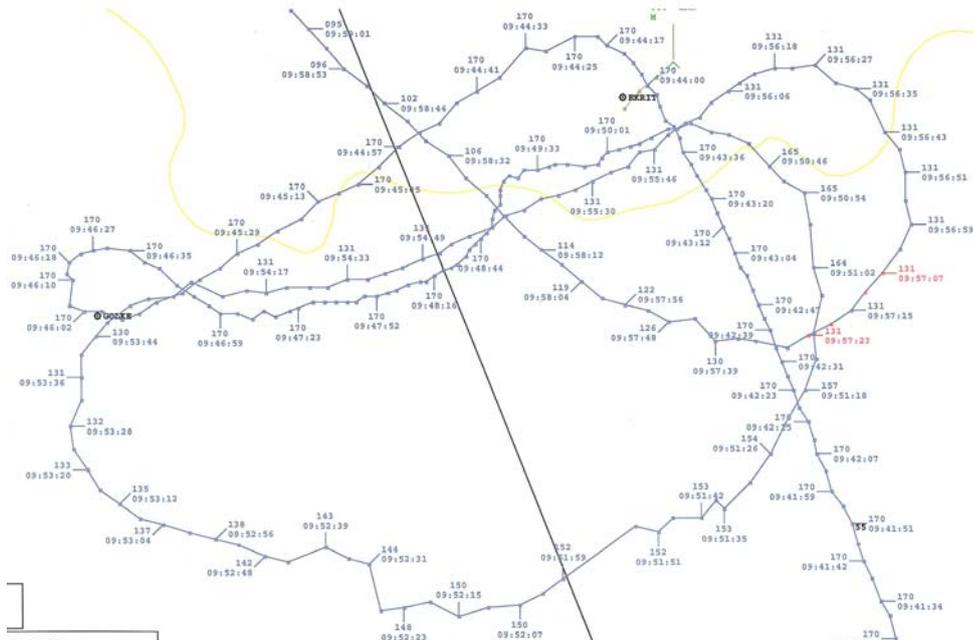
Annexe 3: EC-HFA radar recording, joining EKRIT

From the position which the aircraft was in at this point, the pilot should have joined the EKRIT holding pattern in accordance with a so-called parallel entry procedure (cf. Annex 4.2). As the radar recordings show, EC-HFA continued to fly the outbound leg for approximately one and a half minutes instead of 45 seconds and turned right instead of left in order to follow the inbound track 067° to EKRIT (Annex 4.3). According to the cockpit voice recorder (CVR) recordings, it was precisely in this phase that the pilot explained to his passenger during approximately five minutes how to join the holding pattern correctly. The subsequent holding patterns were flown with major lateral deviations in comparison with the published procedure.

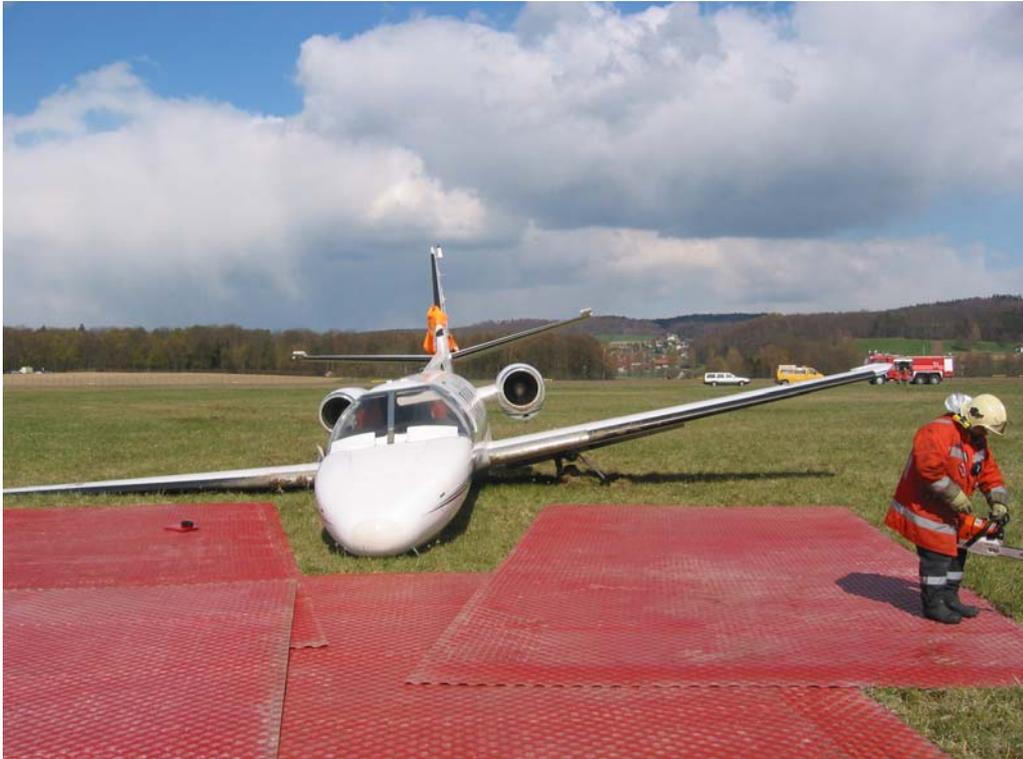
Annexe 5: Wreck of EC-HFA

The aircraft was badly damaged. The Cessna C 500 Citation I/SP touched down in landing configuration on the grass in front of runway 14. The aircraft veered to the right and crossed a minor road. In the process, the nosewheel and the right main landing gear were torn off. The aircraft then continued to skid over the ground on its right wing and the remaining left main landing gear and finally came to a standstill in front of the runway 16 PAPI (cf. Annex 4.5 and 4.6).
