**NATIONAL
TRANSPORTATION
SAFETY
COMMITTEE**

AIRCRAFT ACCIDENT REPORT

AN-72-100 ES-NOP

21 APRIL 2002

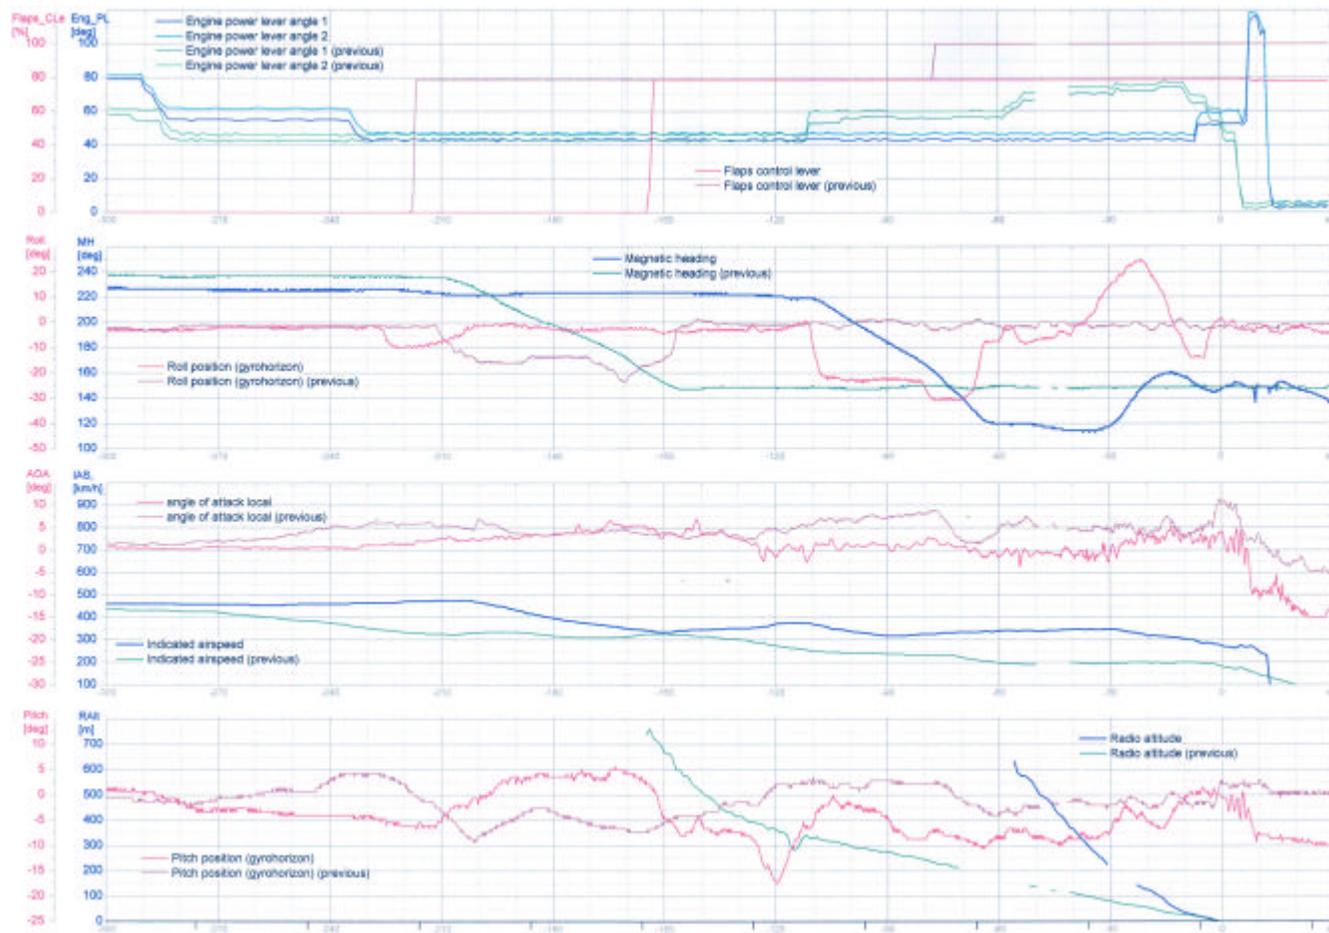
Fig. 3 An-72 ES-NOP flight parameters while landings at Wamena airport (Indonesia) on 21.04.2002.

Therefore, it can be concluded that the aircraft was over speed upon the accident landing. The FDR analysis also noted that the aircraft never fully deploy its flap due to over speed on final (see 0).

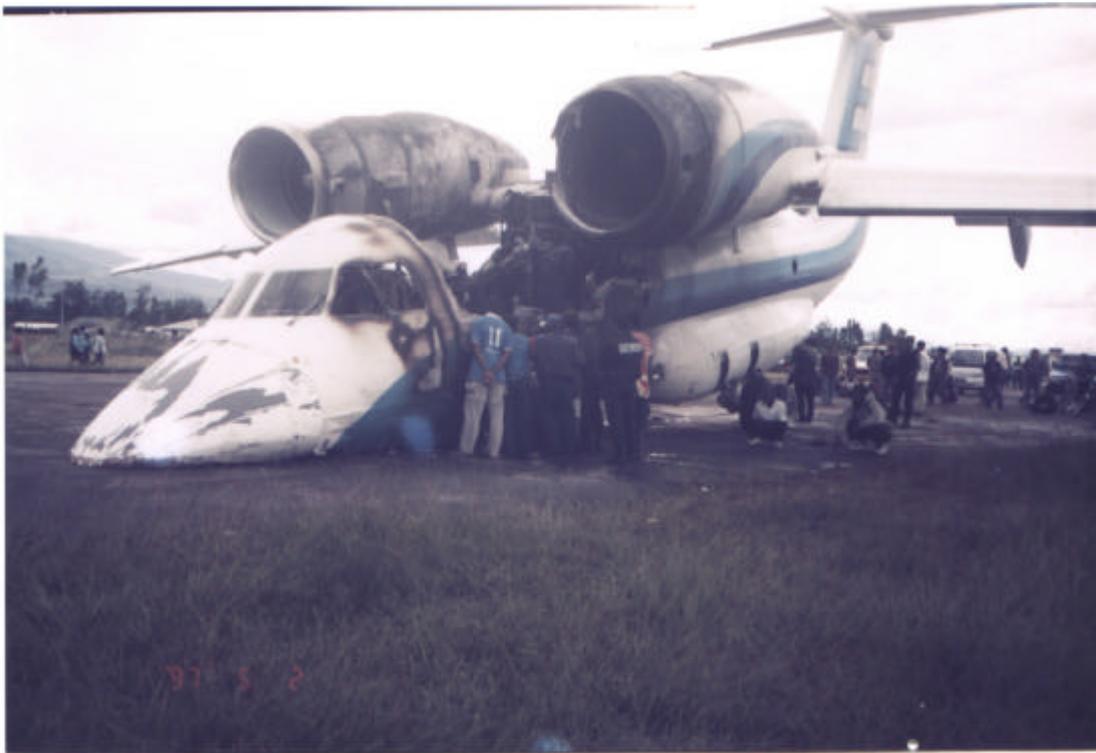
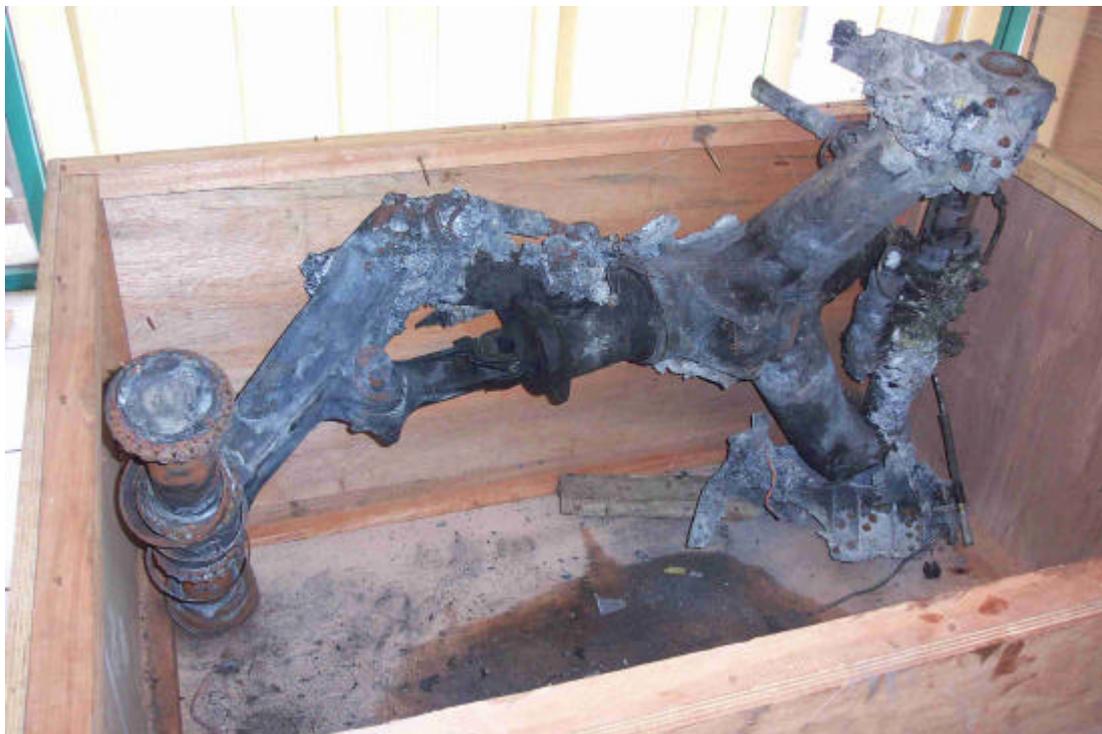
**Appendix C - Aircraft damage and
Landing gear**

The aircraft was found in nose down position, indicating the nose wheel has collapsed. The collapsed nose landing gear was found detached from the airframe, when the aircraft lifted to be moved. Cockpit and front end of airframe (in front of the wing) was found completely burnt. The fronts of both engine cowlings were also burnt. The front tire of right main landing gear was blown because of the fire and also the rear tire of left main landing gear.

The nose landing gear was found detached and burned heavily (see Appendix C -). The fracture surfaces at the landing gear strut mounting to the fuselage frame were damage by fire and therefore recognition on any indication of fatigue was not possible. The tires were burn out by the fire. The front part of then landing gear strut was damaged from scraping with the runway. Some melted magnesium alloy from the fuselage was found in the landing gear strut.

Metallurgist and AN-72 engineer determined that the nose landing gear/wheel fail due to static overload from over speed landing. It is very possible that the right main gear touch the runway first due to the maneuver perform on approach, and therefore creating twisting force on the nose gear.
