AIRCRAFT ACCIDENT REPORT

Controlled Flight into Terrain

Ilyushin IL-76 TD, RDPL-34141

Baucau, Timor-Leste

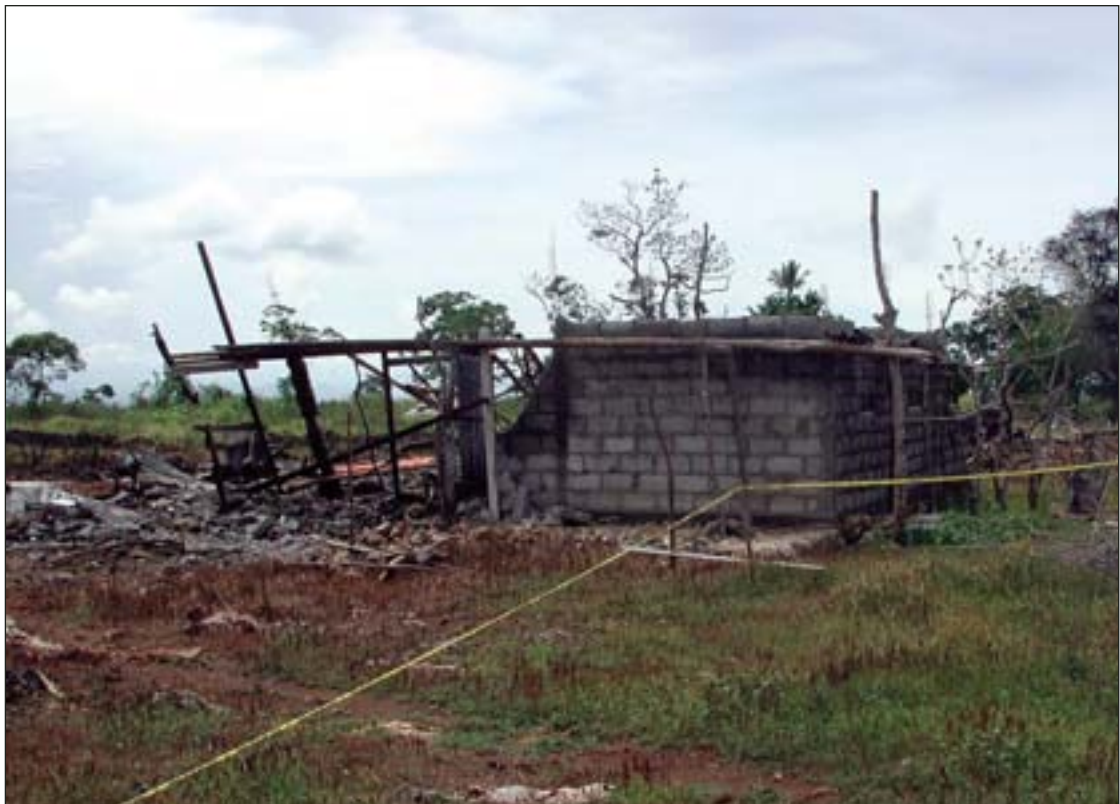
FIGURE 6:
Partially constructed house struck by the aircraft during the impact sequence

During the impact sequence, the right wingtip of the aircraft struck a partially constructed house to the left of the centreline of the wreckage trail, about 190 m from the first impact point (see Figure 6). The house, which was occupied at the time by its owner, was severely damaged. The owner of the house was physically uninjured by the impact.

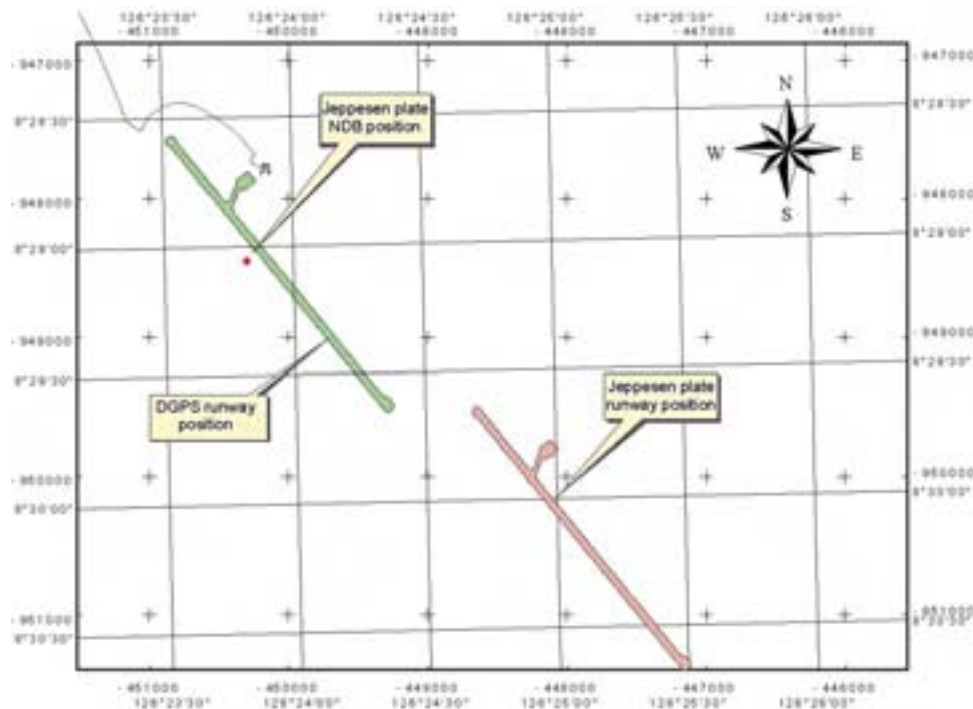
FIGURE 12:
Actual vs. depicted runway position

The Australian accredited representative and his team were unable to locate the aerodrome reference point (ARP) in the position where it was depicted on any of the Jeppesen aerodrome chart. Using the DSTO GPS, the threshold elevation of runway 14 was determined to be 519 m (1,703 ft) AMSL. Subsequent to the accident, the UN commissioned another survey of Baucau, which revealed that the threshold elevation of runway 14 was 516 m (1,694 ft) AMSL.

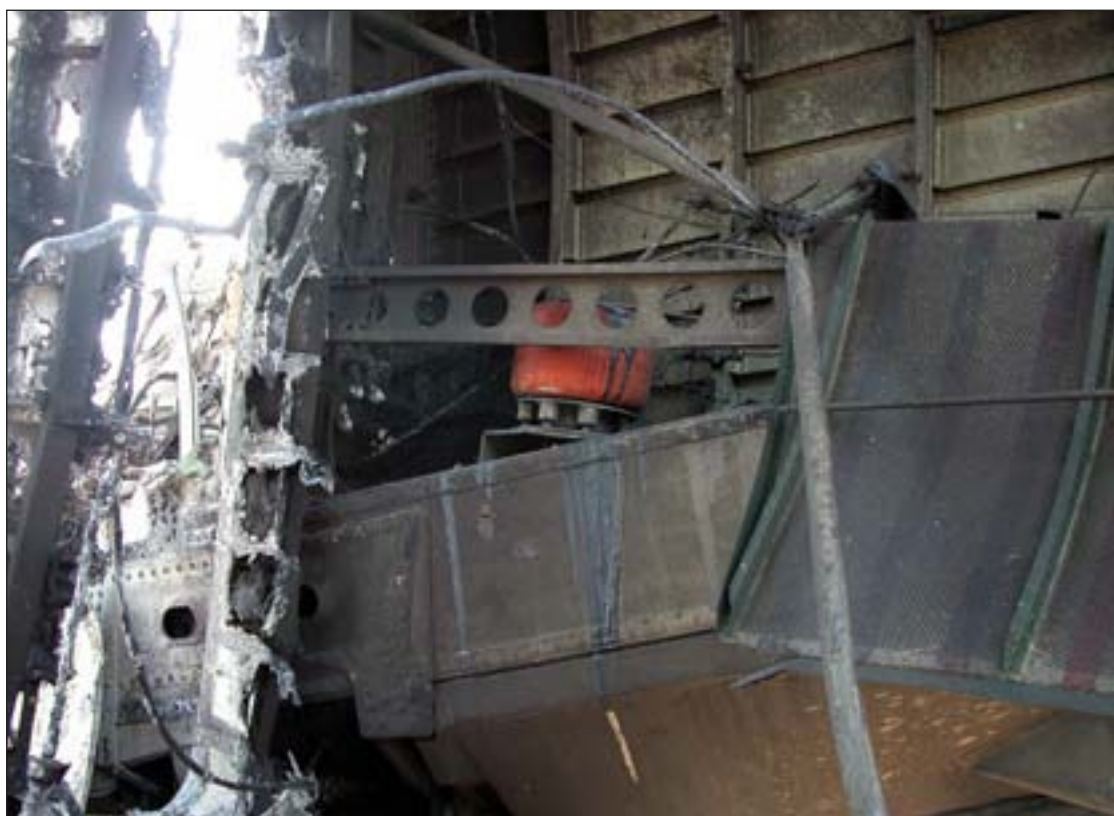
FIGURE 13:
Flight data recorder before recovery from the aircraft wreckage

The casing of the FDR storage unit was sooted from the post-impact fire, but revealed no evidence of heat or structural damage (see Figure 13). Examination of the recorded data revealed that the FDR had operated normally until impact.

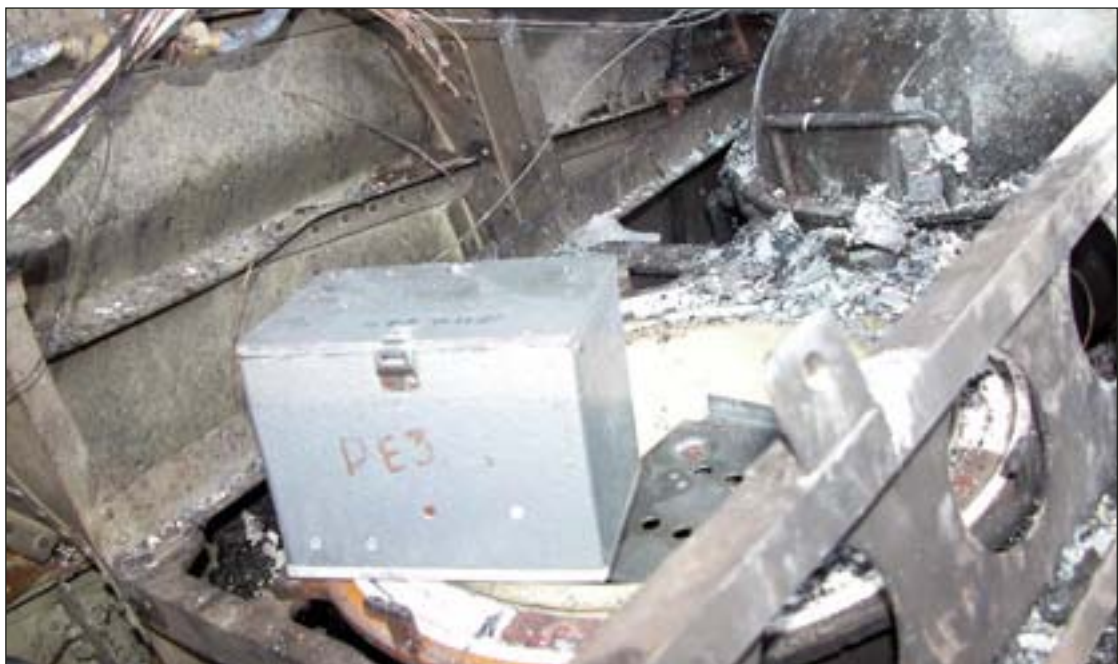
FIGURE 15:
Cockpit voice recorders during recovery from the aircraft wreckage

The cases of both CVRs were also sooted from the post-impact fire, but they revealed no evidence of structural damage (see Figure 15).

The interior of both CVRs showed no evidence of interior heat or impact damage. The wire-recording medium in one of the CVRs was dislodged from the recorder spools in that unit, and provided no useful data. The other cockpit voice recorder provided good quality audio information for the descent and approaches to Baucau.

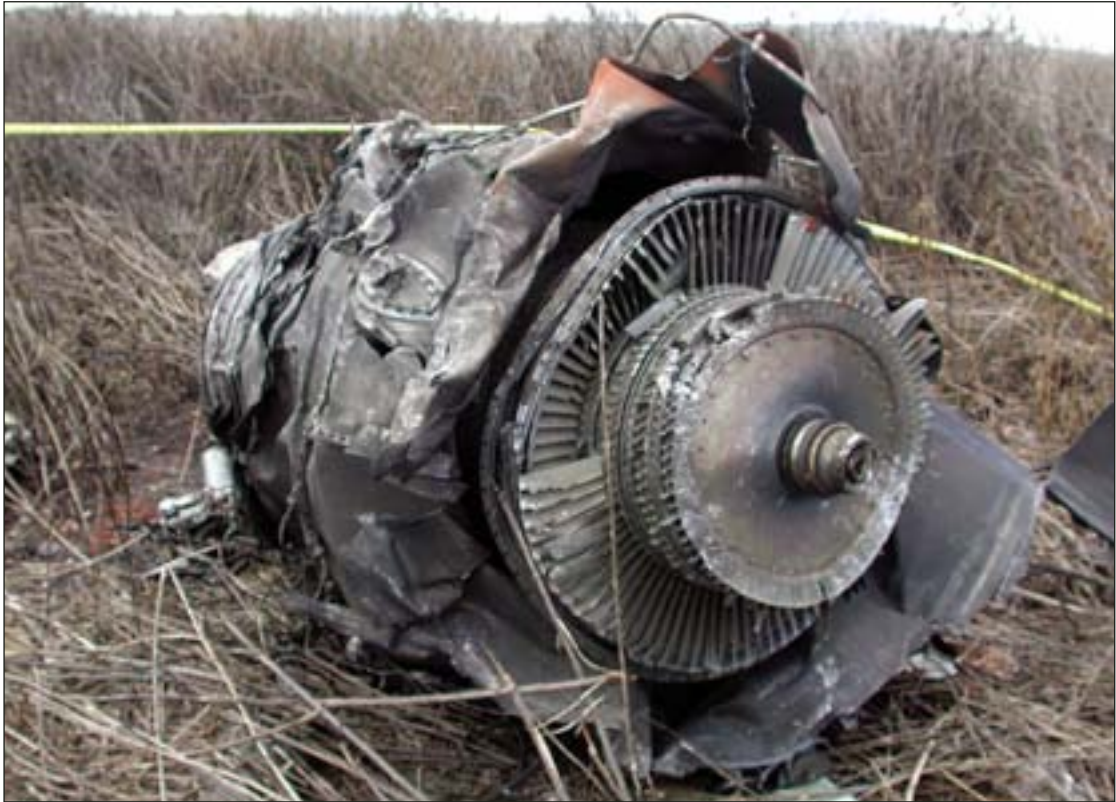
FIGURE 17:
Typical engine damage

The post-occurrence technical examination of the engine fan blades found in the wreckage did not display any evidence of bird strike or blending repairs.³⁰ It was not possible to determine whether the engines had sustained any foreign object damage before impact because of the significant damage resulting during from the impact sequence. The FDR EGT and N2 plots are depicted at Figures A.8 and A.9 in Appendix A. The plots revealed no apparent aircraft engine anomalies during the descent into Baucau or during the approach sequences. The extent of the typical resultant engine damage is depicted at Figures 17 and 18.

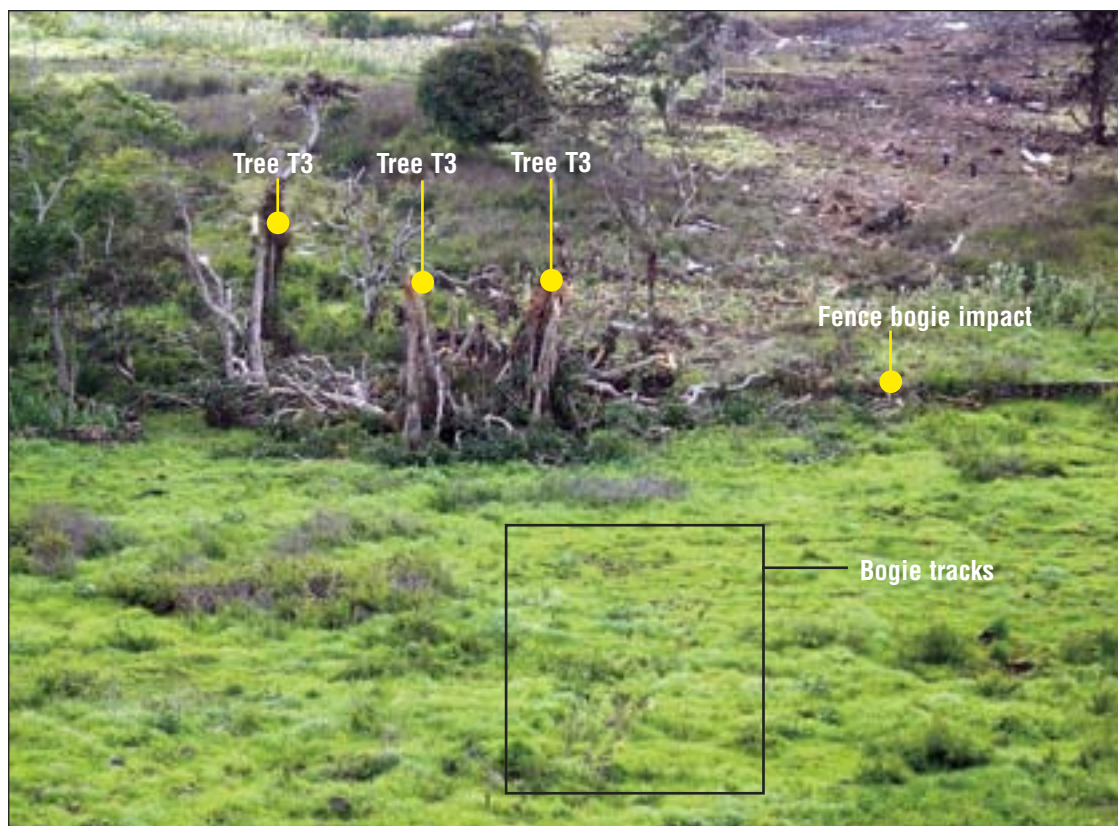
FIGURE 21:
The group of trees at the initial impact area

The first marks in the wreckage path were a single set of ground marks on slightly rising ground, consistent with ground contact of one of the main landing gear bogies. Those marks ran for about 39 m (128 ft) on a track of about 130 degrees magnetic. A single main landing gear bogie had impacted a 1.2 m (3.9 ft) high stone fence about 1m above the ground, nearly in line with, and 41 m (135 ft) from where the initial ground marks ended. Pieces of the lower cockpit windows and a windshield wiper blade were located not far down track from the fence that had been struck by the main landing gear bogie.

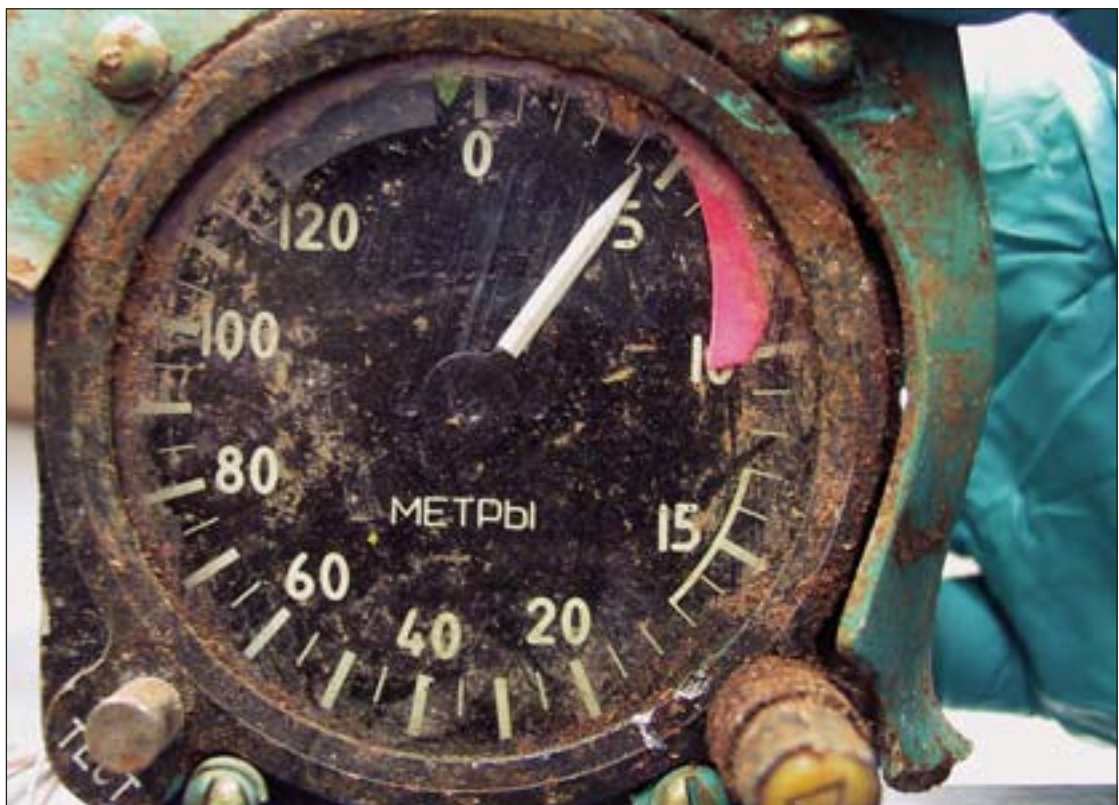
FIGURE 25:
The PB-150 radio altimeter indicator located in the aircraft wreckage

The reference bug on the indicator was not set to a positive altitude setting, but was parked in a position that was slightly less than the zero altitude reading.

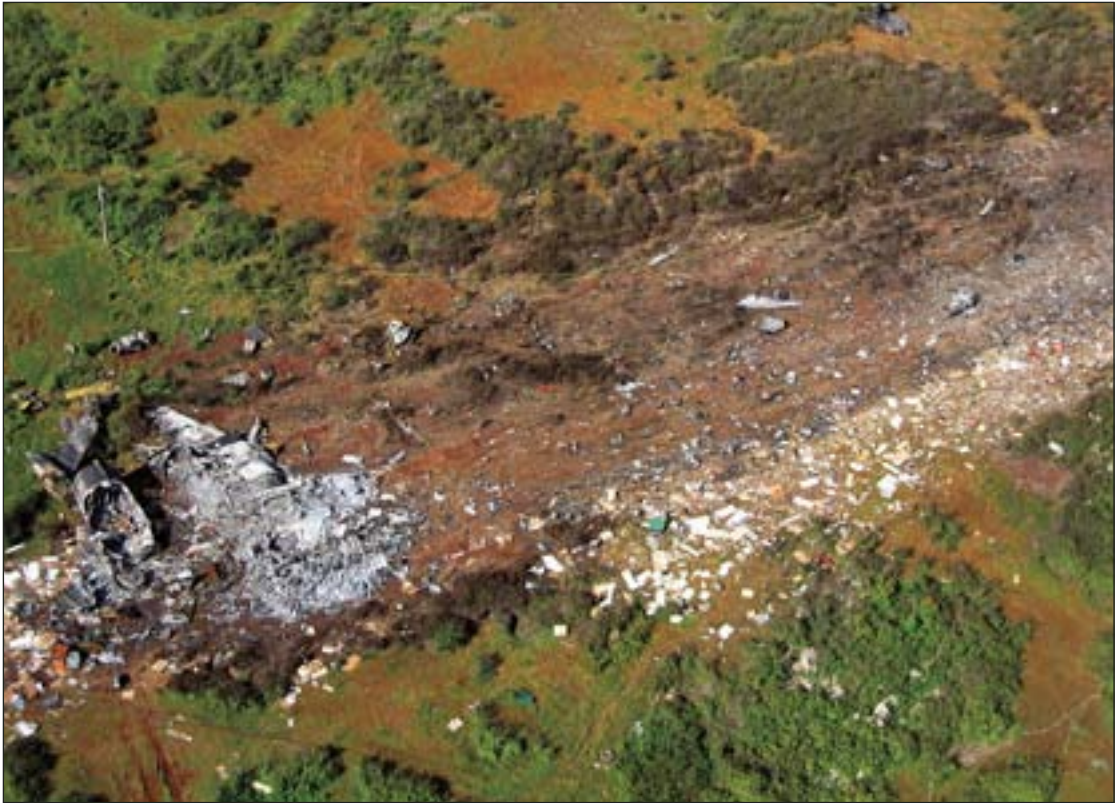
FIGURE 27:
Main wreckage area

The main part of the right and left wings and the wing carry-through structure were found in the correct context but in an inverted position about 190 m (623 ft) beyond the left wing tip light fragments (see Figure 27).

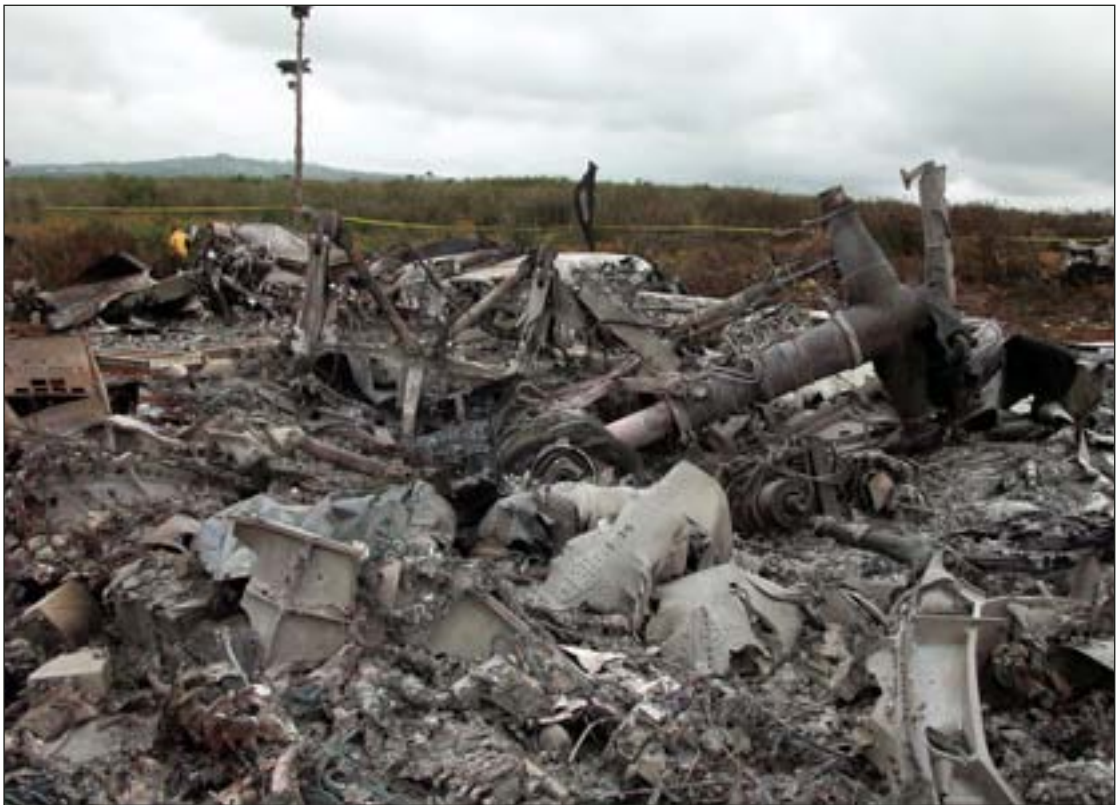
FIGURE 28:
Fire damage in main wreckage area

The post-impact fires had not damaged the vertical and horizontal tail sections of the aircraft. The damage to the vertical fin was confined to leading edge impact damage and sooting from fire. The left section of the horizontal stabiliser had been dislodged during the impact sequence, but the right section was intact.

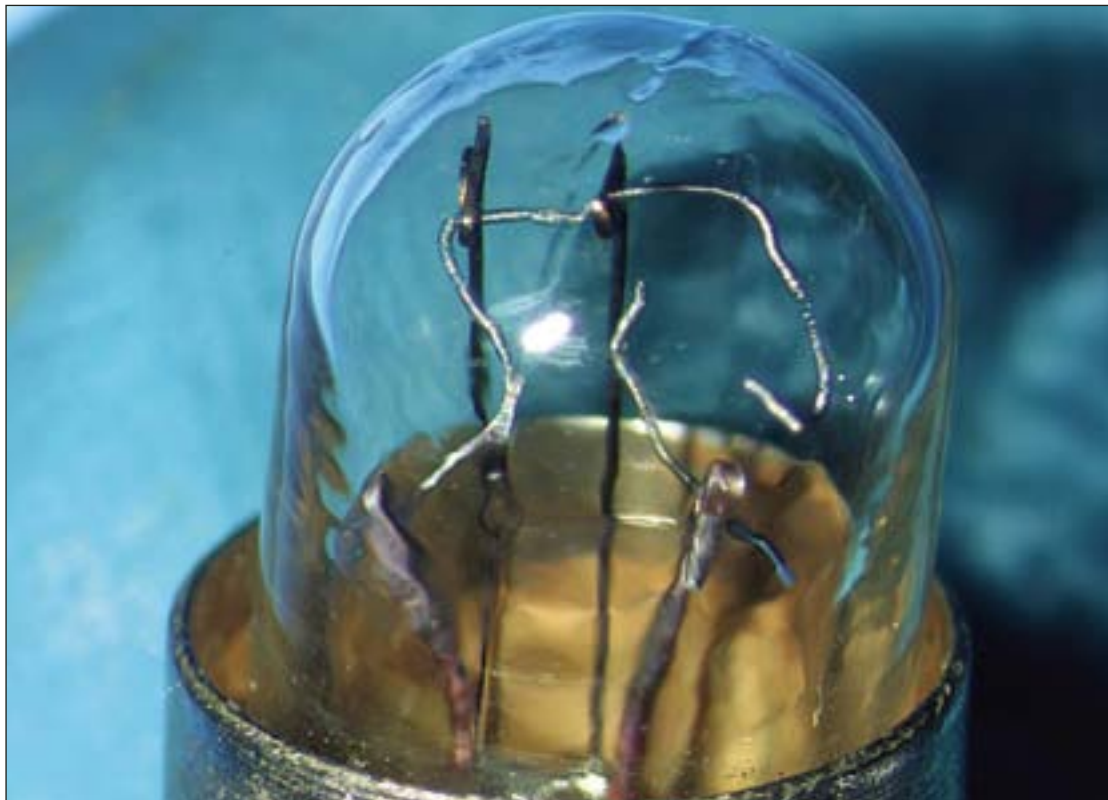
FIGURE 30:
Damaged light bulb filament from the PB-150 radio altimeter indicator

The glass face of the indicator was undamaged, however the rear part of the instrument casing had been damaged, and the gear train assembly within the instrument was not intact. The reference bug adjustment knob was jammed due to damage, and could not be rotated to move the bug. The small light bulb located behind the amber lens inscribed with the delta (Δ) symbol on the reference bug adjustment knob was removed and examined to determine whether it was illuminated at the time of impact (see Figure 30).

The globe envelope was unbroken, and displayed no signs of discolouration. The bulb filament was not severely stretched, and was fractured in one location. The coils had remained mostly symmetrical, and showed little evidence of gross stretch or distortion. The filament was also only slightly elongated.

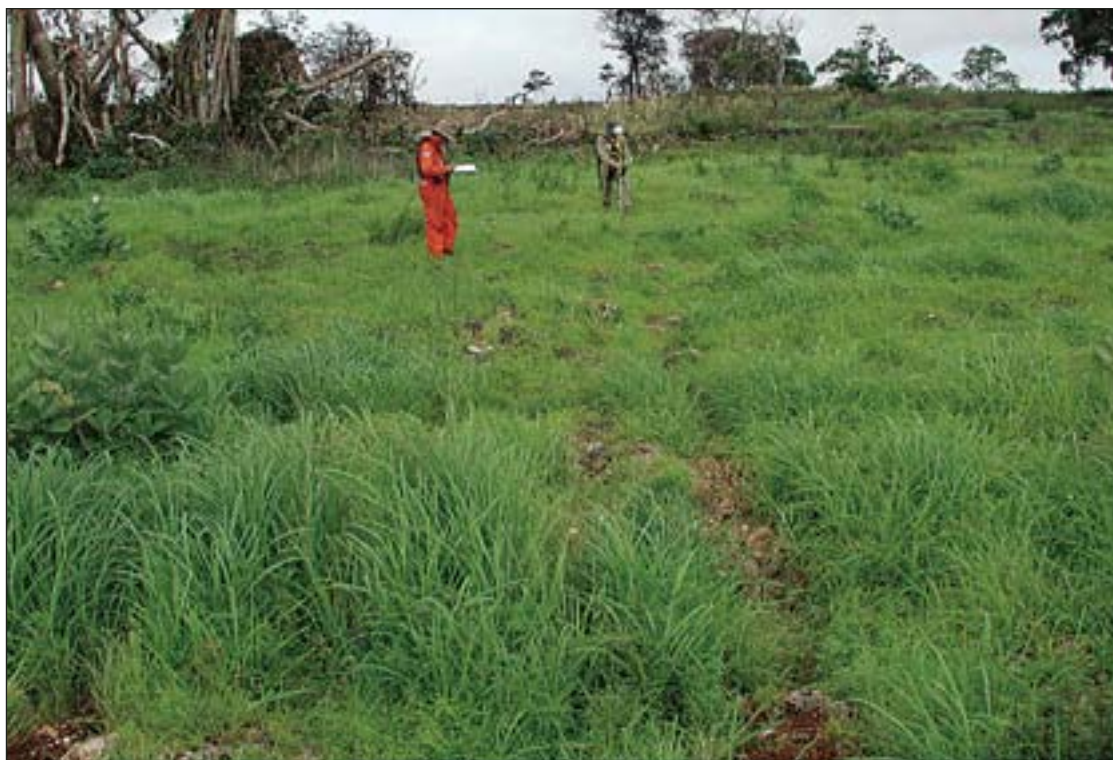
FIGURE F.1:
Witness scars at the first point of ground contact

The distance between ground witness marks indicated that they had been produced by one of the main landing gear bogies. The impressions in the ground also indicated that the aircraft had been in a slightly nose-up attitude during the period that the main landing gear bogie was in contact with the ground. That notion was substantiated by the fact the ground marks were of an even depth along the rising ground, and by the fact that there was no evidence of contact with the ground by the nose landing gear.

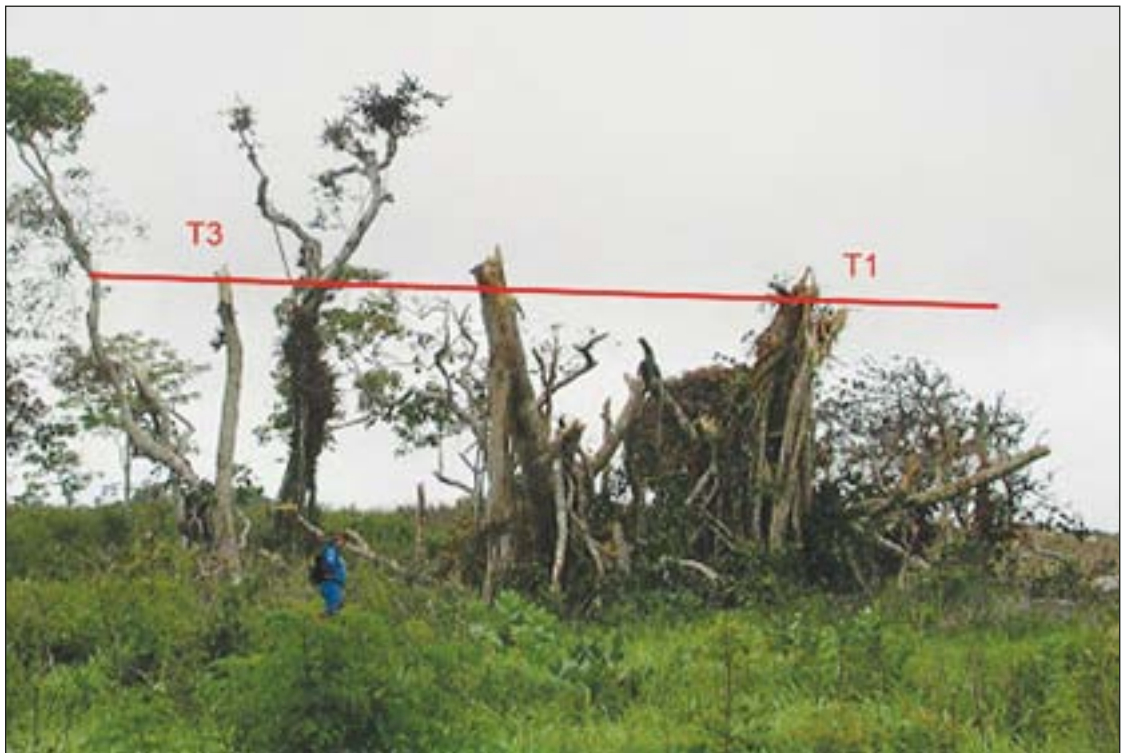
FIGURE F.2:
Impacted trees

Under those circumstances, the perpendicular distance between the left main landing gear bogie and tree T1 when it was abeam that tree would have been 11 m. That would have resulted in the left wing striking tree T1 just outboard of the outboard engine (engine number-1). The furthestmost damaged tree, T3, would therefore have been struck by the left wing about 1 m inboard from the wing tip. That was consistent with a piece of the outboard aileron and various other pieces of the wing having been found directly under the trees. Engine fan blades were also found in the vicinity of the trees and extending away from the trees in the direction in which the aircraft had travelled.

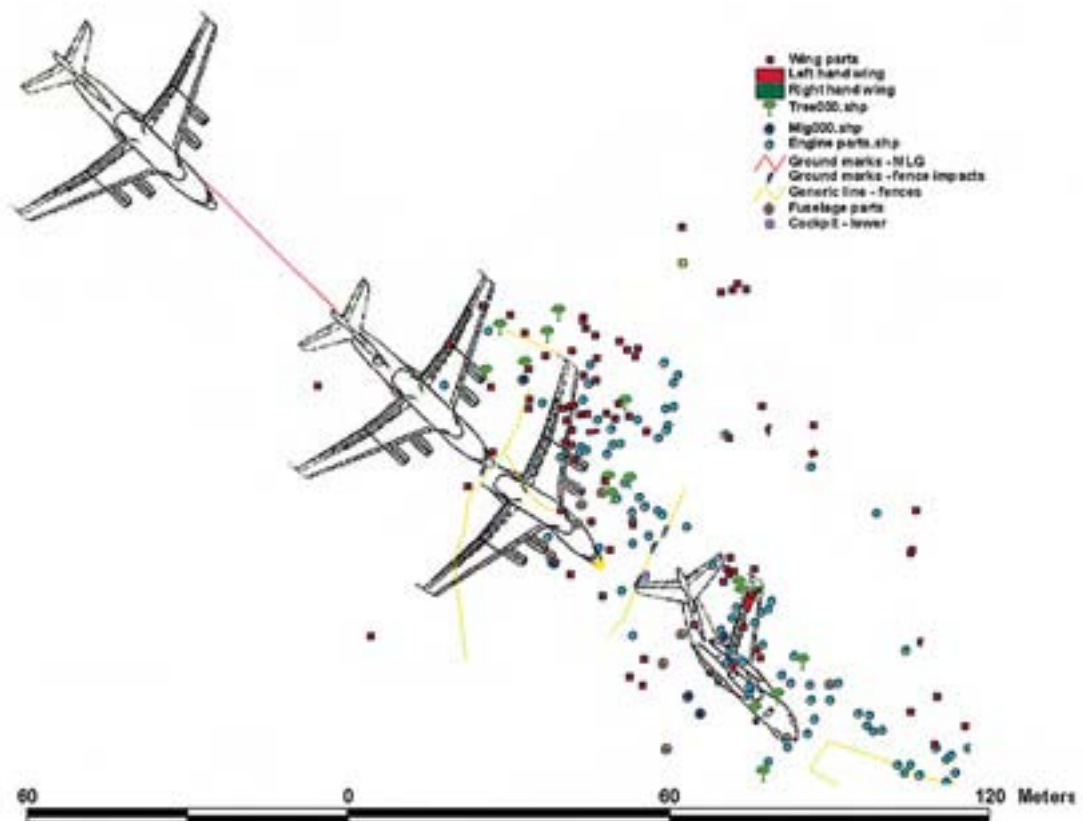
FIGURE F.3:
Initial break-up sequence

The airframe would have experienced considerable structural loads because of the deceleration force when the left wing impacted the trees, and from the resultant sudden and violent yaw to the left. The combination of those structural loads, asymmetric aerodynamic lift, and the subsequent roll to the left, seems likely to have initiated the partial separation of the aft-most fuselage section from the main body of the aircraft.
