SL REP.: 11/2005

**REPORT ON THE AIR ACCIDENT ON 30 NOVEMBER 2001 AT SKIEN AIRPORT
GEITERYGGEN NORWAY, INVOLVING BRITISH AEROSPACE JETSTREAM 31, SE-
LGA, OPERATED BY EUROPEAN EXECUTIVE EXPRESS AB**

SUBMITTED APRIL 2005

ACCIDENT INVESTIGATION BOARD - NORWAY
PO BOX 213
2001 LILLESTRØM
NORWAY

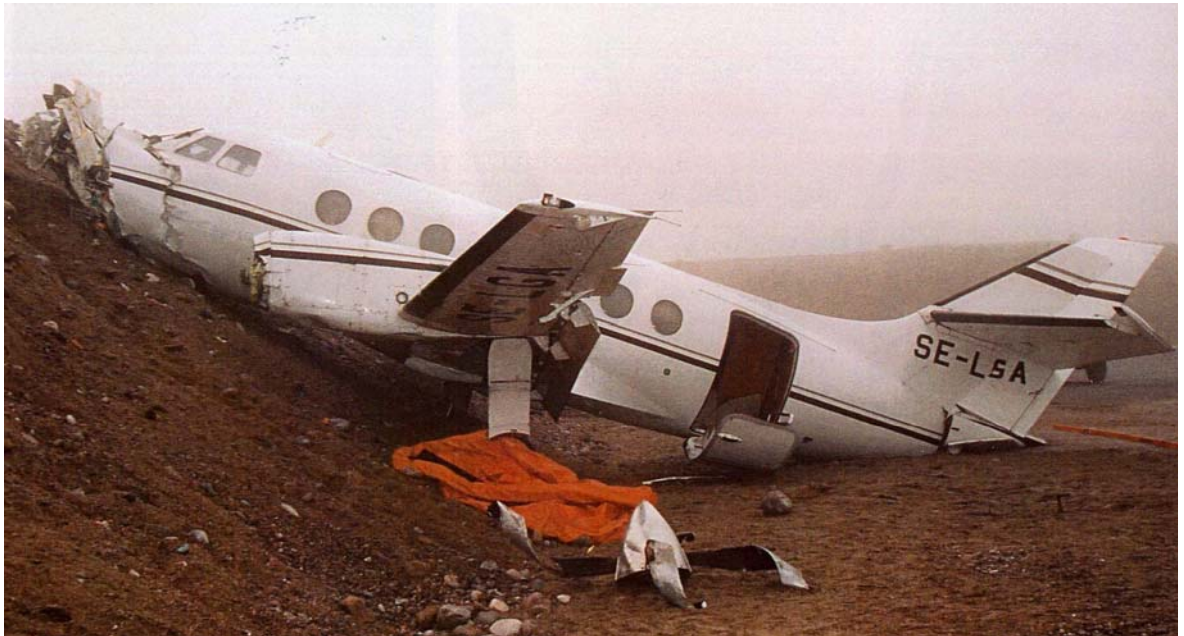
1.1.11

The landing led to permanent deformation of the left wing on the forward wing beam. As a result of this deformation, the left landing gear leg was bent backwards, with the engine and propeller pointing obliquely downwards. The left propeller touched the runway and the crew lost directional control so the aircraft skewed out to the left and left the runway (see diagram in subparagraph 1.12.1.3). It continued, skidding in an arc to the left, crossed a taxiway twice and hit a gravel bank with great force. The gravel bank was hit by the nose of the aircraft and the left propeller at an assumed angle of 45° in the horizontal plane. The aircraft continued up the gravel bank in a virtually horizontal attitude while the tail was thrown out to the right. Then the aircraft fell so that it was resting on its tail and main wheels with the nose up on the gravel bank.

Photograph taken looking south the day after the accident. Note the unusual position of the wing, engine and landing gear

The rear wing spar was bent upward in the area of the main landing gear assembly. The wing has, therefore, rotated (see inwards from the left wingtip) around the forward wing spar, so that the assembly angle was reduced by around 11° . This led to the engine and propeller pointing an equivalent number of degrees downwards, with the main landing gear pointing diagonally backwards. The deformation led to comprehensive damage in the wing section between the engine and the aircraft fuselage and significant fracture of the fuel tank, which is an integrated part of this structure. The landing gear was mainly undamaged, but the hydraulic actuator, which operates the landing gear, was torn in two. The left propeller was knocked off at the mounting flange on the engine gearbox and was found by the aircraft's left wingtip. All of the four propeller blades were bent backwards, were heavily twisted and had scrape marks. The left engine was sent to SAAB Nyge Aero in Sweden for rebuilding, but was later considered to be a total loss. The engine had rotated at the same time as it had drawn sand/gravel into the compressor. Marks in the compressor indicated that the engine had been exposed to high G loads, both while it rotated and when it was still. There was a sheared shaft in the gearbox, resulting from high torque.
