AVIATION OCCURRENCE REPORT

03-004

Piper PA 31-350 Navajo Chieftain ZK-NCA, controlled flight into terrain, near Christchurch Aerodrome

6 June 2003

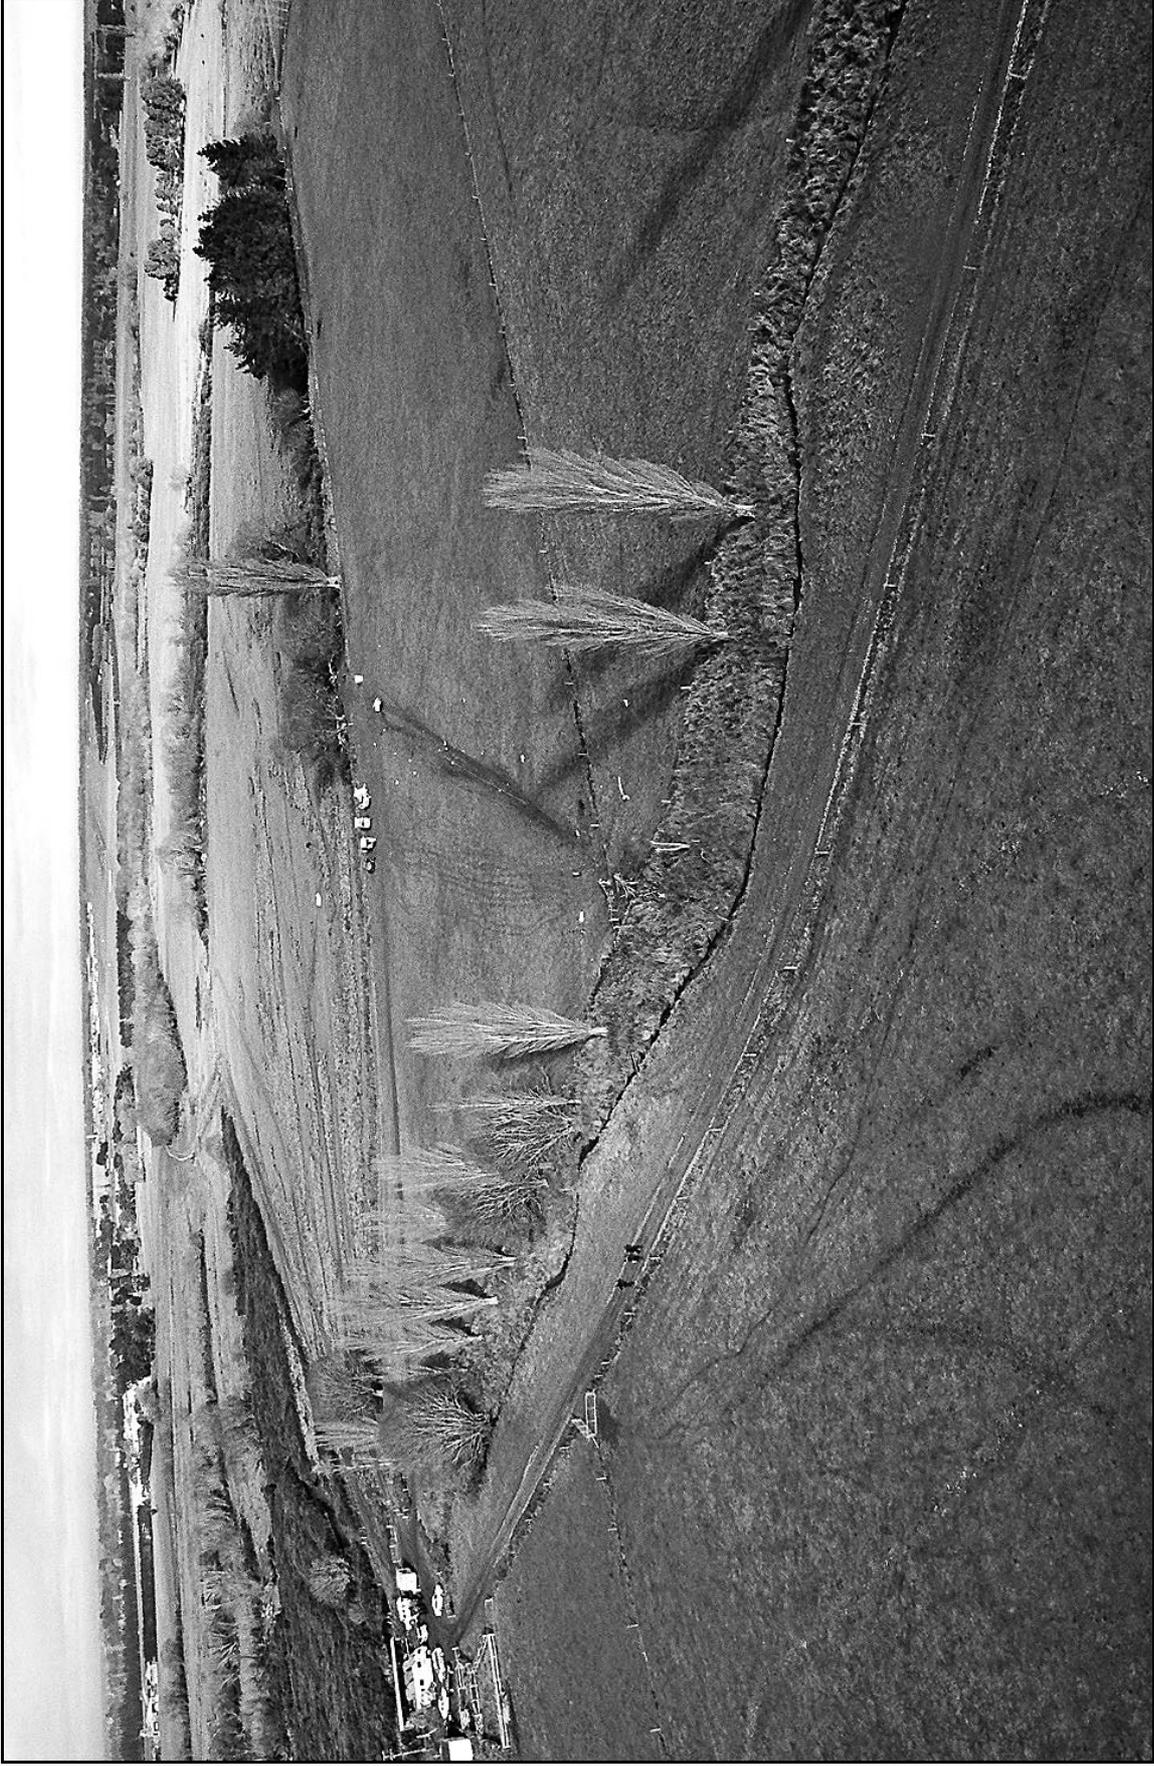
Figure 1
ZK-NCA accident site, looking south towards Christchurch Aerodrome runway 20

- 1.12.3 At the southern side of the paddock, the aircraft fuselage had collided heavily, left side first, with a substantial willow tree. The impact separated the tail section and empennage, and further collapsed the cabin area. The remaining cabin section of the fuselage and the right wing slid a further 27 m, crossing a small stream before coming to rest. The pilot's Instrument Flight Guide was found nearby, open at the Christchurch runway 20 ILS approach chart. The distance the main wreckage travelled from the first tree strike was 207 m, on a track of 204° magnetic. Some items, such as the aircraft battery, had travelled a further 40 m.

- 1.12.4 Propeller slash marks in the ground at 40 m and 105 m along the trail, and matching rotational damage to the blades were consistent with both propellers turning under some engine power. Little fuel was found in the ruptured wing fuel tanks, but appreciable grass staining along the wreckage trail was consistent with fuel spillage.

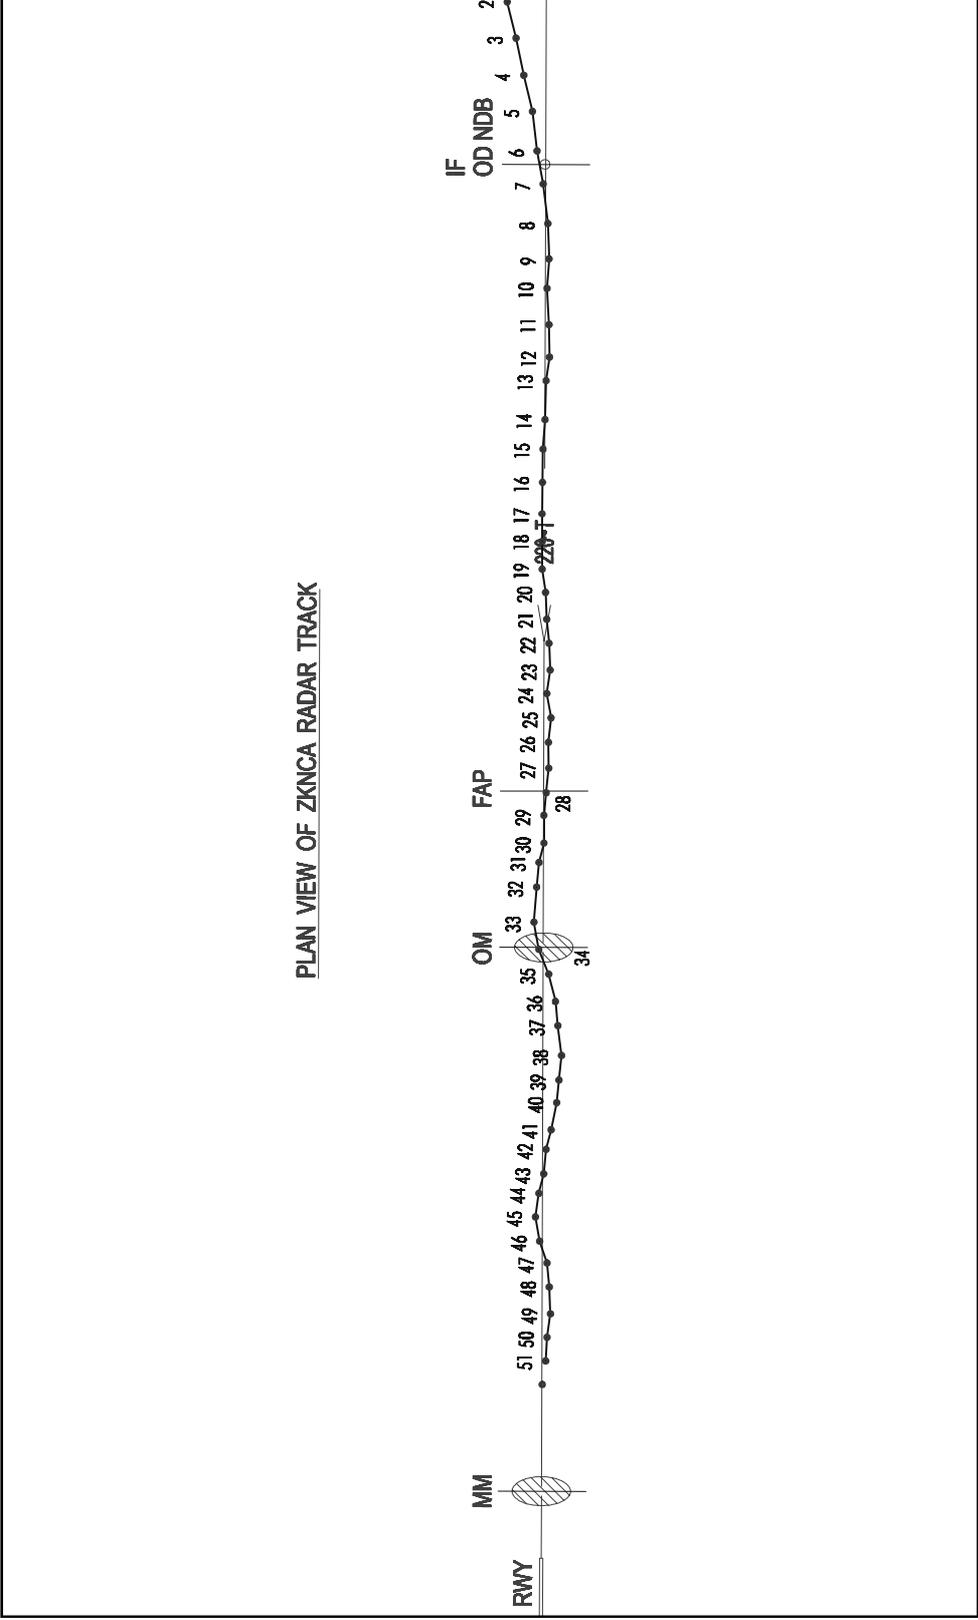
Figure 2
Air Traffic Control radar track of ZK-NCA on the Christchurch 20 ILS approach

- 1.1.16 ZK-NCA continued descending, to collide with trees and flat pasture land 1.2 nm from the runway threshold. The last Air Traffic Control radar return from ZK-NCA was recorded at 1907:29, with the aircraft descending through 200 feet and 1.4 nm from the threshold.

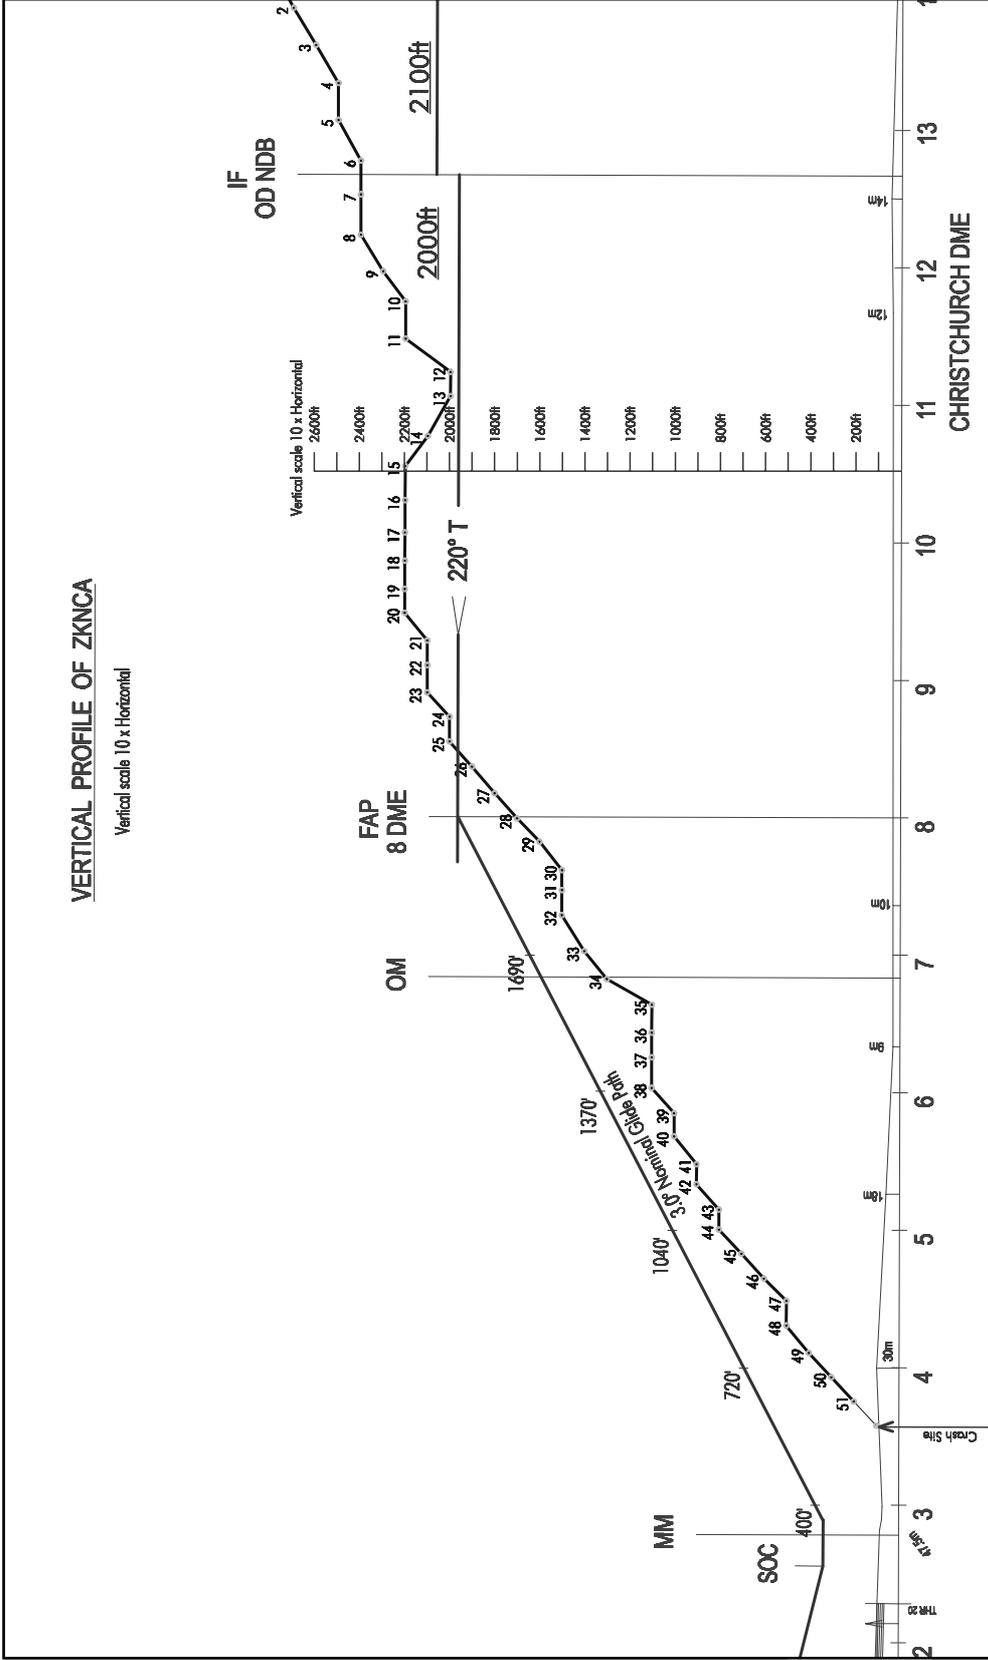
Figure 3
Air Traffic Control radar vertical profile of ZK-NCA on the Christchurch 20 ILS approach

- 2.15 The ILS receivers and indicators in ZK-NCA could not be checked completely because of accident damage, particularly to the glide slope receiver. The HSI, however, which the pilot customarily used, was examined and checked, and was probably working correctly before the accident. The localiser receiver was probably working normally, again because the radar plot of the aircraft's track was consistent with the aircraft manoeuvring in response to normal guidance. The radar plot of the vertical profile flown by ZK-NCA does show that the aircraft began descending before reaching the glide slope, and continued the descent some 200 to 300 feet below the glide slope, increasing to 400 feet low at the last radar return.

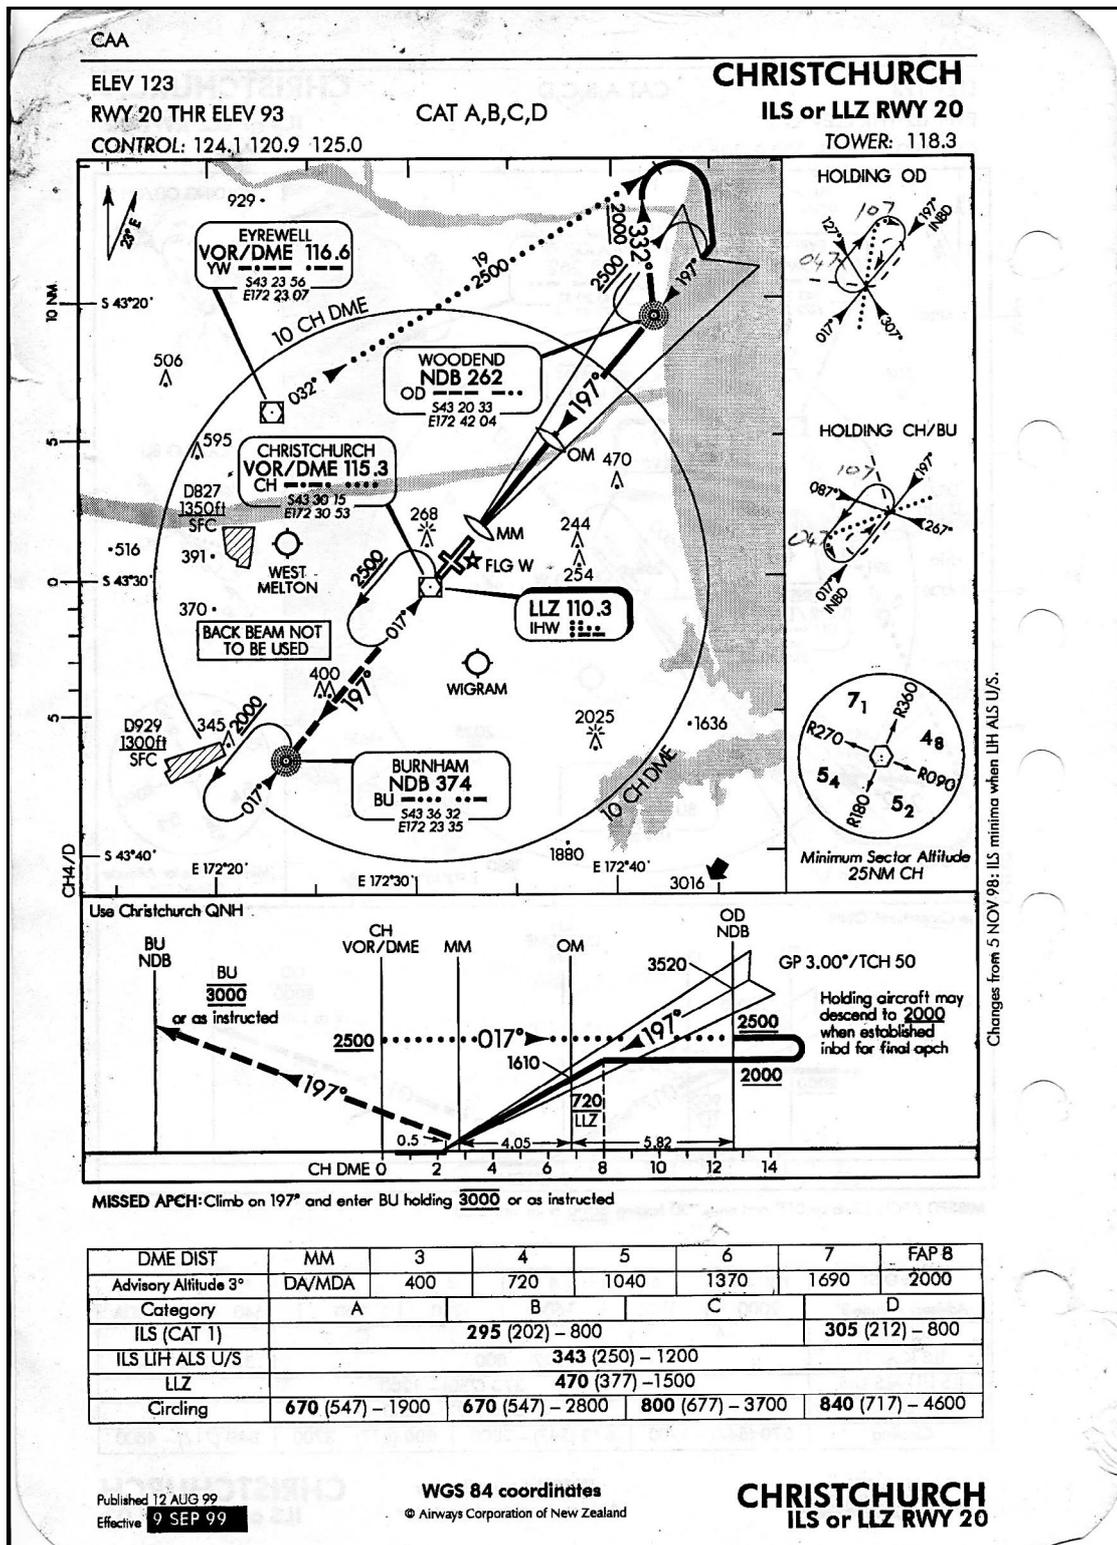
Figure 5
Christchurch 20 ILS approach chart from ZK-NCA

- 1.10.2 The ILS approach procedure to runway 20 commenced from Woodend NDB, not below 2000 feet, on the localiser track of 197°M. The 3° glide path was intercepted at 2000 feet, at 8 nm DME (5.7 nm from the threshold). The relevant procedure minima (category 1 ILS) were: DA 295 feet (202 feet above the runway), and a flight visibility of 800 m. The position of the normal DA corresponded with the middle marker beacon. The missed approach procedure was to climb straight ahead to Burnham NDB at 3000 feet (see Figure 5).

- 2.23 It is noteworthy that neither ADF in ZK-NCA was appropriately tuned for the missed approach, which specified a climb to Burnham NDB at 3000 feet. Normal good practice on any instrument approach would be to make this selection, possibly on the standby tuning head for ADF 1, before the approach. A missed approach can occur for reasons other than below-minima weather, and relevant navigation guidance is necessary. That the pilot had not made
