# **Final Report No. 1922 by the Aircraft Accident Investigation Bureau**

to the aircraft Piper PA-46-350P JetProp, D-EMDB

on 7 April 2004

in the Pradatsch area, Municipality of Madulain/GR

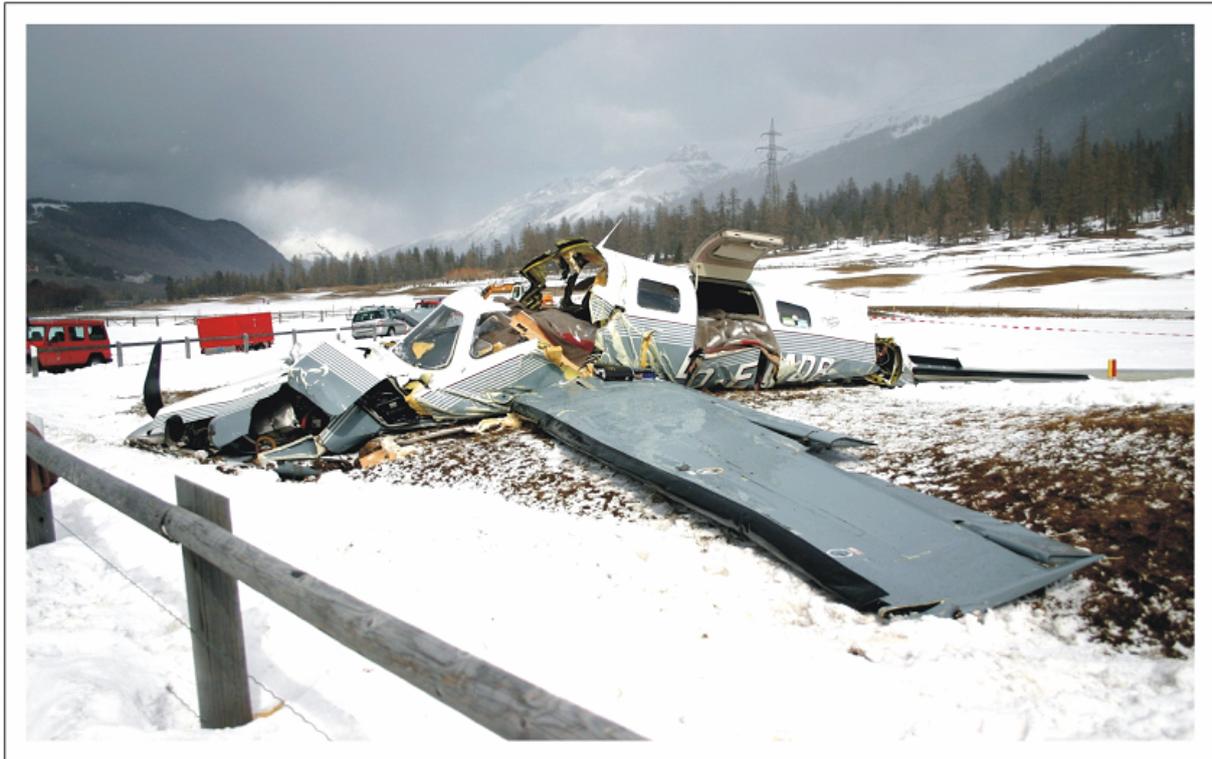
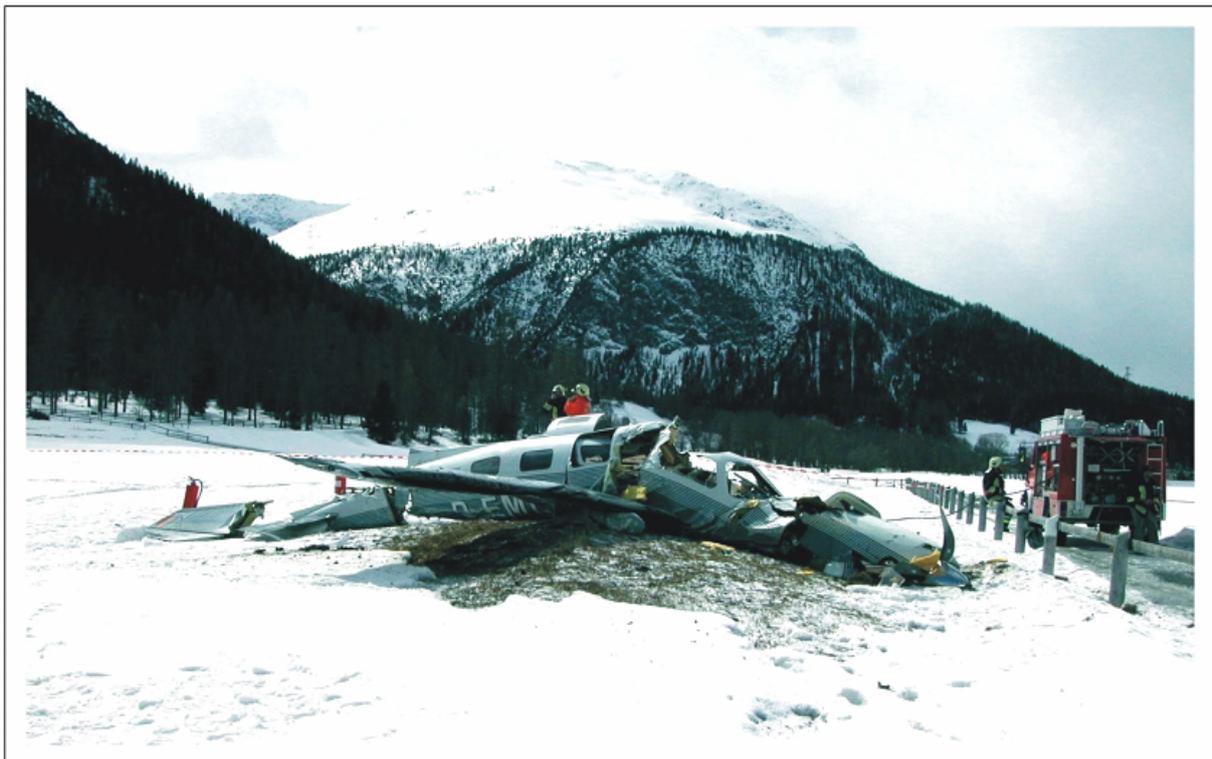
Annexe 1: Overview of the site of the accident

The aircraft came down in a grassed area within the golf course, only a few metres from a minor road (see Annex 4.1).

Considerable crop damage was caused to the terrain at the point of impact. Running out kerosene caused contamination of the soil. The affected grass had to be removed over an area of approximately 200 m<sup>2</sup>.

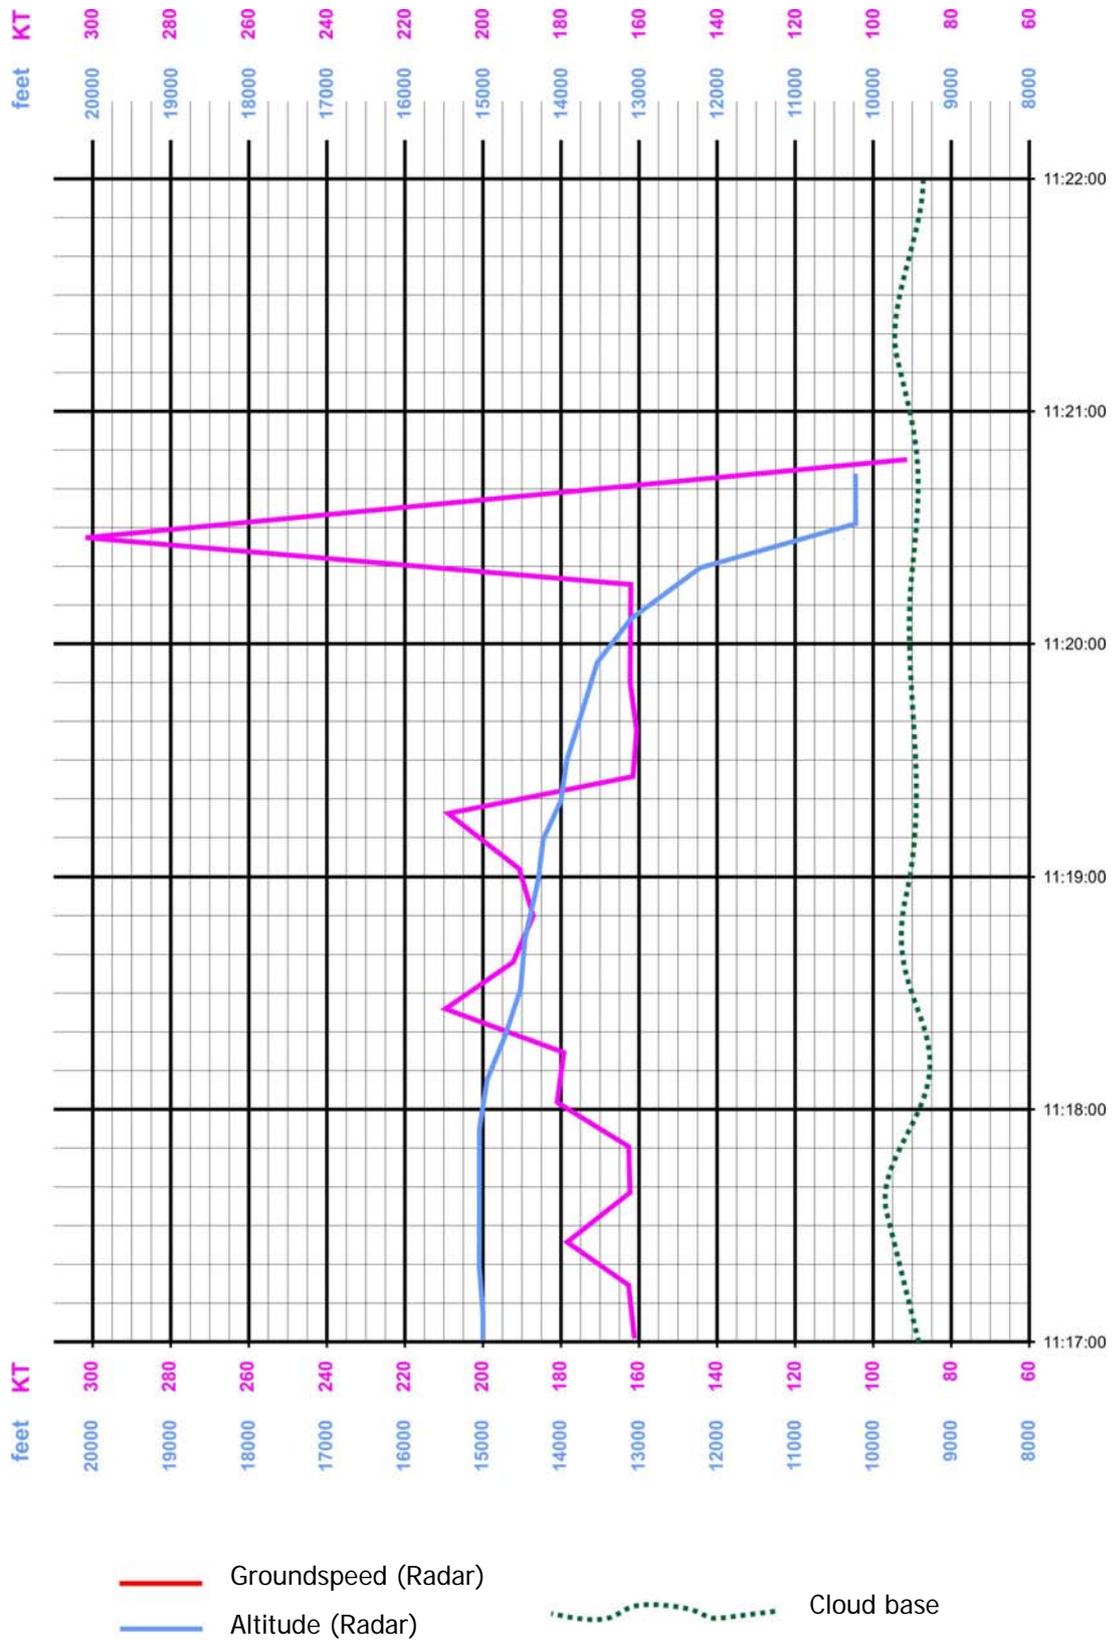
### Annexe 3: Graphic representation of speed and height

Whilst the pilot wanted to manoeuvre the aircraft into the valley through a gap in the clouds, he must have realised as the overspeed warning distinctly sounded that the attitude required to do this was causing his speed to increase rapidly. The subsequent abrupt manoeuvre to pull out led to a drop in speed, down to a range below 60 kt. This manoeuvre can cause considerable acceleration which could have affected the pilot's ability to orientate himself. An unintentional and at least partial penetration into the cloud may have reinforced his spatial disorientation.

In this situation, when the pilot set power above the maximum value (over-torque), this led the aircraft to go into a spin and he lost control of the aircraft. Eyewitnesses, the traces of the impact and the damage to the airframe indicate that it was a flat spin.

Information on the last five minutes according to radar recordings
