Aircraft Type and Registration:	Raytheon 390 Premier 1, N200PR	
No & Type of Engines:	2 Williams FJ-44 turbo-jet engines	
Year of Manufacture:	2001	
Date & Time (UTC):	7 April 2004 at 0932 hrs	
Location:	Blackbushe Airfield, Hampshire	
Type of Flight:	Private	
Persons on Board:	Crew - 1	Passengers - None
Injuries:	Crew - None	Passengers - N/A
Nature of Damage:	Aircraft destroyed	
Commander's Licence:	FAA Private Pilot's Licence with Instrument Rating	
Commander's Age:	39 years	
Commander's Flying Experience:	4,511 hours (of which 413 were on type) Last 90 days - 60 hours Last 28 days - 12 hours	
Information Source:	AAIB Field Investigation

Synopsis

After takeoff the pilot was unable to raise the landing gear and was presented with failure indications affecting both the lift dump and anti skid systems. Following a successful landing at Farnborough, and discussions with the aircraft's maintenance organisation, the aircraft was flown to Blackbushe for further technical investigation. After landing on Runway 26 the aircraft left the runway, struck a series of obstructions and was destroyed: there was no fire and the pilot was uninjured.

The support bracket for the right main landing

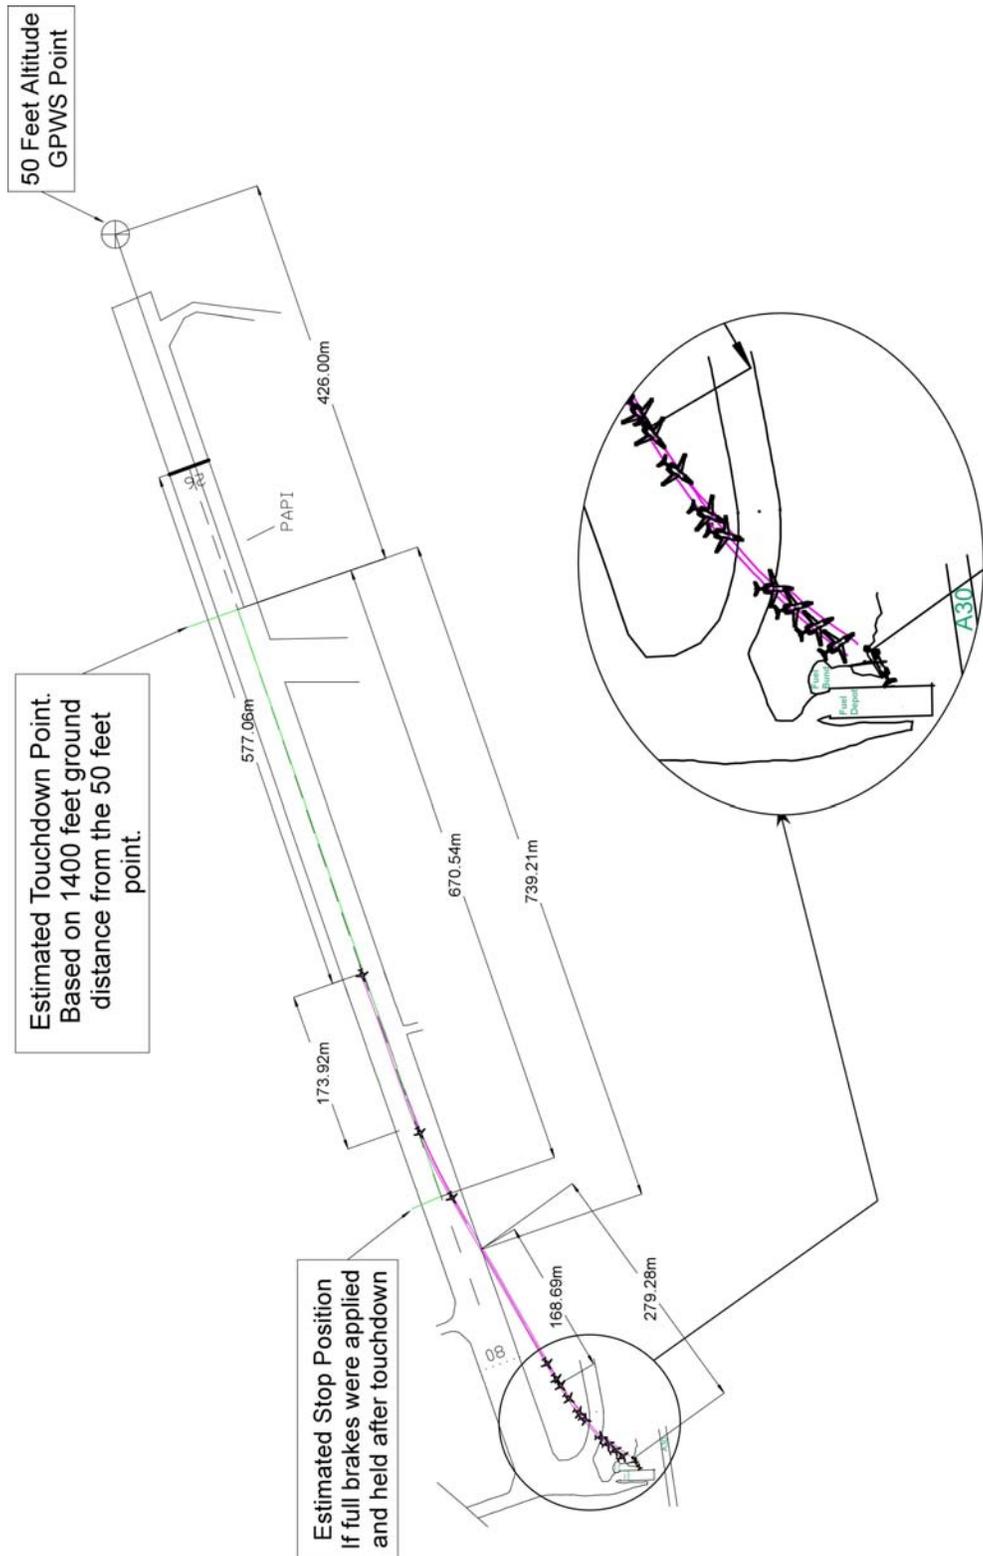
Figure 1 - Accident Sequence

When the wing was abruptly stopped by the fuel bund, the aircraft rolled and pivoted about the tree to the right, in the process detaching the entire wing due to the fracture of the wing to fuselage attaching tie rods. When the aircraft finally came to rest the wing had become airborne and landed on top of the fuselage, just aft of the cockpit area. In the final accident sequence the right main gear had also collapsed and the right engine had detached from its pylon, but was retained to the aircraft by fuel and control lines.

The aircraft had come to rest with the fuselage lying on its left side, thus preventing easy access through the main door. Fortunately, the emergency exit was located on the right of the aircraft and the pilot was able to egress through it. The emergency exit door was found lying in the aircraft on the left passenger seat directly opposite the door and in a position indicating that it had fallen into this position after the aircraft came to rest.

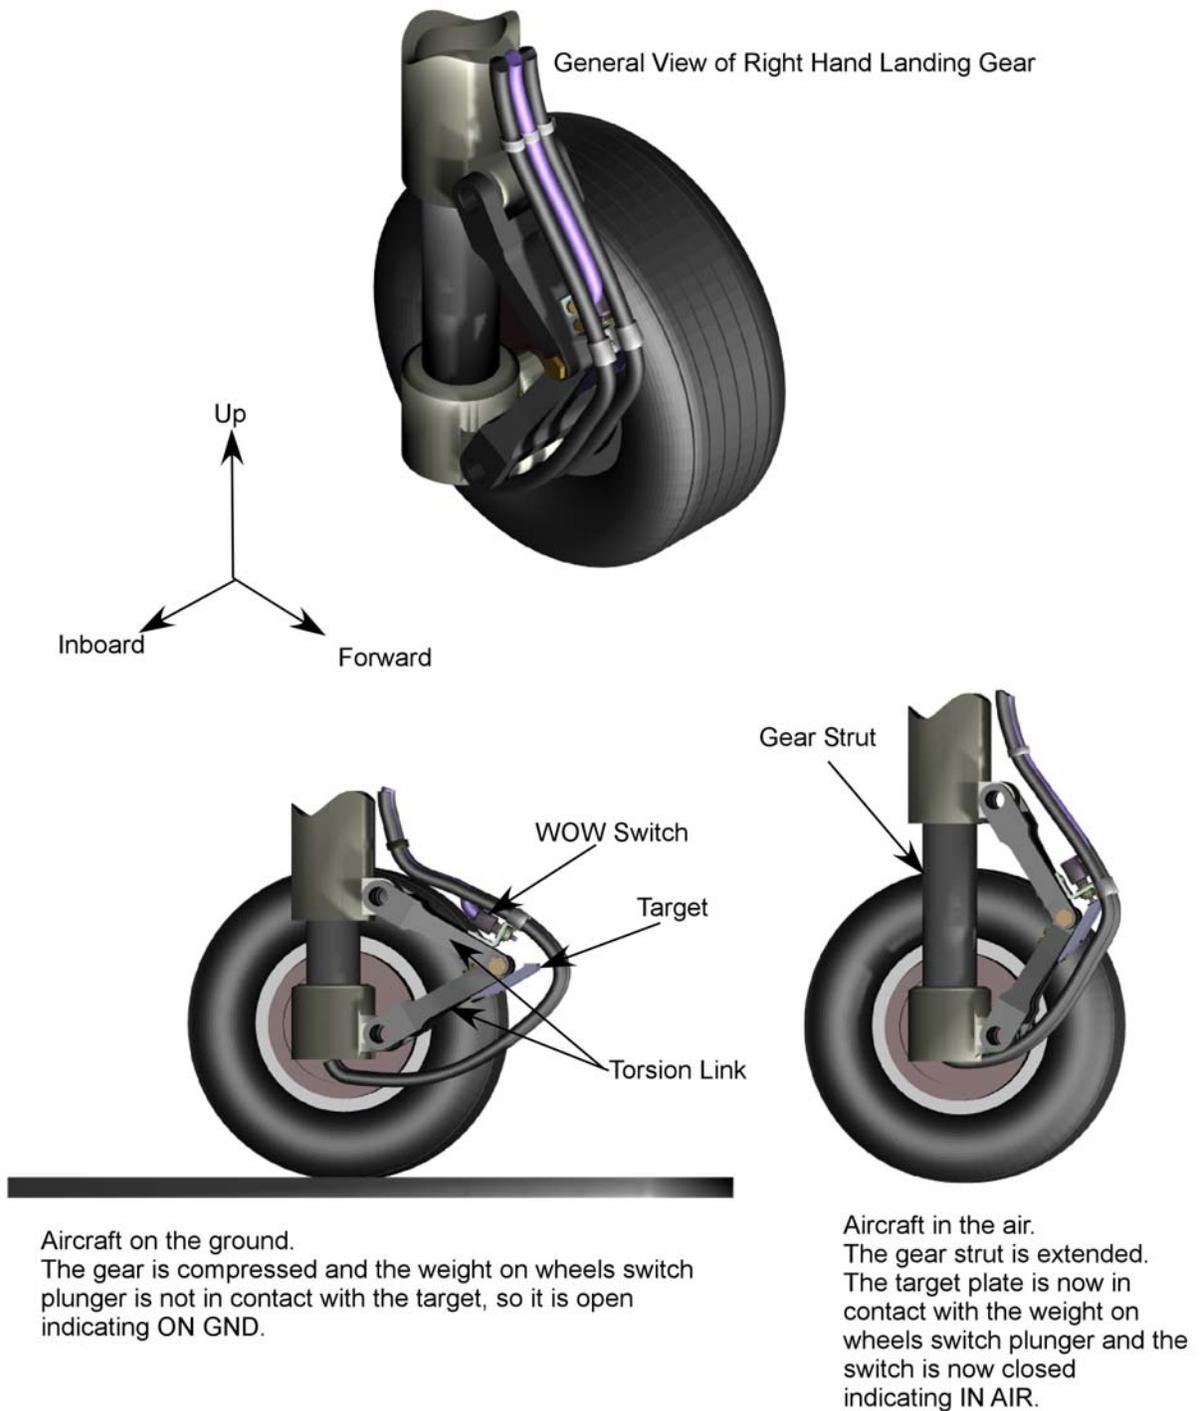
Figure 2 – WOW Switch installation.

The adjustment (rigging) of the WOW switch, so that the target correctly contacted the plunger IN AIR, was accomplished by lower and upper adjustment nuts which had to be tightened and loosened in unison to prevent undue stress on the WOW switch and bracket (Figure 4). Once adjusted the nuts would be wire locked together.

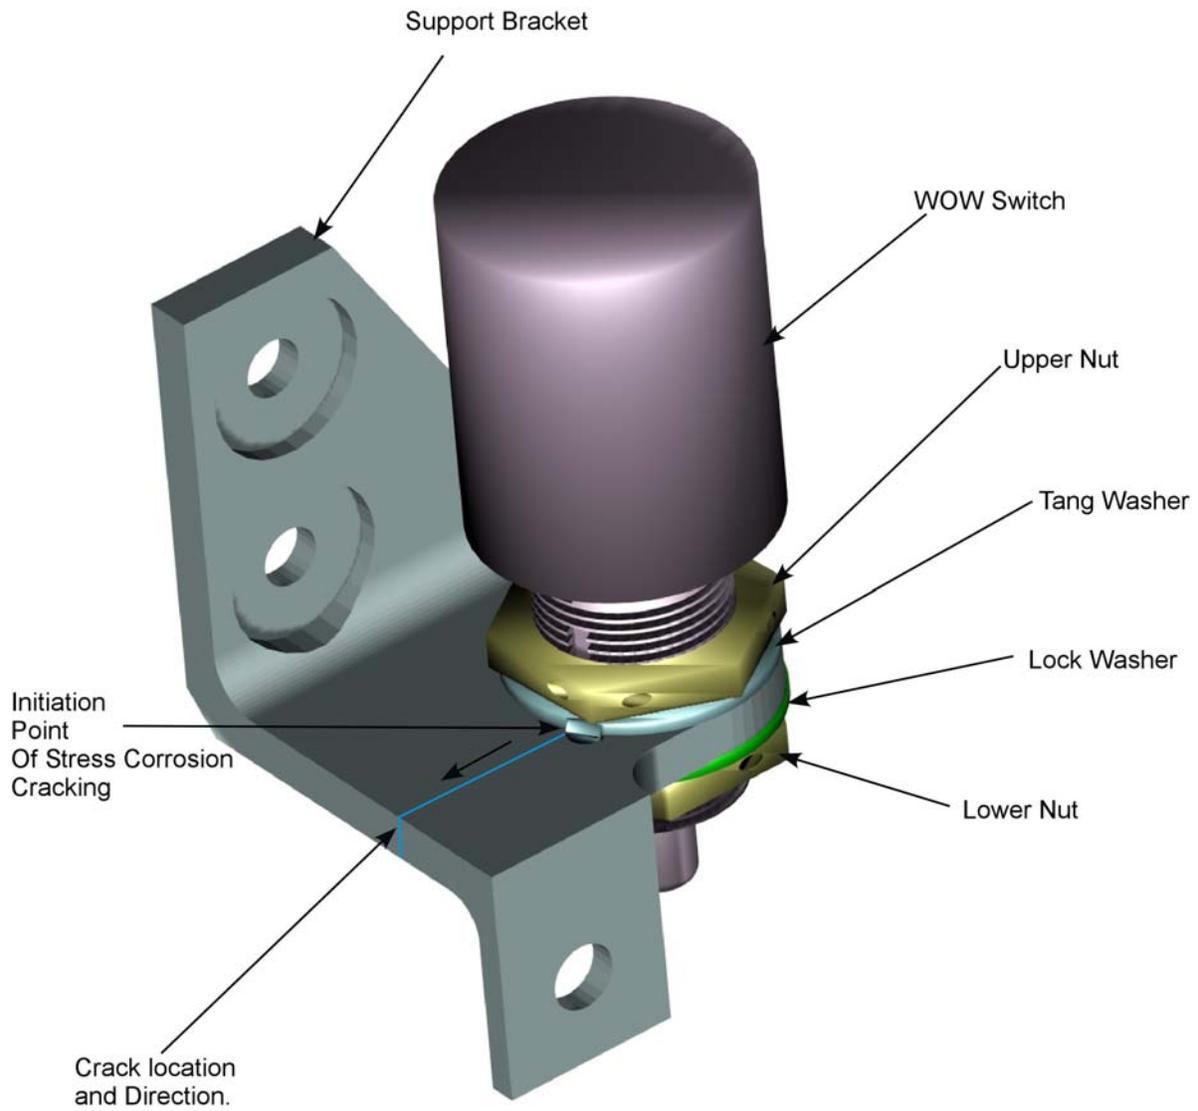
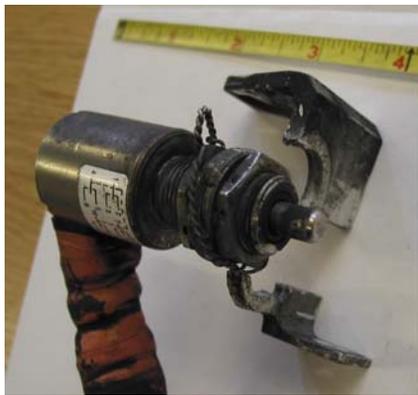
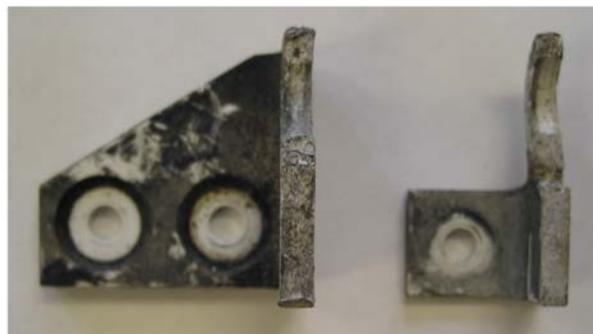
Figure 4 – WOW switch bracket.

The metallurgic examination revealed that the right WOW support bracket had cracked due to stress corrosion which had initiated at the tang washer outer tang support hole (see Figure 4). Localised galvanic corrosion had been set up at the outer tang support hole due to the presence of the dissimilar metals of the aluminium support bracket and the steel tang washer, and brought about by contact with an electrically conductive liquid such as rain water. The stress part of the mechanism was due to the tang washer having been rotated in relation to the WOW switch, causing the inner tang of the washer to become jammed in the threads of the WOW switch. This caused the outer tang of the washer to be forced against the edge of the outer tang support hole, causing the edge of the outer tang to penetrate the paint protection and apply a tensile stress on the bracket. In addition, corrosion was also discovered on the underside of the bracket where the teeth of the steel lock washer had 'bitten' through the paint and into the aluminium of the bracket; this had also set up galvanic corrosion.

The installation of the SB was carried out based on kit drawings. These detailed the installation of the WOW switches and the LIFT DUMP handle. The WOW switch installation however omitted to provide details on the build up of the switch mounting hardware and as such omitted to show the location of the lock washer or tab washer. The WOW switches on N200PR had been installed with the tab washer between the upper nut and the bracket, and the lock washer between the lower nut and the bracket, which had led to damage of the support bracket. (See Figure 4.)

The bracket had failed due to stress corrosion cracking, a mechanism which requires a corrosive environment to develop. This had been provided by the use of dissimilar metals, with the use of aluminium alloy for the support bracket and steel for the WOW switch mounting hardware. These had set up galvanic corrosion and provided the initial mechanism for the crack. The second mechanism for the cracking to develop is stress and this had been provided by the outer tang of the tang washer that had been forced against the edge of the tang support hole of the bracket. The reason for this had been due to the inner tang riding out of its key way and finding its way into the threads of the switch. This can only have occurred during the installation of the WOW switch and was most probably because of the tightening of the lower nut for rigging purposes without the concurrent adjustment of the upper nut. This rigging adjustment placed a torque on the switch body, which then caused it to rotate in relation to the fixed tang washer.

It was also discovered that both the left and right WOW switches had been installed with the lock washer between the lower nut and the bracket, and thus allowing its teeth to dig into the metal of the underside of the bracket. Again, this set up a similar galvanic corrosion mechanism, which could have contributed to the stress corrosion cracking. It is common engineering practice not to put a lock washer immediately against the structure due to the possibility of damage. The WOW switches had formed part of a modification to the lift dump system, and were installed based on the SB and kit

Since this accident, Raytheon have issued SB 32-3678 which requires inspection of the WOW switch support brackets for cracking and provides information on the correct installation of the switch, placing the lock washer between the tang washer and the upper nut. Nevertheless, some features of the design are, in the opinion of the AAIB, unsatisfactory and could still lead to corrosion and or cracking and therefore the following recommendation is made:

It is recommended that Raytheon Aircraft Company review the design and installation of the weight-on-wheels switches and support hardware fitted to the Premier 1 aircraft, with a view to reducing the possibility of stress corrosion cracking.

Raytheon Aircraft Company has accepted this recommendation. In addition to the Mandatory Service Bulletin 32-3678 Raytheon Aircraft Company have revised the appropriate engineering drawings and production planning data to specify the correct assembly of the switches and attaching hardware. Finally, for new production aircraft (beginning at serial number RB-143), and spares, the switch attach bracket material has been changed to 4130 steel to improve corrosion protection.

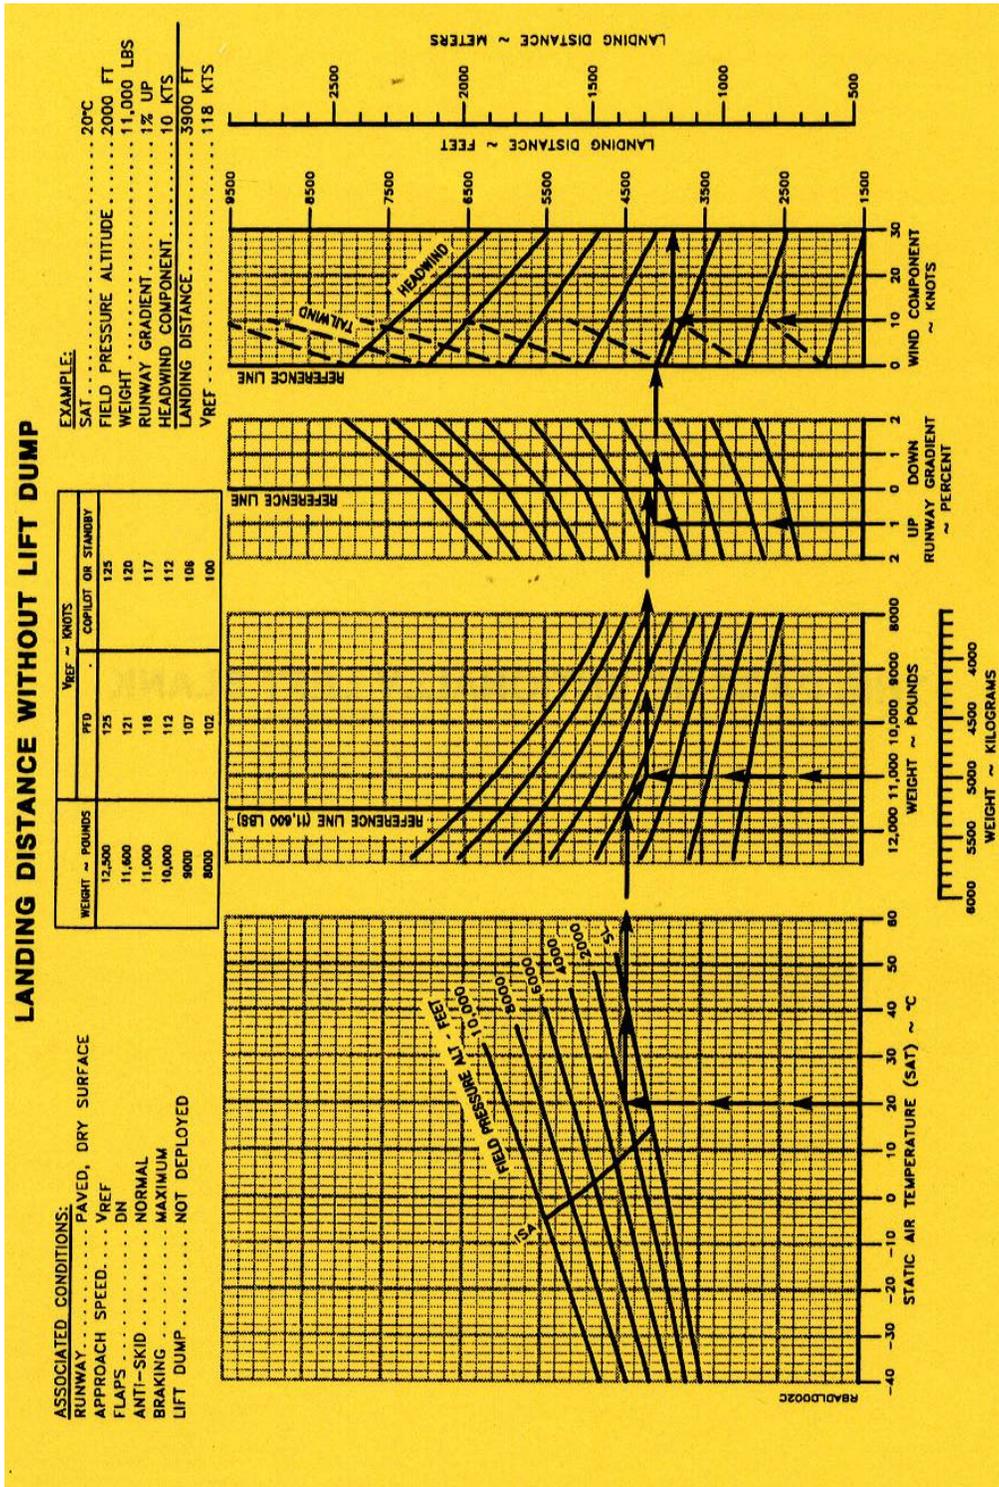
Figure 6 - FAA AD imposed Landing Performance Chart without Lift Dump

The aircraft involved in this accident had a modified lift dump system; however, the temporary landing performance chart for lift dump failure had not been removed from the AFM. When checking the required landing distance for Blackbushe Airport, whilst on the ground at Farnborough, the pilot had used this temporary chart.
