Crash During Approach to Landing
Business Jet Services, Ltd.
Gulfstream G-1159A (G-III), N85VT
Houston, Texas
November 22, 2004

ACCIDENT BRIEF

NTSB/AAB-06/06
PB2007-100699

Accident Number:	DCA05MA011
Aircraft and Registration:	Gulfstream III, N85VT
Location:	Houston, Texas
Date:	November 22, 2004
Adopted On:	November 2, 2006

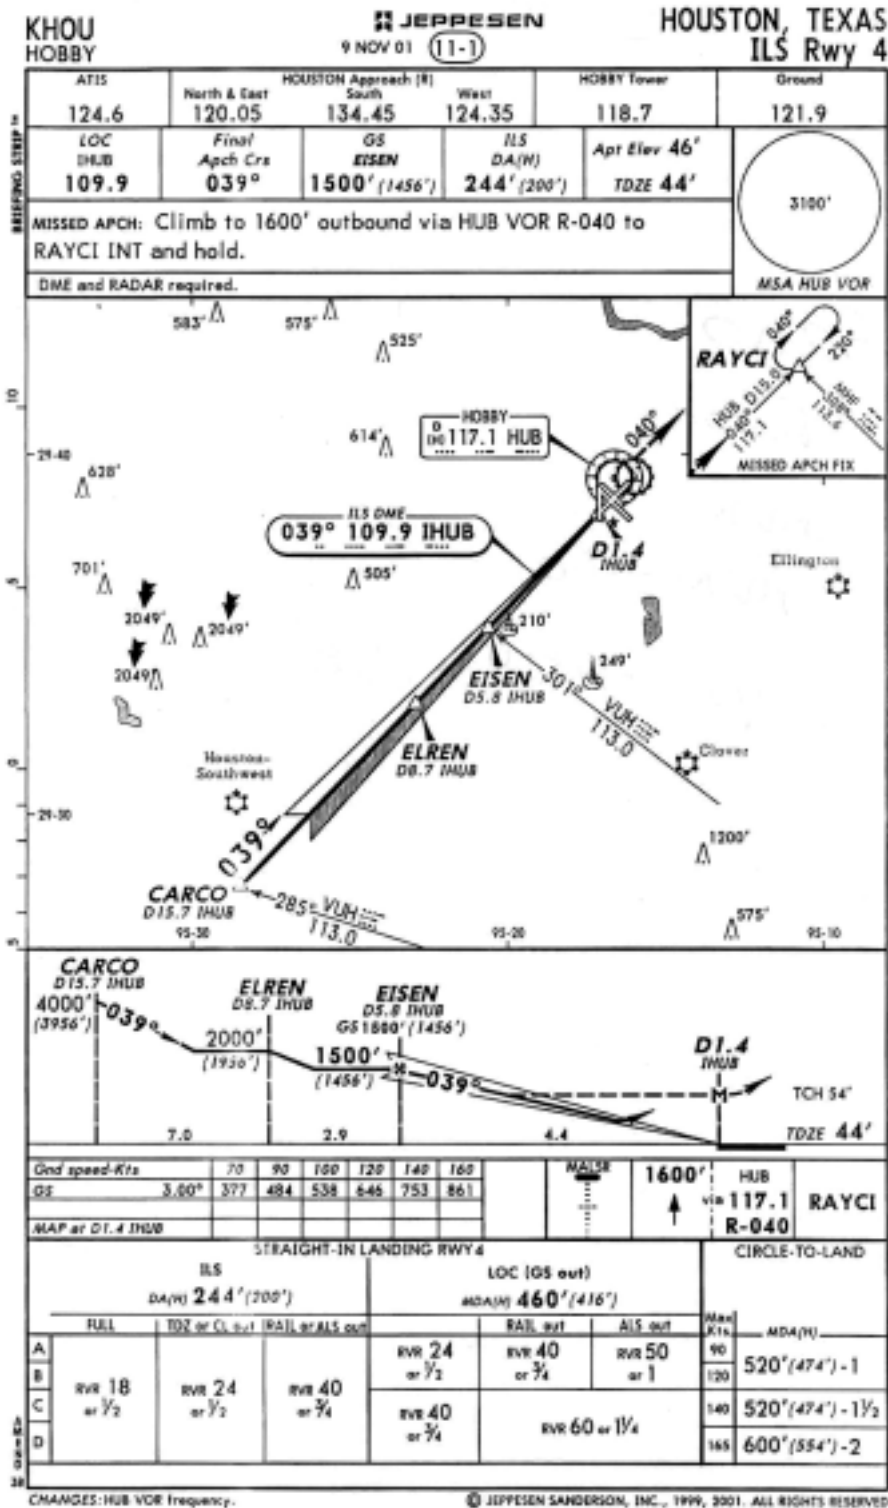
Figure 1. ILS runway 4 published approach chart. (Reproduced with permission of Jeppesen Sanderson, Inc. Not to be used for navigation.)

⁷ According to the published ILS runway 4 approach chart (see figure 1), the minimum allowable RVR for an ILS approach to runway 4 is 1,800 feet. Under 14 CFR Part 91 operations, pilots are allowed to initiate an approach when the reported visibility is below minimums.

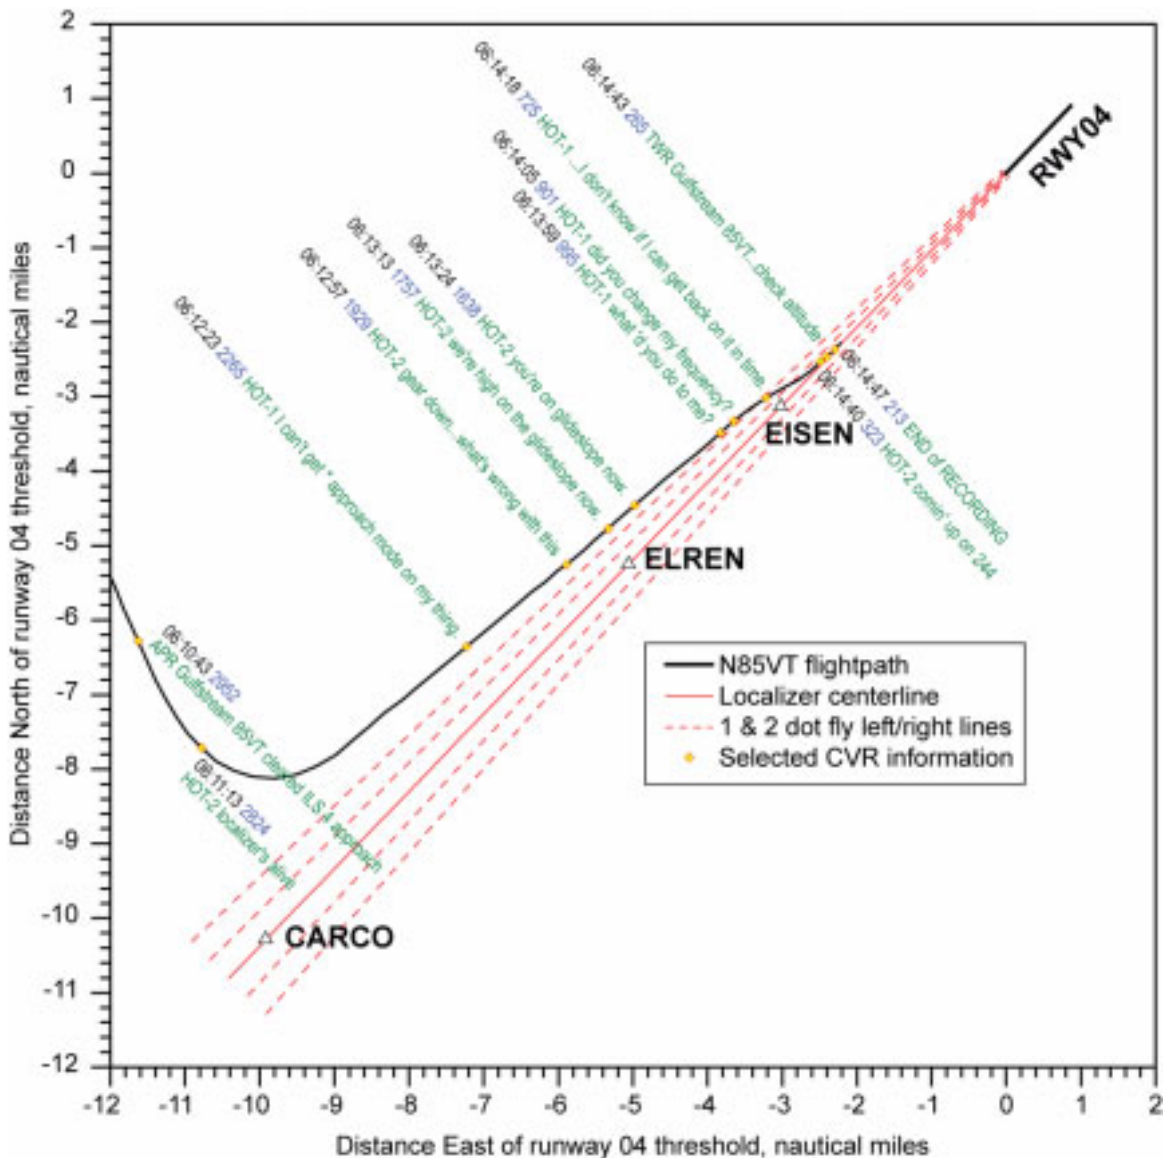
Figure 2. Accident airplane's ground track.

At 0605:05, the Houston TRACON controller instructed the flight crew to descend to and maintain 3,000 feet. Radar data indicated that, about this time, the airplane was at an altitude of about 11,000 feet and was located about 29 miles northwest of HOU. At 0609:33, the first officer started the before landing checklist, and, about 1 minute later, he stated, "five miles...from CARCO." At 0610:43, the controller instructed the flight crew to turn left heading 070° and to maintain an altitude of "2,000 feet or above 'til established [on the] localizer." The controller then cleared the flight for the ILS runway 4 approach. At 0611:13, the first officer stated, "localizer's alive." (See figure 2 for the accident airplane's ground track.)

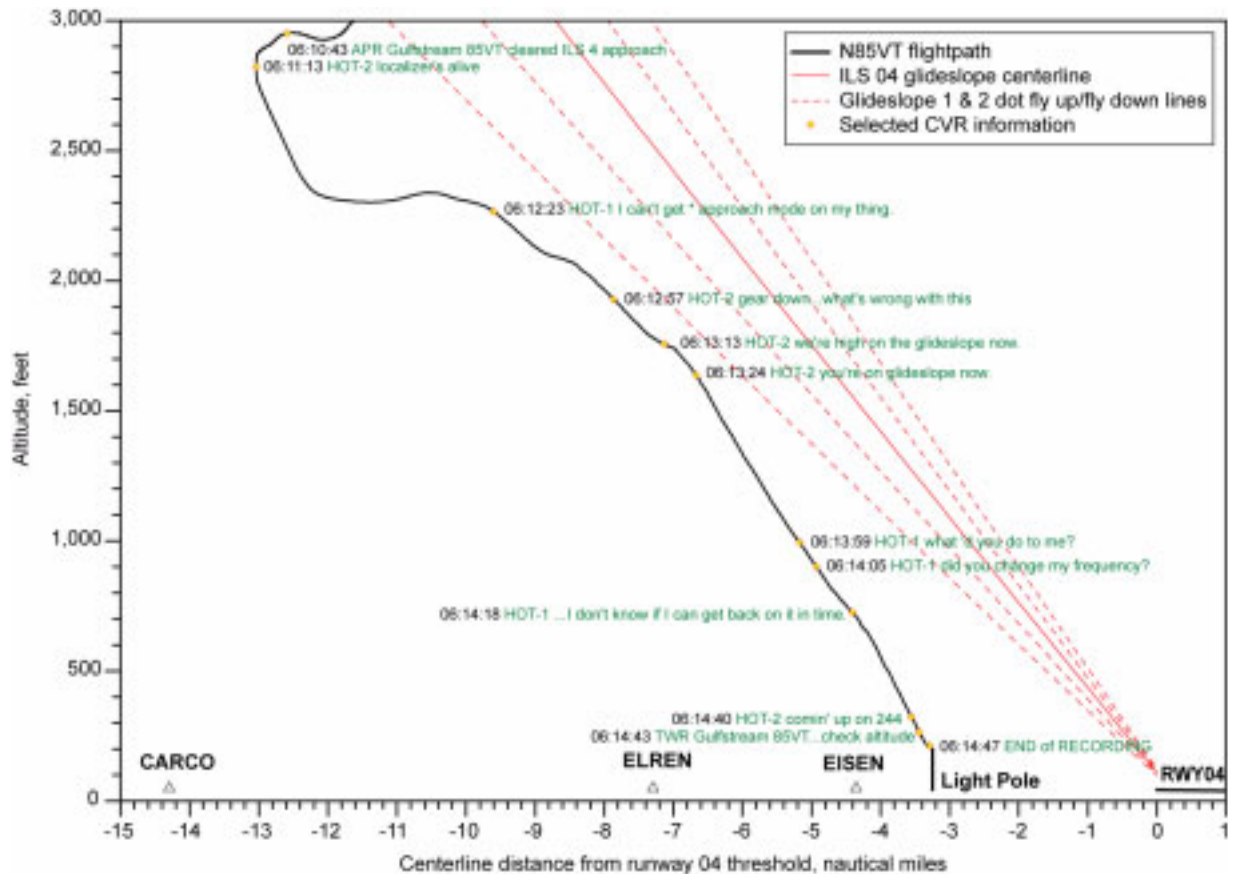
Figure 3. Accident airplane's altitude profile.

At 0612:31, the HOU ATCT controller reported to the first officer that the RVR was 1,600 feet.⁷ The first officer acknowledged the transmission. At 0612:40, the first officer stated, “gear down.” At 0612:57, the first officer asked, “what [is]...wrong with this?” The captain responded, “I don’t know.” At 0613:03, the first officer further asked, “what do we have set wrong? we have...long range [navigation or NAV] or something... that we shouldn’t have?” Five seconds later, the captain reported, “got NAV...VOR one.” The first officer stated, “okay, we’re high on the glideslope now,” and the captain replied, “just gonna have to do it this way.” At 0613:24, the first officer stated, “guess so. yeah you’re on [the] glideslope now.” However, the airplane performance study showed that, about the time that the first officer made the comments about the glideslope, the airplane was at an altitude of about 1,700 feet and was 700 feet below the glideslope. (See figure 3 for the accident airplane’s altitude profile.)

At 0613:44, the captain asked the first officer if they were going to descend to an altitude of 244 feet,⁸ and the first officer replied, “yeah.” The airplane performance study indicated that, about 0614, the airplane was at an altitude of about 1,000 feet. At 0614:05, the captain asked, “what happened? did you change my frequency?” The first officer responded, “yeah we were down there...the VOR frequency was on.” He then stated, “we’re all squared away now...you got it.” The captain responded, “yeah, but I, I don’t know if I can get back on it in time.” The first officer replied, “yeah you will...you’re squared away now.” The airplane performance study showed that, shortly after the captain’s question regarding the frequency, the airplane turned right and subsequently intersected the ILS runway 4 localizer centerline. As shown in figure 3, about this time, the airplane was at an altitude of about 900 feet and was 800 feet below the glideslope.

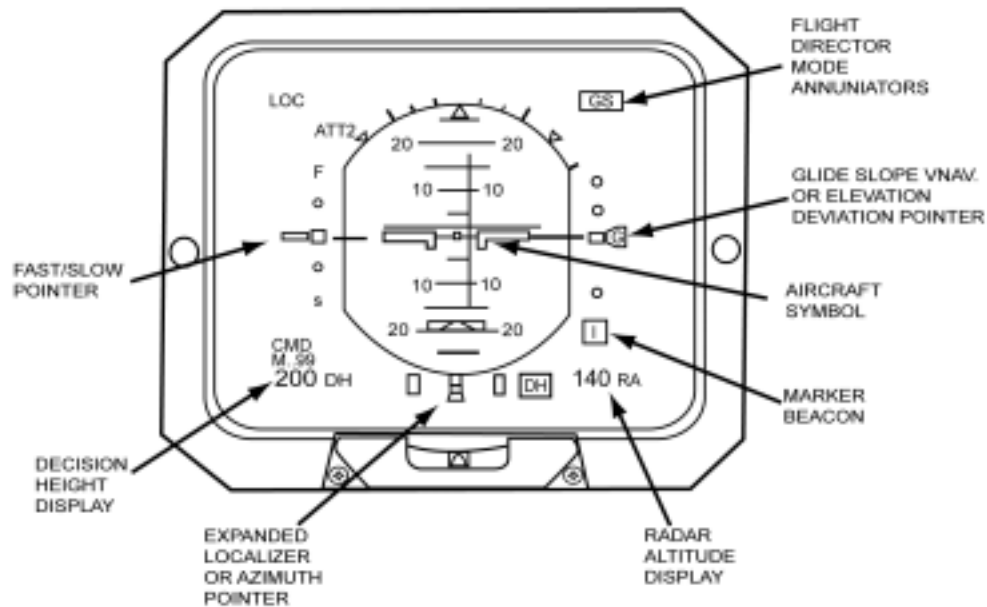
Figure 4. A diagram of the EADI.

The glideslope and fast/slow indicators are the same color and about the same size. Each indicator consists of a moving pointer on a rectangular display, and each display has markers above and below the rectangle to indicate the degree of deviation. The glideslope pointer resembles a blunt-point arrow, and the fast/slow pointer resembles a rectangle (see figure 4). The accident airplane’s EADI was configured with the glideslope indicator on the left side and the fast/slow indicator on the right side.¹² A review of the Safety Board’s accident database revealed

Note: The diagram shows the glideslope and the fast/slow indicators on the right and left side of the EADI, respectively, which is opposite of the accident airplane's configuration.

The first officer’s failure to activate and identify the ILS frequency earlier in the approach prevented the flight crew from recognizing that the airplane was off course and below the glideslope. The fast/slow indicator on the EADI resembles the glideslope indicator and is visible on the EADI at all times, whereas the glideslope indicator only appears on the screen once an ILS frequency has been activated. Postaccident flight simulations revealed that the fast/slow indicator would have been centered within one dot during the approach sequence and that the indications would have been consistent with the first officer’s comments about the glideslope if he had mistaken the fast/slow indicator for the glideslope indicator.
