**Collision with Trees and Crash Short of the  
Runway, Corporate Airlines Flight 5966  
BAE Systems BAE-J3201, N875JX  
Kirksville, Missouri  
October 19, 2004**

**NTSB/AAR-06/01**

**NTSB/AAR-06/01  
PB2006-910401  
Notation 7694A  
Adopted January 24, 2006**

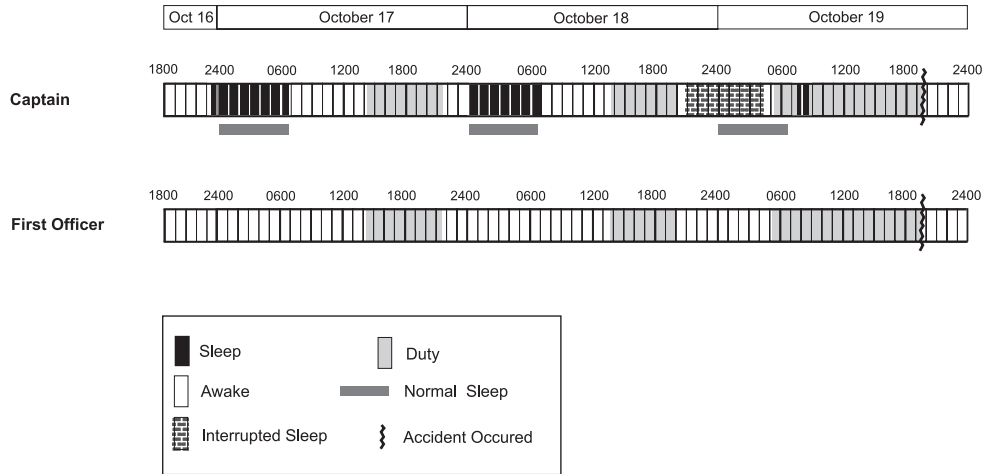
**Figure 1.** The estimated duty schedules for both pilots and the estimated sleep schedule for the captain.

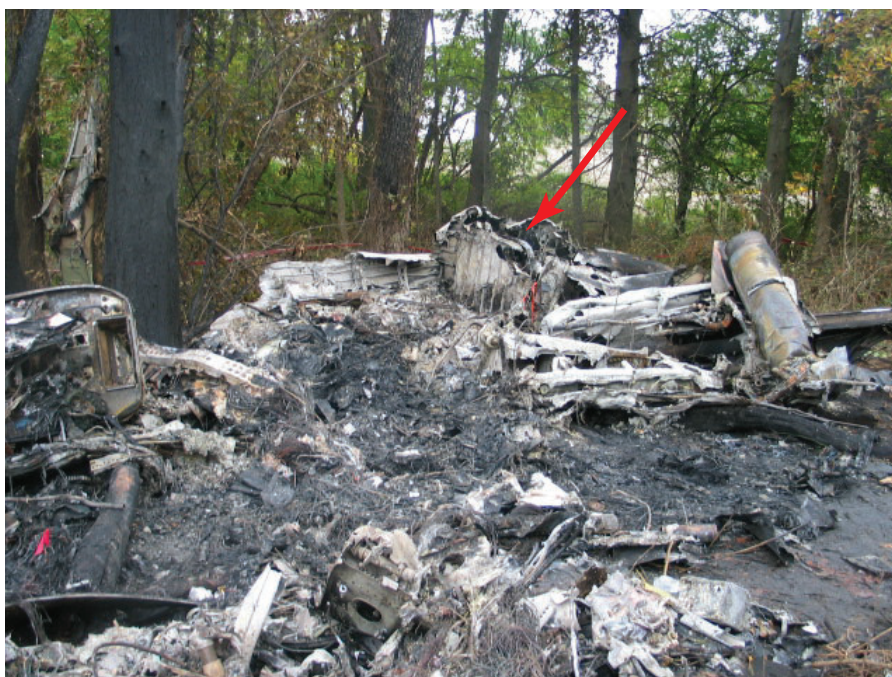
The main wreckage (which included the remains of the fuselage and the empennage, the right wing, the inboard portion of the left wing, and the remains of the right engine and propeller and the left propeller) was located in an almost circular area about 30 feet in diameter and exhibited extensive fire damage. Most of the main wreckage and the surrounding vegetation were consumed by fire. Figure 5 is a photograph of the main wreckage area.

**Figure 5.** Photograph of the main wreckage area.

The forward section of the airplane is in the foreground, and the tail section is in the background (the aft pressure bulkhead is indicated by the red arrow).

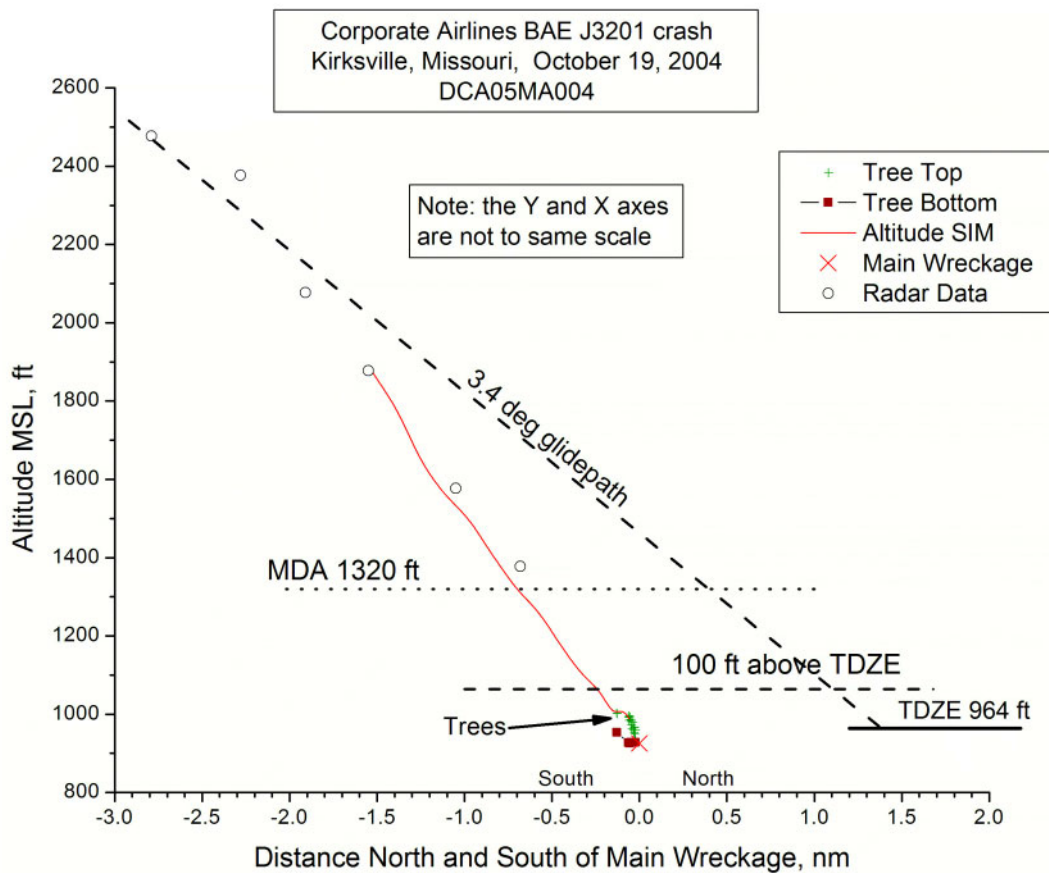
**Figure 6.** The accident airplane’s descent profile during the accident approach with the airport/runway location shown.

The following altitudes are also shown: MDA, 100 feet above the TDZE, and the TDZE. Additionally, a 3.4° visual glidepath to the airport is shown for reference purposes only.

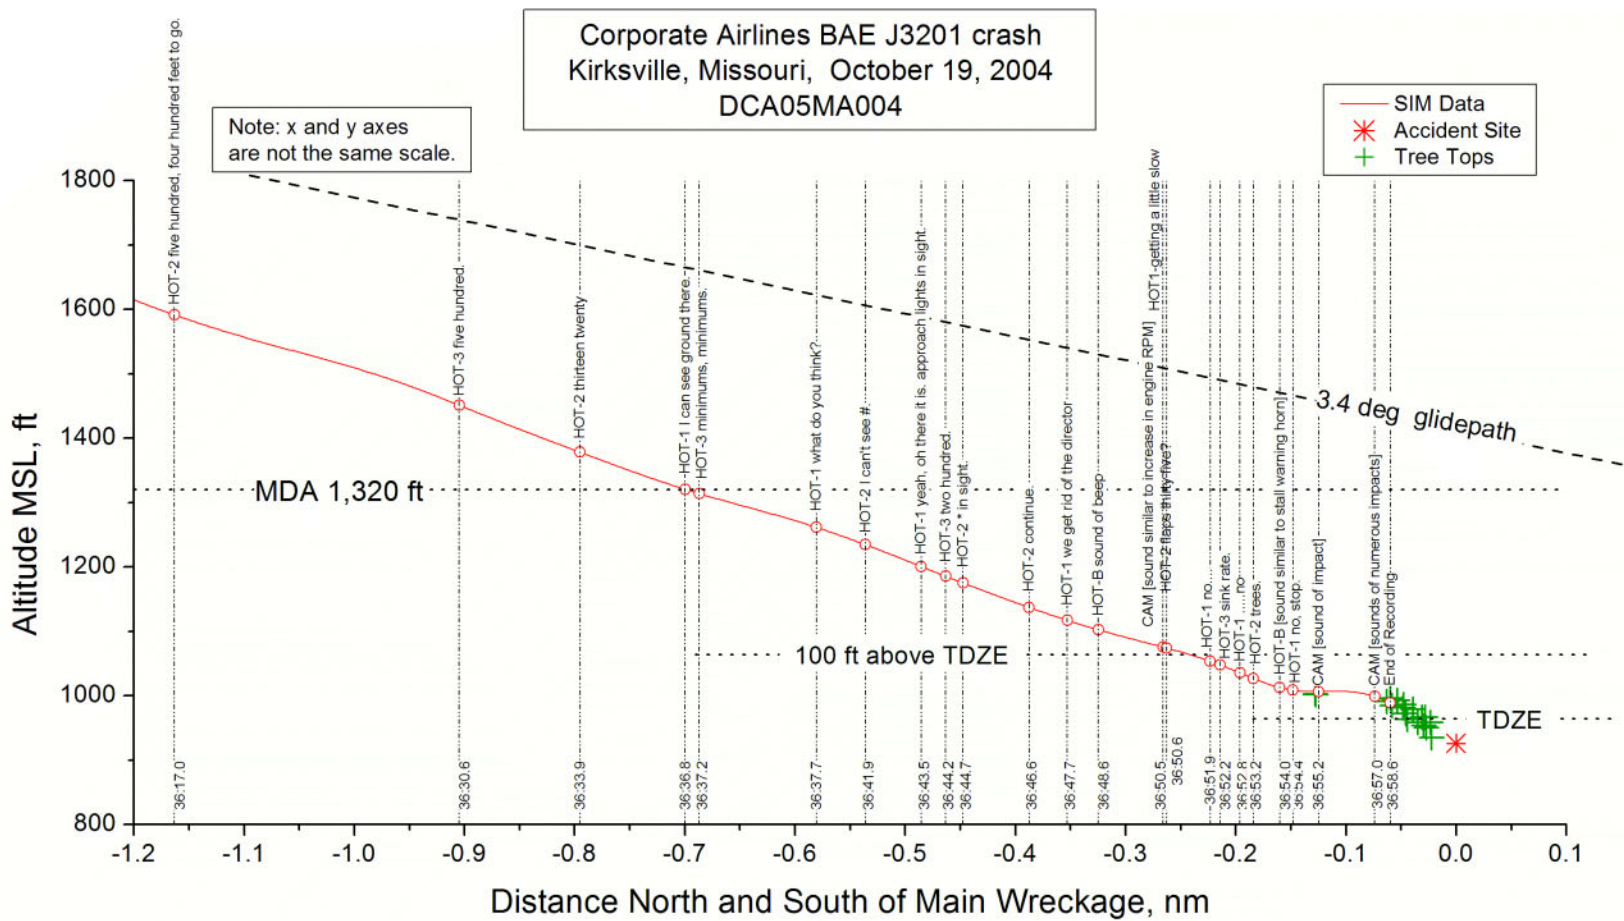
**Figure 7.** The accident airplane's descent profile during the accident approach with CVR comments overlaid.

The following altitudes are shown: MDA, 100 feet above the TDZE, and the TDZE. Additionally, a 3.4° visual glidepath to the airport is shown for reference purposes only.

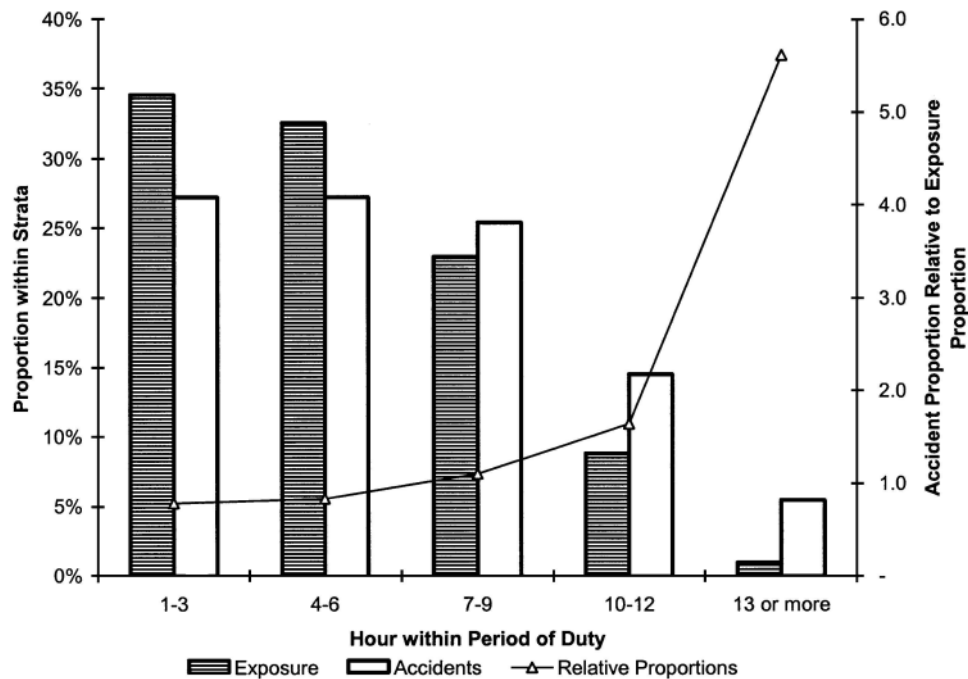
**Figure 8.** Aviation accident data from 55 accidents involving U.S. air carriers between 1978 and 1999, indicating that accidents are more prevalent as the length of the pilots' duty period increases.
