Statens haverikommission
Swedish Accident Investigation Board

Report RL 2005:07e

**Aircraft accident to SE-LNT
at Luleå/Kallax Airport, Norrbotten County,
Sweden, on 17 September 2003**

Case L-49/03

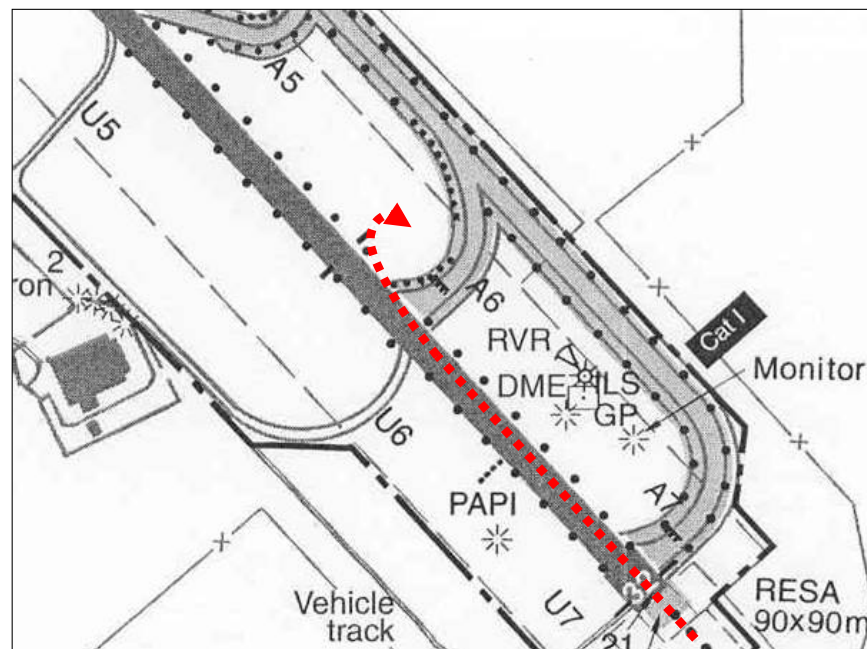
The site of the crash

The aircraft hit the ground first with its right wing-tip which struck on the right verge of runway 32 just over 500 metres from the threshold. About 50 metres further on in the direction of travel, in the area of grass between the main runway and the taxiway, the fuselage struck the ground hard, nose first. The aircraft then slid on its belly, describing a right swerve, for another 50 metres or so before coming to a standstill the right way up. The aircraft was then approximately 60 metres from the runway verge with the nose pointing largely in the direction of its approach. (See sketch below.)

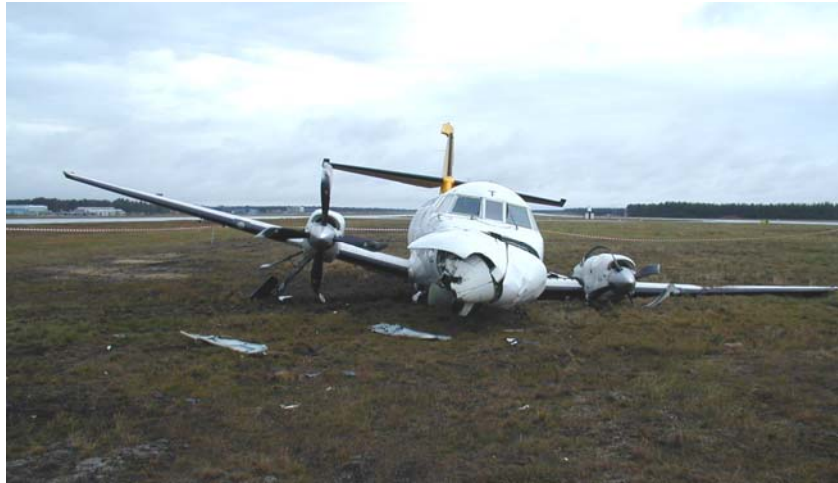
The wrecked aircraft

The aircraft was severely damaged. The nose section was pushed in and the rear of the fuselage was cracked. All the landing gear and the left wing main spar were fractured. All the propeller blades were deformed

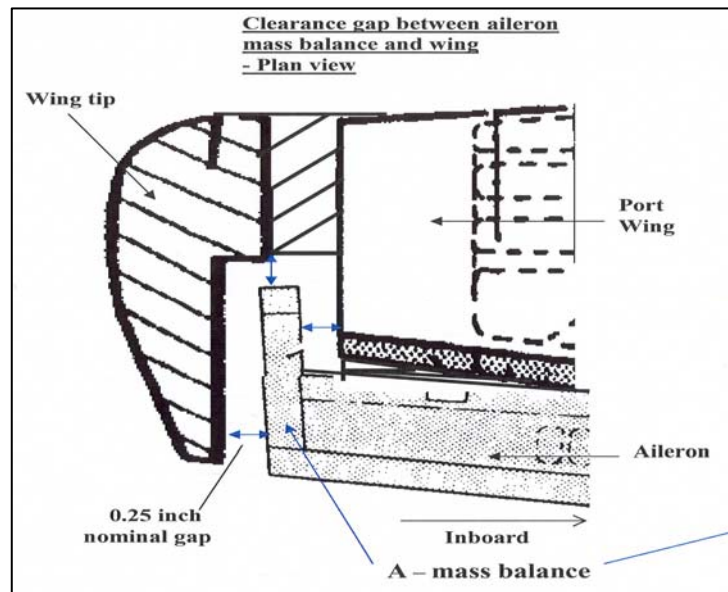
Aileron balance

The aircraft's ailerons are balanced using counterweights in the outer tip of the aileron. The weights are fixed in holders with two bolts. The counterweight holders are let into the wings with a clearance of 0.25 inches (6.4 mm). (See illustration below.)

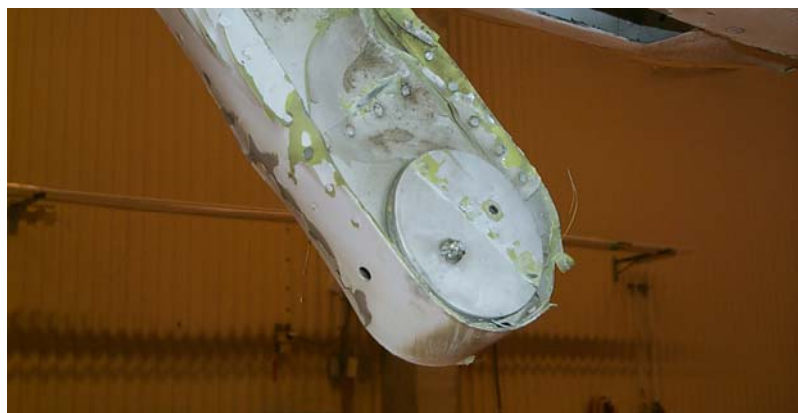
The counterweight holder on the left aileron was partly broken off when the left wing hit the ground. Closer inspection of the counterweight mounting showed that one of the two fastening bolts for the weights had failed and the castle nut was missing.

Broken fixing bolt for balance weights

Metallurgical examination of the fracture surface of the failed fixing bolt showed that the fracture was caused by shearing.

A check measurement of the dimensions of the balance weights and the undamaged fastening bolt in the broken-off weight holder showed that the balance weights were not correctly installed, in that the threaded ends of the fastening bolts projected from the plating of the balance weight holder by 0.1 inches (2.5 mm).

As explained in section 1.16.2 damage to the left aileron was found during the technical inspection. The appearance of the 'stamp' damage to the wing and the fracture analysis of the fastening bolt show that the bolt must have caught in the shell plating when the wing-tip struck the ground and then been shorn off.

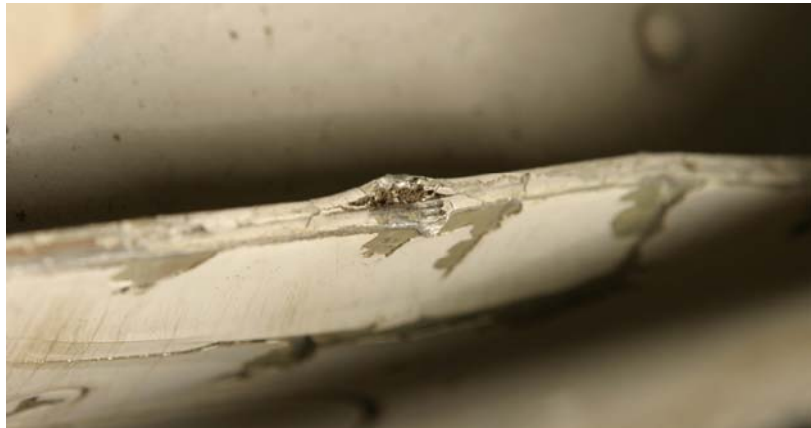
In addition, damage to the metal shell plating on the underside of the wing opposite the balance-weight fastening bolts was noted. The damage was in the form of "stamping" from some object with a threaded profile and

also "wear damage" judged to have arisen through repeated metallic contact.

Damage to shell plating on underside of wing

The wear damage at the same place suggests that there was a certain mechanical contact between the threaded end of the bolt and the shell plating on the underside of the wing before the accident even though the static clearance ought to have been almost 4 mm. The contact was evidently sporadic, depending on movements and vibrations in the wing and aileron. No report was made of inertia or resistance in the aileron system, indicating that in practice the somewhat reduced clearance between bolt and shell plating did not affect the mobility of the aileron.
