**ATSB TRANSPORT SAFETY INVESTIGATION REPORT**  
Aviation Occurrence Investigation  
200400610

FINAL

**Aero Commander Div**  
**Shrike Commander**  
**19 February 2004**

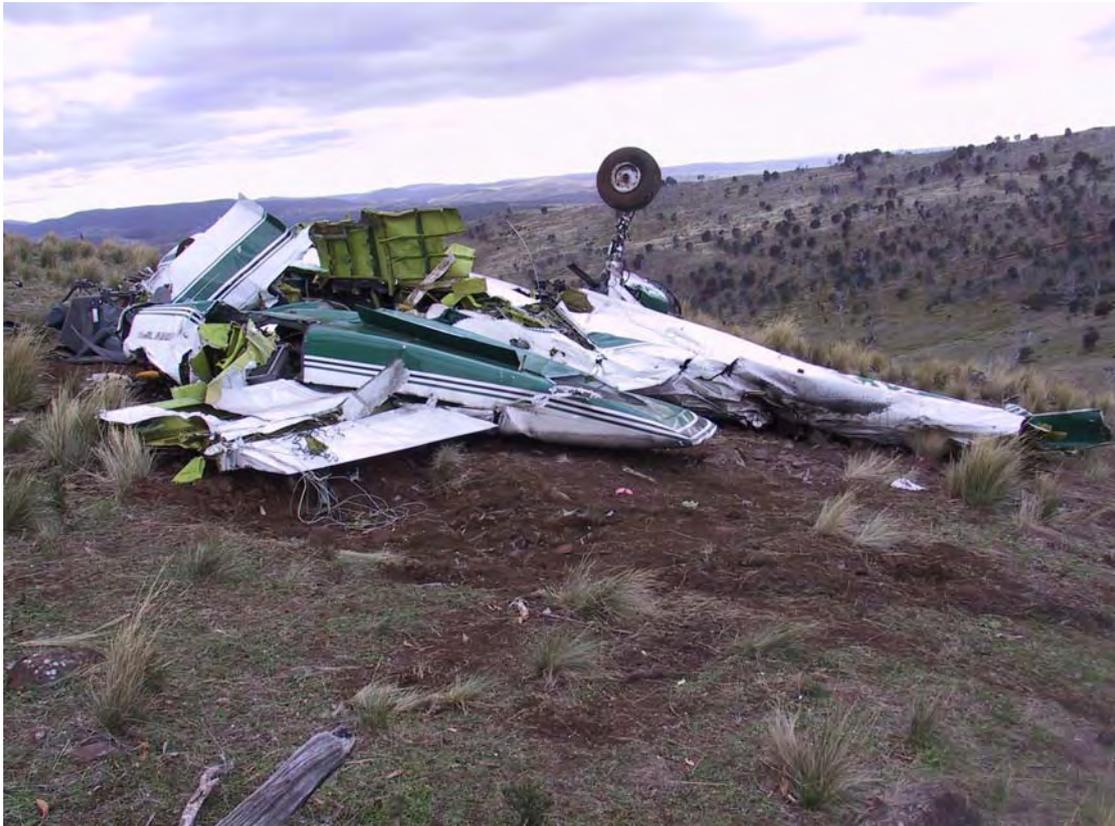
**Figure 1: Main wreckage**

The main wreckage of the aircraft, which comprised the cabin, aft fuselage, inboard wing sections and both engines, came to rest inverted on undulating terrain. The aircraft had moved approximately 4 m from the first impact position. The wing sections outboard of the wing flaps of both wings and the tail section of the aircraft were not co-located with the main wreckage. These items, along with other items from the aircraft, were located in an area that was downwind of the main wreckage. Some lighter items were found up to 1,300 m from the main wreckage.

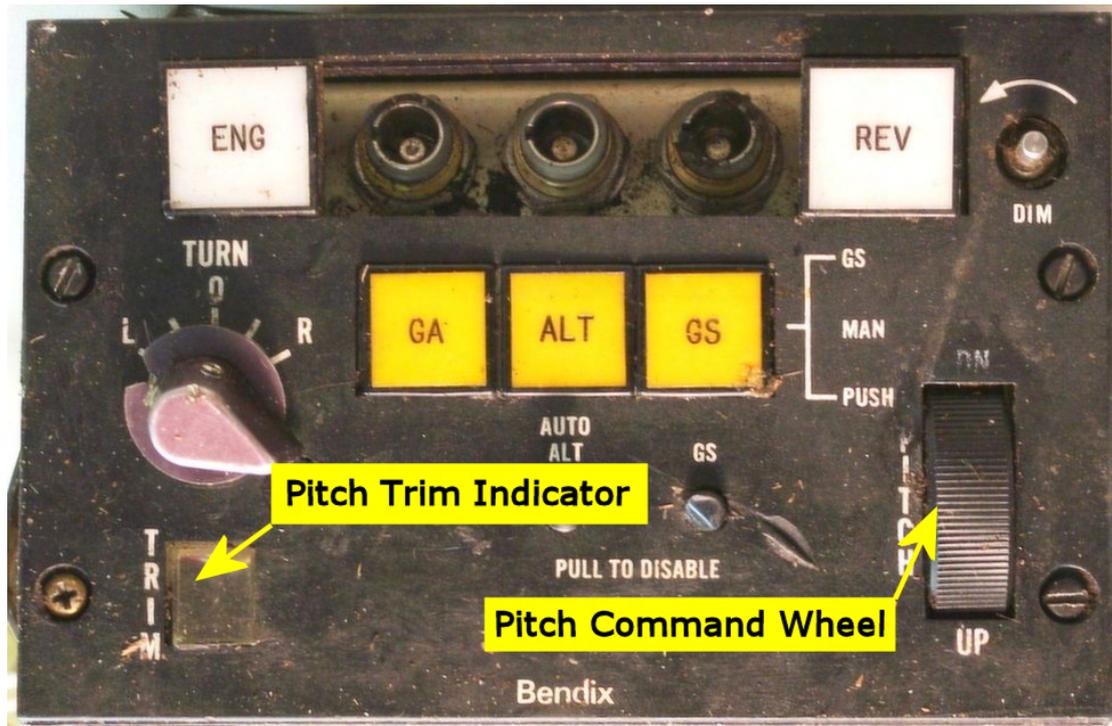
**Figure 3: Autopilot controller recovered from VH-LST**

The autopilot controller pitch command wheel was found in the maximum aircraft nose down position.

Had the autopilot been engaged in cruise with the pitch command wheel in the maximum aircraft nose-down position (as found in the wreckage), the aircraft would have immediately pitched nose down. The natural reaction of a pilot would be to arrest the movement by applying rearward control column pressure. If this pressure was sustained, the autopilot would have progressively driven the elevator trim to the maximum aircraft nose-down trim position.

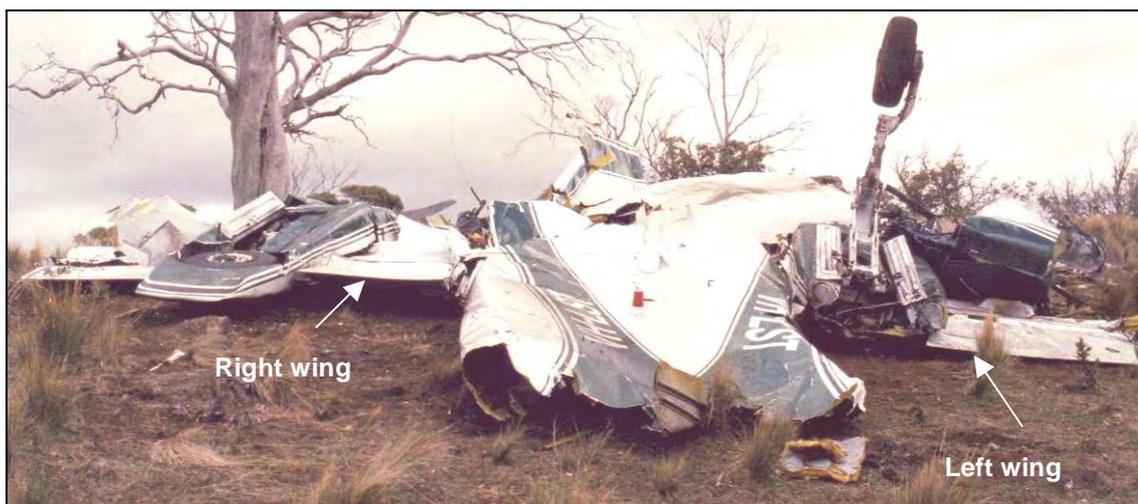
**Figure 2: General view of main wreckage looking towards the cockpit from the tail**

The main wreckage, comprising the aircraft forward and aft fuselage, inboard wing sections and flaps, came to rest inverted in undulating terrain approximately 560 metres above mean sea level at latitude 42.368 °S, longitude 147.211 °E. Both engines and propellers were located with the main wreckage. Both wing sections, outboard of the wing flaps, and the tail section of the aircraft, were not co-located with the main wreckage.

**Note the outer wing panels and empennage had separated from the main fuselage and were located a distance away. Main wreckage impacted the ground inverted**

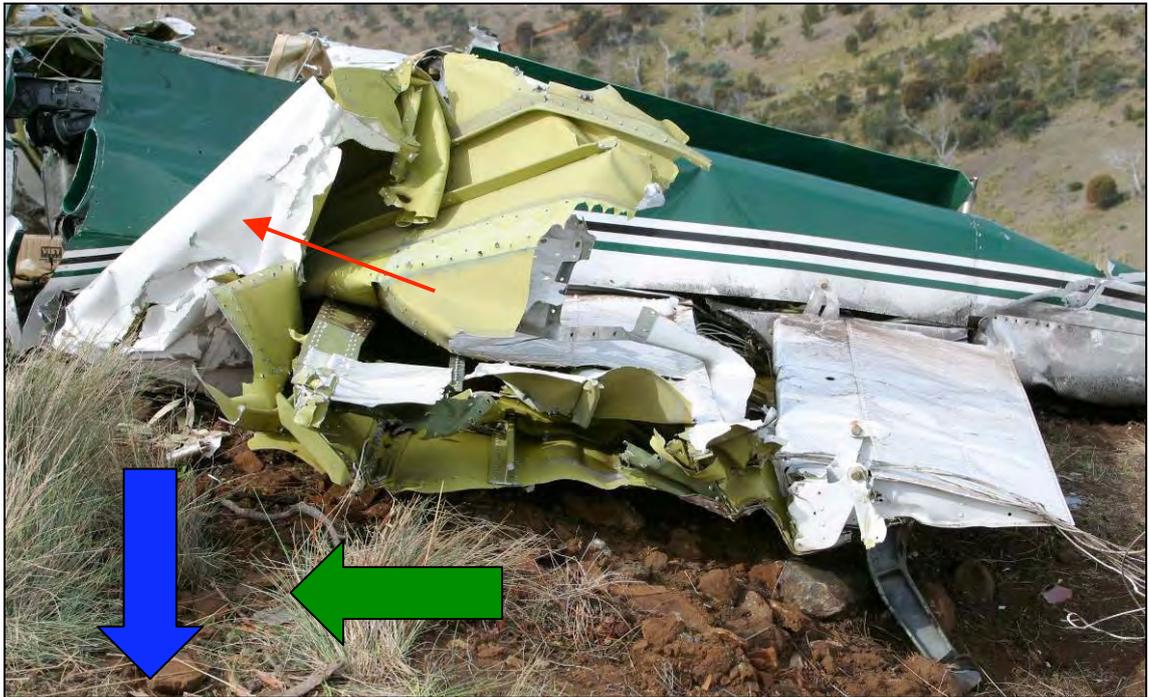
**Figure 7: Main wreckage - right inboard wing separation point with right outboard flap in right foreground**

The left and right wings failed in a symmetrical manner at a similar span wise location. The general span wise location of the wing spar failures was at WS145, coincident with the location of a spar splice at the outboard end of the flaps/ inboard end of the ailerons. The fracture of all wing spars was either at WS145 or at the end of doublers supporting the spar splice. The fractures were all consistent with ductile failures under overload conditions. No evidence of pre-existing defects at these locations was found. The wings failed in a downwards and nose down direction, moving rearwards at separation.

**Note downward and rearward deformation of leading edge structure just outboard of nacelles (arrowed)**

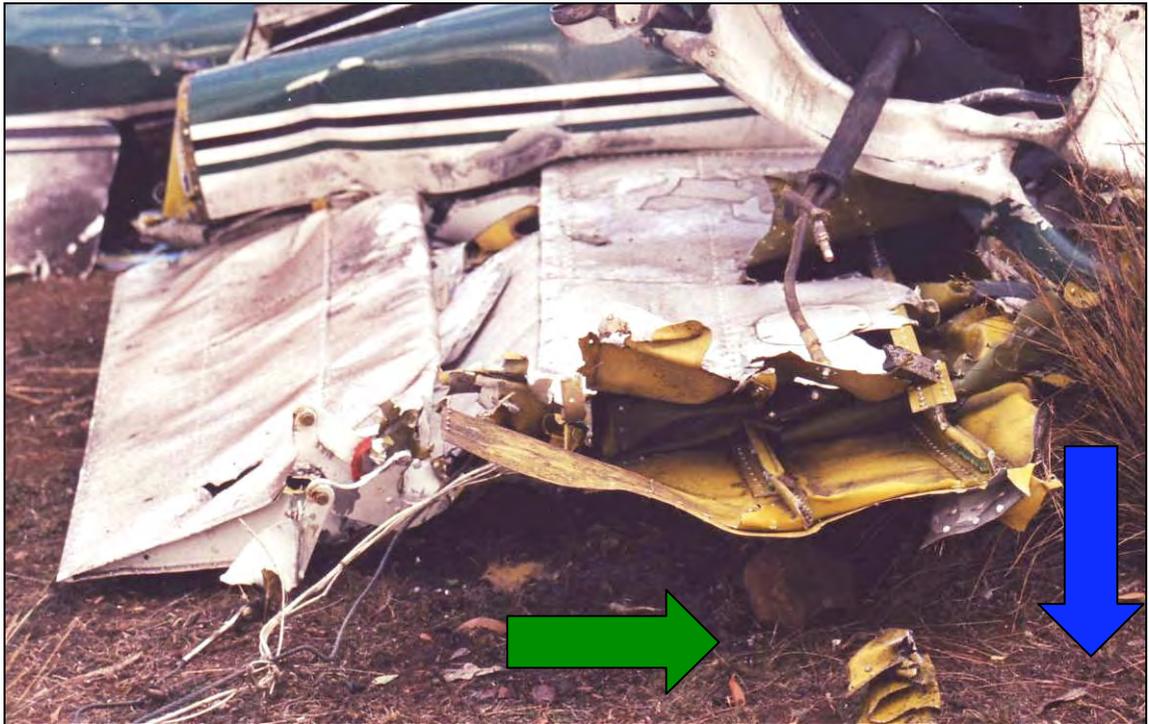
**Figure 8: Main wreckage - left inboard wing separation point with left outboard flap in left foreground**

Note missing rear engine nacelle

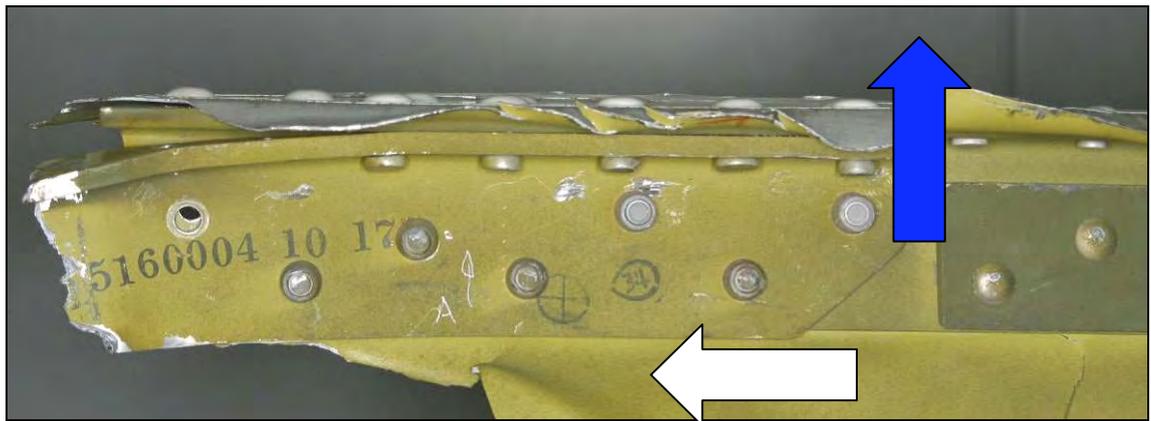
**Figure 10: Right main spar upper cap showing fractured aft doubler and outboard extent of rear doubler (nested angle)**

**Note downward loading**

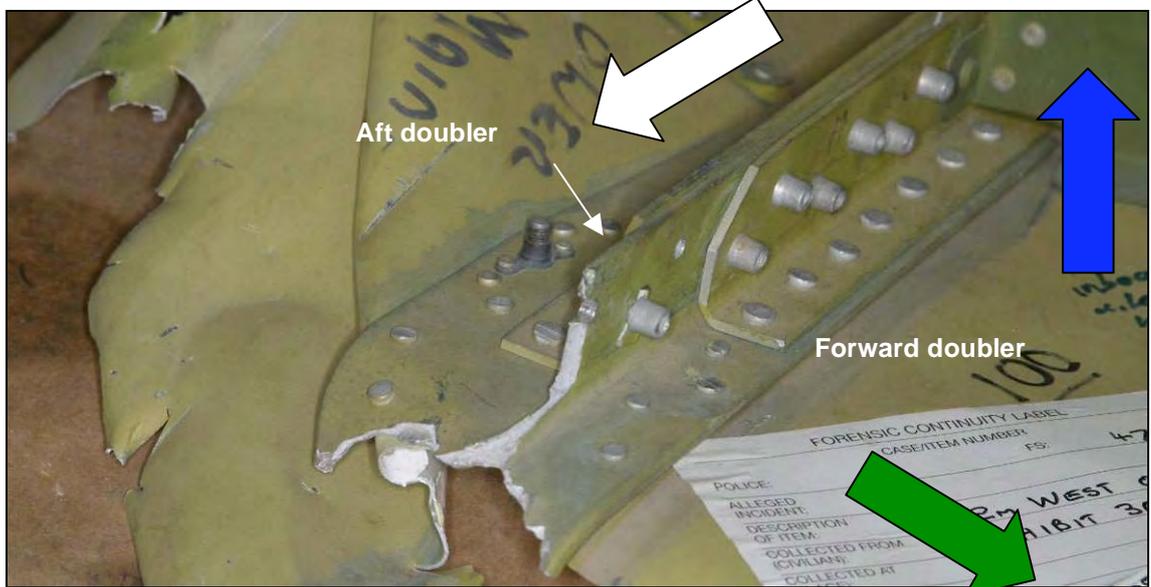
**Figure 11: Left main spar, lower cap failures on Item 47. View of inboard fracture**

**Note downward plastic deformation and tearing of T-section centre leg near the inboard end of the aft doubler**

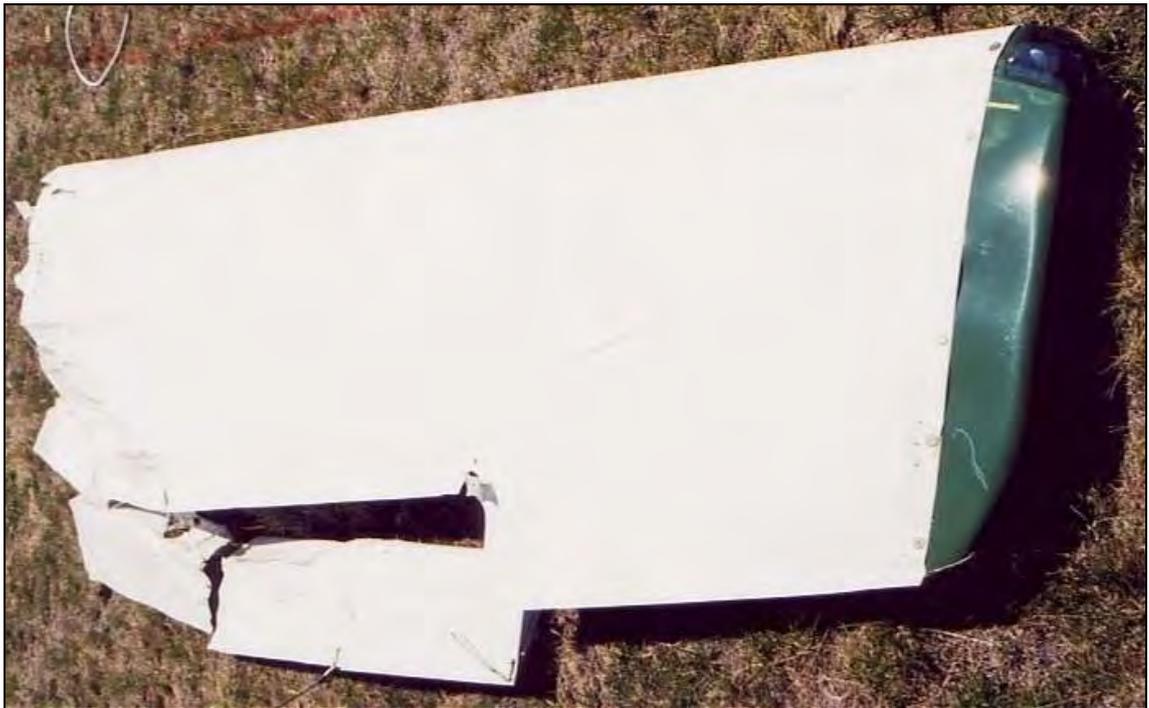
**Figure 12: The separated right wing with the aileron reconstructed in the respective position**

The ailerons separated at the centre hinge and were torn from the wing rear spars. The nature of the aileron failure (twisting around the centre hinge) indicated that the aileron fracture and separation were a consequence of the wing spar fracture. The ailerons therefore separated from the wing at the time of the wing separation.

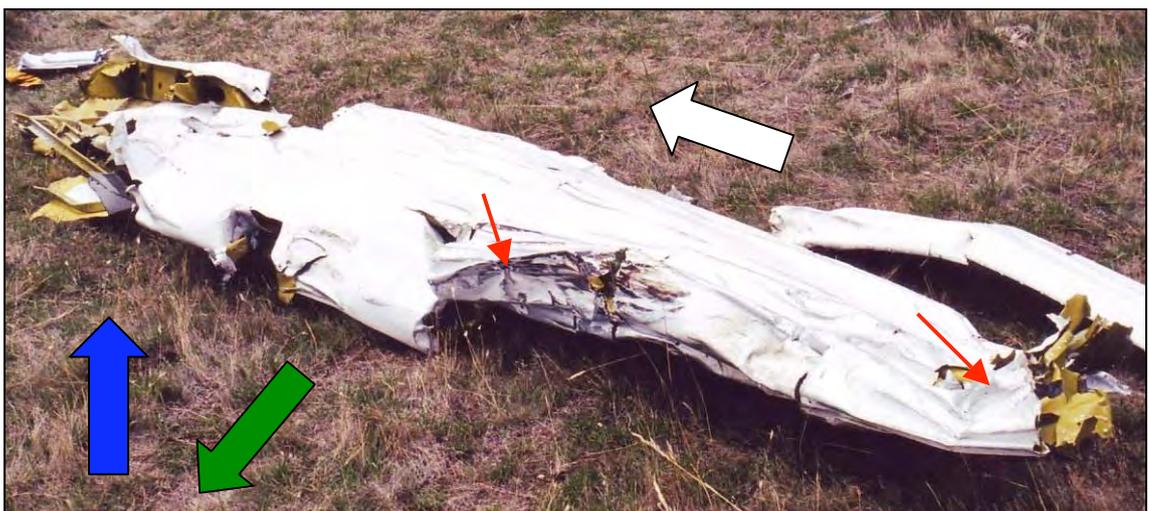
**Figure 13: Separated left outer wing panel**

The separated right wing section had no evidence of contact with other parts of the aircraft following its separation. The separated left wing leading edge and upper leading edge had damage consistent with contact with the left landing gear and aft nacelle. The left wing leading edge and lower surface had deformation and green paint transfer, consistent with contact with the aft fuselage.

**Note extensive leading edge damage with black rubber like smears and upward deformation at outboard end (arrowed)**

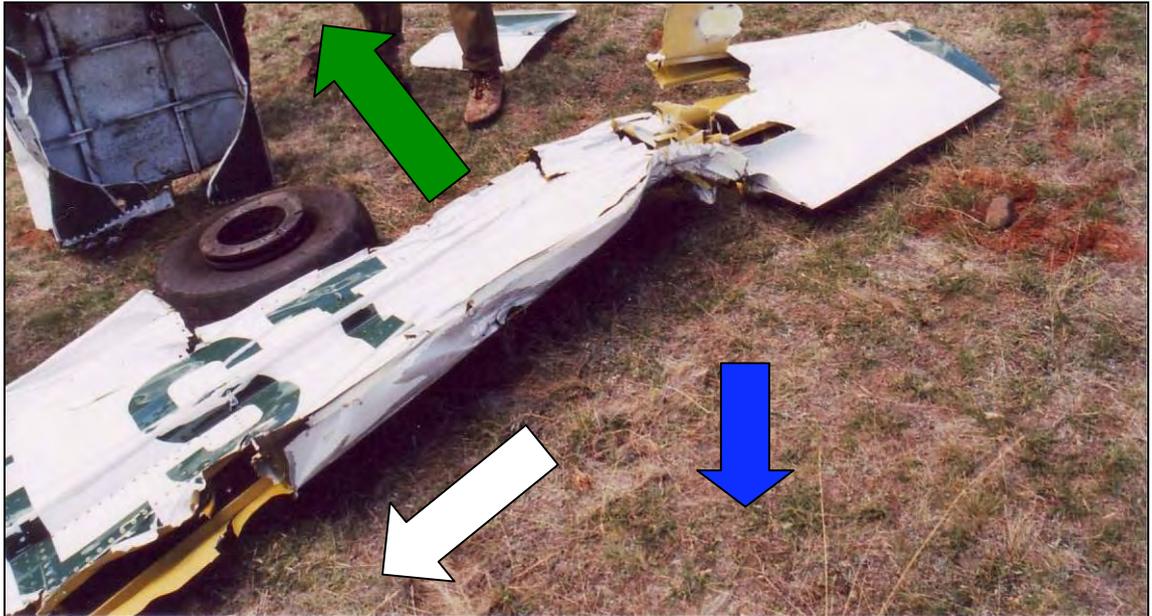
**Figure 14: Trailing edge damage from impact with fin and horizontal stabiliser**

The left wing trailing edge had deformation consistent with contact with the leading edge of the horizontal stabiliser, which resulted in a secondary fracture of the rear spar.

**Note also separated wing tip and upwards deformation at separation point**

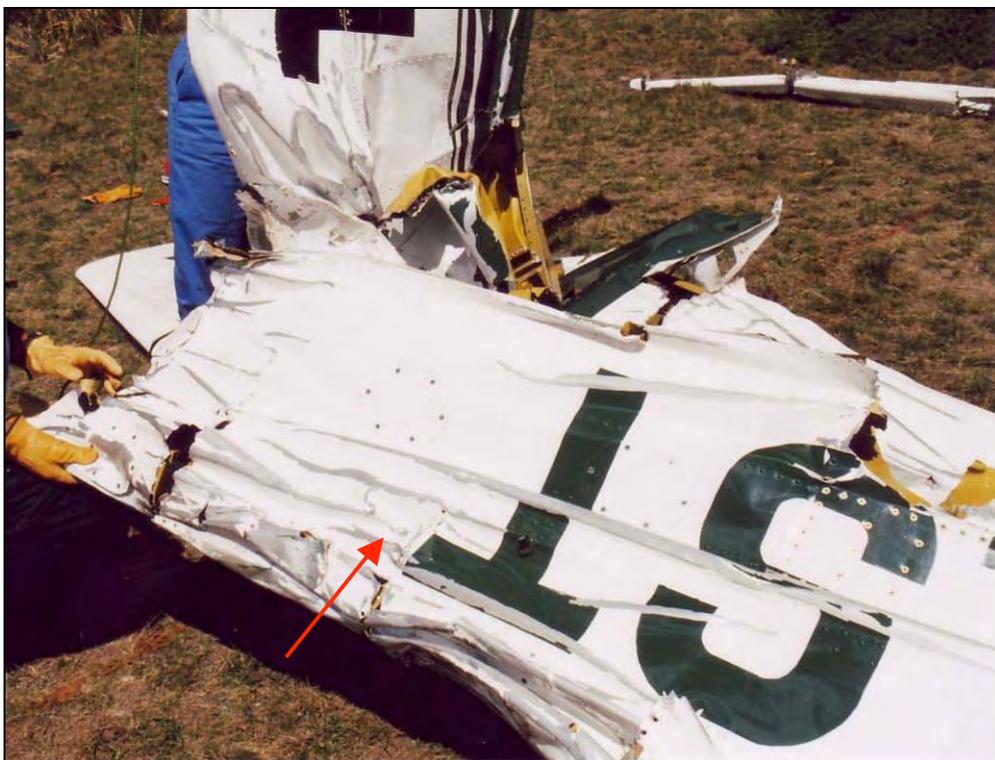
**Figure 15: Left wing outboard trailing edge contact with vertical stabiliser leading edge. View from left side. Inboard section of wing would be lower for trailing edge contact with horizontal stabiliser**

The left wing tip and trailing edge had deformation consistent with contact with the leading edge of the vertical stabiliser.

**Note arrow denotes green witness marks (outboard of left tyre impact) from subsequent aft fuselage contact**

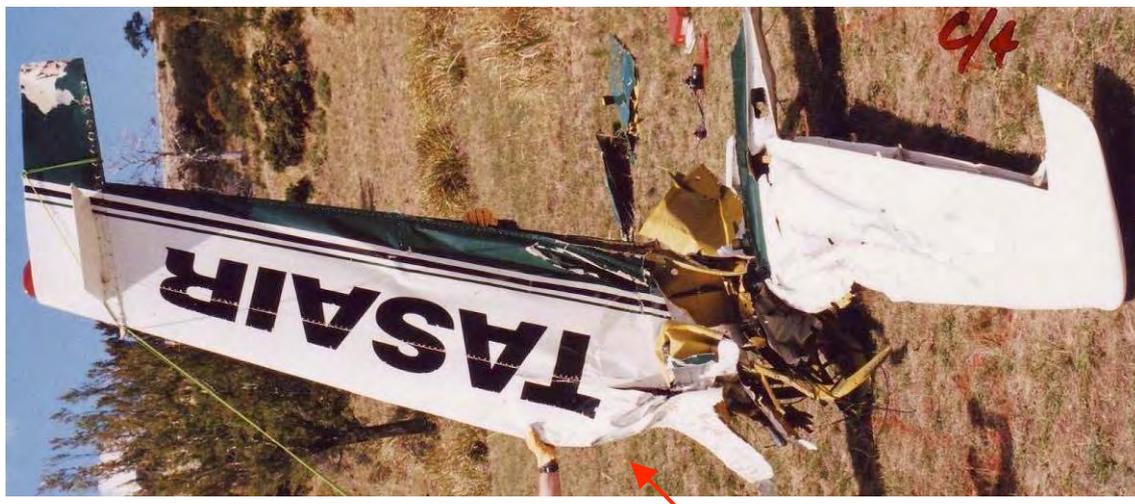
**Figure 16: View of vertical stabiliser from the left with separated horizontal stabiliser in correct relative position**

The horizontal stabiliser had significant contact marks on the left leading edge close to the junction with its aft fuselage attachment. The vertical stabiliser sustained heavy impact damage on its lower leading edge near its junction with the aft fuselage.

**Note compression deformation at root of vertical stabiliser and aft frame at FS312 (arrowed)**

The horizontal and vertical stabiliser spar fractures were consistent with being as a result of damage sustained from impact with the separated left wing structure while under considerable load (immediately after wing separation).

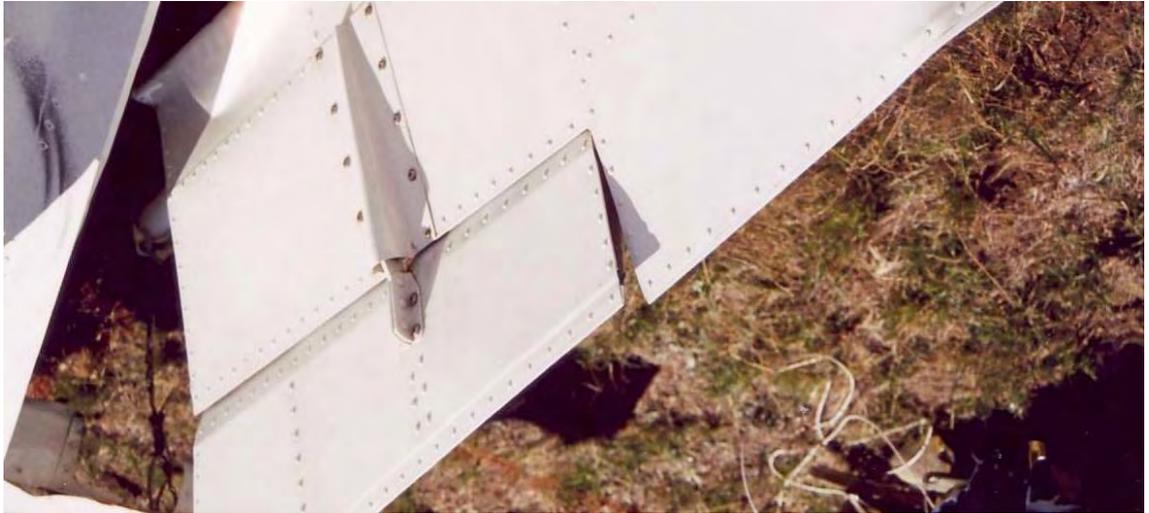
**Figure 17: Right trim tab position (trailing edge up)**

Both trim tabs were found in a fully trailing edge up position (nose down trim).

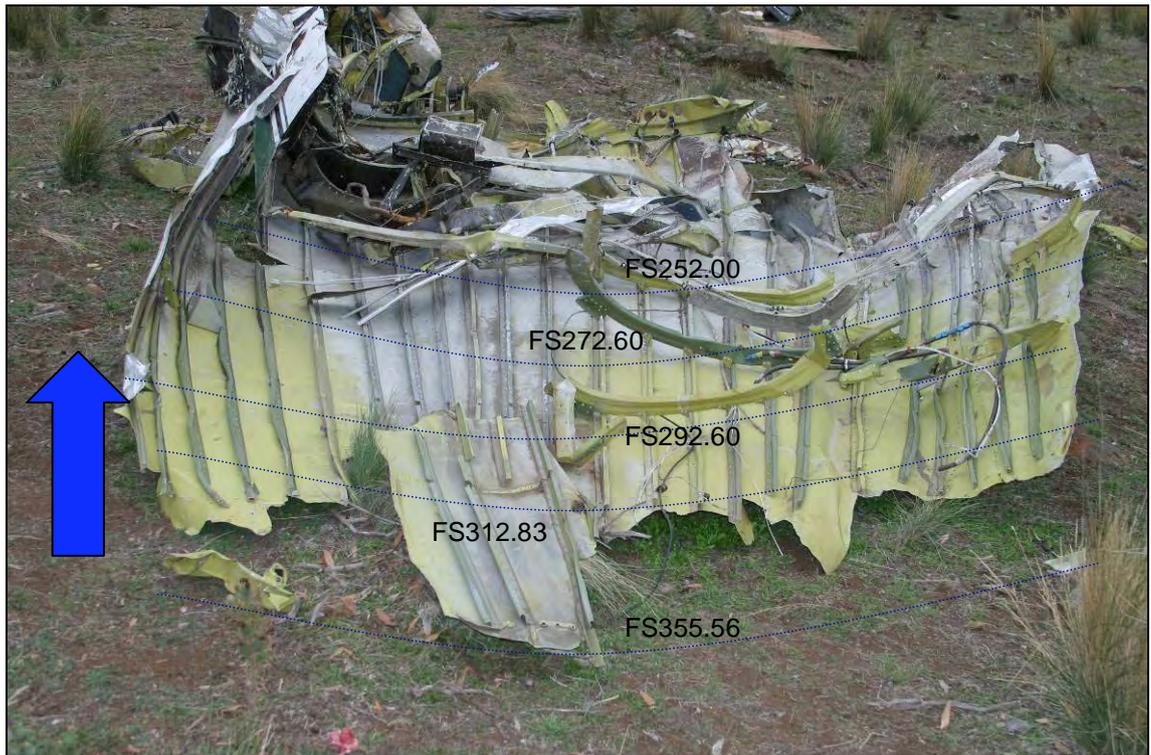
**Figure 18: General view of aft fuselage flattened out left to right**

The empennage had separated from the fuselage generally at the FS312.83 frame, the location of the vertical stabiliser main spar. The aft fuselage was subsequently torn open just left of the aircraft centreline, on the upper surface from the vertical fin, in a forward direction. The aft fuselage section had collapsed on impact with the ground and was loosely attached to the centre fuselage section. The aft fuselage could be easily removed from the main wreckage once control cables were severed. The left side fuselage baggage door had separated during the in-flight break-up sequence and was found in the middle of the wreckage trail.

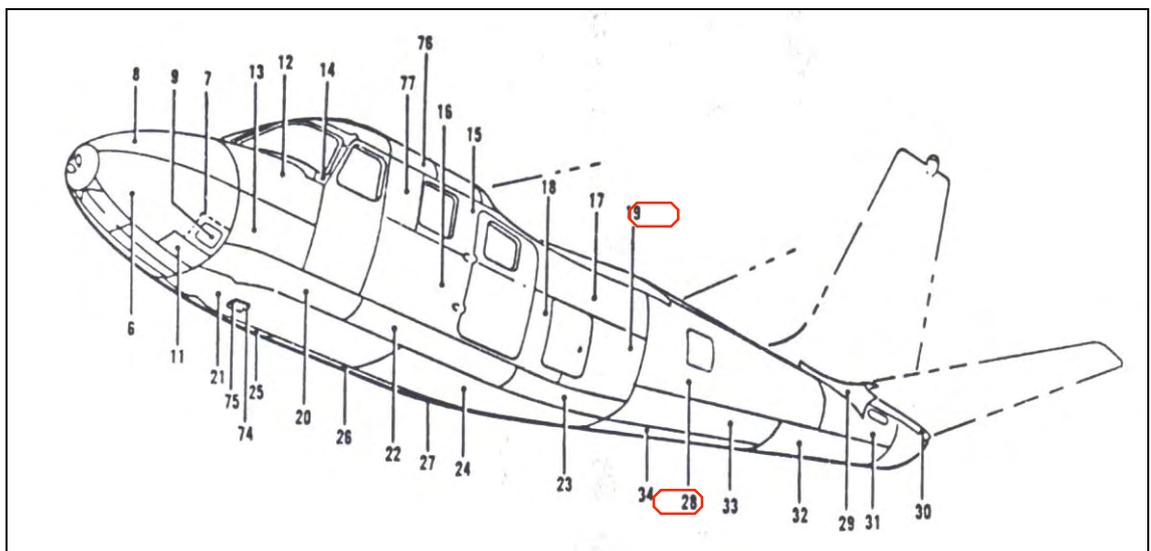
**Figure 19: Fuselage plating showing plating 19 at baggage door lock and its relationship to aft fuselage plating 28**

The fuselage baggage door, located on the left side of the aircraft, had separated during the in-flight break-up sequence and was found in the middle of the wreckage trail. The hinges were found to have failed in tensile overload. It was considered that deformation to the aft fuselage section resulted in fuselage skin deformation near the door lock mechanism, subsequently releasing the door and resulting in its separation during the breakup.
