Aviation Occurrence Investigation – AO-2008-050

**Controlled Flight into Terrain
Near Benalla – 28 July 2004
Piper PA31T Cheyenne, VH-TNP**

ATSB report 200402797

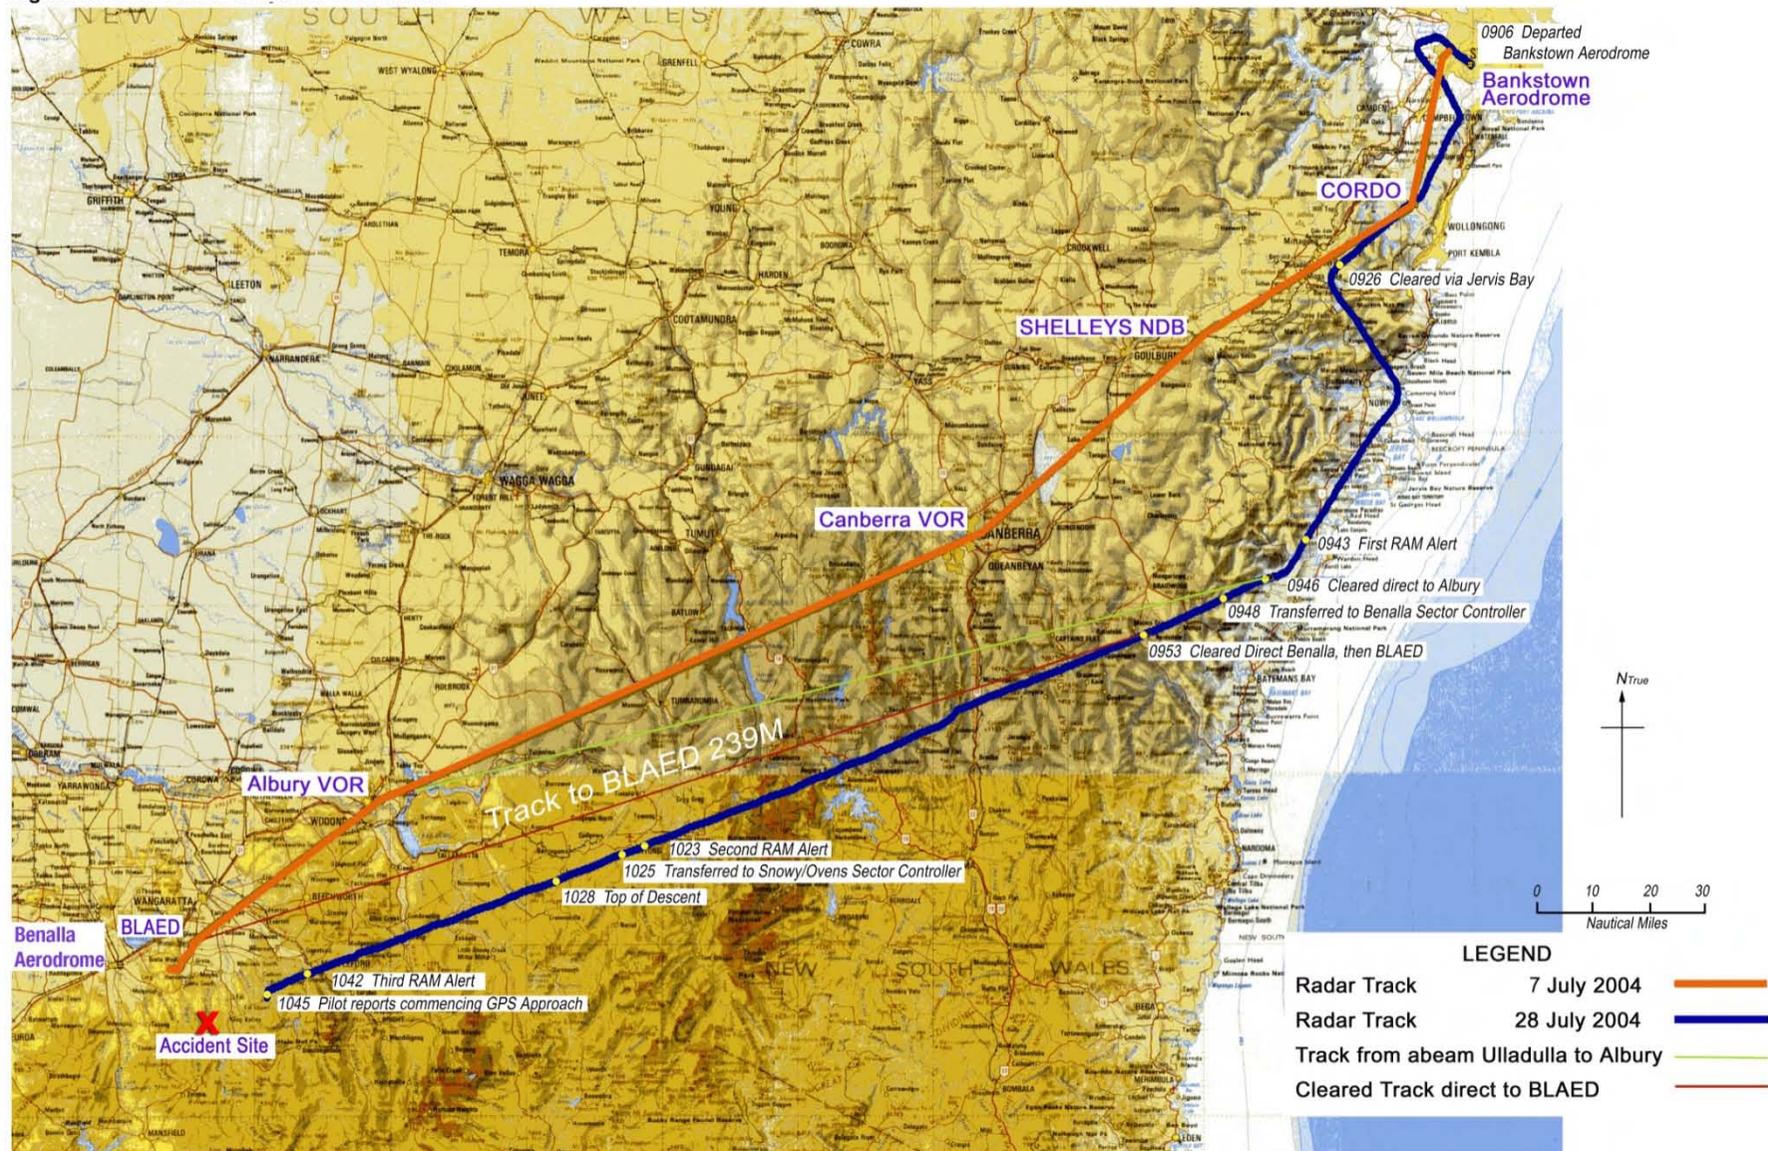
Figure 1: Radar tracks and other information

The controller cleared the pilot to ED and then to Benalla, and then rerouted the flight data record from the aircraft's position direct to ED. The pilot read back the clearance. However, radar data indicated that the aircraft did not track direct to ED, but diverged between 3.5 and 4 degrees left of the cleared track. The Benalla Sector controller did not question the pilot about the track discrepancy.

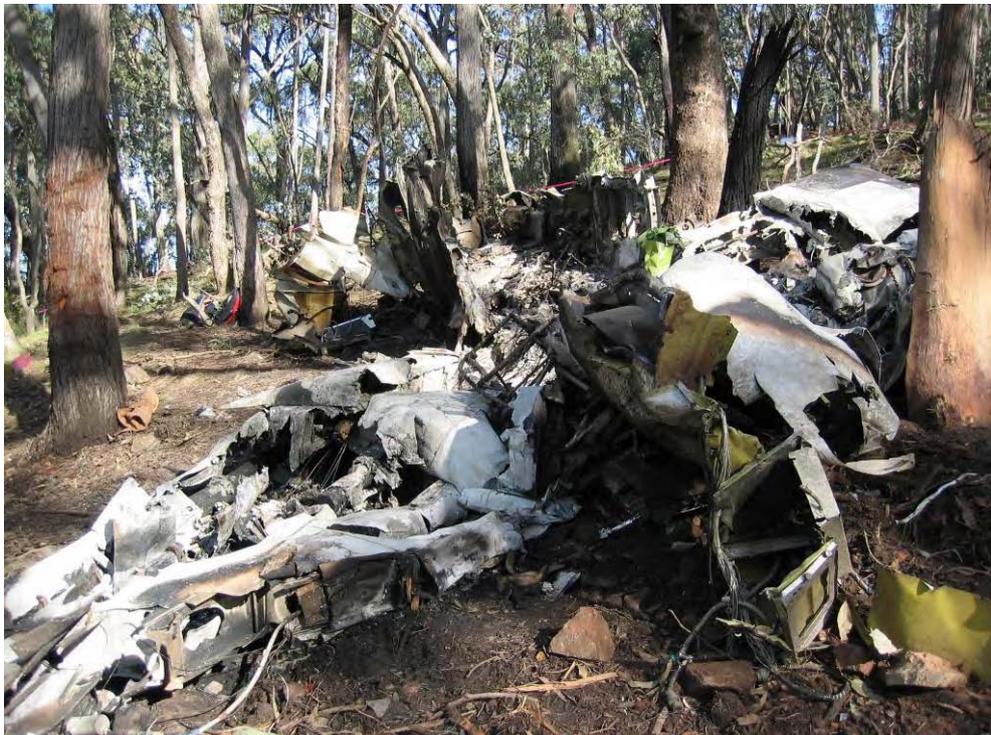
Figure 3: View of the fire-damaged wreckage

The aircraft was destroyed by impact forces and a post-impact fire.

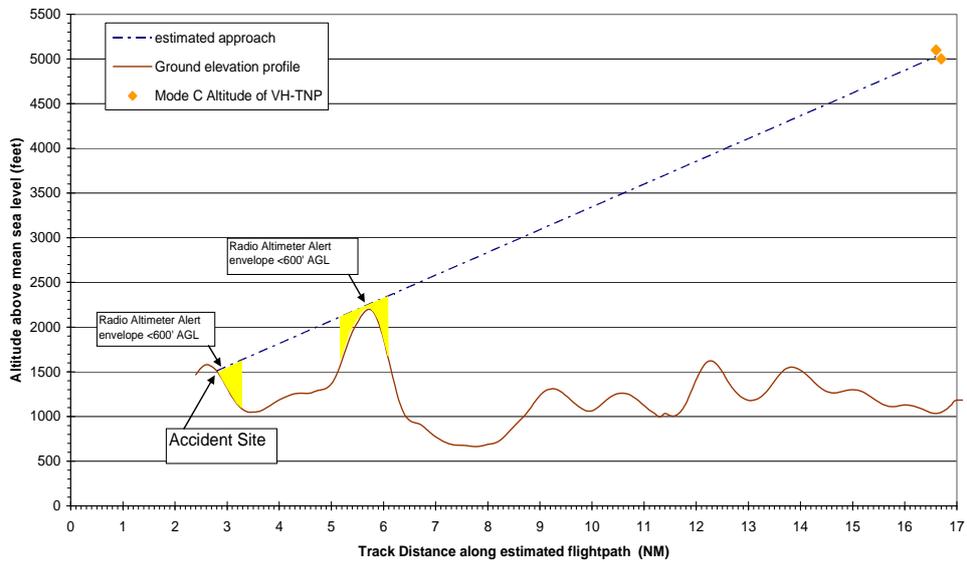
Figure 11: Representation of average descent on 28 July 2004

Figure 11 indicates the radio altimeter alert envelope with a DH set to 600 ft in relation to the accident site and the ridge 3 NM to the east.

The descent flight path represented in Figure 11 was derived from information provided by witness reports, recorded radar data and the location of the accident site.

The investigation was unable to confirm that the actual descent profile flown by the aircraft, because recorded radar data ceased at 1045 when the aircraft turned left at 5,100 ft.

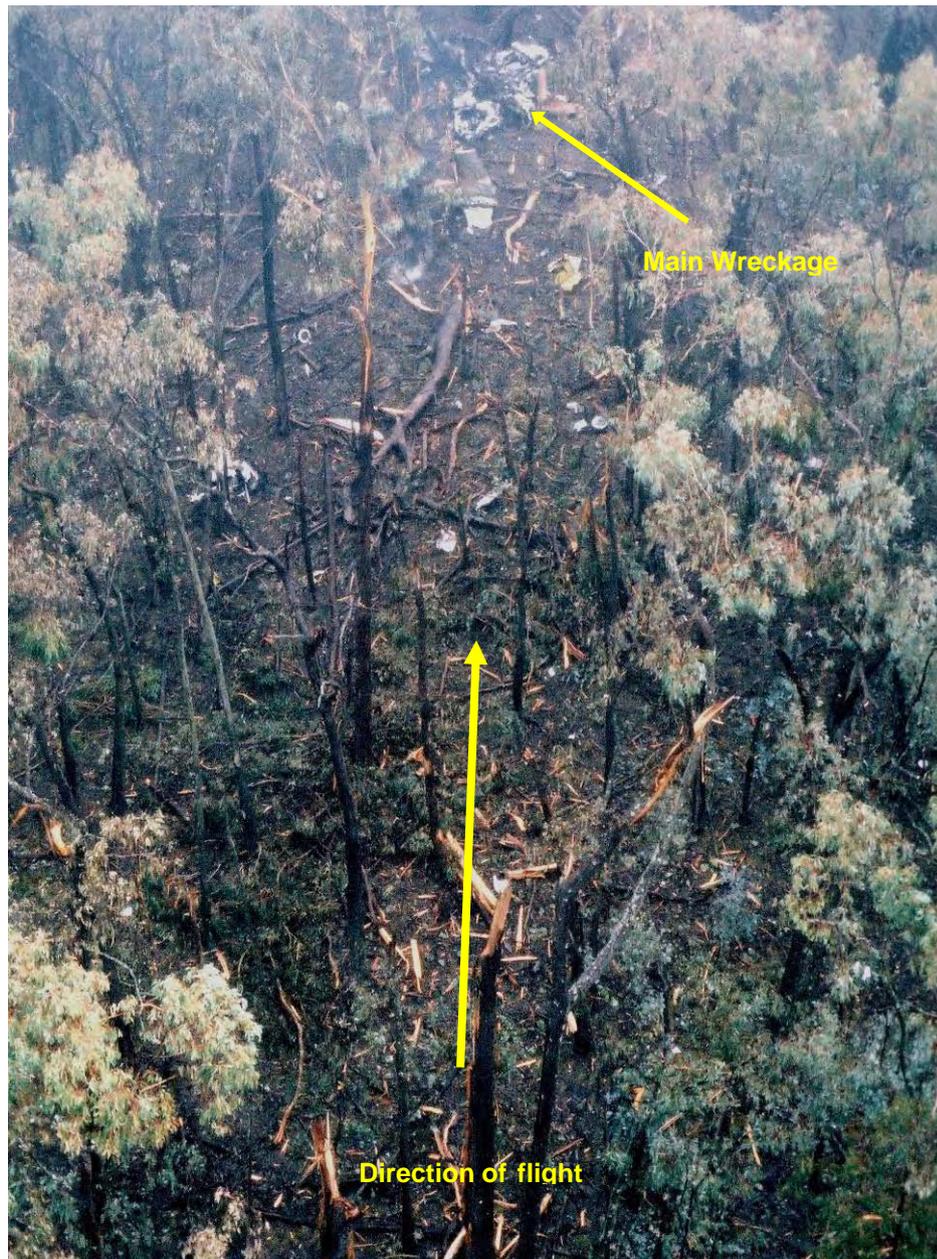
Figure 15: Wreckage site

The propellers and engines were examined on site. All displayed evidence of normal operation at the time of impact with the trees and ground and there was no evidence of any pre-impact failure. Damage to the engines and propellers was consistent with substantial power being delivered by the engines at impact.

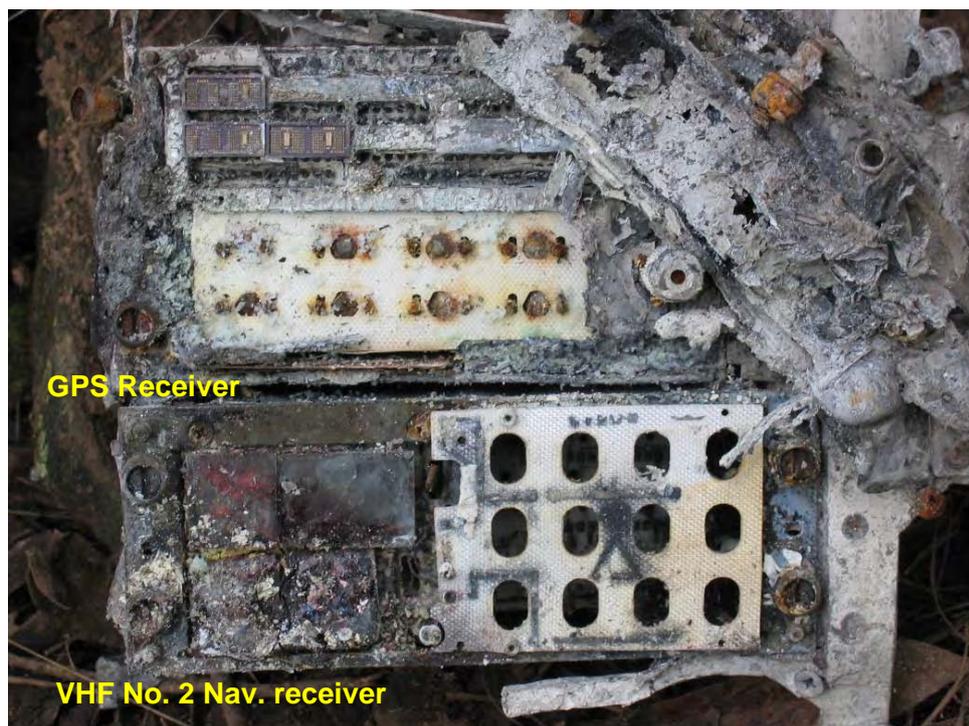
Figure 17: The fire damaged GPS receiver and VHF Nav 2 receiver

The ATSB also sent the damaged GPS data card to the Bureau d'Enquêtes et d'Analyses pour la sécurité de l'aviation civile (BEA) in France for examination in their laboratory. It was hoped that useful data might be extracted from the damaged card. In November 2005, the BEA reported that they had been unable to extract any useful data from the damaged card.

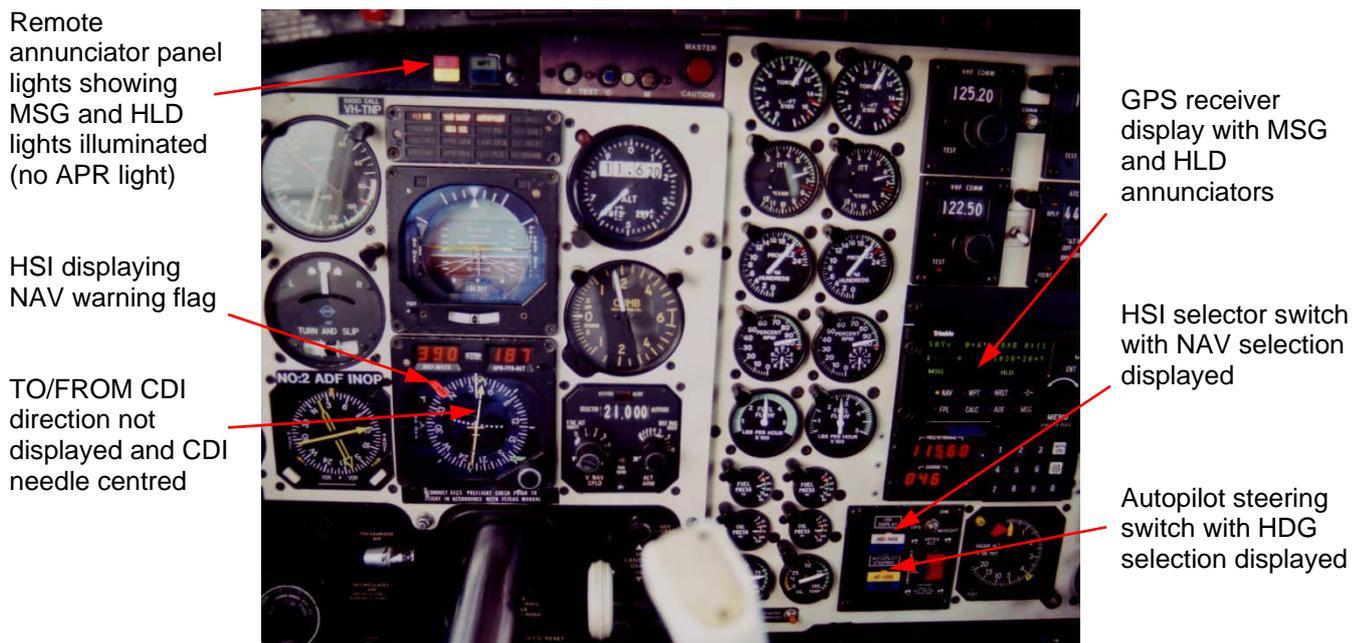
Figure 24: Aircraft panel depicting DR navigation indications

Flying an approach using the course deviation indicator on the GPS receiver display unit (RDU) would have been unusual and contrary to the requirements for approval that permitted GPS non-precision approaches to be flown. The pilot would have had to alternate his instrument scan between the flight instruments on the primary panel, directly in front of him, and the RDU to the right of that panel.
