# CIVIL AVIATION ACCIDENT REPORT

FINAL REPORT ON THE ACCIDENT TO  
SOSOLISO AIRLINES DC 9-32 AIRCRAFT  
REGISTERED 5N - BFD AT PORT HARCOURT-  
INTERNATIONAL AIRPORT ON 10TH DECEMBER  
2005

JULY 2006

**FINAL REPORT ON THE ACCIDENT INVOLVING SOSOLISO  
AIRLINE'S DC-9-32 AIRCRAFT REGISTERED 5N-BFD AT PORT  
HARCOURT INTERNATIONAL AIRPORT, RIVERS STATE ON  
SATURDAY, 10<sup>TH</sup> DECEMBER 2005.**

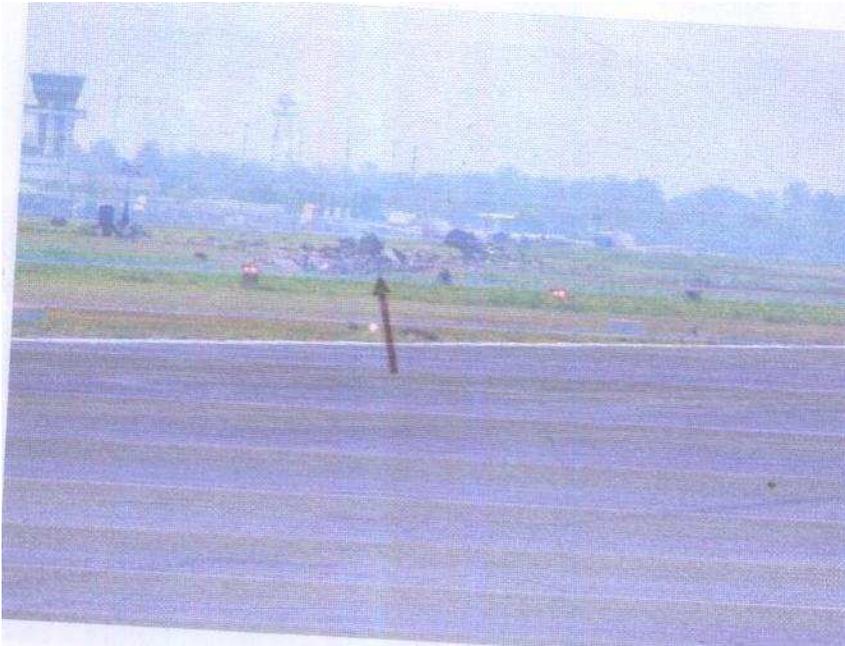
Photograph showing the first impact of the aircraft; having the runway to the right.

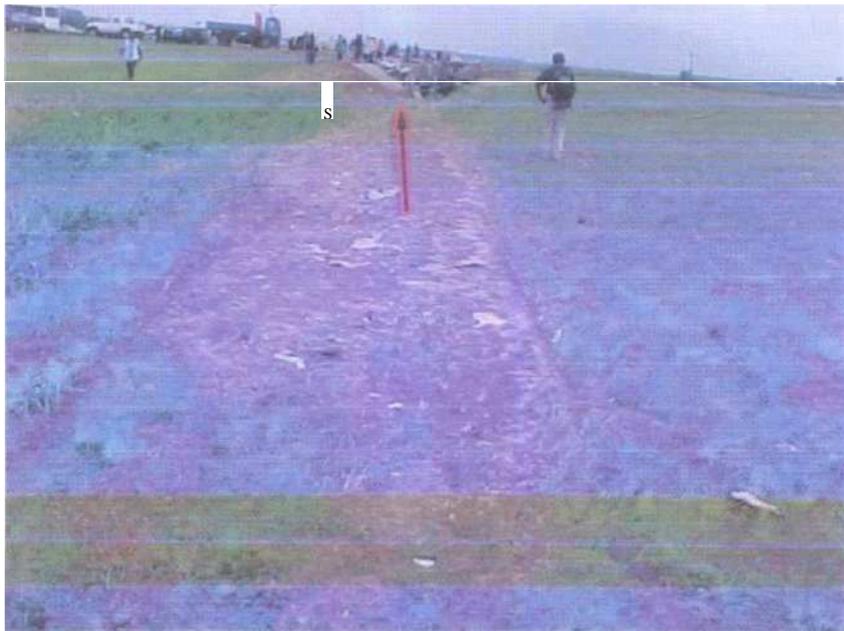
APPENDIX 5.2

Mr. Dennis Jones of NTSR, USA assessing the impact/wreckage of the aircraft

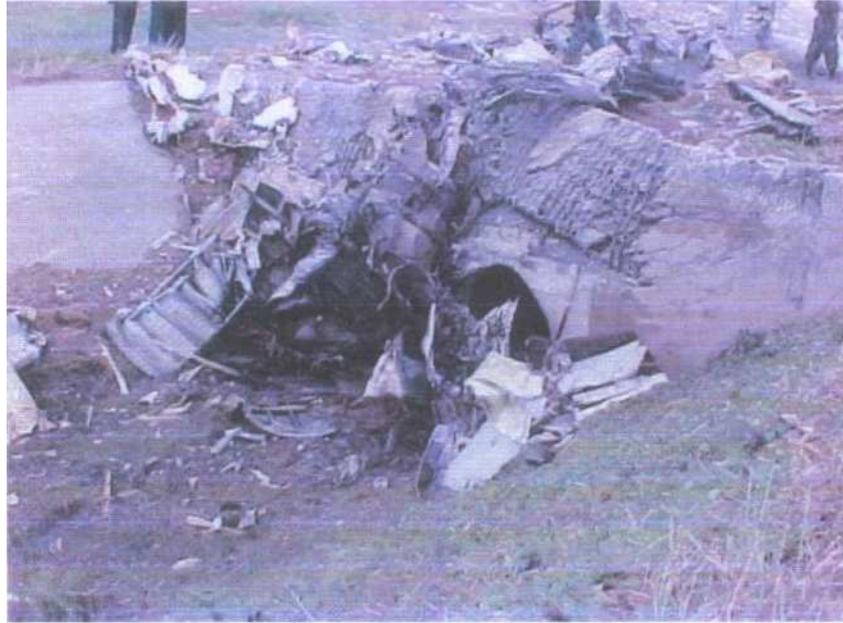
APPENDIX 53

The exposed concrete drainage culvert located at about 70m to the left of runway 21 edge and 540m from the threshold portends serious danger to aircraft during landing and takeoff. The aircraft impacted heavily with the drainage culvert, which resulted into its disintegration and fire outbreak. The first physical evidence of fire was observed at about 200m from the culvert.

- (xviii) The exposed concrete drainage structure is badly located and poses a real danger to aircraft landing on Runway 21.
- (xix) The aircraft disintegrated and caught fire along its path spanning over 790m. The cockpit section with the forward fuselage was found at a further 330m from the rest of the wreckage trail on the taxiway giving a total wreckage distance of 1 120m.

Photograph showing heavy impact with concrete drainage culvert

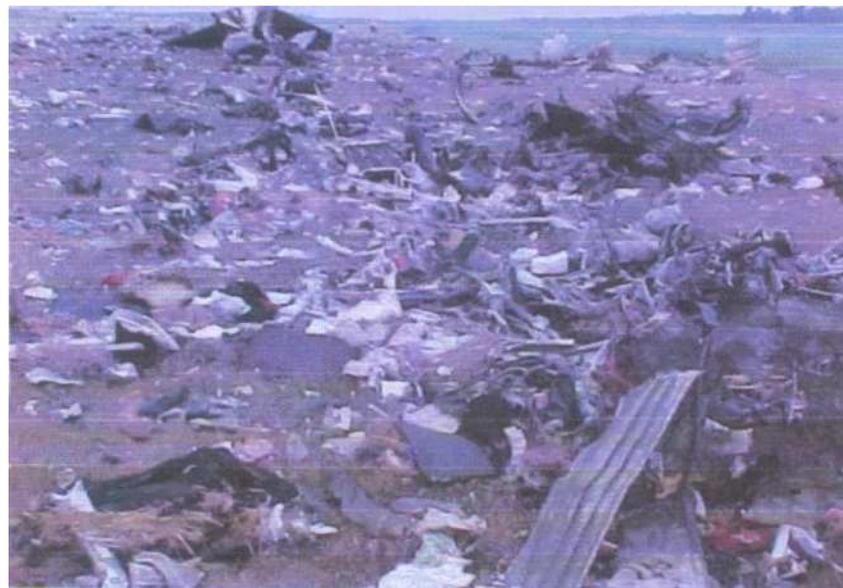
APPENDIX 5\*4

Part of the wreckage trail of the aircraft

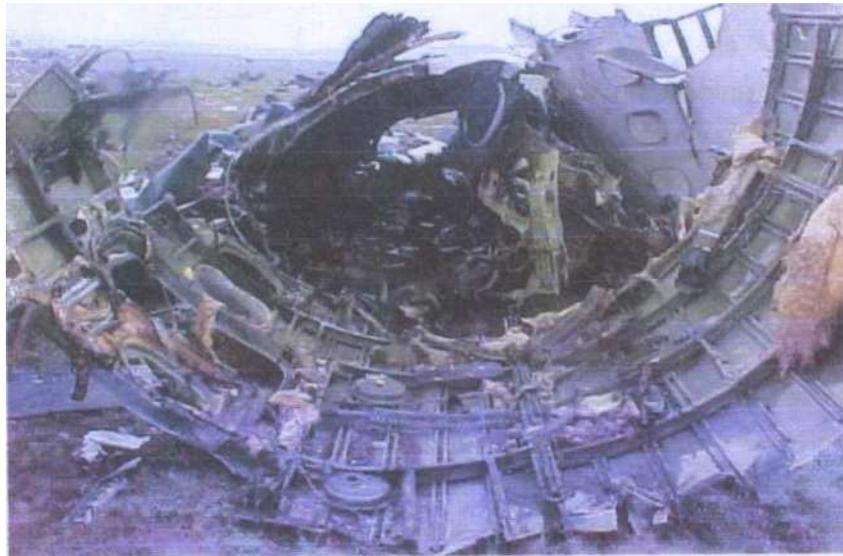
Part of the aft fuselage of the aircraft

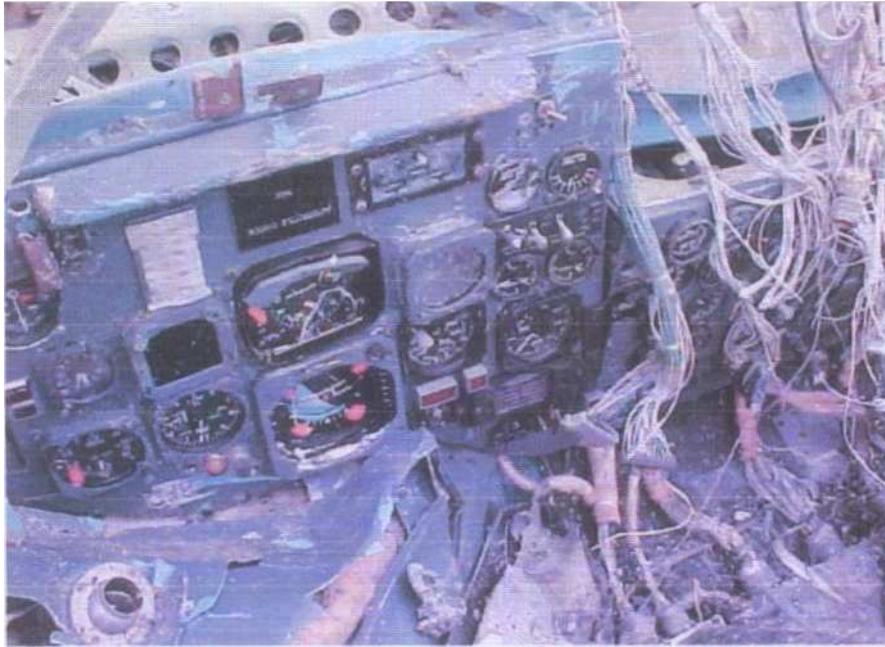
Photograph showing the Instrument panel found on taxiway, 330m away from the rest of the wreckage

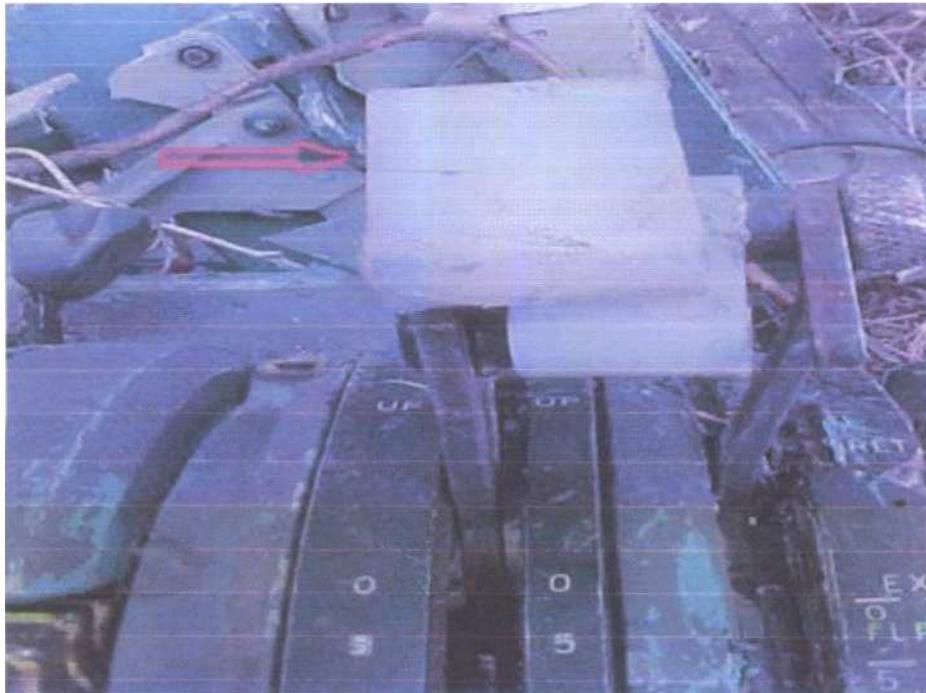
APPENDIX 5.8

Flap lever - UP position but the flap indicator was at 15°

Arrow showing the Flap lever at up position

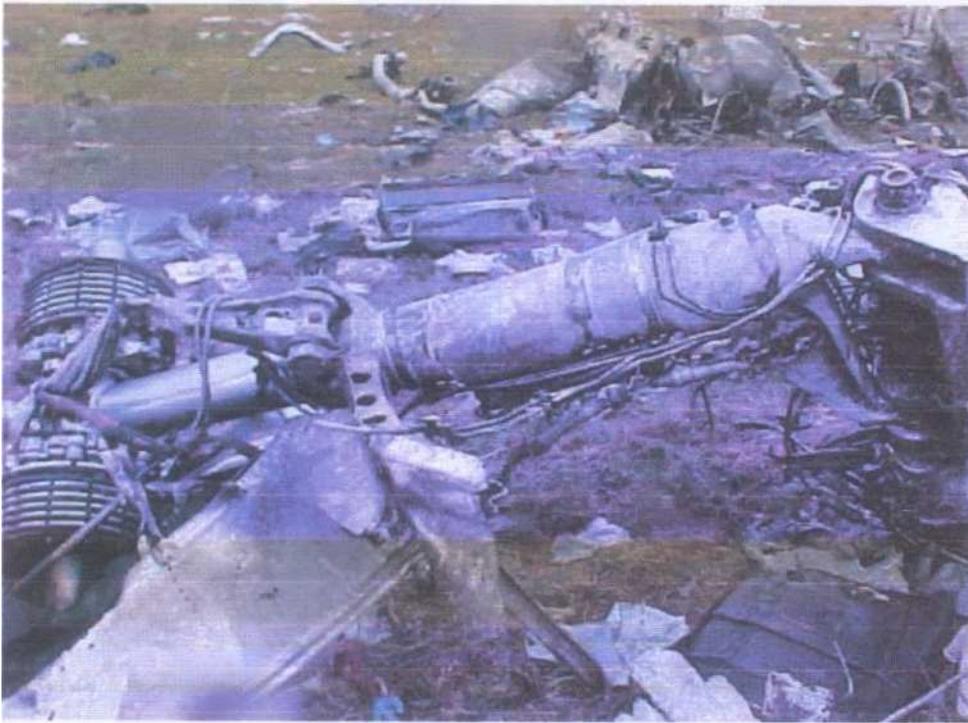
Picture showing a main landing gear APPENDIX 5.14

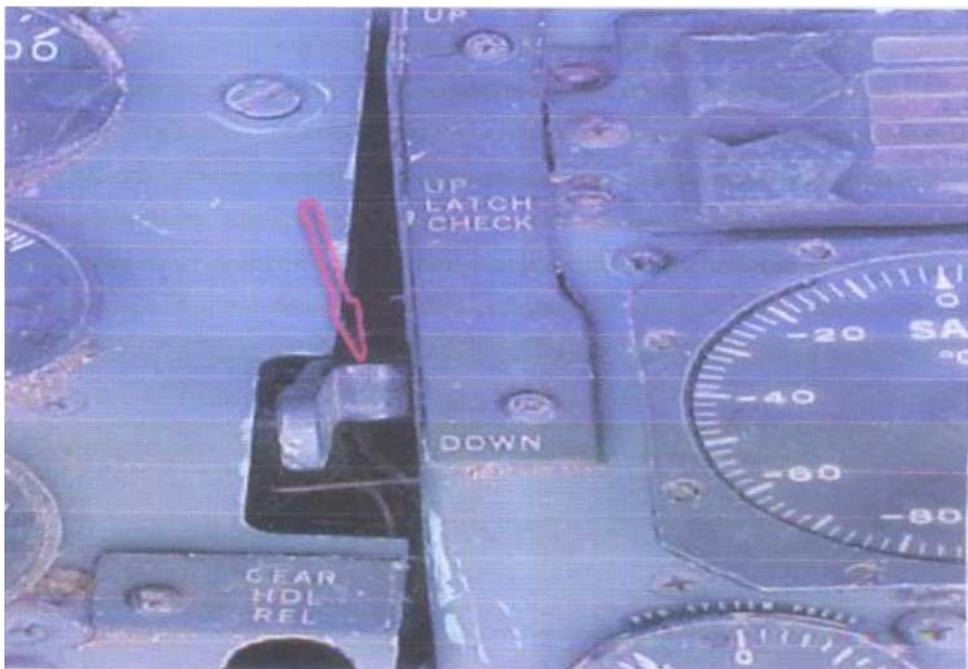
Gear lever - UP position

Arrow showing the position of the landing gear lever

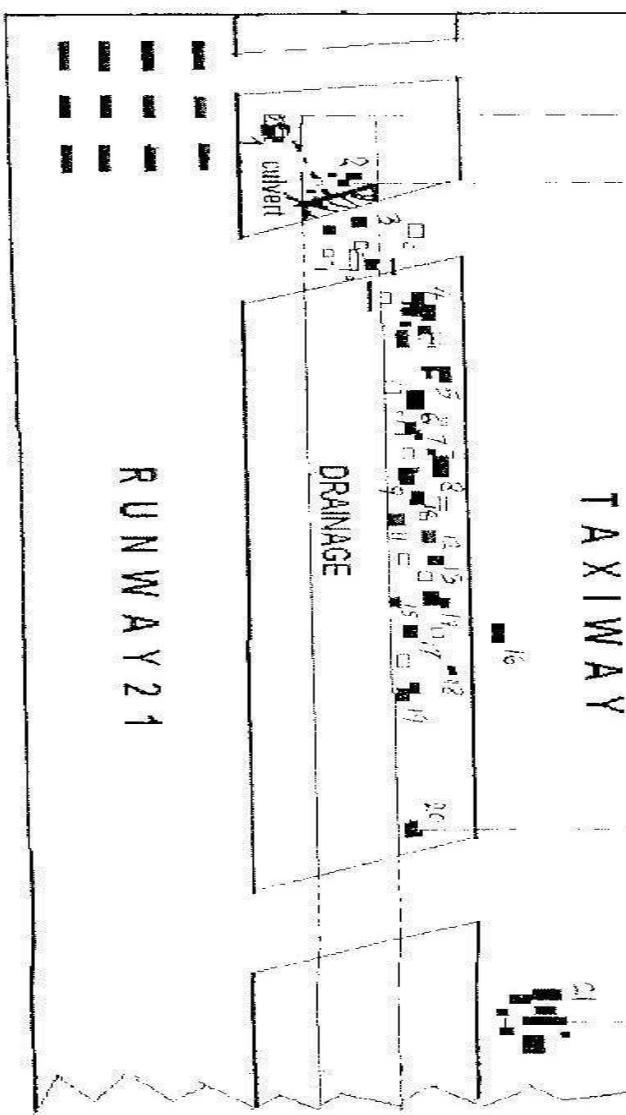
<ul style="list-style-type: none"> <li>1. Clothing, shoes, bags, hooks, cushions, etc</li> <li>2. Seats etc.</li> <li>3. Aircraft parts</li> </ul>	<ul style="list-style-type: none"> <li>4. APU, Tail cone, elevator cable drum, pylon etc</li> <li>5. Parts of antenna &amp; Flaps</li> <li>6. Part of the flaps</li> <li>7. Air conditioning system</li> <li>8. Parts of the wing with flaps in extension</li> <li>9. Trimmage with horn, stab &amp; elevator</li> </ul>	<ul style="list-style-type: none"> <li>10. Parts of the fuselage</li> <li>11. Main Landing Gear (MLG)</li> <li>12. Engine cowling</li> <li>13. Parts of the wing with slats</li> <li>14. Hoist 1 Camera</li> <li>15. Hoist</li> <li>16. Nose wheel</li> <li>17. Parts of the wing with slats</li> <li>18. Main wing with fuselage</li> </ul>	<ul style="list-style-type: none"> <li>19. MG</li> <li>20. Nose Tyre</li> <li>21. FWD Fuse</li> </ul>
--	--	--	---

7. 2nd business aircraft with the drainage culvert by Ho. 2. rear stair lodged in the culvert
