AIRCRAFT ACCIDENT FINAL REPORT # A0619890

Landing Gear System Failure

**Cambridge Air Services Limited
Cessna 402C C6-KEV
Freeport, Grand Bahama,
Bahamas**

April 21, 2006

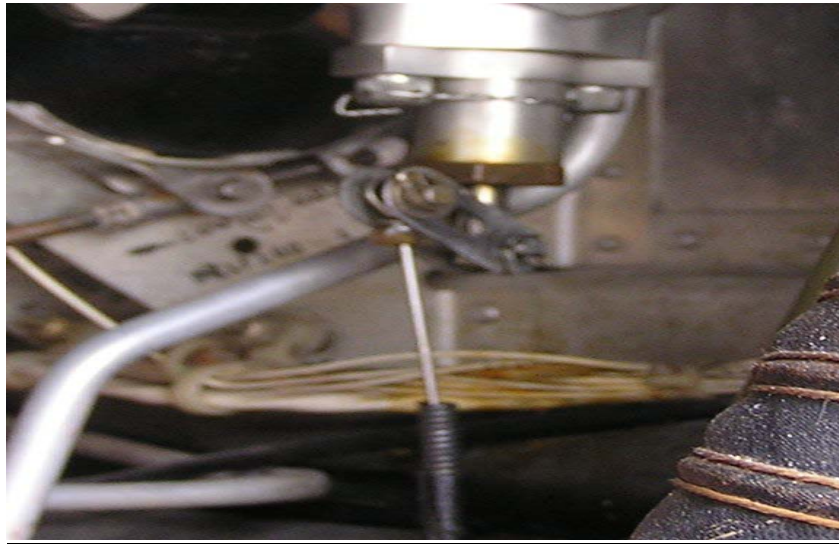
Emergency gear extension system cable prior to selector handle being pull to activate system.

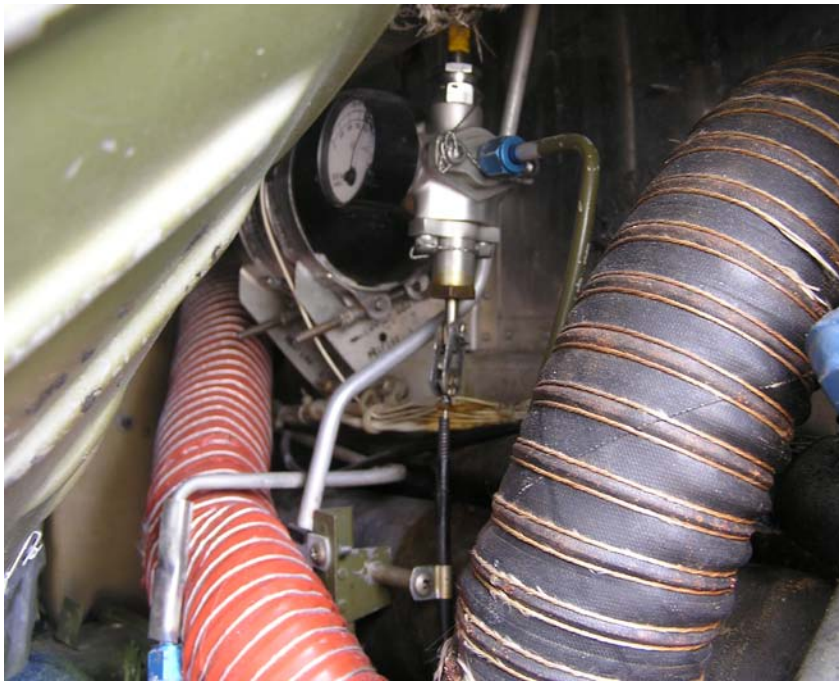
- **Failure of the back up emergency blow down bottle system.** It has been determined from inspection that the cable that connects the emergency blow down bottle system in the nose well of the aircraft to the T-handle in the cockpit, exhibited excessive play. Therefore even though the cable was pulled all the way to its fullest extent, it did not allow movement of the pin that would have provided activation of the system. *Annual inspection report completed in December 2005 revealed that the portion of the Annual Inspection that required inspection of the emergency blow down bottle was not signed off by the mechanic as having been accomplished. However, the aircraft was returned to service with this discrepancy outstanding.*

Emergency gear blow down bottle after handle pulled to activate system. Although handle was pulled, back up system did not activate due to the excessive play in the cable linking the emergency gear blow down bottle activation handle and the emergency system located at the firewall in the nose of the aircraft.

- Recommend that an investigation be made to determine why gear backup blow down system did not activate as it was supposed to.
- Recommend that an investigation be made to determine why gear backup blow down system check was not accomplished as required by Annual Inspection.

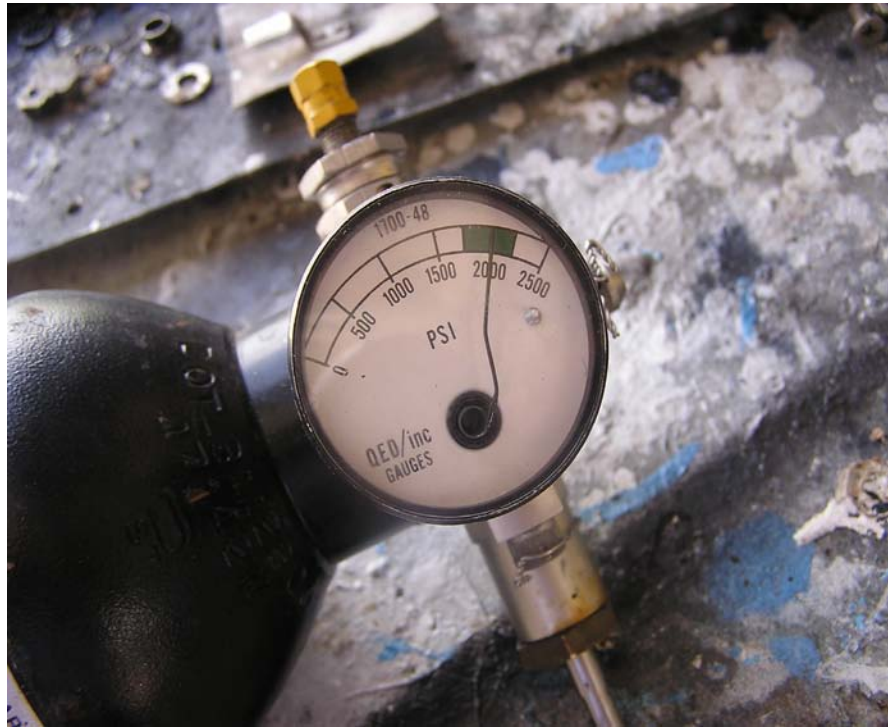
Emergency gear blow down bottle showing a positive pressure charge on the nitrogen bottle.

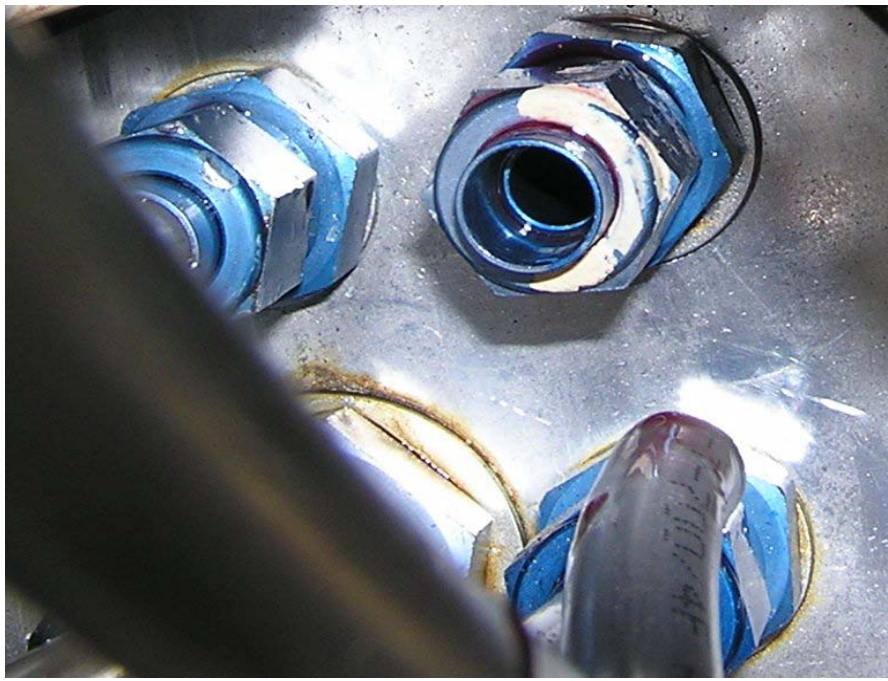
Hydraulic line shown as it disengaged from the housing.

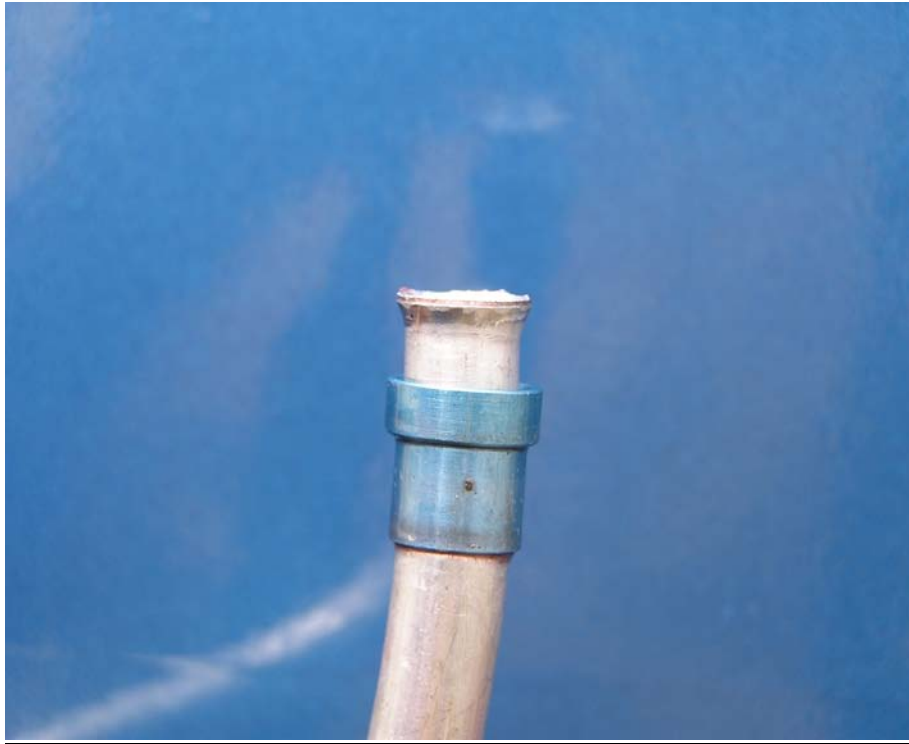
- **Substandard maintenance that was performed.** (Due to the improper flange on the hydraulic line, the hydraulic line came loose from its housing and depleted the fluid from the hydraulic reservoir).

Improper flange on hydraulic line cause line to separate from housing resulting in all hydraulic fluids being depleted from hydraulic system.

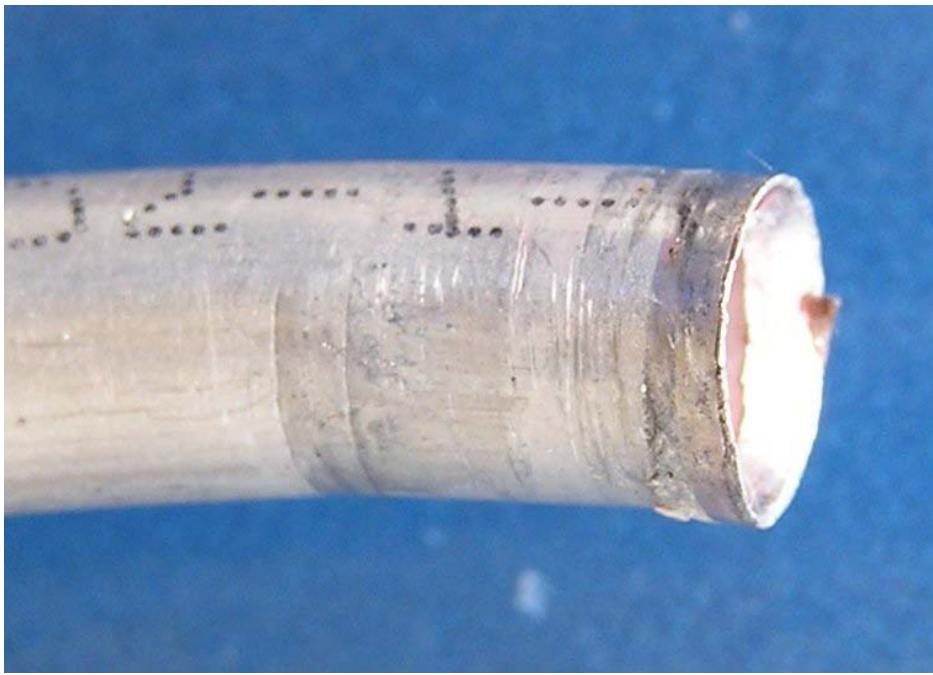
Enlarged shot showing flange work carried out on hydraulic line.

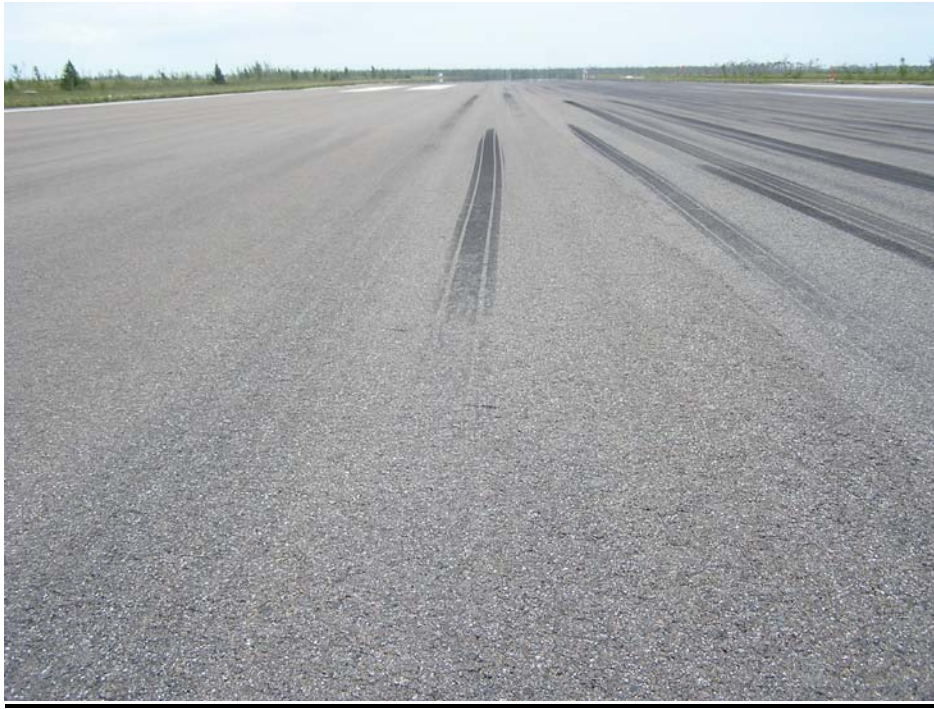
Signature marks of touchdown point on Runway 06 approximately 8,100 feet from the threshold of the 11,000 feet runway.

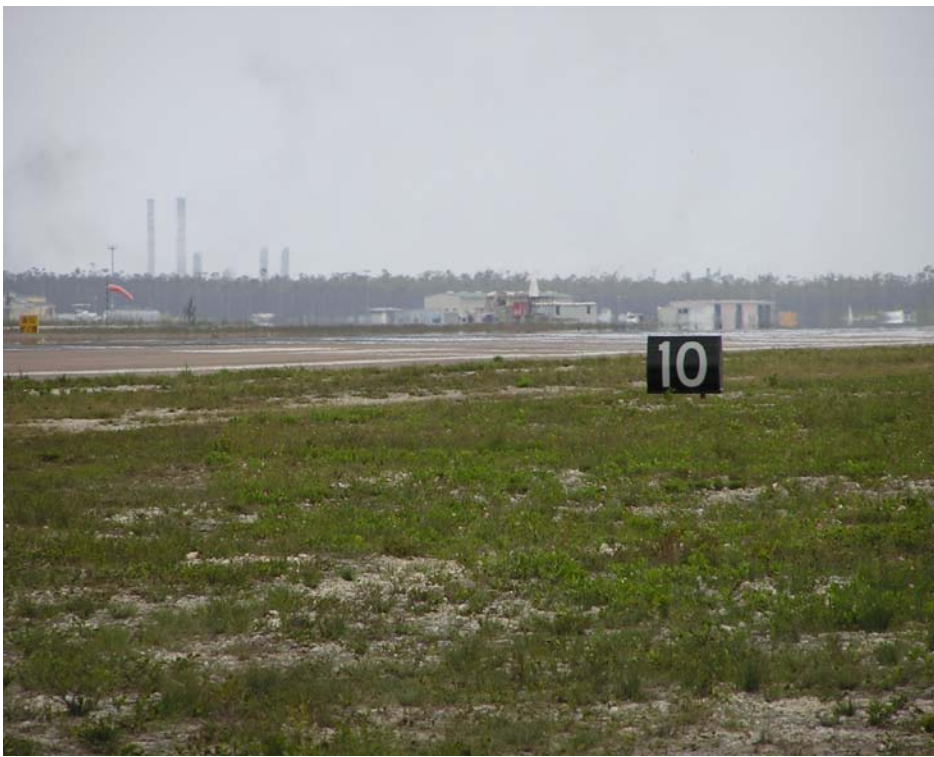
The aircraft departed the runway approximately 9,700 feet from the threshold of Runway 06. Aircraft came to rest approximately 10,400 feet from the threshold of Runway 06 and 180 feet from the shoulder of the runway. Aircraft hit trees and rock prior to stopping. Aircraft burst into flames on the left side shortly thereafter.
