**AVIATION INVESTIGATION REPORT
A05H0002**

RUNWAY OVERRUN AND FIRE

**AIR FRANCE
AIRBUS A340-313 F-GLZQ
TORONTO/LESTER B. PEARSON INTERNATIONAL
AIRPORT, ONTARIO
02 AUGUST 2005**

Report Number A05H0002

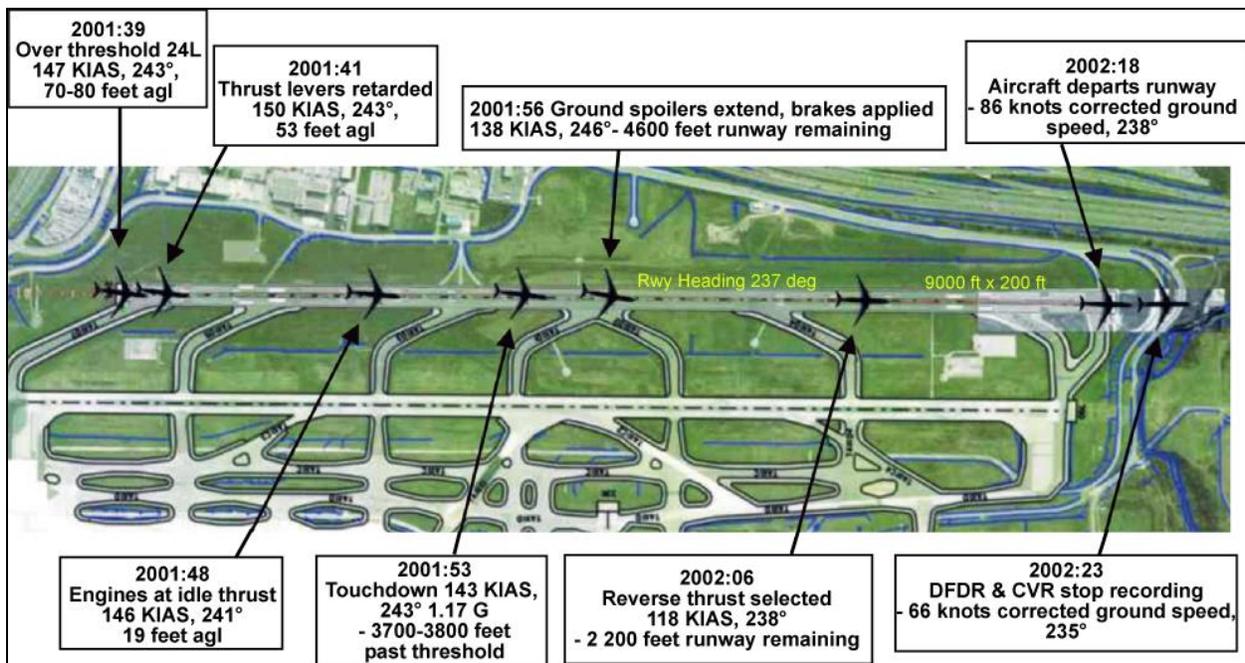
Figure 1. Landing sequence key events

The PF began the flare when the aircraft was about 40 feet above the runway. From this point to touchdown, there were numerous and sometimes significant pitch inputs made on the PF side stick, and the aircraft levelled off at approximately 25 feet for a period of 2½ seconds. During this time, there were also regular and sometimes large inputs in roll on the PF side stick. Combined, these inputs would indicate that significant workload and attention were required on the part of the PF to control the aircraft. The crew began a progressive reduction in thrust from a 76 per cent N1 when the aircraft was at 50 feet, with the throttle levers reaching the idle position when the aircraft was about 20 feet above the runway.

The aircraft touched down at 2001:53, approximately 3800 feet down the 9000-foot runway. On touchdown, the right main landing gear was slightly left of the runway centreline, and the aircraft was crabbed about six degrees to the right. The spoilers deployed automatically, as designed, after the main wheels contacted the runway. The flight crew immediately applied maximum manual braking and attempted to align the aircraft with the centreline. Idle reverse was selected 12.8 seconds after main gear touchdown, and full reverse was selected 16.4 seconds after main gear touchdown. Standard callouts to indicate spoiler and reverser deployment were not made by the PNF. The aircraft was not able to stop on the remaining runway. It departed the end of the runway at a groundspeed of approximately 80 knots and came to rest in a ravine. The aircraft left the runway at 2002:19.

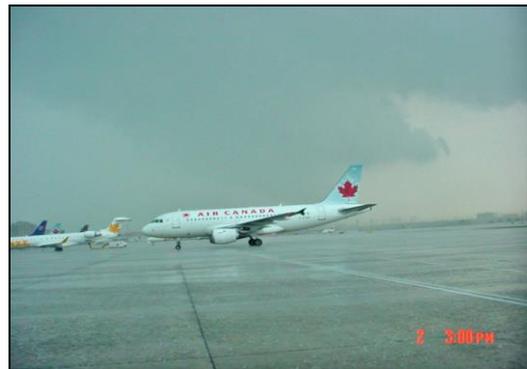
Photo 1. Weather at threshold about two minutes before landing

Photo 1 was taken two minutes before the arrival of AFR358. It is raining at the time and the visibility is good with a number of aircraft visible along the flight line.

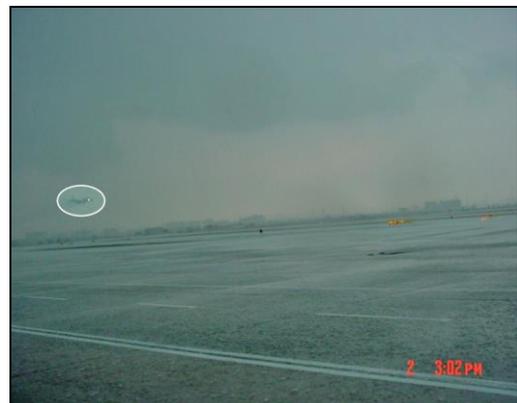
Photo 2. AFR358 on short final

Photo 2, taken two minutes later, shows AFR358 on short final in final approach approximately 230 feet agl. The camera is aimed slightly to the right from Photo 1 and the photo shows that the rain is heavier and the visibility is decreasing.

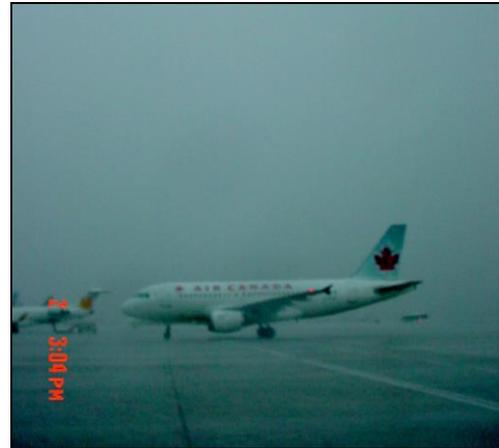
Photo 3. Weather shortly after landing

Photo 3, taken about two minutes later, shows how the visibility decreased to the east as the storm intensified. There are fewer aircraft visible along the flight line.

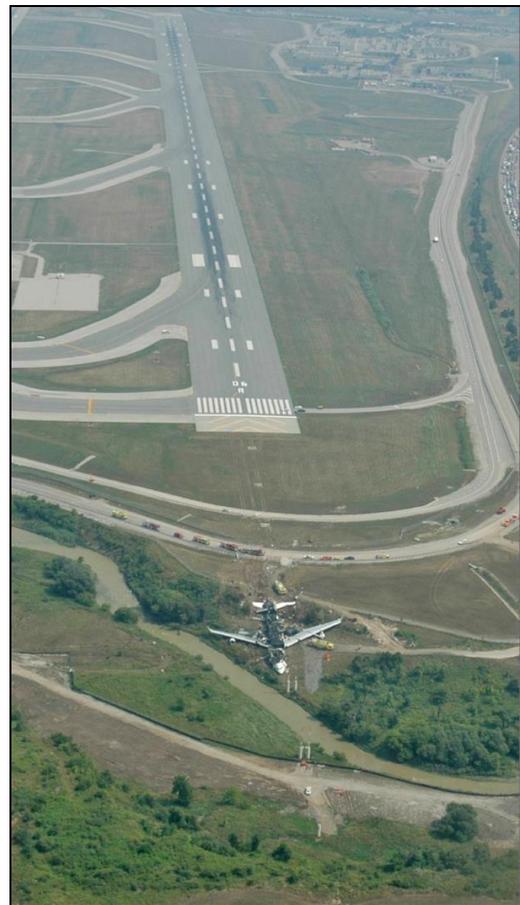
Photo 4. Accident site

The aircraft came to rest in a ravine alongside Etobicoke Creek, on the extended centreline of Runway 24L. Most of the wreckage was contained within the radius of the aircraft, but there were several small components in the field before the ravine. The aircraft struck and destroyed the fifth set of approach lights as it entered the ravine. This set of lights comprised three pairs of frangible light towers, individually mounted on poured concrete pillars and arranged perpendicular to the runway centreline. The right landing gear struck and uprooted the inner concrete pillar of the right set of lights.

A post-crash fire consumed most of the upper portion of the main fuselage, vertical fin, and inner wing sections. The fire was intense and mainly limited to the fuselage. Fire singed and burned some of the surrounding vegetation, but did not spread beyond the circumference of the aircraft.

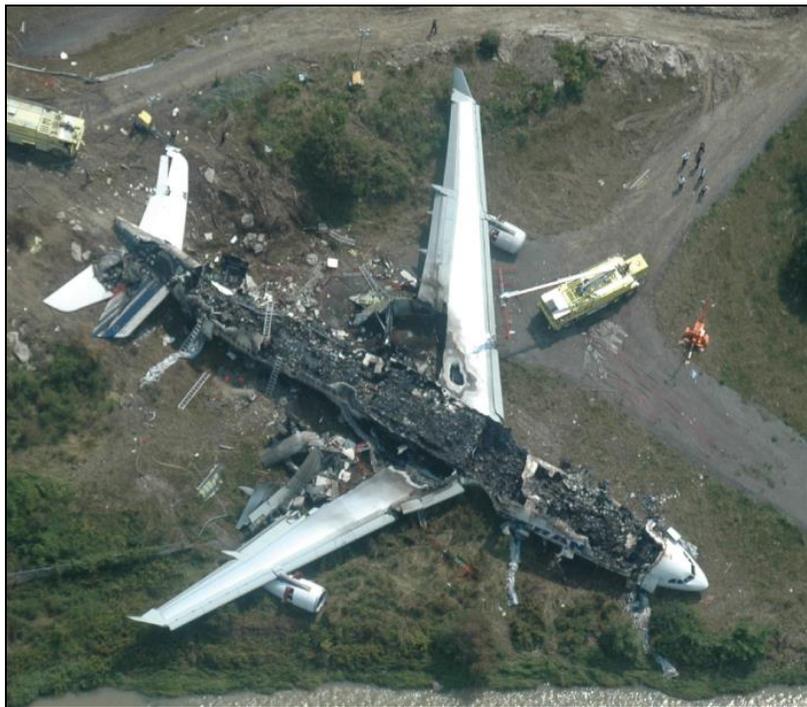
Photo 5. Aircraft wreckage

The rear portion of the fuselage on the left side was consumed by fire down to and including the cabin floor. Part of the left-side cabin wall was standing,

though heavily damaged by the fire. Approximately four feet ahead of cabin door R4, there was a fold in the outer fuselage skin, indicating that the location was subjected to substantial bending forces during deceleration and break-up. The permanent deformation of the fuselage was very likely transmitted to the door frame. This would explain the difficulty the cabin crew experienced when attempting to open the R4 door. The door initially resisted opening and required two cabin crew members to push the door open. The rear cargo compartment door was found in place and closed, though almost burned through. The bulk cargo door was found on the ground, with the charred remains of the cargo spilling out of the door opening.

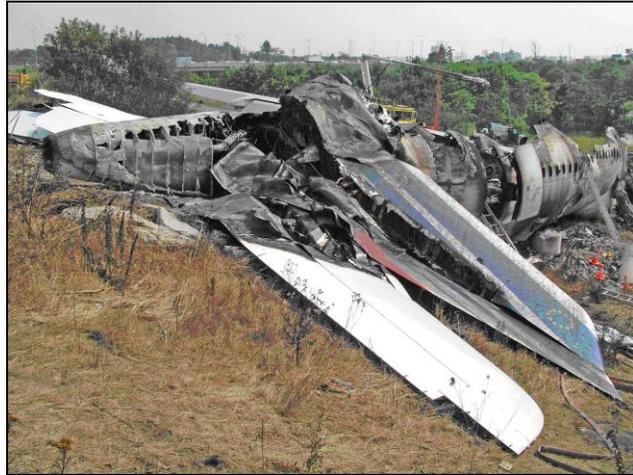
Photo 6. Aircraft stabilizers

The trimmable horizontal stabilizer was still joined to the fuselage through the main box. The left-hand stabilizer was attached in position and had impact damage. The left-hand elevator was partially detached, but in position, and had impact damage. The right-hand stabilizer and elevator were attached in position and partially burned away. The tailplane tips, made of an aluminum alloy and part of the lightning protection system, were examined for evidence of a lightning strike; none was found. The vertical stabilizer was attached to the aircraft and in position. It was only after the intense fire that the lower half of the fin and rudder burned away and the rest collapsed to the right side. The rudder was separated from the fin box.

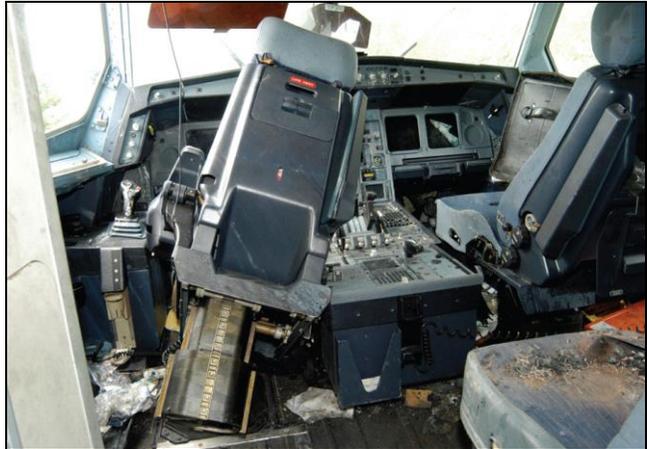
Photo 7. Cockpit seats

Both seats experienced high vertical forces during the event. The captain seat was displaced from its normal position. The floor of the seat base had fractured, allowing the chair to detach from the base. The nut attaching the centre screw to the bottom of the base on the first officer seat had pulled through the retainer. The force necessary to pull the nut through the retainer was mathematically calculated. It was determined that a vertical acceleration of a minimum of 16 g was likely reached before the seat broke. The seats were designed to withstand 5.7 g vertically and 9 g longitudinally.

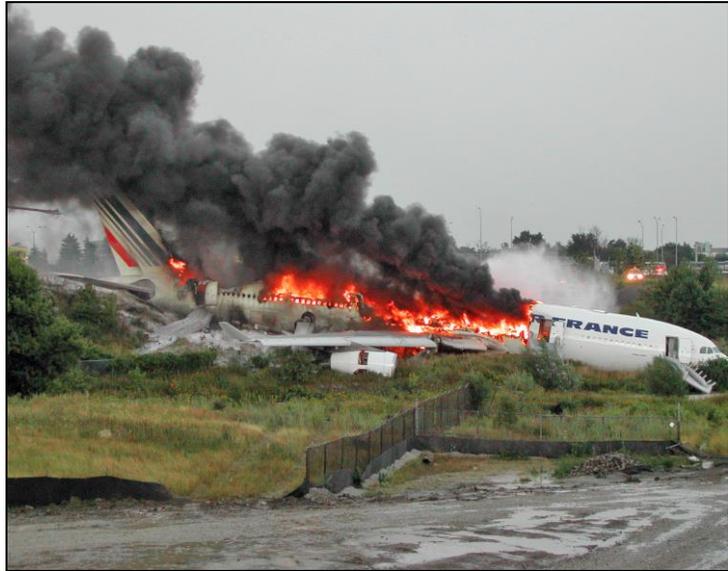
Photo 8. Aircraft fire in progress

Evaluation of the wreckage trail indicated that there was no fuel leakage until the aircraft crossed Convair Drive. The first debris related to the fuel tanks and the fuel distribution system was found in the field adjacent to the ravine. Traces of fuel were visible at the top of the embankment on the left-hand side of the aircraft trajectory. A piece of an internal wing box rib was also found in the same area. A wing access door panel with slight fire damage was identified among the debris deposited halfway between Convair Drive and the edge of the ravine. There was no indication of fire on top of the embankment because no scorched grass or soil was visible.

The fire intensified as the aircraft came to a halt. The fire path was from the wing area toward the fuselage. By the time the fuselage was seriously threatened by fire, the aircraft had been totally evacuated. There were four principal areas of fire:

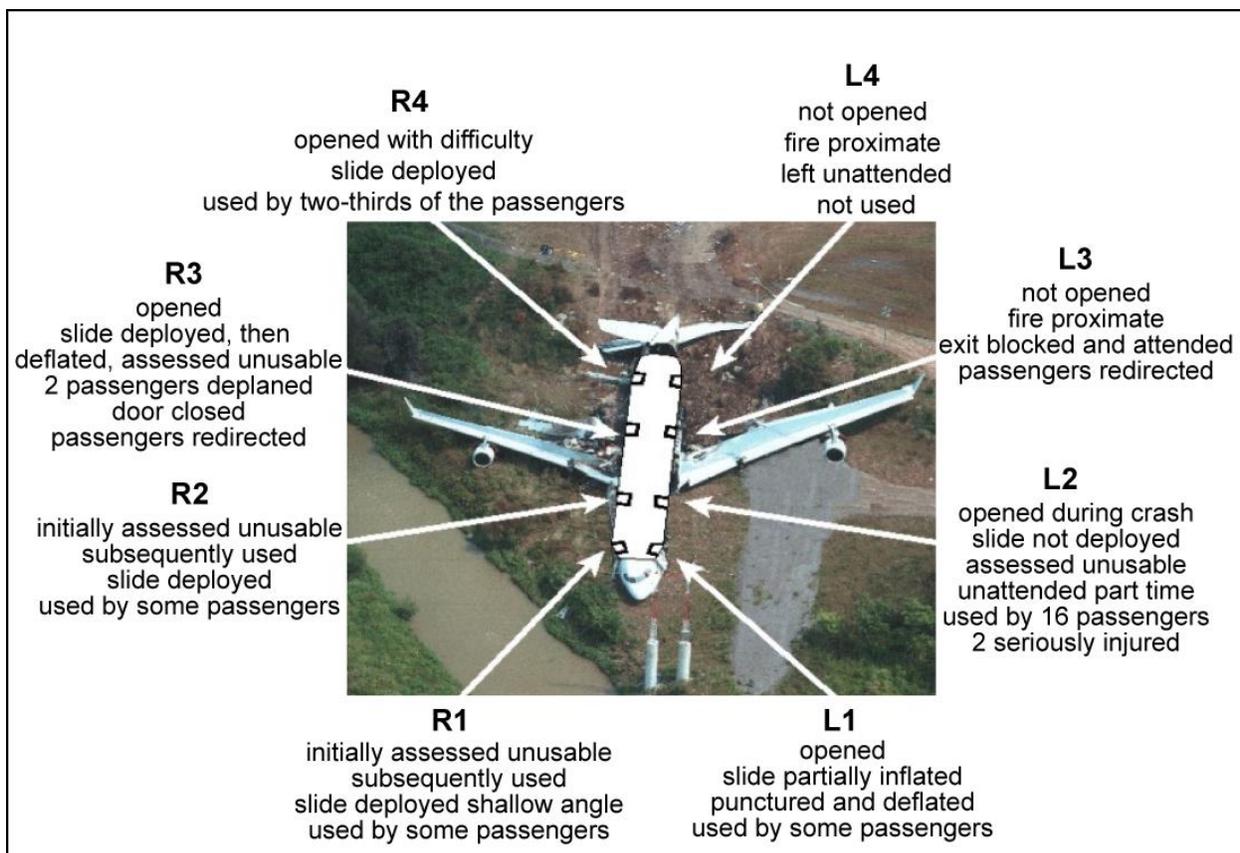
Figure 4. Emergency exits

At the onset of the evacuation, exits R1 and R2 were assessed by cabin attendants as unusable because the creek was immediately outside the exits. Both attendants followed the prescribed procedure for unusable exits. As the evacuation progressed, the attendants reassessed their

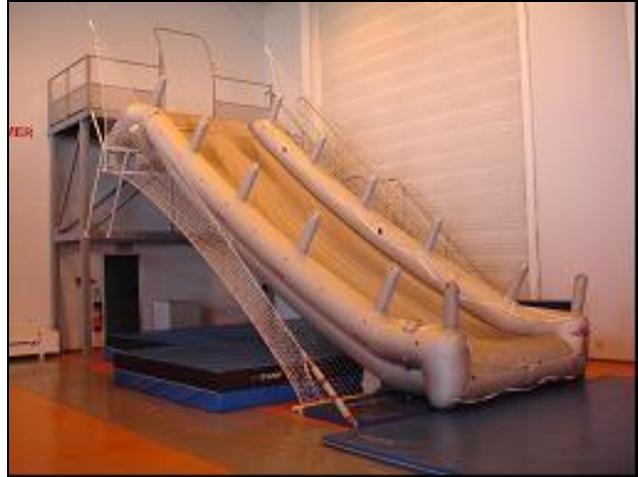
Photo 9. Slide training device

Following a review of Air France's emergency evacuation procedures and discussions with Air France training personnel, it was confirmed that their evacuation procedures for dual-lane slides called for cabin crew to instruct passengers to form two lines at the entrance to the slide and to instruct passengers to jump onto the slide two at a time by using the command "JUMP." Cabin crew members train for this procedure during aircraft qualifications training and recurrent emergency procedures training. Photo 9, taken by investigators at the Air France cabin crew training facility, in September 2005, shows the slide training device used by cabin crew.

The occurrence cabin crew noted that there was not enough room to form two lines of passengers at the entrance of the slide. Moreover, cabin crew conveyed that it was somewhat difficult for two passengers to jump onto the slide simultaneously, given the position of the slide in relation to the door opening and the location of the exit door alongside the exterior fuselage. One cabin attendant assisting at the bottom of a slide noted that passengers tended to jump onto the middle of the slide. All of the escape slides used during the evacuation of AFR358 were dual-lane slides. Only 23 per cent of passengers who indicated that they evacuated via an escape slide reported that they went beside another passenger.
