AIRCRAFT ACCIDENT REPORT FINAL REPORT

**Propulsion System Malfunction +
Inappropriate Crew Response**

**GOLDEN WINGS CHARTER
PILATUS BRITTEN
NORMAN ISLANDER BN2A-26
N133RS
S/N 606**

**Nassau, N.P., Bahamas
August 13, 2007**

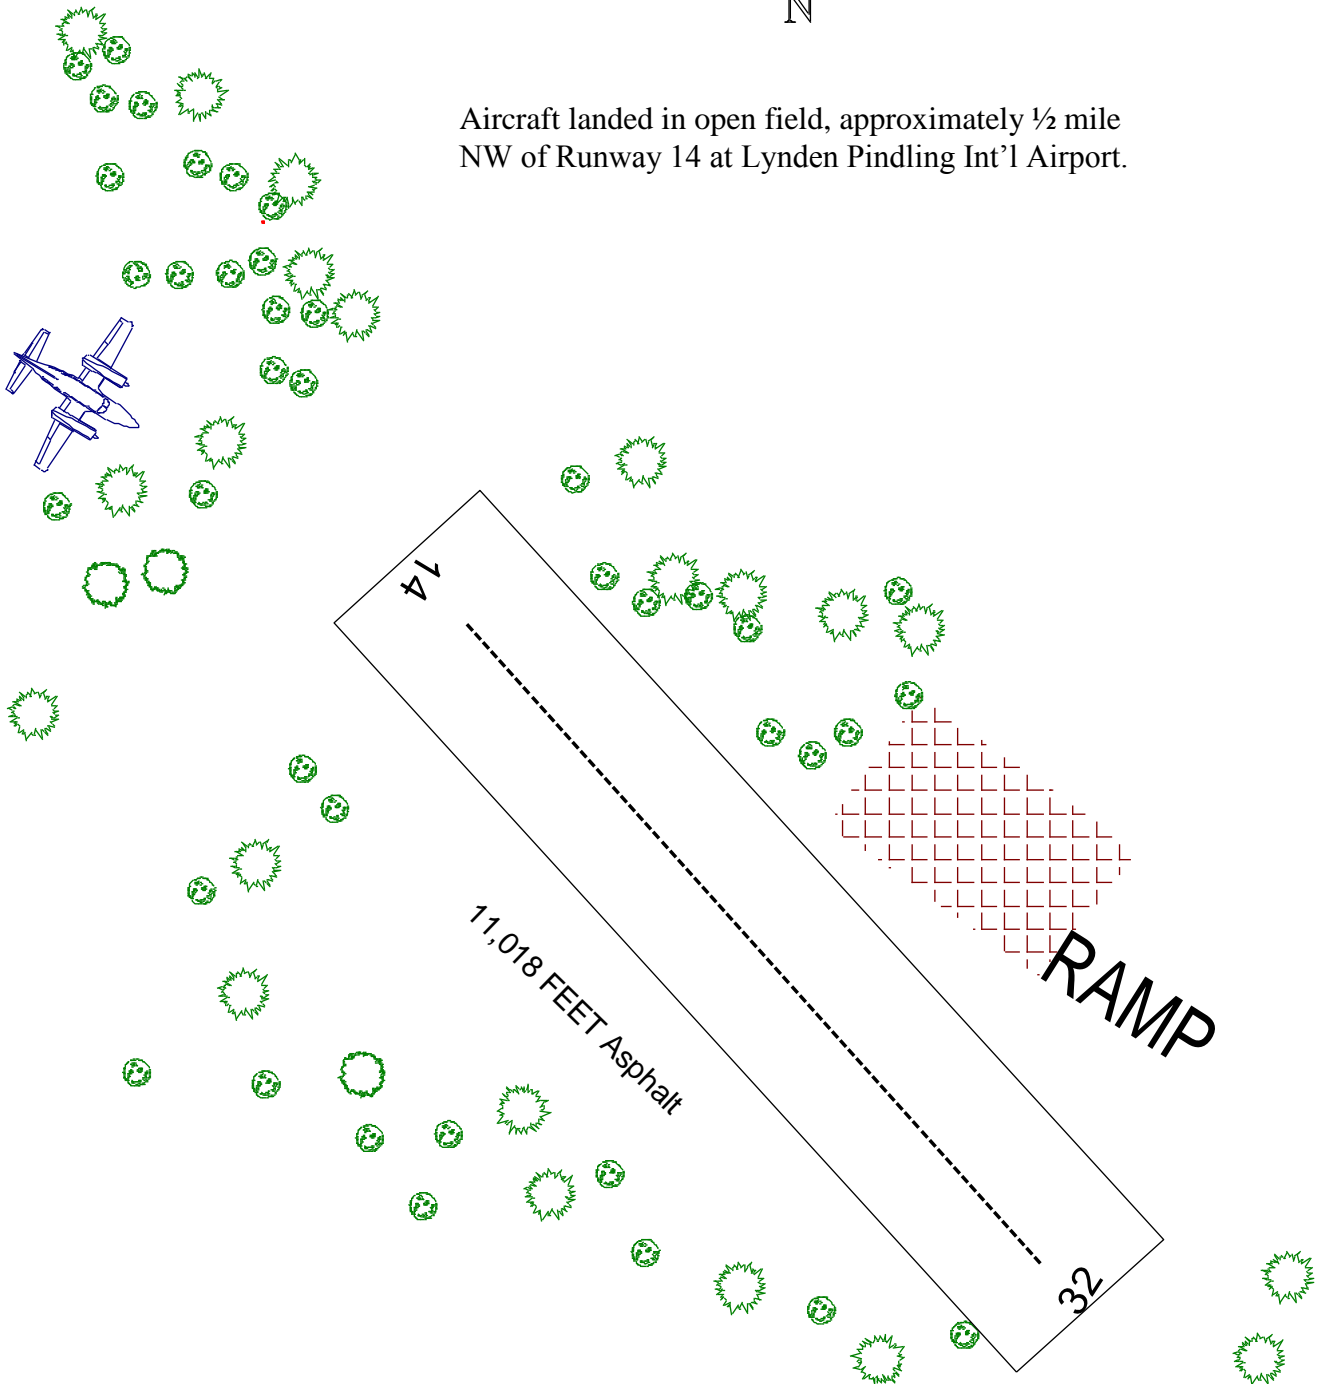
CRASH SCENE DIAGRAM

Aircraft landed in open field, approximately 1/2 mile NW of Runway 14 at Lynden Pindling Int'l Airport.

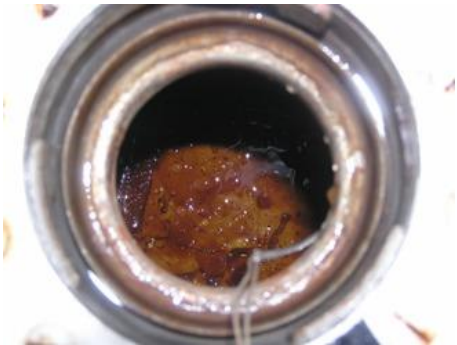
Left Wing Fuel Tank

**Approximately 1 US gallon of unusable fuel
drained from tank post accident
28th June 2007**

- c. Golden Wings Charter and the Flight Standards Inspectorate removed approximately 1US gallon of fuel from the left tank of aircraft N133RS on June 28, 2007. *See photograph in photo gallery*
- d. Golden Wings Charter and the Flight Standards Inspectorate removed approximately 13 US gallons of fuel from the right tank of aircraft N133RS on June 28, 2007.

2. Post accident investigation of N133RS, Approximately 1 US gallon of fuel was drained from the left tank and 13 US gallons from right tank (3.5 gallon of this 13 gallons is deemed unusable by the manufacturer).

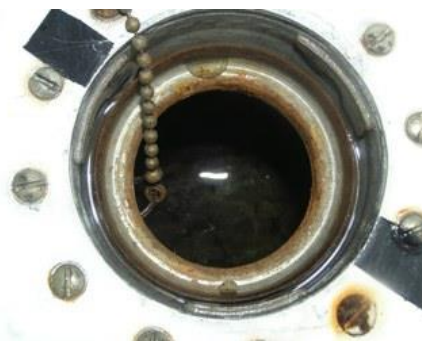
Right Wing Fuel Tank

**Approximately 13 US gallons drained
from tank post accident
28th June 2007
3.5 US gallons Unusable**

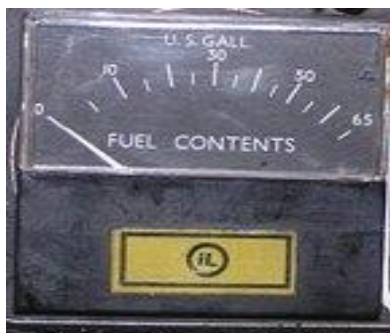
Left Fuel Quantity Indicator

**With power selected "ON"
Gauge reads "0"**

3. Post accident - Both fuel selectors were set at the respective tanks.
4. The pilot stated, "Yeah there is a slight problem with the left indicator it would show slightly less than the right, but that was only on the ground, once it became air borne it would level off." The pilot further stated, "I checked the fuel by the gages". He also stated that he never made a technical log entry or reported the matter to Golden Wings management.

5. The pilot used a fuel quantity indicator, which he stated was faulty, as a primary means of determining the amount of fuel on board the aircraft.
6. Left engine failure due to fuel exhaustion.

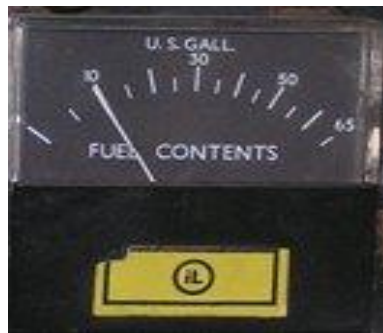
Right Fuel Quantity Indicator

**With power selected "ON"
Gauge reads "10" US gallons**
