**KNKT/05.24/09.01.38**

**AIRCRAFT ACCIDENT REPORT**

**PT. Mandala Airlines; MDL 091**

**Boeing B737-200; PK-RIM**

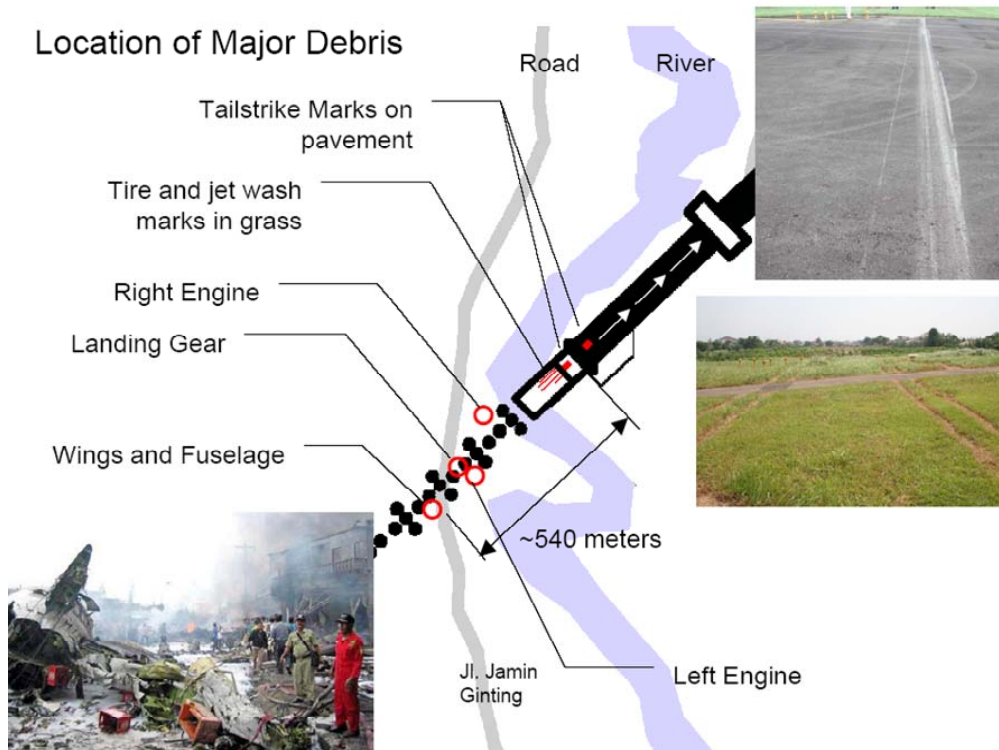
Both engines have detached from the aircraft due to impact to the ground. The right engine was found about 300 m and the left engine about 400 m from the end of the runway 23 (see Figure below).

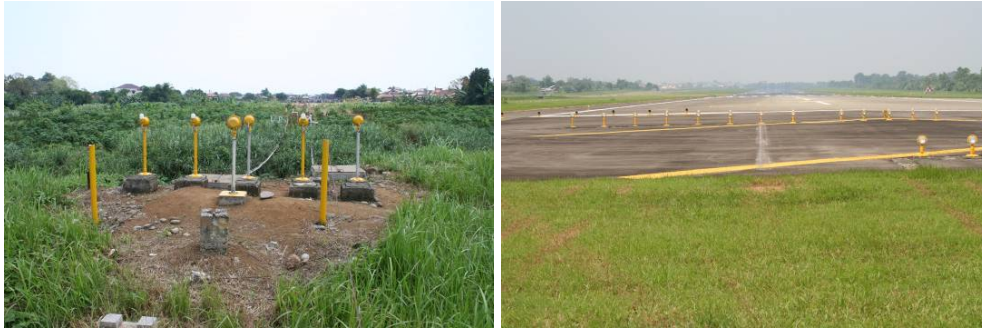
- a. Six approach lights including three support structures were damaged due to the impact.
- b. Approximately 30 houses were damaged due the impact and post-impact fire. Some cars, motorcycles and bikes were hit by the aircraft and burned.

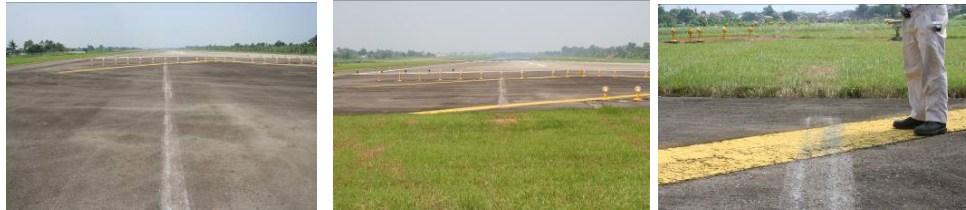
There was a 24 meter long silvery color scrape mark present on the stop-way starting about 7.3 meters right of the centerline and 61 meters prior to the intersection. A second scrape mark began at the second row of lights and ran about 58 meters towards the end of the overrun area.

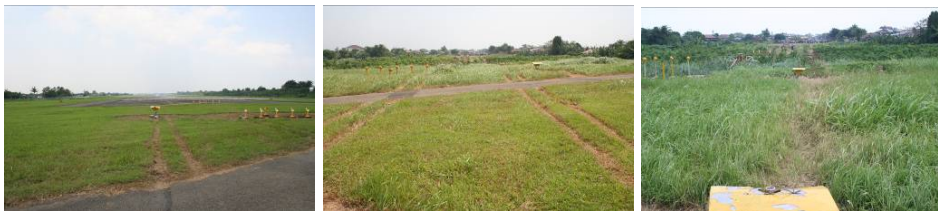
There were 4 main landing gear (MLG) tire impressions and evidence of jet wash from both engines present in the grass and dirt between the end of the overrun area and the river. There was also a small impression in the grass between the MLG impressions and in line with the scrape mark on the pavement. The airplane also impacted several of the approach lights between the end of the pavement and the river.

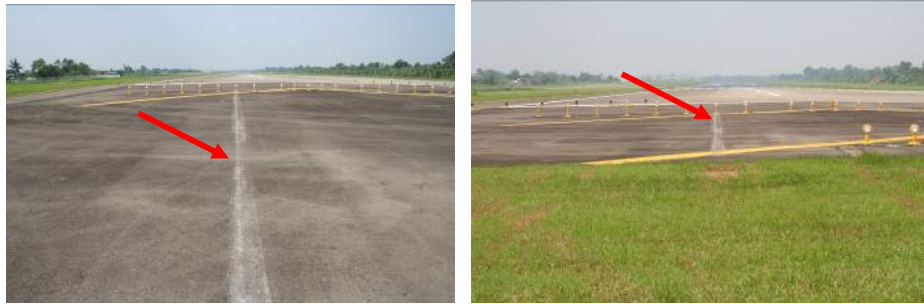
The first mark is at approximately 36 m long (from runway end), 5–7 cm wide, and 7.5 m right of centerline.

The second mark is at 26 m from end of runway 05.

The marks are confirmed as a result of tail strike.

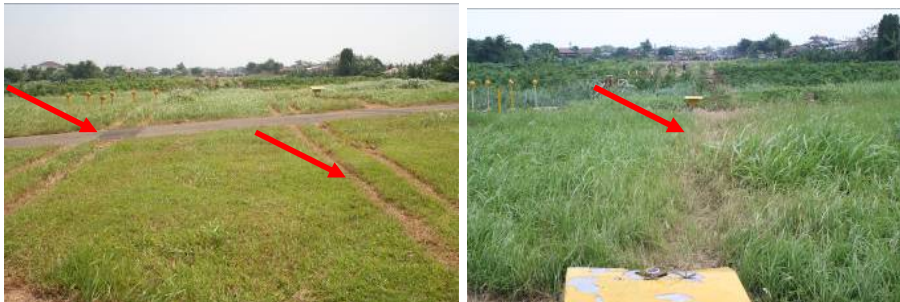
At the grass starting from the asphalt runway end to 12 m from the runway end, main landing gears' marks are clearly found. It continues up to a electrical box at the end of runway, while there is no any mark of the nose wheel. The outer wheel of left and right main landing gear struck the concrete structure of the approach light and the electrical box, respectively.

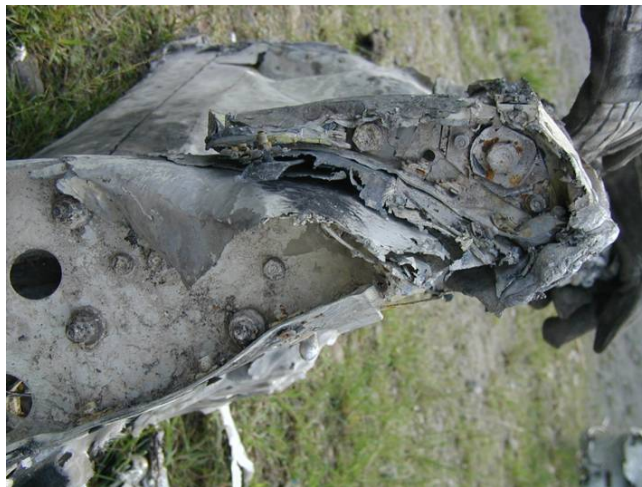
Portion of the front spar in the area of slat #4 remained intact including the two slat #4 main tracks, the two auxiliary tracks and a portion of the slat actuator fitting. The slat and actuator were not recovered. The inboard main track was partially extended and could be moved by hand while the inboard auxiliary track, outboard auxiliary track and outboard main track were jammed in the fully retracted position.

The photograph (Figure below) shows that the slat was in retracted position.

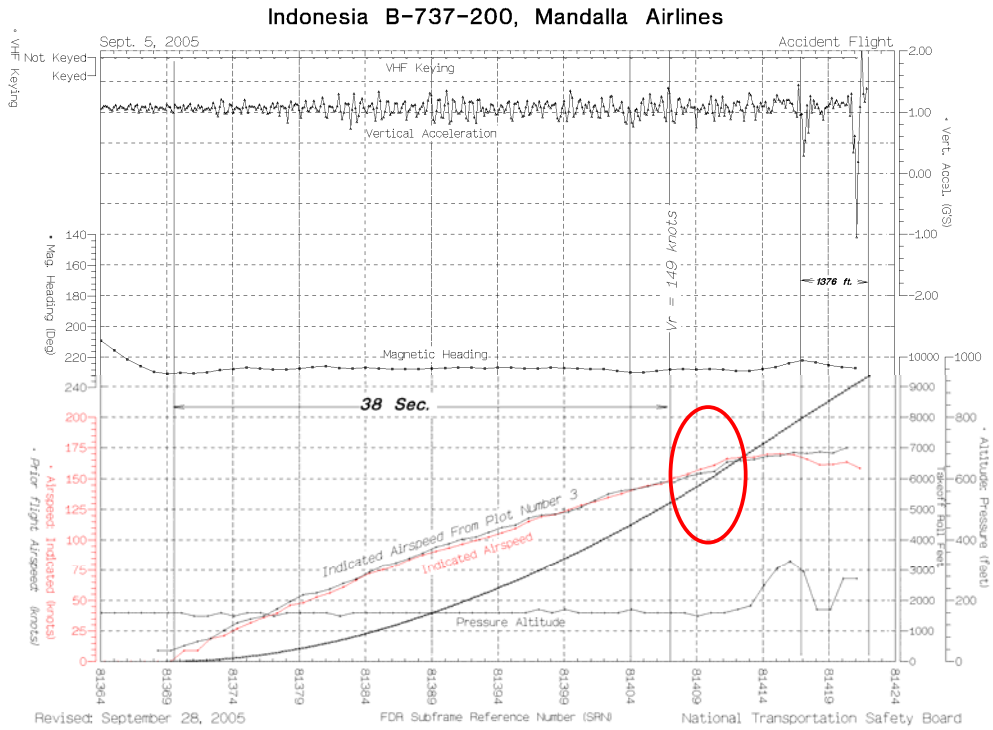
FDR plot of accident flight compared to previous flight from Medan in airspeed. Note that the airspeed of both flights are similar. Note also that the accident flight had a failure in lift-off as indicated by the trend in the pressure altitude.

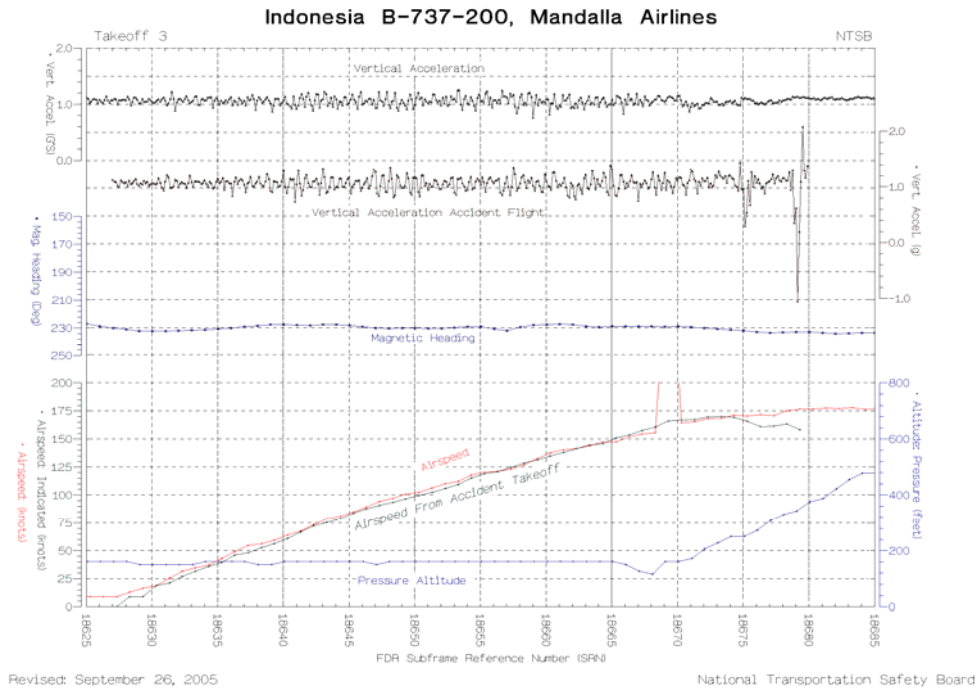
FDR plot of previous flight from Medan compared to accident flight in airspeed and vertical acceleration. Note the successful lift-off as indicated by increasing in pressure altitude.

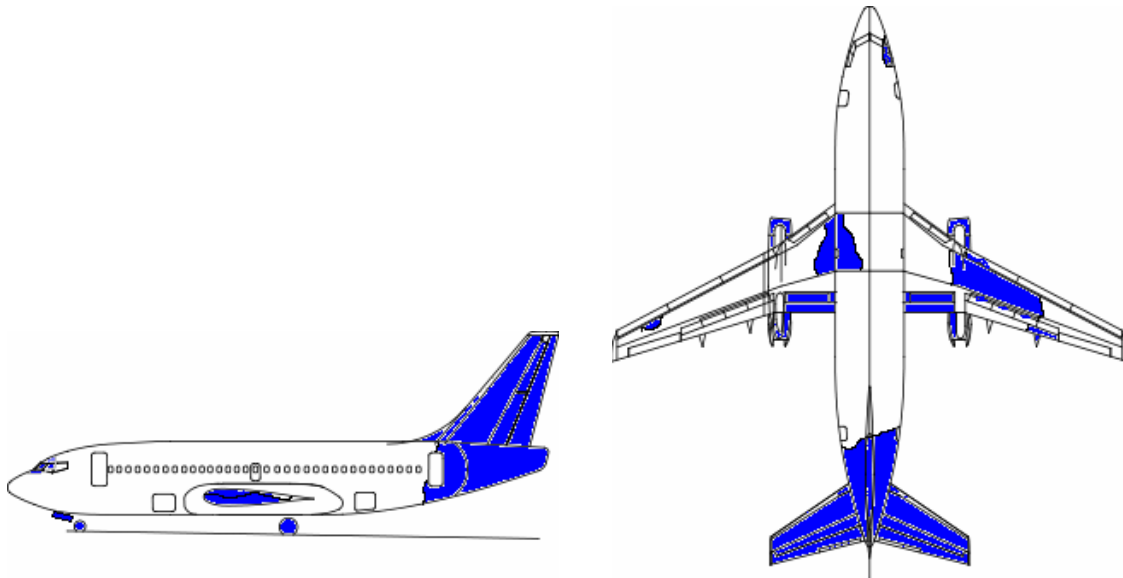
## Appendix A Recovered and identified portions of the wreckage

Most of the fuselage section was destroyed by post-impact fire. The remaining part of the fuselage is only the tail section (see Appendix A).

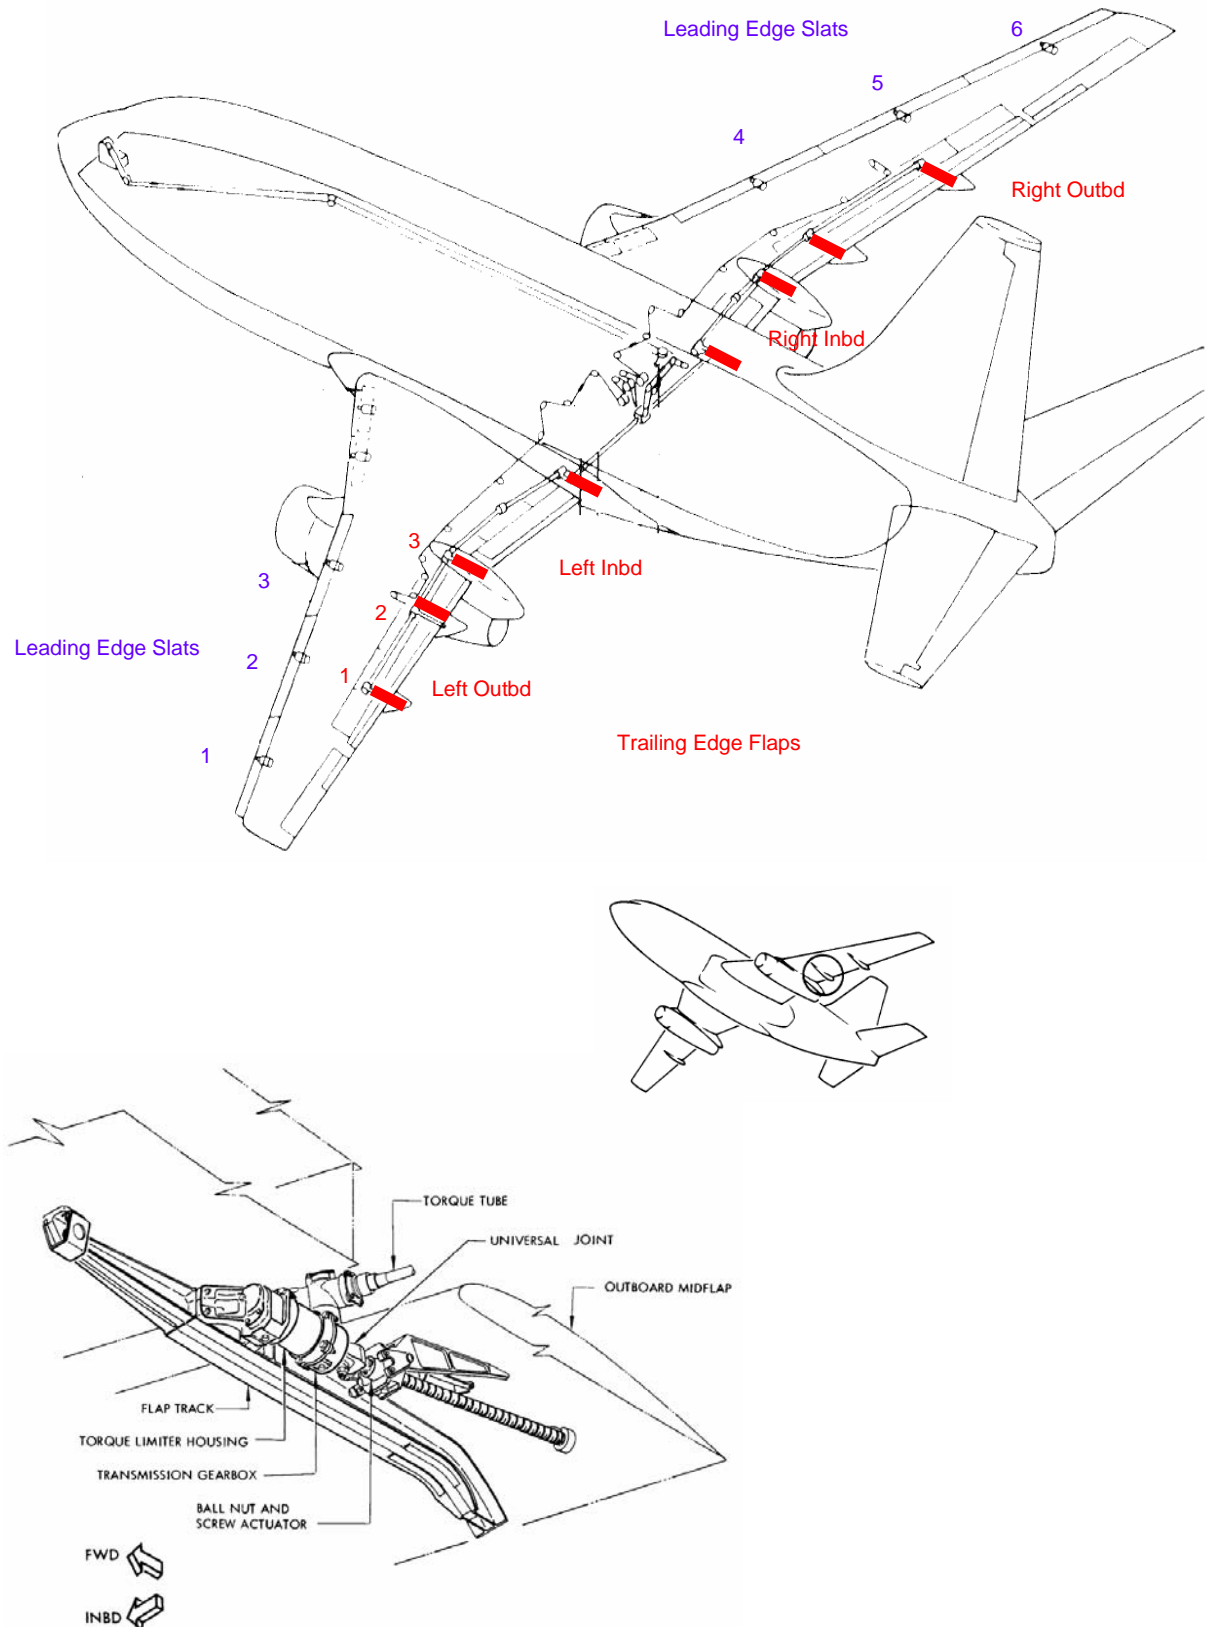
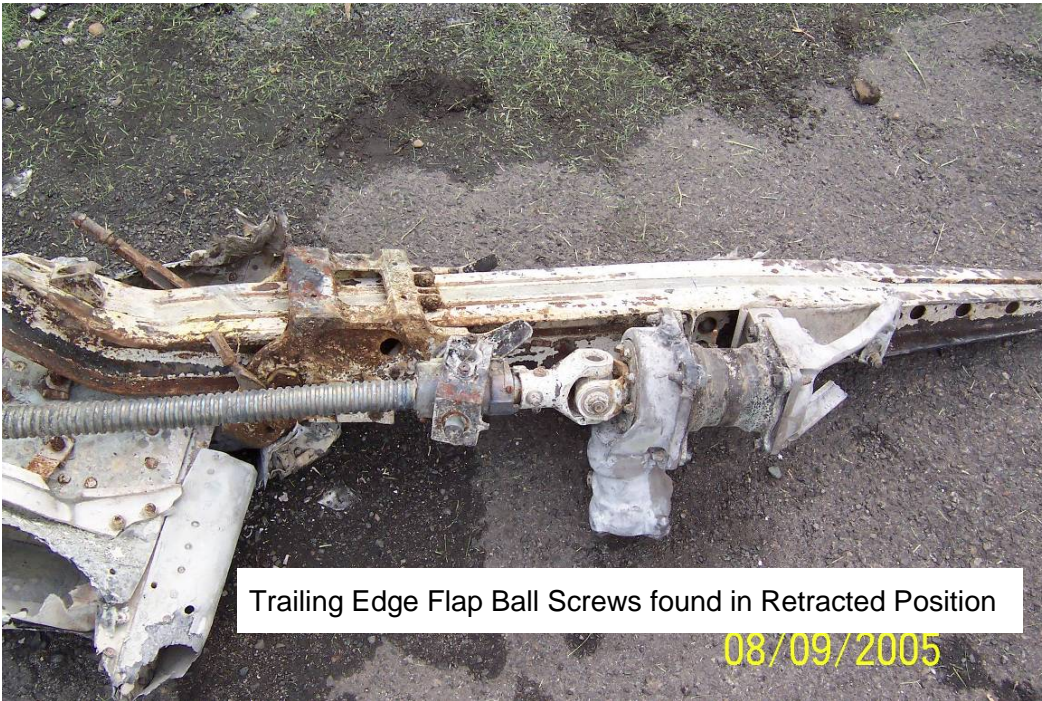
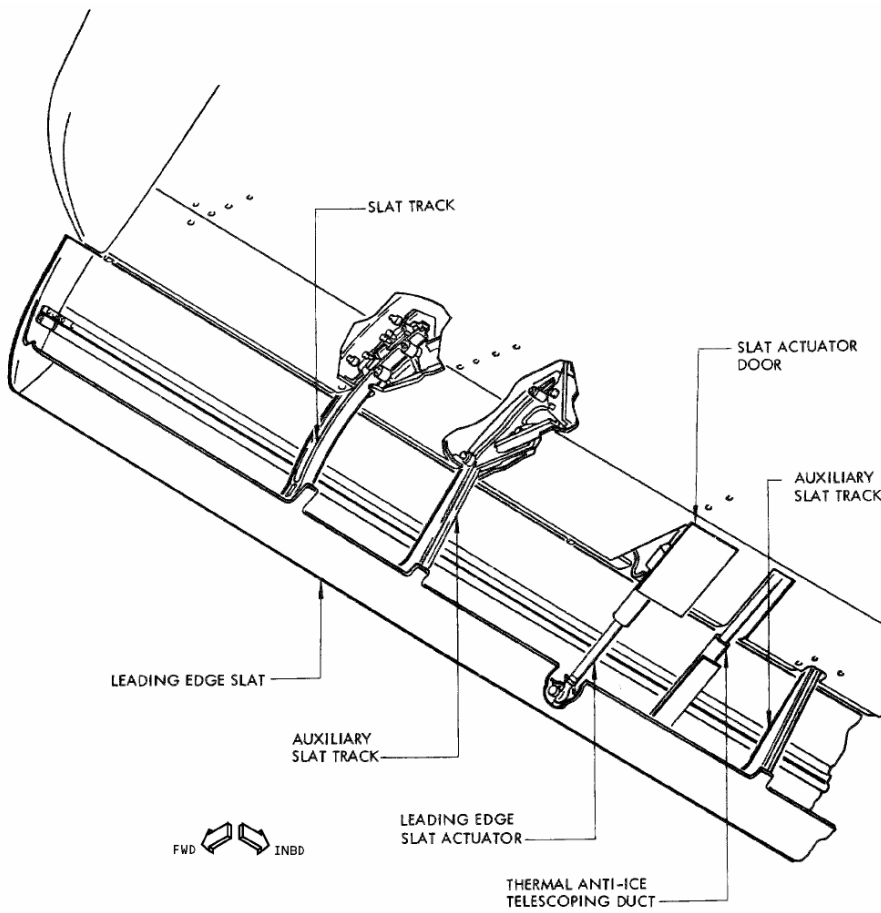
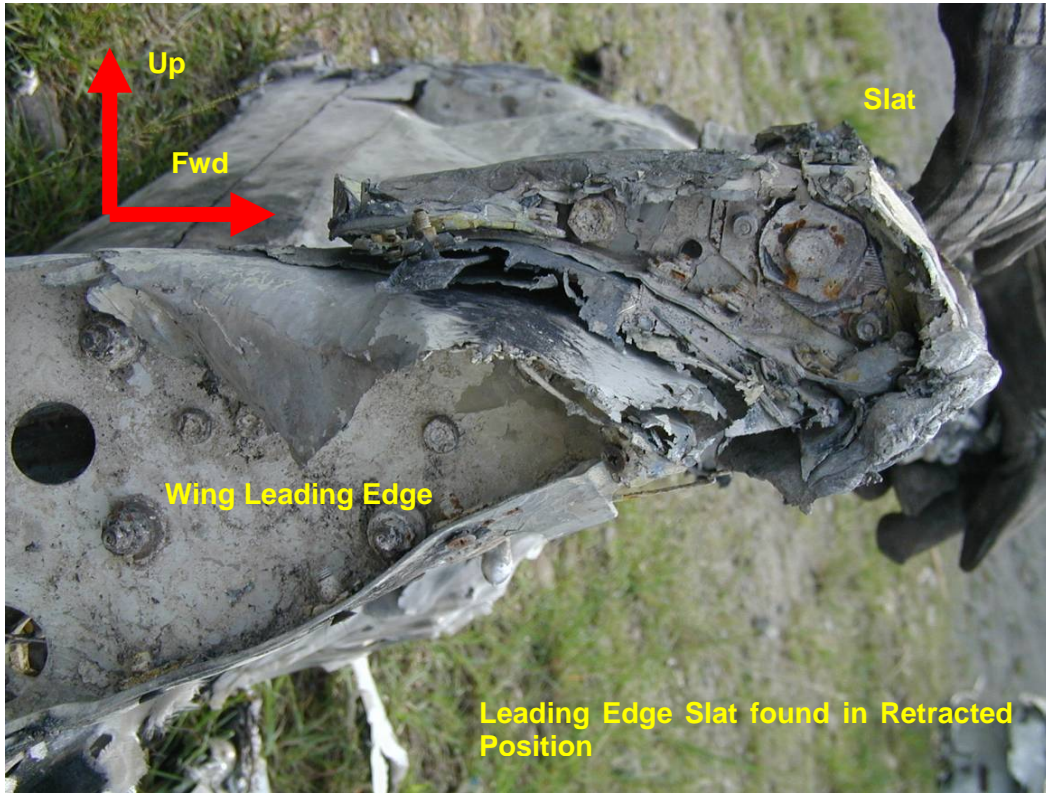
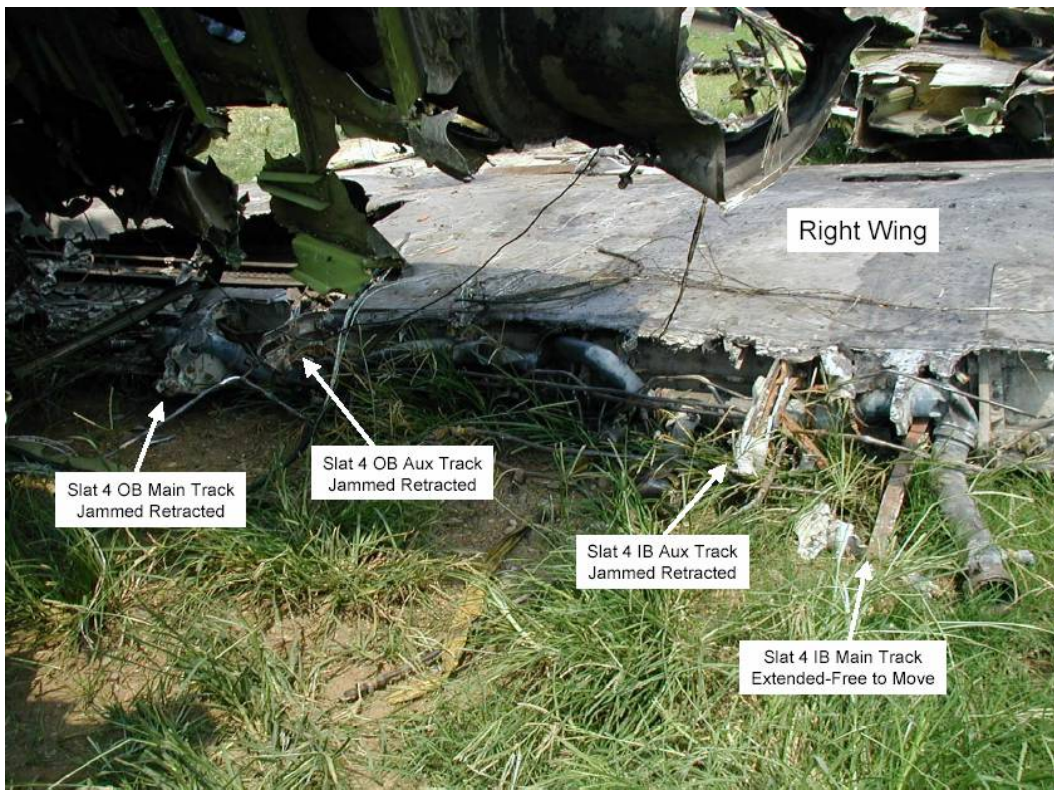
## Appendix B Picture of Flap Jackscrews

Six flap jackscrews (out of eight) were located and measured. One of which indicated to 2 to 2½ threads from the ball nut to the mechanical stop.

Trailing Edge Flap Ball Screws found in Retracted Position
