ATSB TRANSPORT SAFETY INVESTIGATION REPORT

Aviation Occurrence Report – 200503265

**Collision with Terrain
Mount Hotham, Victoria
8 July 2005**

Piper Aircraft Corporation PA31-350 Navajo Chieftain

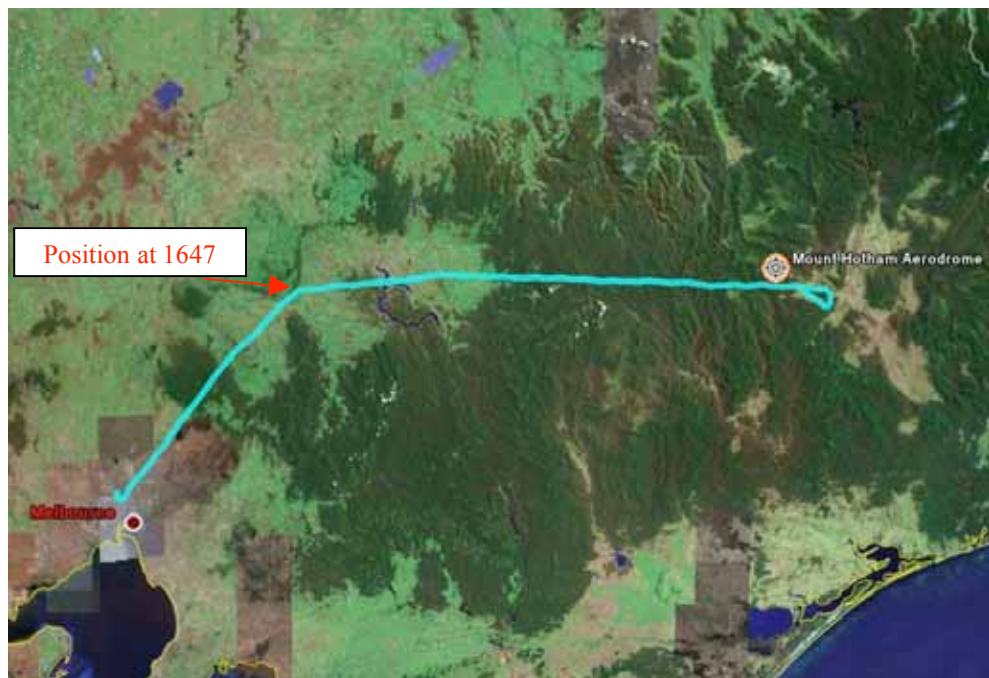
Figure 1: Diversion from the Essendon – Wangaratta track to Mount Hotham

At 1647 the pilot changed his destination to Mount Hotham (Figure 1)². That was acknowledged by air traffic control, who advised that the aircraft was outside

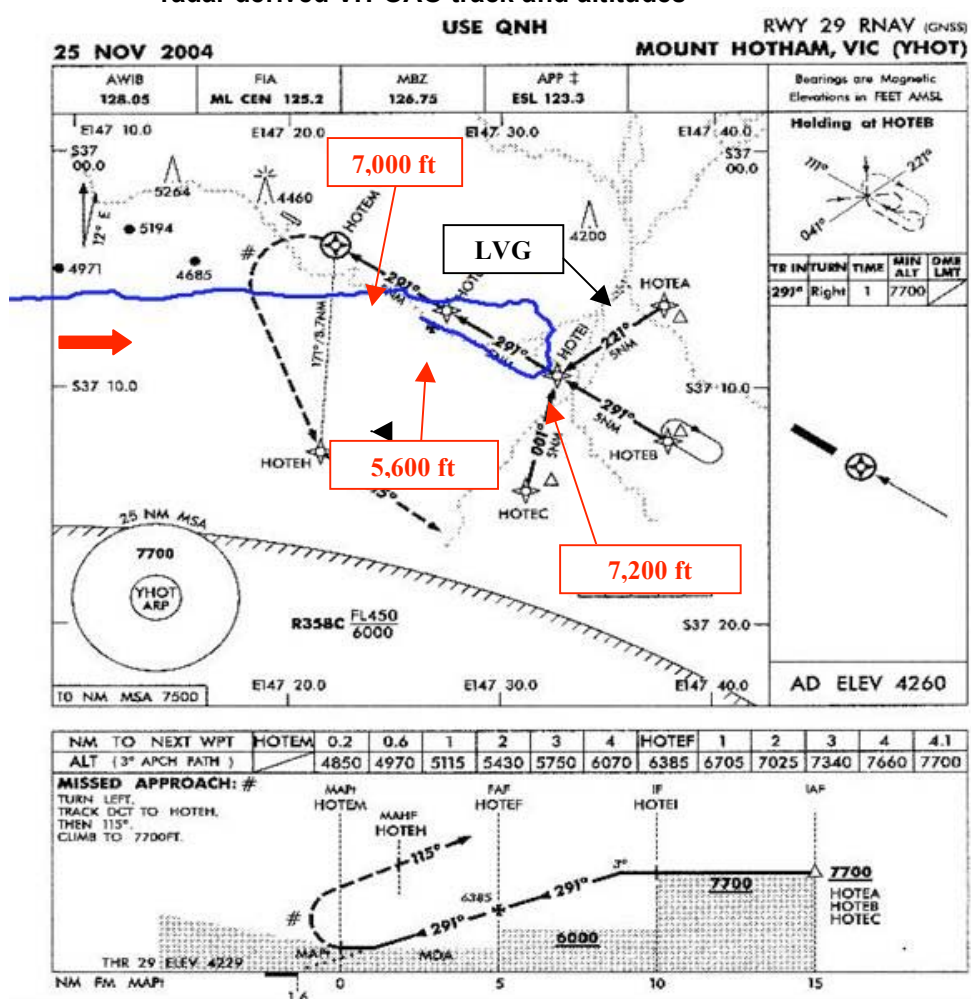
Figure 2: Runway 29 RNAV GNSS instrument approach chart showing the radar derived VH-OAO track and altitudes

HOTEL. When passing left abeam the final approach fix HOTEF, the Chieftain's altitude was 5,600 ft. The published minimum altitude at the final approach fix was 6,385 ft. Radar data also showed that the aircraft appeared to be tracking adjacent to the Great Alpine Road on the last segment of the flight (Figure 4) and diverging further left of the published RNAV GNSS inbound track. It passed 1.3 km to the left of the final approach path fix at HOTEF.

It is evident that the pilot did not follow the prescribed entry, tracking, or altitude requirements of the instrument approach procedure. Earlier that day a witness had observed the aircraft flying a final approach track corresponding to that flown on the occurrence flight, which suggests that he had conducted a similar approach on the earlier flight. That accorded with comments made by the pilot, as well as observations of his approaches in adverse weather. It is likely that the pilot adopted practices to gain visual contact with the ground and follow the Great Alpine Road (Figure 4). He was relying on local knowledge and experience to establish visual reference with the ground. The Chief Pilot was aware that in adverse weather conditions, the pilot did not always track via the published procedure at Mount Hotham.

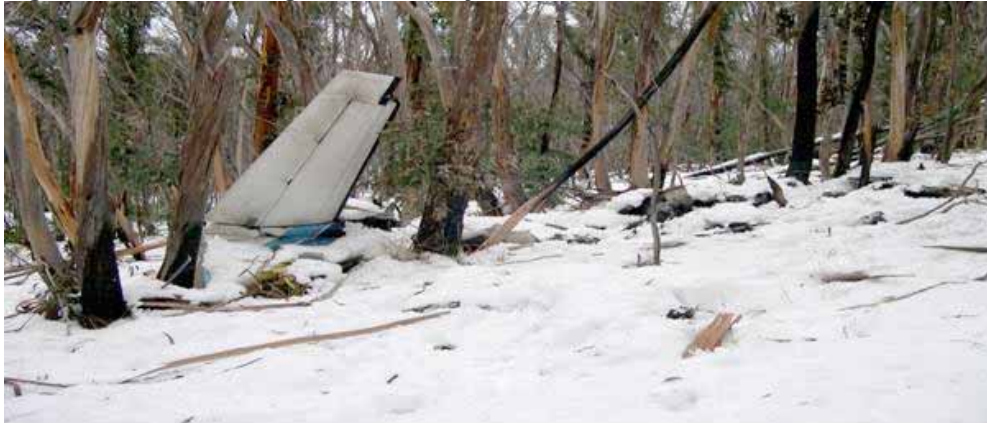
Figure 3: Main wreckage obscured by snow

The aircraft had cut a swath through trees on the slope of a steep ridge and came to rest near the top of the ridge. Tree damage indicated that the aircraft was maintaining an approximately level attitude, slightly banked to the right, and aligned on a magnetic bearing of 280 degrees.

Damage to the engines and propellers was consistent with both engines delivering power at the time of impact. The landing gear was extended, but its pre-impact position could not be confirmed. The wing flaps were fully retracted. An intense post-impact fire destroyed most of the fuselage, including the instrument panel and avionics.

An intense fire, fed by fuel from the ruptured right wing fuel tanks, consumed most of the fuselage.

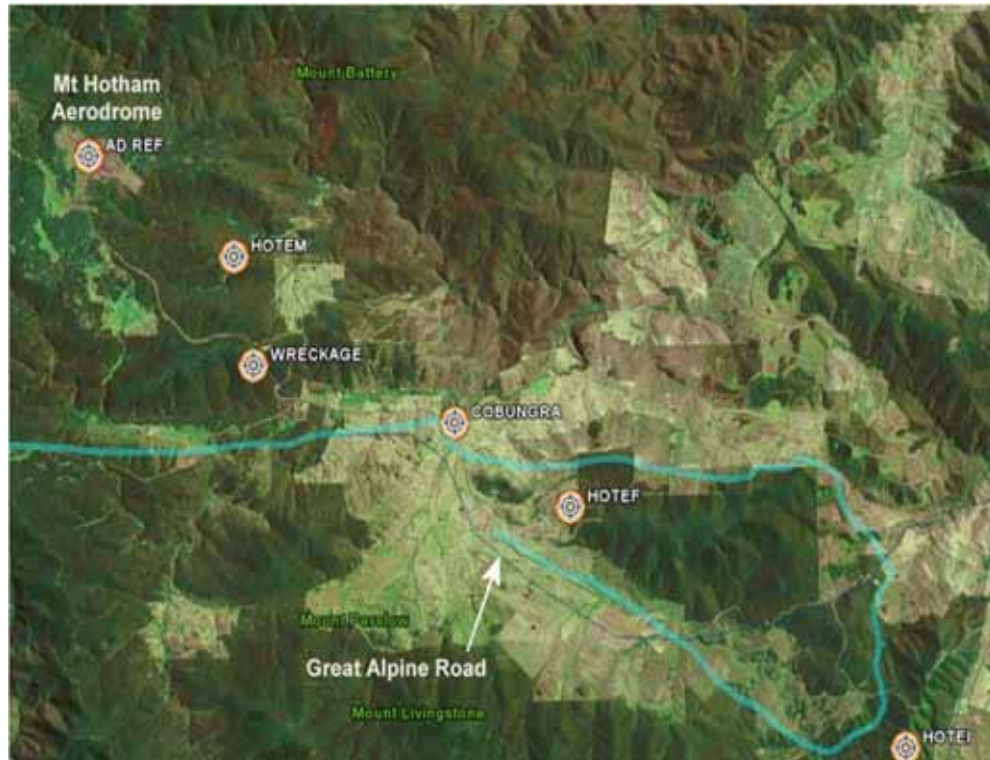
Figure 4: Aircraft flight path into lower terrain and relative to the Great Alpine Road

The controller did not see that the Chieftain had turned onto a southerly heading when about 5 NM west of HOTEH, but observed the aircraft when it turned toward Mount Hotham. TAAATS incorporated safety functions to automatically alert air traffic controllers to situations such as deviations by aircraft from their assigned altitude or flight path when within radar system coverage. Outside controlled airspace, altitude deviation alerts were not available and tracking alerts would only activate if an aircraft deviated more than 7.5 NM from a nominated track. The aircraft was not subject to any alerts during the flight, as it did not deviate more than 7.5 NM from the tracking requirements of the RNAV GNSS approach.

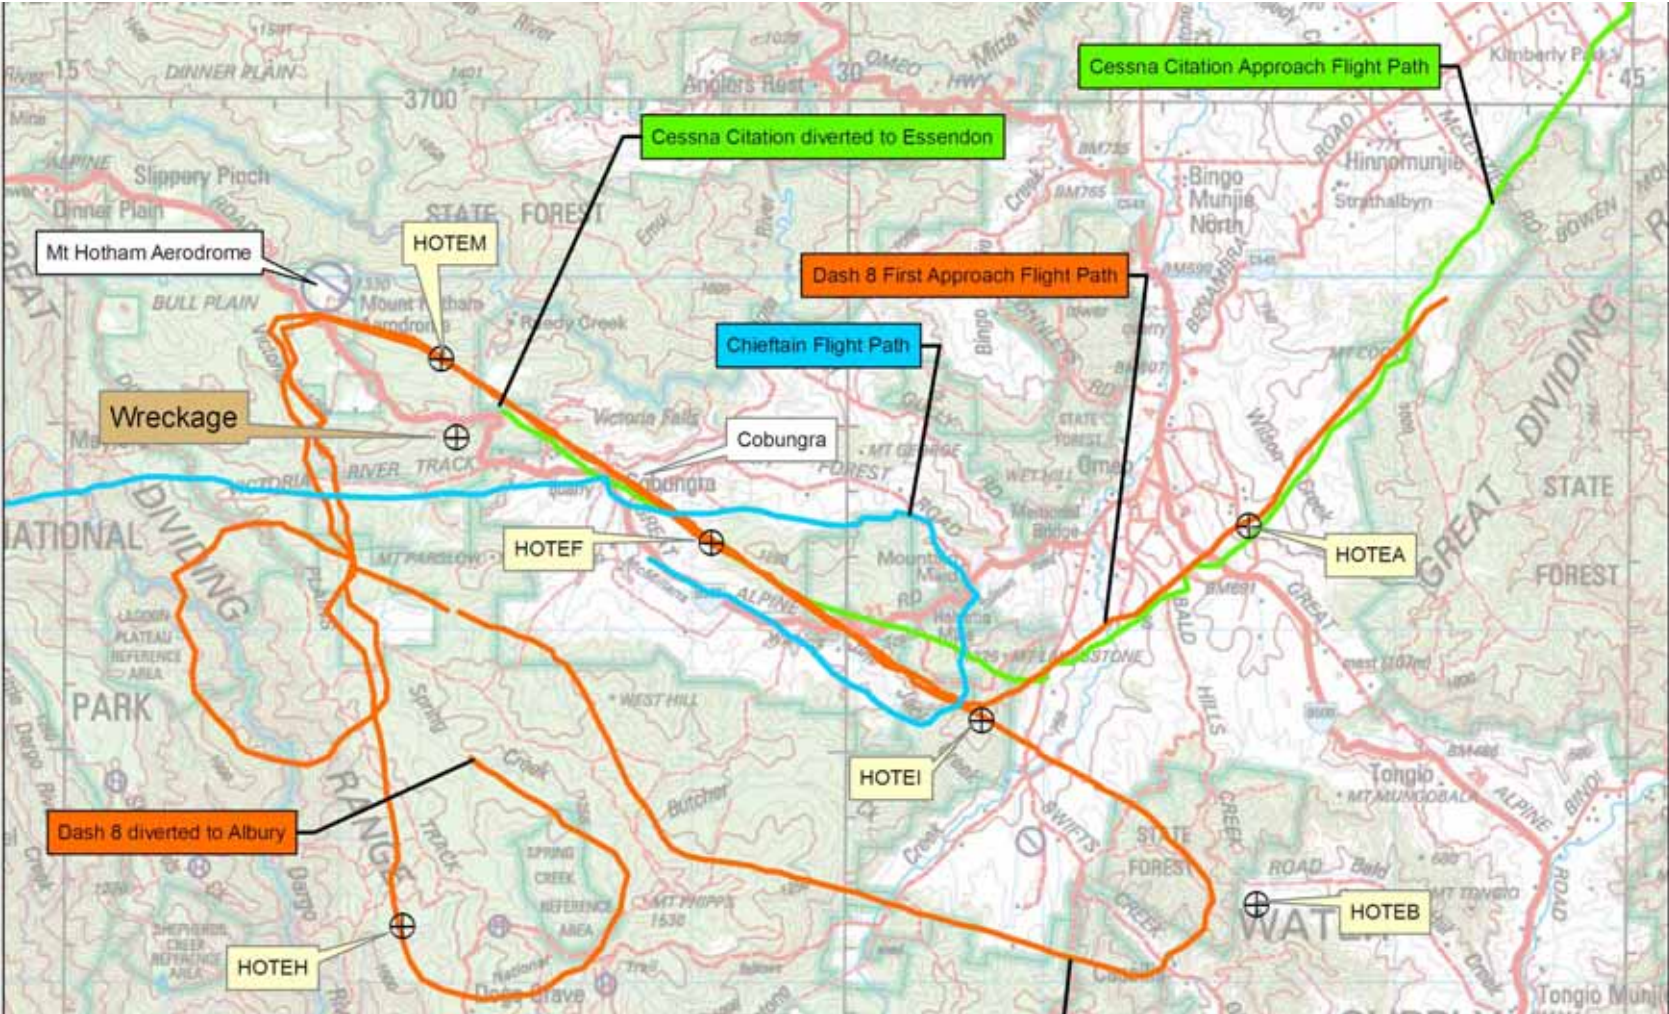
5.2 APPENDIX B The Dash 8, Cessna Citation and Chieftain flight tracks at Mount Hotham

During the day, a Bombardier Dash 8 (Dash 8) and a Cessna Citation aircraft had attempted RWY 29 RNAV GNSS approaches. Each aircraft's crew had commenced the approach by overflying the initial approach fix HOTEA. The Dash 8 crew conducted a second instrument approach, and joined the procedure from a position abeam HOTE B. As the crews were unable to establish visual reference at the approach minima, they diverted to alternate aerodromes. Radar data showed that the instrument approaches were conducted in accordance with the published procedure (Appendix B).
